**VERIDIAN REMOTE KNEE BOLSTER AIR BAG INJURY
INVESTIGATION
SCI TECHNICAL SUMMARY REPORT**

NASS/SCI COMBO CASE NO. 2000-09-033C

VEHICLE - 1999 KIA SPORTAGE SPORT UTILITY VEHICLE

CRASH DATE - MARCH, 2000

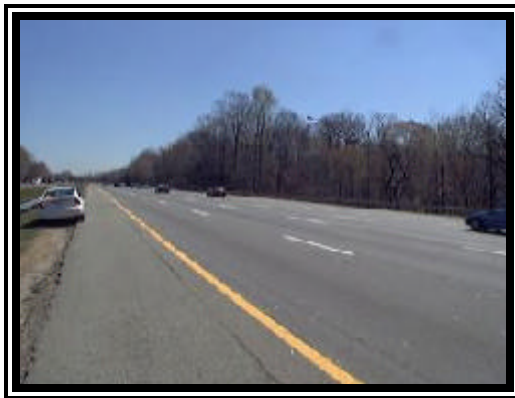
The 30 year old male driver of the 1999 Kia Sportage was operating the vehicle eastbound (**Figure 1**) in the inboard lane at a driver reported speed of 92 km/h (57 mph) when he was reportedly cutoff by a (non-contact) vehicle in the adjacent lane and forced to enter the left (north) shoulder into the center median area.

Figure 1. East view of travel lanes.

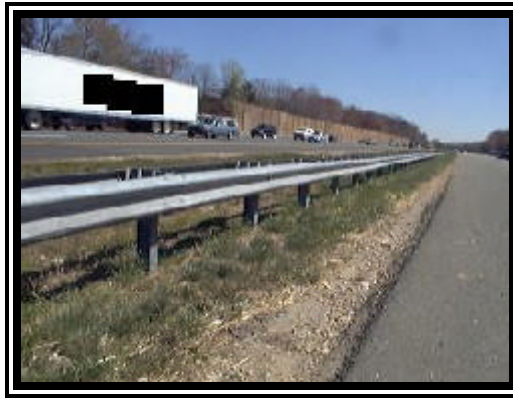
As the Kia departed the north pavement edge, the left side surface impacted the center median W-beam guardrail (**Figure 2**) resulting in minor damage. The Kia re-entered the eastbound lanes in a southeasterly direction and across the path of the eastbound Crane roll-off truck. As the Kia entered the outboard #2 lane, the front right area struck the left side surface of the Crane truck resulting in moderate damage. The impact induced deceleration was sufficient to deploy the Kia's driver knee and frontal air bag system. *Contrary to the NASS case file*, a barrier equivalent velocity change for this impact could not be computed due to the overlapping nature of subsequent impacts. The right rear side surface of the Kia subsequently sideslapped the left rear side surface of the Crane which resulted in minor damage. At this point, the Kia was re-directed across the eastbound lanes and into the center median area. As the Kia departed the north pavement edge, the front left area impacted the W-beam guardrail resulting in moderate damage. The Kia rotated approximately 30 degrees counterclockwise and came to rest in close proximity to the final impact perpendicular to the north shoulder facing northwest. The Crane truck was driven to final rest on the south shoulder.

Figure 2. Impacted W-beam guardrail.

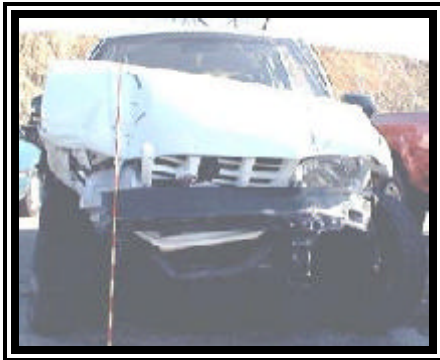
The 1999 Kia Sportage sustained moderate frontal damage as a result of the impact with the Crane truck (**Figures 3 & 4**). The direct contact damage began at the front right bumper corner and extended 45.0 cm (17.7 in) inboard. The impact deformed the full frontal end width resulting in a combined direct and induced damage length (Field L) of 101.0 cm (39.8 in). Six crush measurements were documented at the level of the reinforcement bar (*bumper fascia separation*): C1= 25.0 cm (9.8 in), C2= 25.0 cm (9.8 in), C3= 14.0 cm (5.5 in), C4= 9.0 cm (3.5 in), C5= 9.0 cm (3.5 in), C6= 0 cm. The Collision Deformation Classification (CDC) for this impact to the Kia was 01-FREW-2 with a principal direction of force of (+)30 degrees. Direct contact damage was also identified to the front left area attributed to the secondary W-beam guardrail impact. The direct contact damage began at the front left bumper corner and extended 50.0 cm (19.7 in) inboard. The CDC for this final impact to the Kia was 12-FLEW-2 with a principal direction of force of (-)10 degrees. Two substantial impacts along the front end structure resulted in overlapping damage, therefore, NASS Delta-V calculations were invalidated. The hood and fenders were displaced rearward from the impact force. Reduction in the right side wheelbase measured 6.0 cm (2.4 in) as the left wheelbase was elongated 3.0 cm (1.2 in). The windshield was fractured from exterior impact forces only. No wheels/tires were restricted or flat. All left side tempered glazing remained undamaged.

Figure 3. Frontal (overlapping) damage to the 1999 Kia Sportage.

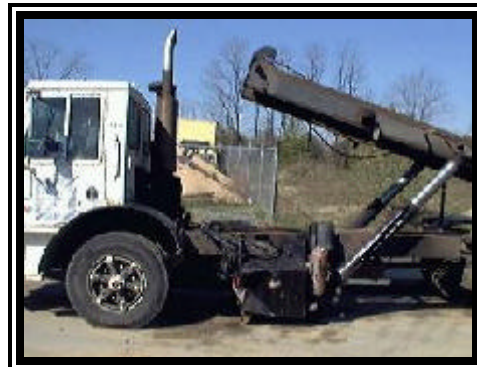
Figure 4. Impact damage to the (left side surface) hydraulic box of the 1982 Crane roll-off truck.

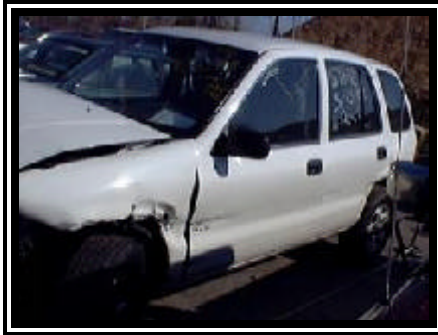
Additional contact damage was identified to the left side surface attributed to the initial W-beam guardrail impact (**Figure 5**). The direct contact damage began 16.0 cm (6.3 in) aft of the front left bumper corner and extended rearward 340.0 cm (133.9 in). A maximum crush value of 4.0 cm (1.6 in) was approximated just forward of the left A-pillar area. No engagement was noted to the end structure for this initial impact, therefore, a CDC of 12-LDES-1 was assigned to the side surface. Contact damage was also documented to the right rear side surface attributed to the secondary (sideslap) impact with the Crane truck (**Figure 6**). The direct contact damage began 6.0 cm (2.4 in) forward of the rear right bumper corner and extended forward 32.0 cm (12.6 in). Four crush measurements were documented at the level of the mid-door: C1= 2.0 cm (0.8 in), C2= 6.0 cm (2.4 in), C3= 5.0 cm (2.0 in), C4= 0 cm. A maximum crush value of 8.0 cm (3.1 in) was documented between the C2 and C3 position. The CDC for this impact to the Kia was 03-RBAN-1. The rear right tail light was fractured

Figure 5. W-beam guardrail damage to the left side surface.

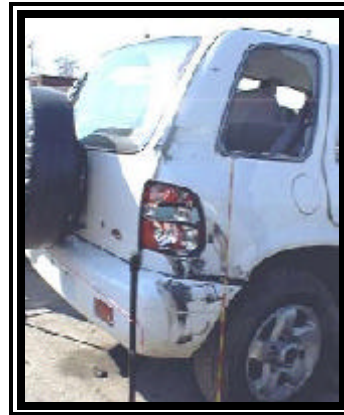
with rubber transfers surrounding the damaged area and attributed to the 3rd axle (tire) on the Crane truck. The right rear quarter window tempered glazing was disintegrated.

Figure 6. Sideslap damage to the right rear side surface.

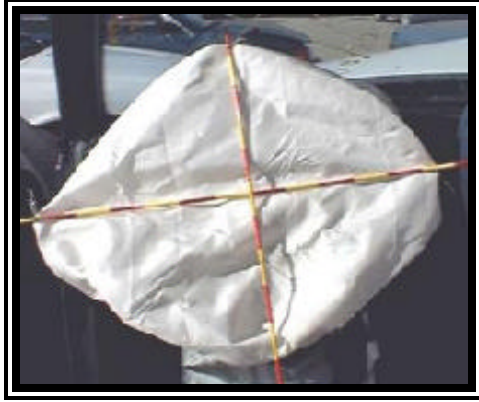
The 1999 Kia Sportage was equipped with a driver knee bolster air bag and redesigned frontal air bags for the driver and front right passenger positions which deployed as a result of the impact with the Crane truck. The driver air bag was housed in the center of the steering wheel with a horizontally oriented flap tear seam (H-configuration). The flaps were asymmetrical in shape as the upper flap measured 15.0 cm (5.9 in) in width and 7.0 cm (2.8 in) in height while the lower flap measured 15.0 cm (5.9 in) in width and 6.0 cm (2.4 in) in height. Although no contact evidence was identified on the exterior surface of the module cover flaps, black vinyl transfers were noted to the right centered portion of the bag from expansion within the module. The NASS researcher measured the diameter of the driver bag at 61.0 cm (24.0 in) in its deflated state (**Figure 7**). No internal tether straps were present. The bag was vented by two ports located at the 11 o'clock and 1 o'clock sectors on the rear aspect of the air bag.

Figure 7. 1999 Kia Sportage deployed redesigned driver air bag.

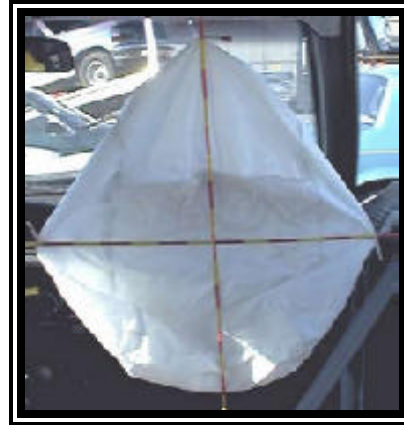
The front right passenger air bag deployed from the right mid-instrument panel area with a single cover flap design hinged at the top aspect. The passenger air bag was identified by the part number: P119455-02M with a bar coded lot number of: TAW365M10135. No contact evidence was identified on the air bag or exterior surface of the module cover flap. The cover flap was rectangular in shape and measured 24.0 cm (9.4 in) in width and 12.0 cm (4.7 in) in height. The NASS researcher measured the passenger air bag at 40.0 cm (15.7 in) in width and 76.0 cm (29.9 in) in height in its deflated state (**Figure 8**). The bag was tethered by one internal strap. No vent ports or cutoff switch were reported for the front right passenger air bag.

Figure 8. 1999 Kia Sportage deployed redesigned passenger air bag.

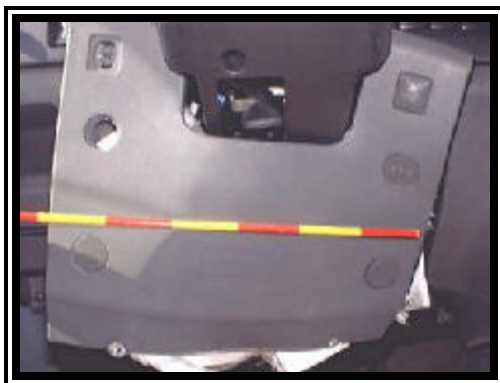
The Kia was also equipped with a driver knee bolster air bag that deployed from the left lower instrument panel area. The air bag was identified by the part number: P118959-016 with a bar coded lot number of: TAW015N10433. The module cover flap was “U” shaped and measured 31.0 cm (12.2 in) in width and 30.0 cm (11.8 in) in height (**Figure 9**). This design provides protection to the driver’s lower extremities by allowing the bag to expand against the (tethered) module cover panel. The rear aspect of the air bag was attached to a metal reinforcement plate below the steering column. No contact evidence was identified to the air bag membrane. The NASS researcher measured the knee bolster air bag at 47.0 cm (18.5 in) in width and 33.0 cm (13.0 in) in height in its deflated state (**Figure 10**). No vent ports were present. The front outboard restraint systems also included buckle pretensioners mounted longitudinally alongside the seat cushions. The activation of the driver side pretensioner pulls a cable which lowered the height of the buckle assembly, reducing slack in both the lap and shoulder belt webbing.

Figure 9. 1999 Kia Sportage driver knee bolster air bag module cover.

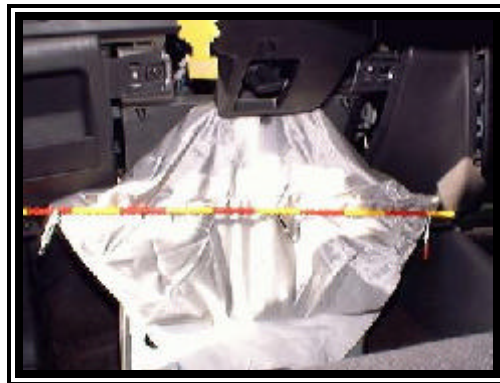
Figure 10. 1999 Kia Sportage deployed driver knee bolster air bag.
