**REMOTE REDESIGNED AIR BAG DEPLOYMENT INVESTIGATION
SCI TECHNICAL SUMMARY REPORT**

NASS/SCI COMBO CASE NO. 00-11-078J

VEHICLE - 1999 FORD F150 PICKUP TRUCK

CRASH DATE - JULY 2000

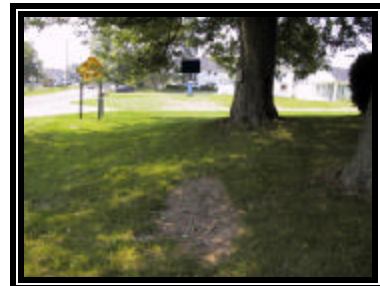
The front right wheel area struck a tree and the pickup truck continued to travel in a west direction across a driveway and lawn area in a tracking mode. The principal direction of force was 10 degrees. The tree was located 7.0 m (23.0') north of the right road edge (**Figure 3**).

Figure 3. First impact with tree

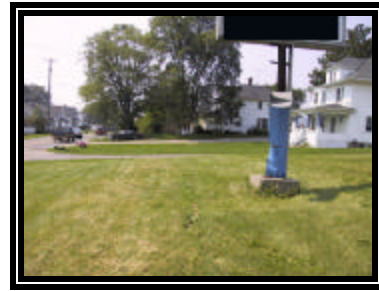
The front right area of the pickup truck sideswiped a non-breakaway commercial sign post with a concrete base and continued to travel in a west direction across another driveway and lawn area maintaining a tracking mode. The principal direction of force was 10 degrees. The sign post was located 11.6 m (38.1') north of the right road edge (**Figure 4**).

Figure 4. Second impact with sign post

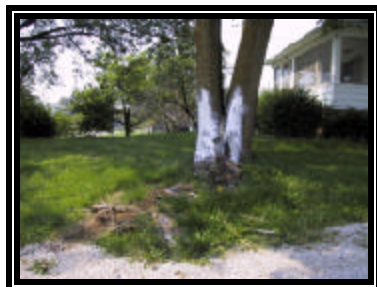
The Ford pickup truck traveled across a third driveway and continued across a lawn area prior to impact with a second tree cluster. A gouge mark was noted in the vehicle's trajectory in the lawn prior to where it crossed the third driveway. The pickup truck traveled on the lawn approximately 4 m (13') from the western edge of the driveway to the edge of the tree. The lawn sloped upward from the edge of the driveway to the base of the tree approximately 0.3 m (1.0'). The front right area of the Ford F150 pickup truck impacted the common trunk of a tree cluster measuring 1.5 m (4.9') in diameter (**Figure 5 and Figure 6**). The tree cluster was located 14.3 m (46.9') north of the right road edge. The principal direction of force was 10 degrees. The damage algorithm of the WinSMASH program computed a velocity change of 98.6 km/h (61.3 mph). The longitudinal and latitudinal components were -97.1 km/h (-60.3 mph) and -17.1 km/h (-10.6 mph), respectively. The impact force was sufficient to deploy the redesigned frontal air bag system in the Ford F150 pickup truck. The severe impact force probably caused the rear of the pickup truck to pitch upward. The pickup truck rotated approximately 30 degrees clockwise (CW) to final rest adjacent to the tree.

Figure 5. Point of impact

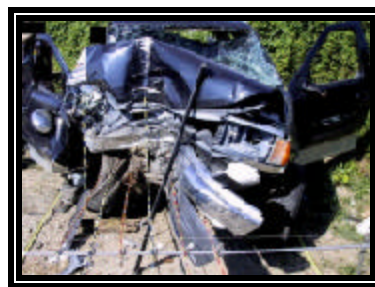
Figure 6. Damage to the Ford F150 pickup truck

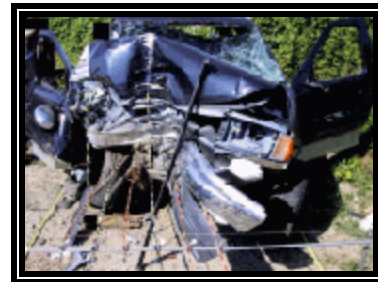
The 1999 Ford F150 pickup truck sustained severe frontal damage as a result of the impact with the 1.5 m (4.9') diameter tree cluster (**Figure 8**). Maximum crush was located at C4 and measured 121 cm (48"). Direct contact damage began at the center of the frontal plane and extended to the right bumper corner. The combined direct and induced damage involved the entire frontal width of the vehicle and measured 76 cm (30") from bumper corner to bumper corner. The Collision Deformation Classification(CDC) for this impact to the tree was 12-FZEW-5. The right half of the bumper, radiator support, and leading edge of the hood were crushed rearward to the right A-pillar (**Figure 9**). The right front axle position was displaced rearward to the right A-pillar which resulted in a shortening of the right side wheelbase by 77 cm (30"). The hood was buckled at the designated fold points. The left bumper corner was protruded forward toward the center of the vehicle. The left front fender was bowed inward toward the center of the vehicle. Both side view mirrors were displaced and abrasions were noted along the right side of the cab. The roof was buckled on the right side. The windshield was cracked from impact forces and partially separated along the windshield header. All door glazing and back light glazing were disintegrated from impact forces. Six crush measurements were taken by the NASS Researcher at the level of the bumper and were

Figure 8. Frontal view of damage

as follows: C1 = 0 cm, C2 = 107 cm (42"), C3 = 117 cm (46"), C4 = 121 cm (48"), C5 = 118 cm (46"), C6 = 110 cm (43").

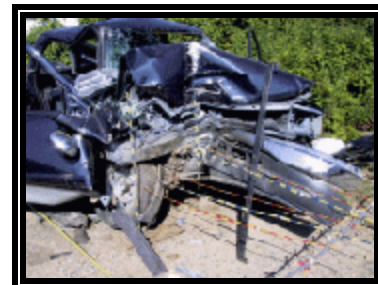
Figure 9. Right front view of damage

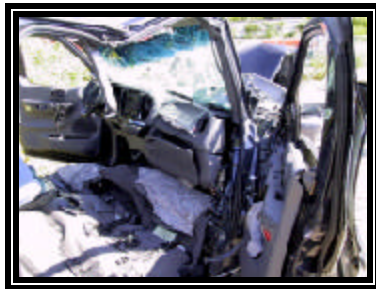
Interior damage to the Ford F150 pickup truck was moderate and attributed to occupant contact and compartment intrusion (**Figure 10**). Intruding components included the toe pan, instrument panel, and windshield. The magnitude of intrusion was highest on the right side of the vehicle and measured 46 cm (18") at the right toe pan. The entire instrument panel was displaced rearward and the plastic fascia panels had separated from each other. The steering column was compressed from occupant loading however, there was no damage to the steering wheel rim (**Figure 11**). The top aspect of knee bolster was displaced. The rear view mirror was separated from the windshield. Scuff marks were noted on the knee bolster, the left instrument panel, the top left aspect of the center console, and the windshield header from occupant contact.

Figure 11. Interior damage

Component	Magnitude of Intrusion	Direction
Right toe pan	46 cm (18")	Longitudinal
Center toe pan	36 cm (14")	Longitudinal
Right windshield	16 cm (6")	Longitudinal
Right instrument panel	16 cm (6")	Longitudinal
Left toe pan	16 cm (6")	Longitudinal
Center instrument panel	11 cm (4")	Longitudinal
Center windshield	5 cm (2")	Longitudinal
Left instrument panel	5 cm (2")	Longitudinal

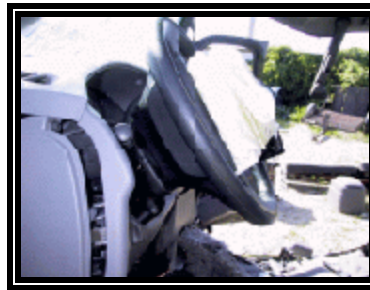
Figure 12. Compressed steering column

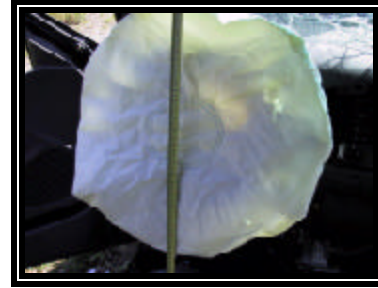
The 1999 Ford F150 pickup truck was equipped with redesigned frontal air bags for the driver and front right passenger positions. The air bags deployed as a result of the third event with the tree cluster. The driver's redesigned air bag was housed in the center of the steering wheel with asymmetrical H-configuration module cover flaps. The top cover flap measured 19 cm (7") in width and 12 cm (5") height. The lower cover flap measured 19 cm (7") in width and 3 cm (1") in height. The redesigned driver's air bag measured 60 cm (24") in diameter in its deflated state (**Figure 12**). The redesigned driver's air bag was equipped with two internal tether straps and was vented by 2 ports located at the 11 o'clock and 1 o'clock positions on the rear aspect of the air bag. The NASS researcher identified a scuff in the upper left quadrant on the air bag membrane.

Figure 12. Redesigned driver's air bag

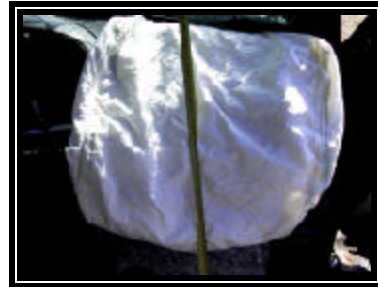
The redesigned front right passenger's air bag deployed from the right mid-instrument panel area with a single cover flap design hinged at the top aspect. The cover flap was rectangular in shape and measured 37 cm (15") in width and 20 cm (8") in height. The redesigned front right passenger's air bag measured 57 cm (22") in width and 57 cm (22") in height in its deflated state (**Figure 13**).

Figure 13. Redesigned front right passenger's air bag

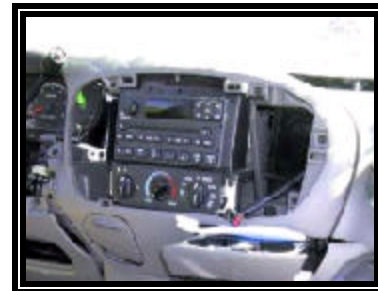
A cut off switch for the redesigned front right passenger's air bag was standard equipment for the 1999 Ford F150 pickup truck. It was positioned to the right of the climate controls on the right aspect of the center instrument panel. However, one was not identified in the NASS vehicle inspection because the panel containing the cut off switch was separated from the instrument panel (**Figure 14**).

Figure 14. Center instrument panel showing separated panel
