**ADVANCED OCCUPANT PROTECTION SYSTEM STUDY
2000 FORD TAURUS INVESTIGATION**

NASS/SCI CASE NO. 2000-11-145K

LOCATION - MICHIGAN

CRASH DATE - OCTOBER 2000

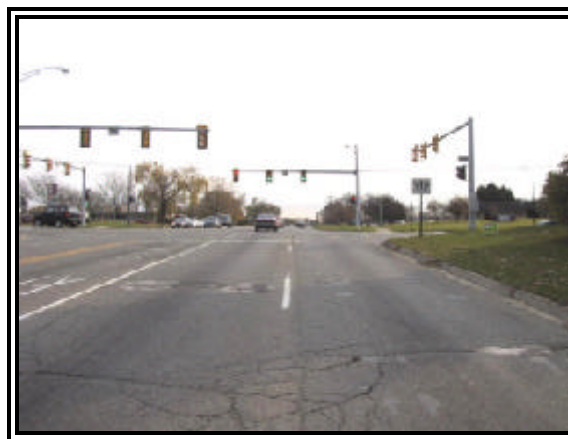
This two-vehicle crash occurred during the nighttime hours of October, 2000. It was dark at the at the time of the crash and the area was lighted by overhead street lights. The weather was not a factor and the asphalt road surface was dry. The crash occurred at the intersection of a five-lane east/west roadway and a five-lane road north/south roadway. A standard (red/amber/green) traffic signal controlled the traffic flow through the intersection. The signal was functioning properly at the time of the crash. The speed limit in the area of the crash was 64 km/h (40 mph). **Figure 1** is a eastbound view looking into the intersection.

Figure 1: Eastbound trajectory view of the 2000 Ford Taurus.

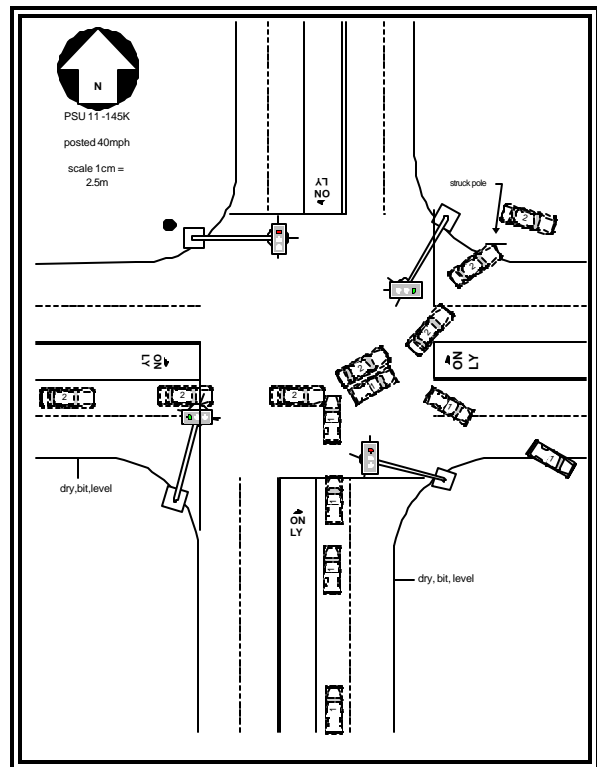
The crash occurred when the front right area of the Taurus struck the left frontal area of the Ranger in a 12/9 o'clock impact configuration. Refer to the crash schematic **Figure 2**. The lateral impact of the Taurus, forward of the Ranger's center of gravity, caused the Ranger to rotate clockwise. The pre-crash steering of the Taurus coupled with the lateral momentum of the Ranger caused the Taurus to rotate counterclockwise. As the respective vehicles rotated away from the initial impact, the left side of the Ranger contacted the right side of the Taurus in a secondary side slap.

Figure 2: Crash schematic.

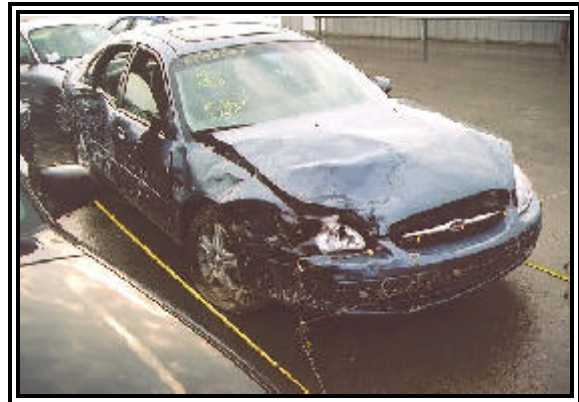
Figure 3 is a right front view of the damaged vehicle. The front plane of the Ford Taurus sustained 51 cm (20 in) of direct contact damage. The direct contact began 25 cm (10 in) right of center and extended to the right front bumper corner. This damage pattern wrapped around the right front corner and extended longitudinally 56 cm (22 in) on the right side of the vehicle. The crush profile measured at the bumper elevation was as follows: C1=0, C2=0, C3=0, C4=1.0 cm (0.4 in), C5=5.0 cm (2.0 in), C6=15.0 cm (6.0 in). There was no measurable change in the wheelbase dimensions. The Collision Deformation

Figure 3: Right front view of the damaged Taurus.

Classification (CDC) of the frontal impact was 01-FZEW-1. The Missing Vehicle algorithm of the WINSMASH model calculated total velocity change of 12.2 km/h (7.6 mph) for the frontal impact. The longitudinal and lateral components of the delta V were -11.5 km/h (-7.1 mph) and -4.2 km/h (-2.6 mph), respectively. It should be noted the SCI calculated delta V was slightly less than the values reported in the NASS file. The SCI revised calculation utilized a crash test based stiffness coefficient rather than the default stiffness values used by NASS.

The right side damage resultant to the side slap extended along the full length of the vehicle. The damage consisted of CDC extent zone 1 buckling and abrasion of the body panels. The CDC of this impact was 03-RZEW-1.

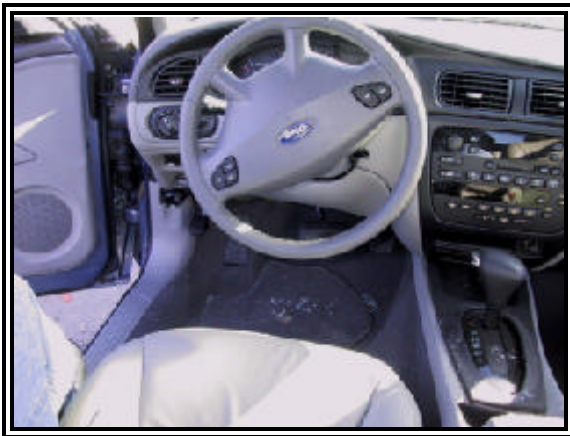
Figures 4 and 5 are views of the left and right interior, respectively. There was no interior damage or intrusion associated with the exterior forces of the crash. No interior occupant contacts were noted during the NASS inspection. The power-adjusted driver seat was in the full rear position at inspection. The right front seat was in a rear track position. The adjustable foot controls were in the full forward position (with respect to the vehicle).

Figure 4: Front left interior view.

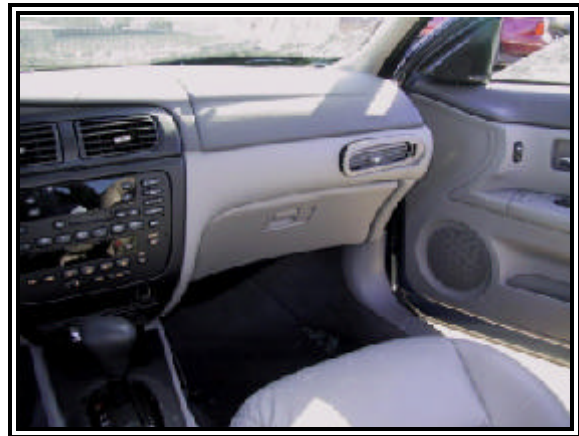
Figure 5: Front right interior view.

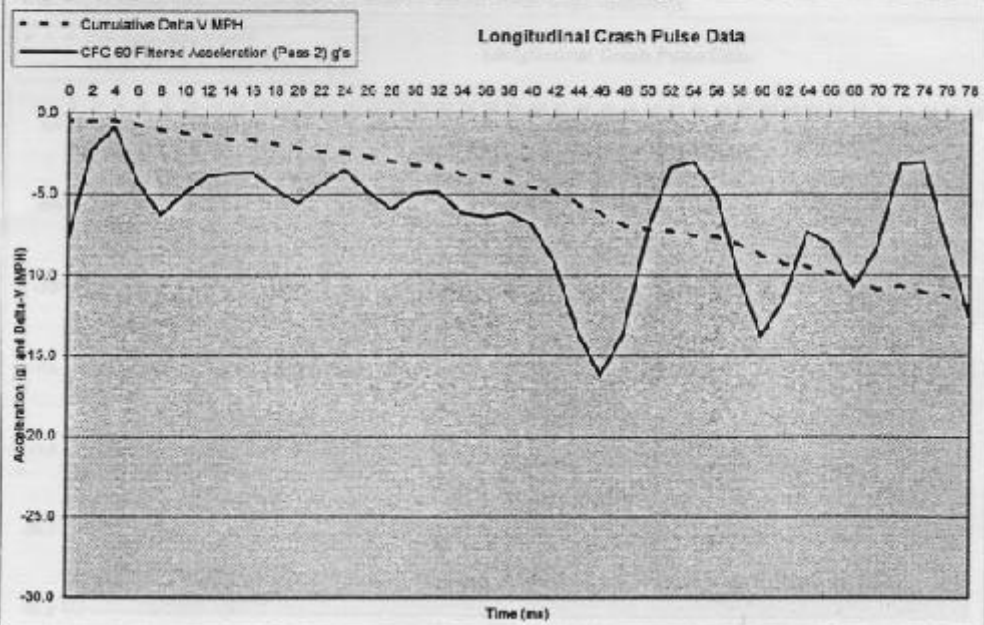
Longitudinal Cumulative Delta-V

| Time (ms) | 0 | 10 | 20 | 30 | 40 | 50 | 60 | 70 | 78 |
|---|---|---|---|---|---|---|---|---|---|
| Delta-V (MPH) | -0.5 | -1.2 | -2.2 | -3.2 | -4.6 | -7.1 | -8.7 | -10.9 | -11.9 |

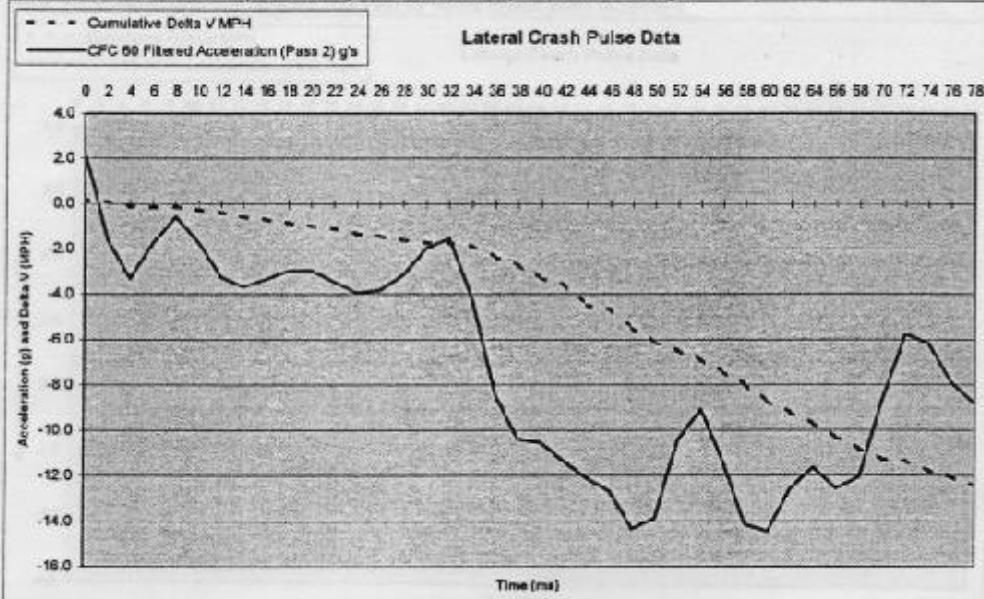
Lateral Cumulative Delta-V

| Time (ms) | 0 | 10 | 20 | 30 | 40 | 50 | 60 | 70 | 78 |
|---|---|---|---|---|---|---|---|---|---|
| Delta-V (MPH) | 0.2 | 0.3 | 1.0 | 1.7 | 3.5 | 6.1 | 8.7 | 11.3 | 12.4 |
