**REMOTE NASS/SCI COMBINATION  
SIDE IMPACT INFLATABLE OCCUPANT PROTECTION INVESTIGATION**

**VERIDIAN CASE NO. 2000-12-177J**

**VEHICLE - 2000 CHEVROLET VENTURE**

**CRASH DATE - OCTOBER 2000**

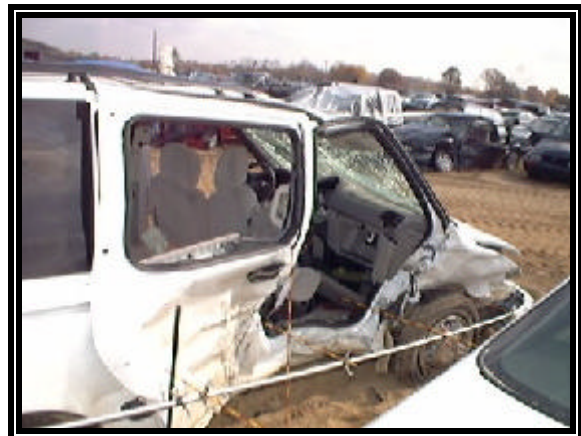
The right side of the Chevrolet Venture, **Figure 4**, sustained 320 cm (126 in) of direct contact damage that began at the right corner of the front bumper and ended 77 cm (30 in) forward of the left rear axle. The width of the direct and induced damage (Field L) measured 385 cm (152 in). The Field L began at the

**Figure 4:** View of the right side damage to the Chevrolet Venture.

right corner of the front bumper and extended rearward to a point 12 cm (5 in) forward of the left rear axle. The maximum crush occurred at C4, approximately at the location of the B-pillar. The crush profile recorded at the mid-door location was as follows: C1=0, C2=8 cm (3 in), C3=44 cm (17 in), C4=62 cm (24 in), C5=14 cm (5.5 in), C6=1 cm (2.5 in). The Principle Direction of Force was in the 2 o'clock sector. The windshield was fractured in the impact and the right side glazings disintegrated. The right side wheelbase was foreshortened 39 cm (15 in). The delta V calculated by the Damage algorithm of the WINSMASH model was 23.4 km/h (14.5 mph). The longitudinal and lateral components were -11.7 km/h (-7.3 mph) and -20.3 km/h (-12.6 mph), respectively. The barrier equivalent speed was 35.6 km/h (22.1 mph). The Collision Deformation Classification (CDC) coded by the researcher was 02-RYEW-4.

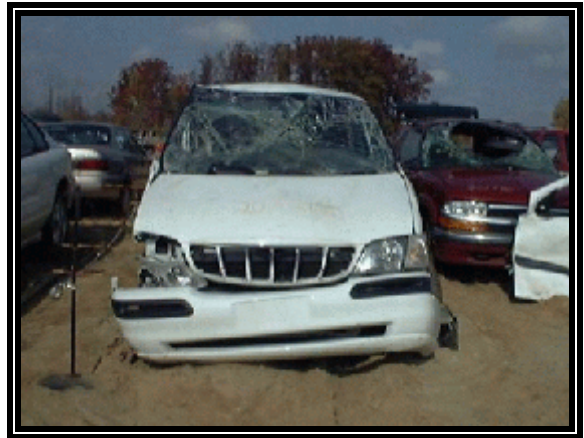
The balance of the Chevrolet's exterior damage was consistent with a 4-quarter turn rollover. **Figure 5** is a front view of the vehicle. The vehicle's front and back planes sustained minor damage indicative that the roll was primarily lateral in direction. The longitudinal dimensions of the vehicle were unchanged. The side and top planes of the vehicle were abraded from the ground contact. There was no vertical roof deformation. The left side glazings disintegrated due to ground contact during the first quarter roll. The CDC of the rollover damage was 00-TDDO-1.

**Figure 5:** Front view of the Chevrolet Venture.

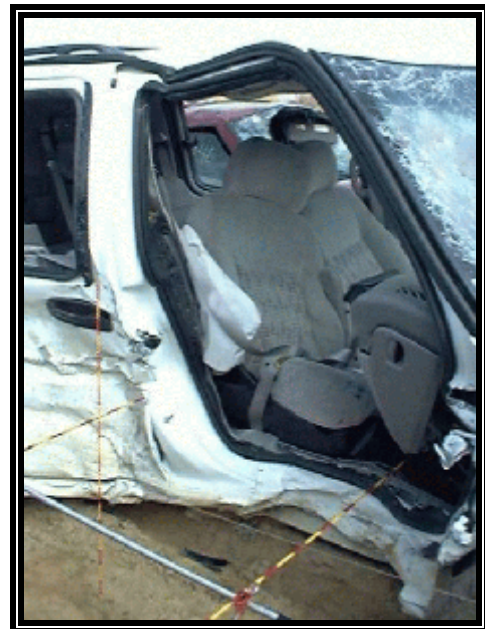
The right side interior compartment of the Chevrolet Venture sustained moderate damage and intrusion as a direct result of the impact. **Figure 6** is a view of the front right occupant position. The lateral intrusion of the mid-door and floor pan measured 37 cm (14.6 in) and 35 cm (13.8 in), respectively. The front right seat moved laterally 12 cm (4.7 in) and rolled to the left due to the floor pan deformation. The right side impact air bag had deployed from the seat back.

**Figure 6:** Front right interior view.

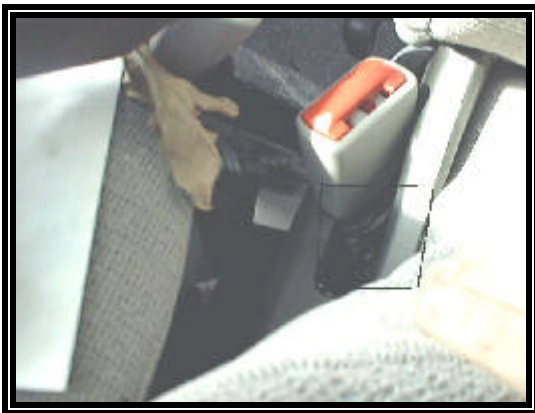
The driver's belt was stowed in the retractor at inspection and exhibited signs of historical use. The adjustable upper anchorage(D-ring) was in the full down position. The pretensioner attached to the inboard buckle was reported as fired, **Figure 7**. There was no evidence of direct loading to the webbing identified by the inspection. The occupant kinematics and minor nature of the driver's injuries are consistent with the driver being restrained at the time of the crash.

**Figure 7:** Left buckle and reportedly fired pretensioner.

Although the NASS researcher coded a split-deployment of the front pretensioners, it was more likely the left pretensioner did not fire in this crash. The deployment logic of the Supplement Restraint System of the Chevrolet Venture fired both front pretensioners at the time of frontal air bag deployment. Given that the frontal air bags did not deploy in this crash, the pretensioners should not have fired.

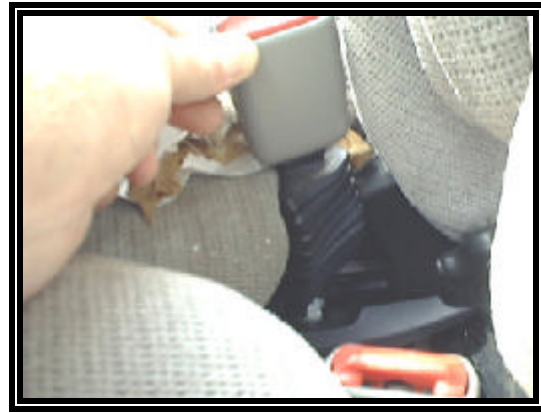
The front right seat belt webbing was extended from its retractor and lying on the seat at inspection. The retractor was probably locked due to the deformation. **Figure 8** is a view of the right seat belt buckle. The pretensioner, incorporated into the buckle, reportedly did not fire. The adjustable upper anchorage (D-ring) was in the full down position. Evidence of historical use was identified on the latch plate. The 14 year old passenger was reportedly restrained at the time of crash. He sustained a lacerated spleen (AIS 4) as a result of his interaction with the seat belt during the impact.

**Figure 8:** Right buckle and reportedly non-fired pretensioner.

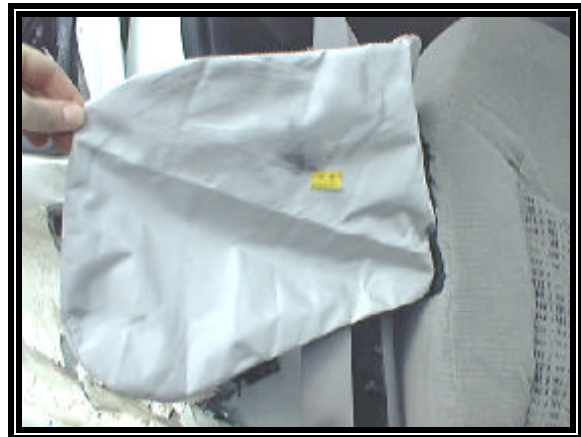
The right side impact air bag, **Figure 9**, deployed as a result of the right side impact with the Pontiac. The side impact air bag was mounted in the upper outboard aspect of the seat back and was designed for thorax protection. The air bag was rectangular in shape and measured 45 cm x 25 cm (18 in x 10 in). It was not tethered and was vented by a single port. Considering the nature of the occupants injuries, the 14 year old occupant benefitted from the addition protection of the side impact air bag. His major injuries were abdominal (lacerated liver and spleen) and related to intrusion.

**Figure 9:** Right side impact air bag.
