**VERIDIAN REMOTE KNEE BOLSTER AIR BAG DEPLOYMENT INVESTIGATION
SCI TECHNICAL SUMMARY REPORT**

NASS/SCI COMBO CASE NO. 00-41-152C

VEHICLE - 2000 KIA SPORTAGE

CRASH DATE - SEPTEMBER 2000

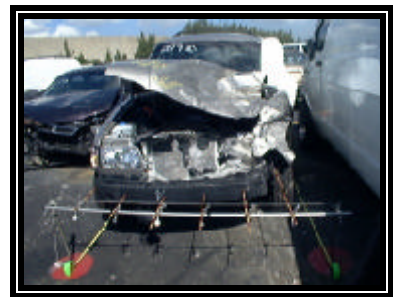
The 2000 Kia Sportage sustained moderate damage as a result of the impact with the van (**Figure 4**). The direct damage began at the front left bumper corner and extended 98 cm (39") across the frontal plane. Direct damage was also noted on the leading edge of the hood at the left corner. The combined direct and induced damage measured 131 cm (52") across the entire frontal plane. The maximum crush was located at C1 and measured 27 cm (11"). The bumper beam was crushed rearward on the left side, and fractured at the front left corner. The bumper fascia and grille were separated from the vehicle. The radiator core and upper radiator support were crushed rearward. The front left fender was crushed rearward and displaced to the right. The

Figure 4. Frontal damage to the Kia Sportage

hood was significantly buckled on the left side, and displaced vertically on the right side. The left front wheel was deflated and restricted and the right rear wheel was deflated. Based on the post-crash measurements from the NASS researcher, the left wheelbase was shortened 13 cm (5") and the right wheelbase was shortened 7 cm (3"). The Collision Deformation Classification (CDC) for this event was 11-FDEW-2. Six crush measurements were taken by the NASS researcher at the level of the bumper beam and above the bumper and the average profile was as follows: C1= 27 cm (11"), C2 = 14 cm (6"), C3 = 16 cm (6"), C4 = 11 cm (4"), C5 = 0, C6 = 0.

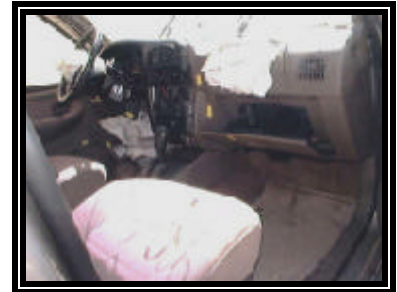
Interior damage to the 2000 Kia Sportage was moderate and attributed to occupant contact. The NASS researcher documented 17 cm (7") of integrity loss at the top aspect of the left front door. The windshield was fractured from impact forces and occupant contact and the left front door glazing was disintegrated from impact forces. The remaining glazing did not sustain damage. The rearview mirror was separated from the windshield glazing. The plastic cover around the steering column was fractured. The padded knee bolster was deformed from occupant contact, and lower left instrument panel was scuffed and cracked. The foot controls were bent. The center instrument panel and below was cracked and abraded from occupant contact. The glove box door opened as a result of the crash and was abraded from occupant contact. The left door interior surface was deformed and abraded from occupant contact. The NASS researcher did not document any intrusions.

Figure 5. View of interior damage to the Kia Sportage

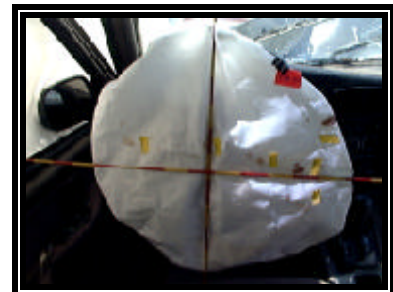
The 2000 Kia Sportage was equipped with redesigned air bags for the driver and front right passenger positions that deployed as a result of the impact with the Ford van. The driver's air bag was housed in the center of the steering wheel with asymmetrical module cover flaps (**Figure 6**). Both the top and bottom flaps measured 16 cm (6") in width. The height of the top and bottom flaps were 7 cm (3") and 6cm (2"), respectively. The driver's air bag measured 54 cm (21") in diameter in its deflated state. The air bag was not tethered and was vented by two ports located at the 10 and 2 o'clock positions. Blood was noted on the front aspect of the air bag and on the top rear aspect of the air bag. A black transfer, most likely a vinyl transfer from the module cover flap, was identified by the NASS researcher on the right side aspect of the air bag.

Figure 6. Driver's redesigned air bag

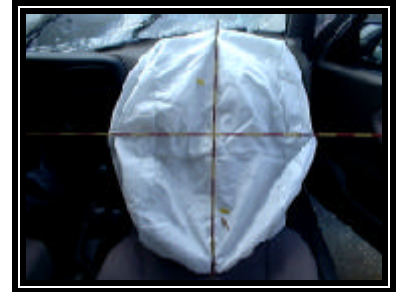
The redesigned front right passenger's air bag deployed from the mid-instrument panel area with a single cover flap design hinged at the top aspect (**Figure 7**). The module cover flap was rectangular in shape and measured 12 cm (5") in height and 24 cm (9") in width. The redesigned front right passenger's air bag measured 70 cm (28") in height and 58 cm (23") in width in its deflated state. The air bag was not tethered. The NASS researcher identified blood and a single unknown circular black transfer on the frontal surface of the front right passenger's air bag. Probable vinyl transfers were noted on the top rear aspect of the air bag.

Figure 7. Front right passenger's redesigned air bag

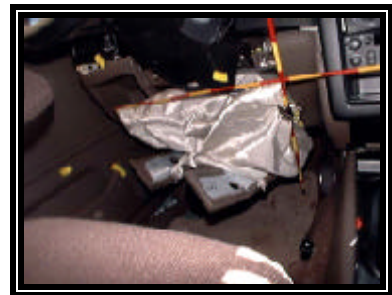
The Sportage was also equipped with a knee bolster air bag for the driver's position (**Figure 8**). The knee bolster air bag deployed from behind the bolster panel as a result of the frontal collision. The plastic knee bolster was rectangular in shape. The top edge of the bolster was contoured to fit around the bottom aspect of the steering column. The height of the bolster measured 28 cm (11") and the overall width measured 30 cm (12"). Two holes on each side which measured 2 cm (1") in diameter were located 7 cm (3") vertically from the top aspect of the bolster and spaced vertically 10 cm (4") apart. The knee bolster air bag measured 30 cm (12") in height and 48 cm (19") in width. The NASS researcher documented a puncture in the rear right quadrant of the air bag membrane (**Figure 9**). This puncture was a result of the compression of the air bag between the driver's knees and the bolt on the mounting bracket for the air bag module.

Figure 8. Kia Sportage knee bolster air bag

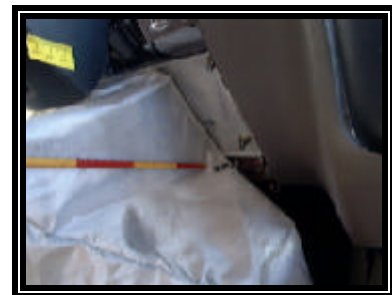
Figure 9. Puncture damage to the right rear aspect of the knee bolster air bag
