## SCI/NASS COMBINATION CASE REPORT

CASE NUMBER - NASS-00-74-008E

VEHICLE - 2000 HONDA ACCORD

CRASH DATE - January 2000

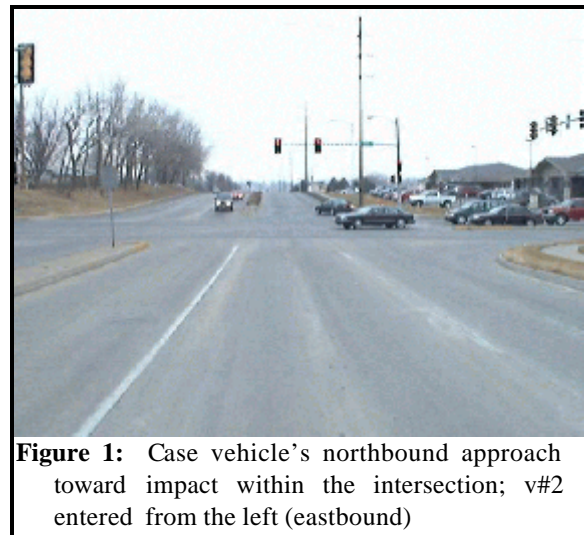
**Figure 1:** Case vehicle's northbound approach toward impact within the intersection; v#2 entered from the left (eastbound)

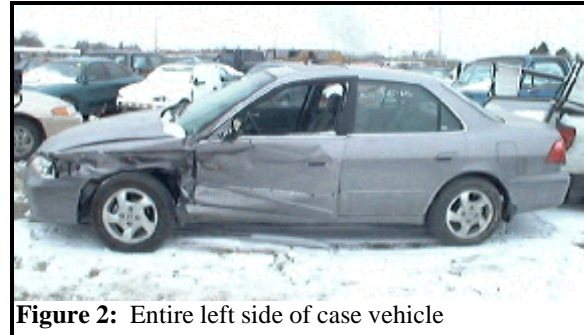
The case vehicle sustained direct contact damage in the area of the left A-pillar, wheel well and the forward edge of the driver's door, with induced damage extending forward to the left front corner and rearward to the trailing edge of the left front door. The door sill was crushed inward at the base of the A-pillar, the outside rearview mirror was damaged by direct contact, the driver's door glazing was disintegrated (kernelized) and the driver's door was jammed shut (**Figures 2 & 3**). The CDC was determined to be **10-LYEW-3** with direction of principal force 300 [-60] degrees. The winSMASH ROLDMIS algorithm was used to calculate Delta V based on the case vehicle's crush profile because vehicle #2 was partially repaired at the time of inspection. The calculated Total, Longitudinal and Lateral Delta Vs are, respectively: 25 km.p.h. [15.5 m.p.h.], -13 km.p.h. [-8.1 m.p.h.] and +22 km.p.h. [+13.7 m.p.h.]. These results appear reasonable, indicating a crash of low-to-moderate severity for the case vehicle.

Figure 2: Entire left side of case vehicle

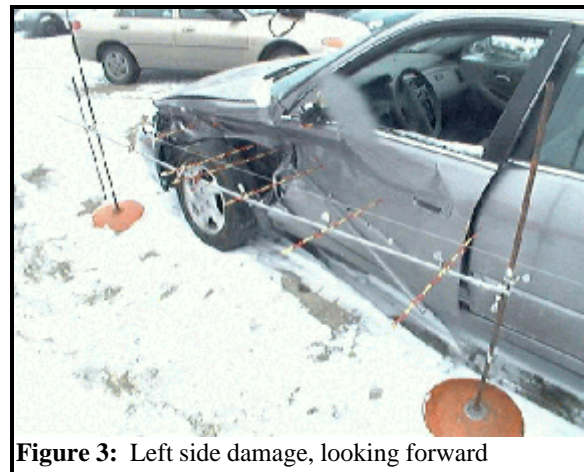
The driver's seat area sustained moderate lateral intrusion by the side panel forward of the A-pillar (9 centimeters [3.5 inches]), the left of the instrument panel (10 centimeters [4 inches]) and the interior door panel (7 centimeters [2.7 inches]). The driver's seat was not damaged.

Figure 3: Left side damage, looking forward

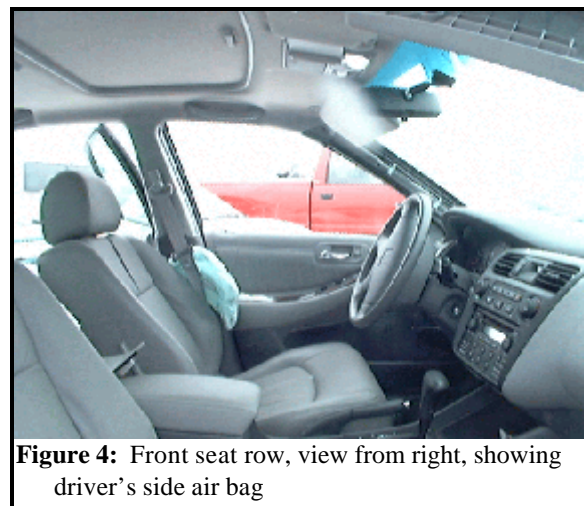
The case vehicle was equipped with dual redesigned front air bags and seat back-mounted side air bags for the two front seat positions, for a total of four air bags. The driver's side air bag was the only air bag to deploy (**Figure 4**). The driver's side air bag was mounted in the outboard edge of the driver's seat back and deployed through a pre-stressed seam in the

Figure 4: Front seat row, view from right, showing driver's side air bag

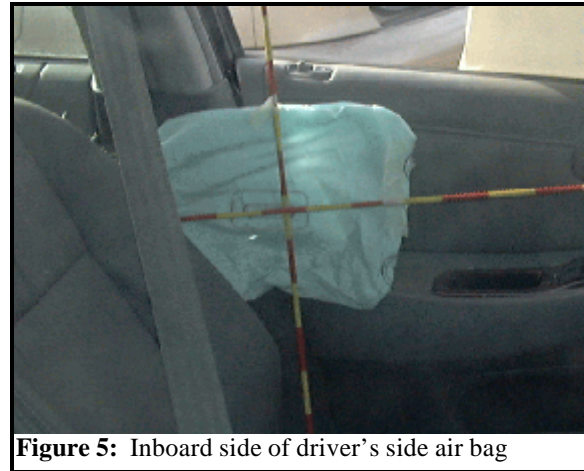
soft vinyl seat upholstery (**Figure 7**). The deployed air bag was approximately rectangular, 27 centimeters [10.6 inches] long and 24 centimeters [9.4 inches] high. There were two tethers located in the middle of the air bag (**Figures 5 & 6**). The forward edge of the air bag had two vent ports, at the top and bottom. When fully deployed, the top edge of the air bag was approximately level with the driver's door window sill.

**Figure 5:** Inboard side of driver's side air bag

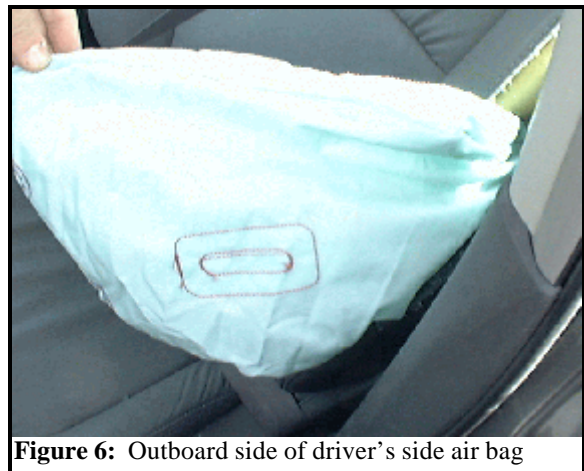
**Figure 6:** Outboard side of driver's side air bag

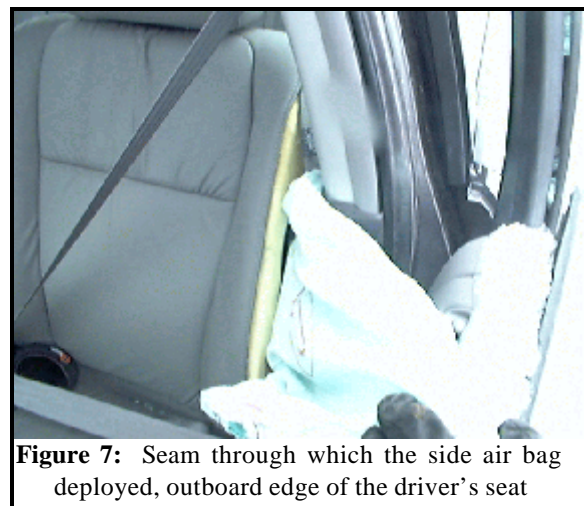
**Figure 7:** Seam through which the side air bag deployed, outboard edge of the driver's seat

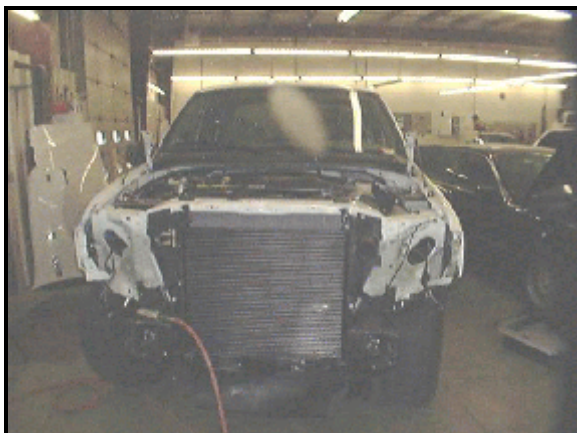
**Figure 8:** Front of V#2, under repair

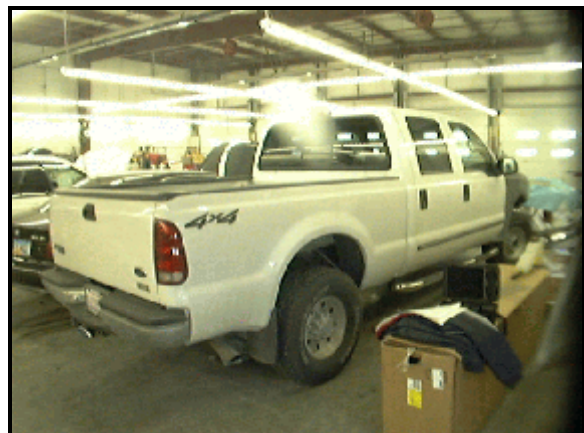
**Figure 9:** Right side of V#2, under repair
