**VERIDIAN ON-SITE AIR BAG RELATED ADULT PASSENGER  
FATALITY INVESTIGATION  
VERIDIAN CASE NO. CA00-002  
VEHICLE: 1993 MERCURY GRAND MARQUIS  
LOCATION: MARYLAND  
CRASH DATE: JANUARY 2000**

| 15. <i>Supplementary Notes</i><br>On-site investigation of a run-off-road crash that resulted in frontal air bag deployment and the death of an 85 year old female front right passenger. | | | |

**VERIDIAN ON-SITE AIR BAG RELATED  
ADULT PASSENGER FATALITY INVESTIGATION  
VERIDIAN CASE NO. CA00-002  
VEHICLE: 1993 MERCURY GRAND MARQUIS  
LOCATION: MARYLAND  
CRASH DATE: JANUARY 2000**

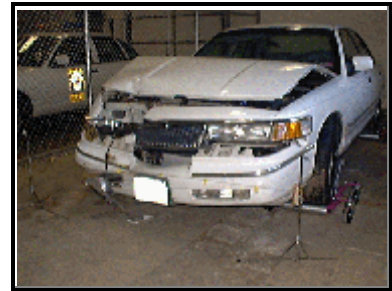
**Figure 1. Frontal damage to the 1993 Grand Marquis.**

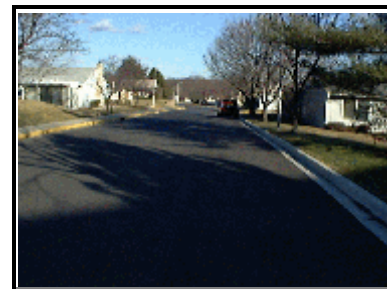
The crash occurred on private property in a large retirement community during daylight hours. The weather was reported as mostly sunny with no precipitation and temperatures in the mid single digits Celsius (mid 40s F). The crash occurred in a mid block area on a residential street (**Figure 2**) that was 8.6 m (28.2') in width bordered by 15 cm (6") barrier curbs. A lawn area bordered the south curblines while a concrete sidewalk paralleled the north curblines. The dry asphalt road surface was straight with a slight negative grade. The posted speed limit was 40 km/h (25 mph). The struck tree was 33 cm (13") in diameter and was located 1.0 m (3.3') outboard of the

**Figure 2. Overall view of the crash site.**

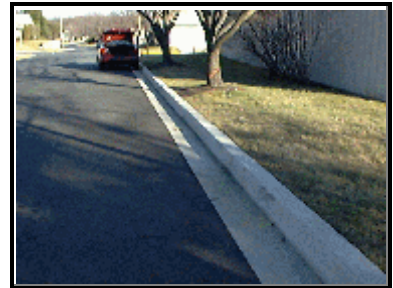
**Figure 3. Struck curb with trajectory into tree.**

The right front tire impacted and overrode the barrier curb 6.9 m (22.6') west of the struck tree. The vehicle continued on a straight line trajectory in a tracking mode to impact (**Figure 3**). There was no evidence of tire marks on the lawn area between the point of departure and the struck tree to indicate avoidance actions.

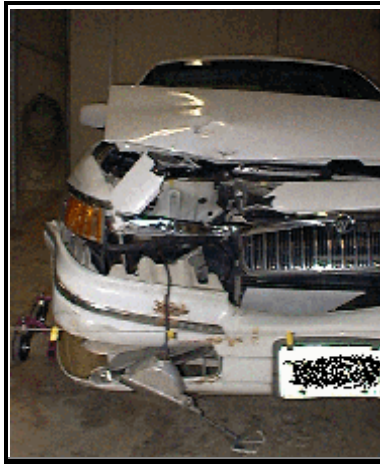
The Mercury Grand Marquis sustained moderate frontal damage as a result of the frontal impact sequence with the tree. The direct contact damage to the bumper fascia began 21.8 cm (8.6") right of center and extended 32.8 cm (12.9") to the right (**Figure 4.**). The impact fractured the bumper fascia and fragmented the alloy bumper reinforcement beam at the impact location. The bumper beam separated from its mounting points at the energy absorbing devices (EAD). There was no evidence of the compression on the left EAD, however, the right EAD was abraded full length, indicative of compression. This EAD had returned 5.7 cm (2.25") to its original position. The deformed and fractured bumper beam was supported exclusively by the bumper fascia post-crash, therefore this structural component was not used to document a crush profile.

**Figure 4. Front right damage to the Grand Marquis.**

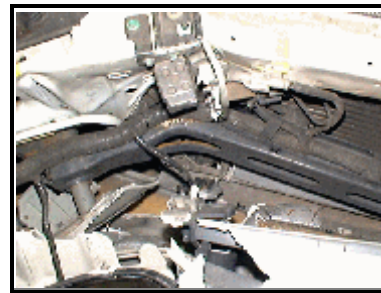
The tree penetrated through the bumper beam and engaged the cross member which extended laterally between the frame rails and the upper radiator support panel. This deformation involved the full frontal width of the vehicle resulting in a combined induced and direct damage length of 156.8 cm (61.75"). Maximum crush was 19.7 cm (7.75") located on the cross member 37.5 cm (14.75") right of center (**Figure 5**). Crush profiles were documented at the level of the cross member and the radiator support panel due to the separation of the bumper reinforcement beam. The cross member crush profile was as follows: C1 = 0 cm , C2 = 0 cm , C3 = 7.0 cm (2.75"), C4 = 16.5 cm (6.5"), C5 = 12.7 cm (5.0"), C6 = 9.2 cm (3.6"). This profile was used for reconstruction in the WinSMASH program. The residual profile at the level of the radiator support was as follow: C1 = 0 cm, C2 = 3.6 cm (1.4"), C3 = 8.3 cm (3.25"), C4 = 12.1 cm (4.75"), C5 = 9.2 cm (3.6"), C6 = 2.5 cm (1.0"). It should be noted that these profiles understate the overall damage to the Grand Marquis due to the fracture of the bumper reinforcement beam. The maximum crush value was adjusted to a depth of 49.5 cm (19.5") to reflect the rearward displacement of the bumper for the WinSMASH reconstruction program. The Collision Deformation Classification (CDC) for this impact sequence was 12-FZEN-2.

**Figure 5. Overhead view of the crush profile to the cross member.**

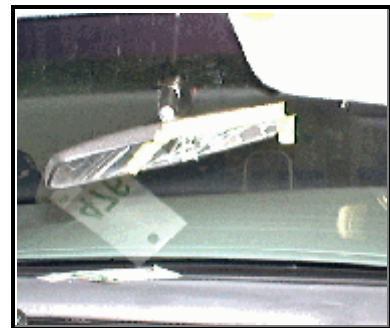
Interior damage to the Grand Marquis was minimal and was associated with deployment of the frontal air bag system and occupant contact. The upper steering wheel rim was deformed approximately 1.3 cm (0.5") forward from probable driver loading against the deployed air bag. There was no compression of the energy absorbing steering column. The rear view mirror was deflected to the right and the glass was fractured from a probable fling contact by the front right passenger (**Figure 6**). There was no intrusion of interior components. The

**Figure 6. Fractured rear view mirror.**

The forward positioned passenger was struck by the expanding front right air bag as she responded to the frontal impact force (**Figure 11**). The air bag expanded against her left anterior forearm, displacing the wrist/hand into the rear view mirror. This contact fractured the mirror glass and displaced the mirror to the left. No injury was reported from this contact sequence. The passenger was probably wearing a winter-type coat and/or gloves which could have protected her from soft tissue injuries.

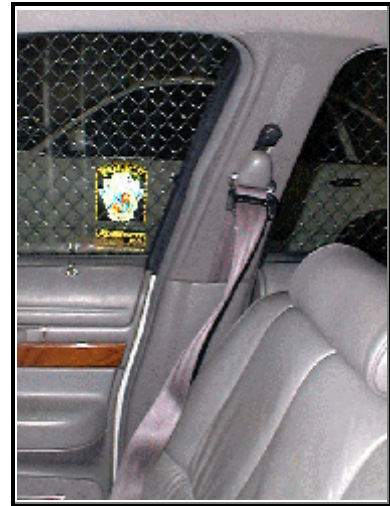
The Mercury Grand Marquis was equipped with 3-point lap and shoulder belt systems in the four outboard seated positions. The front belt systems consisted of continuous loop webbing with sliding latchplates that retracted onto emergency locking retractors located in the lower B-pillars. The upper D-rings were adjustable with both front systems adjusted to the lowest positions (**Figure 7**). The adjustments provided 9.5 cm (3.75") of vertical travel to the D-rings. The driver side belt system yielded evidence of occasional usage, but not frequent usage over the 129,000 km (80,000) miles recorded on the vehicle. Wear marks were present on the latchplate and the webbing was soiled in the areas of the D-ring and latchplates. There was no loading evidence on the belt system.

**Figure 7. Adjusted position of the front right passenger's D-ring.**

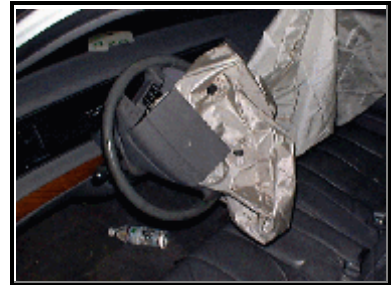
The driver air bag was constructed of a typical nylon-type fabric sewn with an internal peripheral seam. The overall bag diameter in its deflated state was 66.0 cm (26.0"). The driver air bag was vented by two 2.8 cm (1.1") diameter ports located on the back side of the bag at the 11 and 1 o'clock sectors. The ports were centered 8.9 cm (3.5") below the peripheral seam. Internally, the bag was tethered by four tether straps sewn to the face of the bag with a 17.8 cm (7.0") diameter reinforcement. With the steering wheel assembly positioned in a 12/6 o'clock position, the tether straps were located at the 12/6 and 3/9 o'clock positions. **Figure 8** is an overall view of the driver air bag module.

**Figure 8. Overall view of the driver air bag, cover flaps, and the vent ports.**

There was no damage or driver contact evidence to the bag membrane. Deployment of the driver air bag did separate the cruise control trim panel that was positioned between the spokes on the left side of the steering wheel rim.

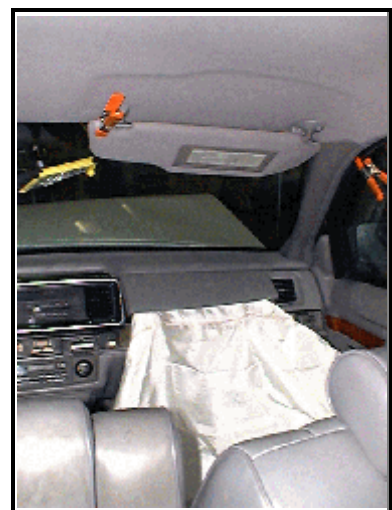
The front right passenger air bag module was a mid mount design that was concealed by a single cover flap (**Figure 9**) in the right instrument panel. The flap was hinged at the top aspect and opened at the side and bottom tear points. The flap measured 40.0 cm (15.75") horizontally and 13.7 cm (5.4") vertically. The acronym SRS was molded into the lower left corner of the cover flap. The air bag module assembly was loose in the mid instrument panel.

**Figure 9. Deployment of the front right air bag from the mid mount module assembly.**

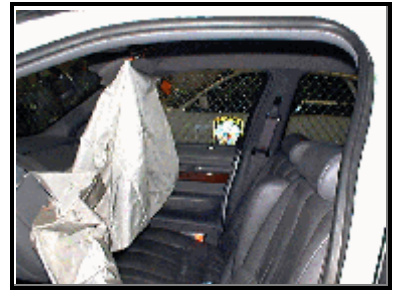
The passenger air bag membrane measured approximately 66.0 cm (26.0") horizontally and 61.0 cm (24.0") vertically in its extended, but deflated state (**Figure 10**). The bag was not tethered internally. A single vent port was located on the left side panel of the bag and was 5.7 cm (2.25") in diameter. The bag membrane was not damaged and did not yield evidence of passenger contact (i.e., lipstick, makeup and/or tissue transfers).

**Figure 10. Profile view of the deployed front right air bag.**

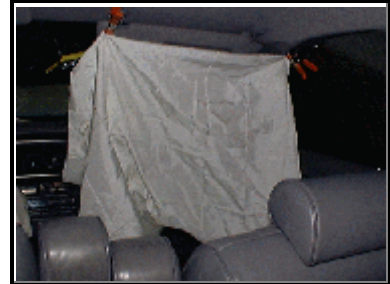
**Figure 11. Deployment path of the front right air bag.**

The continued expansion of the front right air bag resulted in contact against the face of the passenger. It was reported by the investigating officer that she sustained superficial abrasions of the face, however, these abrasions were not medically noted. (The hospital did report minor facial erythema which is not a codeable injury under AIS rules.) This expansion accelerated her head in a rearward direction as the passenger was displaced into the seat back support where she came to rest. There was no evidence of contact to the air bag membrane, cover flap, or rebound contact to the seat back, head restraint, or the B-pillar.

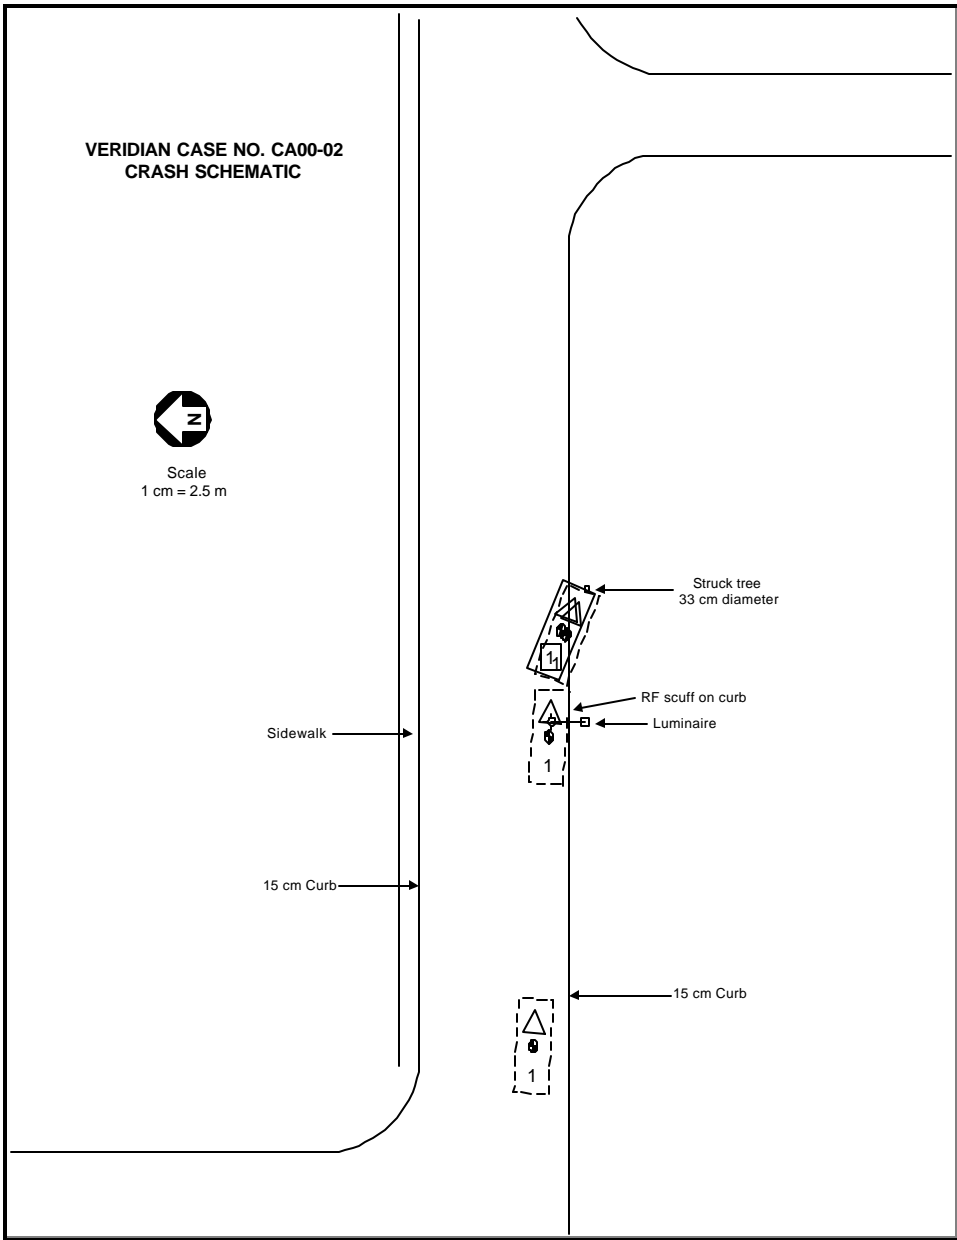
Figure 12. Crash Schematic

south curblane. There were no defects or visual obstructions at the crash scene. The crash schematic is included as **Figure 12**, Page 10.
