ON-SITE AIR BAG INVESTIGATION

CASE NUMBER - IN00-002
LOCATION - WEST VIRGINIA
VEHICLE - 1990 PLYMOUTH SUNDANCE
CRASH DATE - February, 2000

1. <i>Report No.</i> IN00-002	2. <i>Government Accession No.</i>	3. <i>Recipient's Catalog No.</i>	
4. <i>Title and Subtitle</i> On-Site Air Bag Fatality Investigation Vehicle - 1990 Plymouth Sundance Location - West Virginia		5. <i>Report Date:</i> December 5, 2002

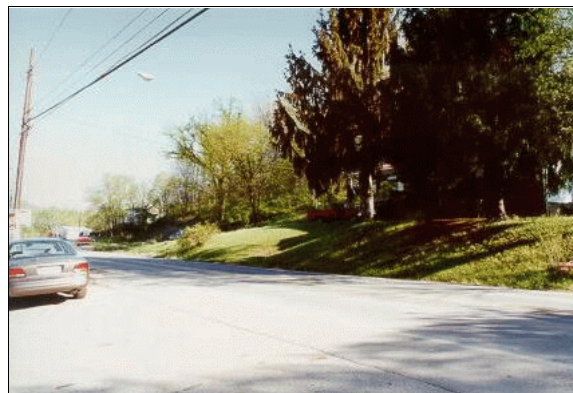
The case vehicle was making a left-hand turn from a commercial parking lot driveway and was traveling in a northerly direction (**Figure 1**), attempting to enter the "northbound" lane of a two-lane, undivided, State roadway and travel north-northeastward. The Chevrolet was negotiating a left-hand curve while traveling southwestward in the "southbound" lane of the same two-lane, undivided, State roadway (**Figure 2**) and intended to continue traveling southward. The case vehicle's driver made no avoidance maneuvers prior to the crash. The driver of the Chevrolet steered to his left and braked, depositing several (i.e., unknown) meters of skid marks in his attempt to avoid the crash. The crash occurred within the driveway junction, just inside the "northbound" lane of the roadway; see **CRASH DIAGRAM** below.

Figure 1: Case vehicle's northerly travel path from parking lot driveway as driver attempted to turn left onto state roadway; Note: parked car at left obstructs view (case photo #01)

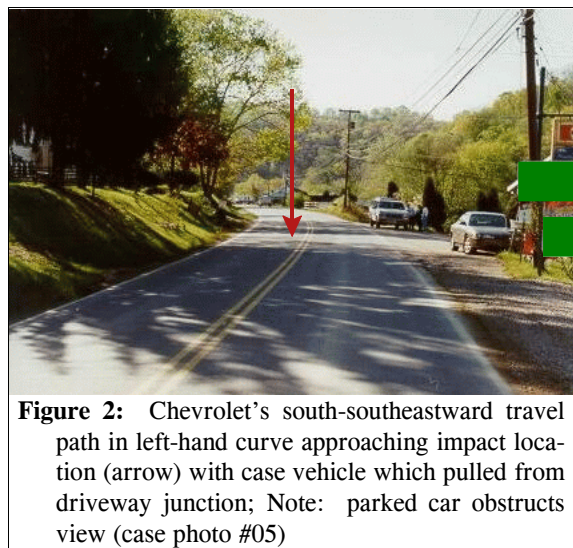
Figure 2: Chevrolet's south-southeastward travel path in left-hand curve approaching impact location (arrow) with case vehicle which pulled from driveway junction; Note: parked car obstructs view (case photo #05)

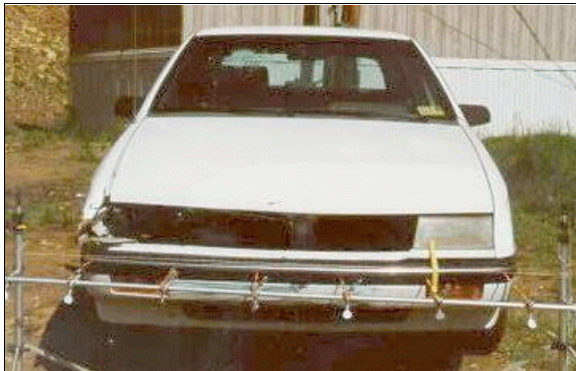
Figure 3: Case vehicle's front oblique damage; Note: yellow tape marks width (leftmost) of direct damage from Chevrolet (case photo #08)

The front (Figures 3 and 4) of the case vehicle was impacted by the front right corner (Figures 5 and 6) of the Chevrolet, causing the case vehicle's driver supplemental restraint (air bag) to deploy. The case vehicle rotated approximately 5 degrees clockwise before coming to rest, heading east, with its front axle straddling the roadway's double solid yellow center lines (Figure 7). The Chevrolet continued southward after impact and its front traveled off the eastern edge of the roadway into a drainage ditch. The Chevrolet came to rest heading southward, primarily in the "northbound" lane, with the Chevrolet's front straddling the "east" edge line of the roadway (Figure 8 below).

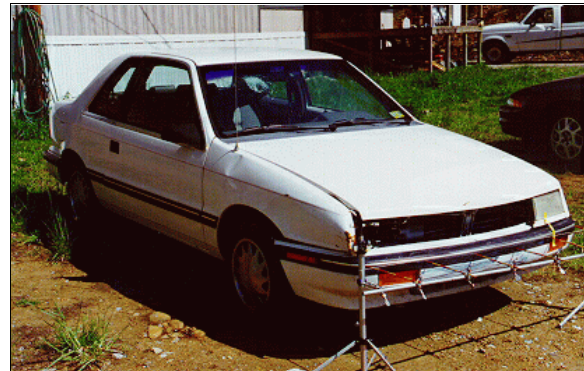
Figure 4: Case vehicle's frontal damage, viewed from right of front with contour gauge present, showing minimal deformation from oblique type impact with Chevrolet (case photo #16)

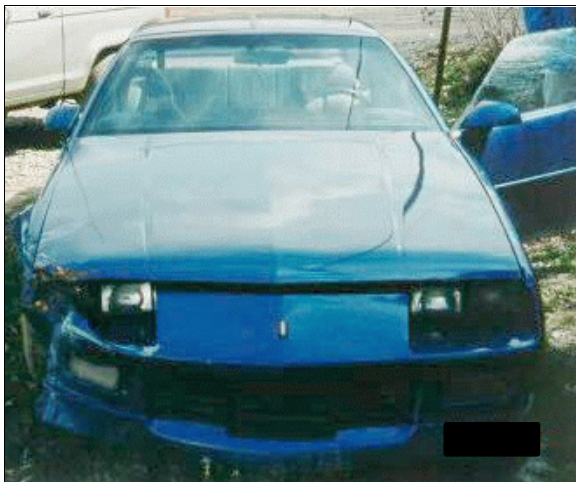
Figure 5: Attorney provided photo of Chevrolet's front right corner damage viewed from front at eye level (case photo #35)

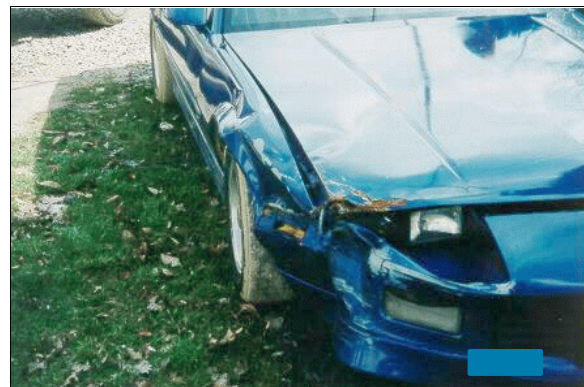
Figure 6: Attorney provided photo of Chevrolet's front right corner damage, viewed down right side from impact with case vehicle (case photo #42)

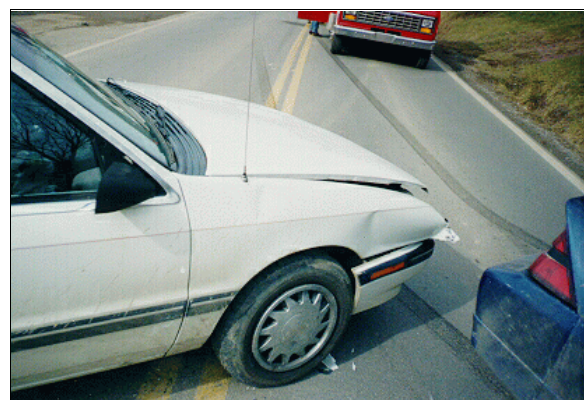
Figure 7: On-scene view looking north-northeastward showing case vehicle's final rest position straddling double yellow center lines and Chevrolet's evasive skid marks leading into case vehicle's front (case photo #46)

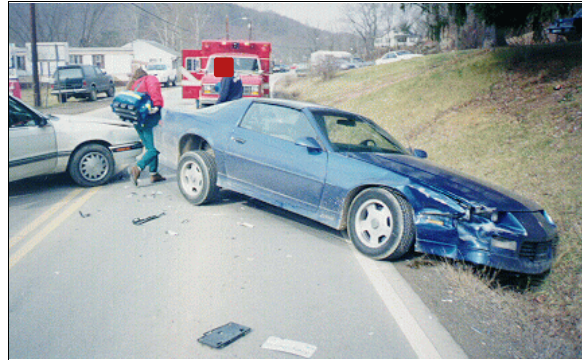
Figure 8: On-scene view looking north-northeastward in the northbound lane at Chevrolet's final rest position straddling east edge line of roadway; Note: case vehicle's front straddling center lines (case photo #45)

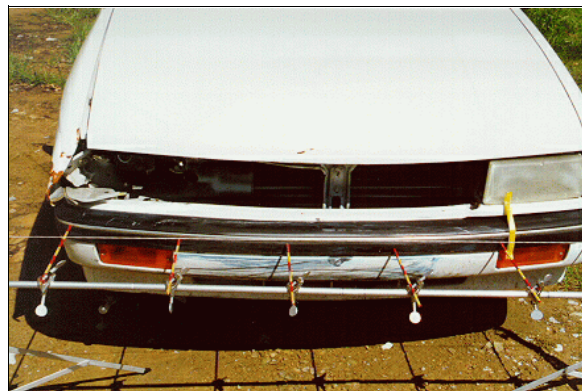
The case vehicle's contact with the Chevrolet involved almost the entire width of its front (**Figure 9**). Direct damage began 45 centimeters (17.7 inches) left of center (i.e., towards the driver's side) and extended to the right bumper corner, a measured distance of 116 centimeters (45.7 inches). The field L extended from bumper corner to bumper corner a measured distance of 138 centimeters (54.3 inches). Residual maximum crush was 9 centimeters (3.5 inches) at C₆. There is no evidence that the case vehicle's wheelbase was altered from the crash.

Figure 9: Elevated view of deformation to case vehicle's front with contour gauge present; Note: yellow tape indicates width (i.e., leftmost) of direct damage (case photo #09)

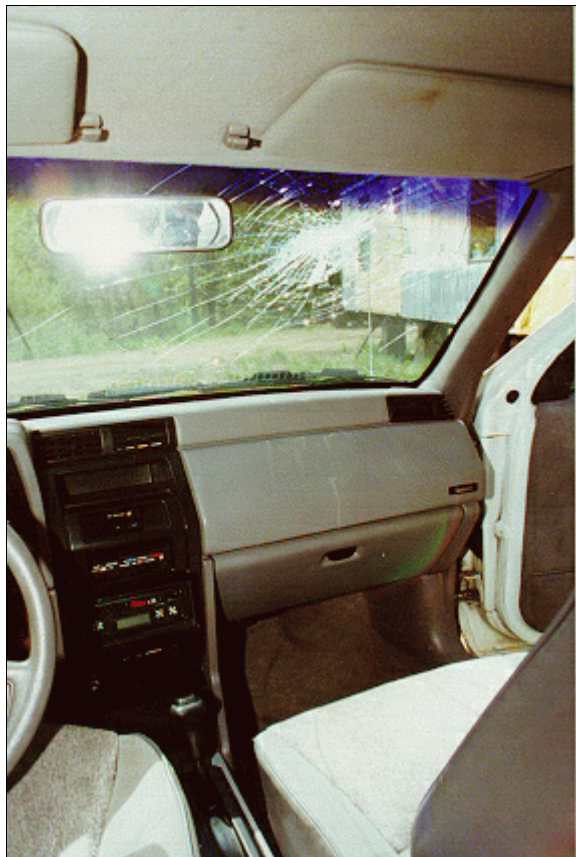
Figure 10: Vertical view of case vehicle's front right passenger seating area showing head contact to right windshield (case photo #24)

Inspection of the case vehicle's interior revealed that right windshield's glazing sustained a spider web-type contact from the front right passenger (**Figure 10**), and there was no other evidence of occupant contact on the interior surfaces of the case vehicle (**Figures 10** and **11**). Finally, the energy absorbing steering column's shear capsules were completely separated with over 4 centimeters (1.6 inches) of separation on both sides (**Figure 12**).

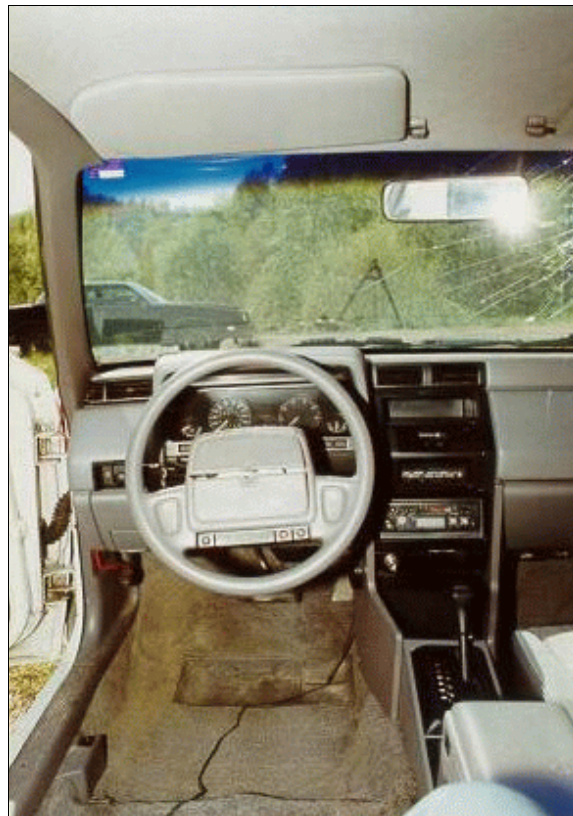
Figure 11: Case vehicle's driver seating area showing steering wheel, instrument panel, and greenhouse area with no apparent evidence of occupant contact; Note: air bag was cut out and driver's seat was removed by family (case photo #23)

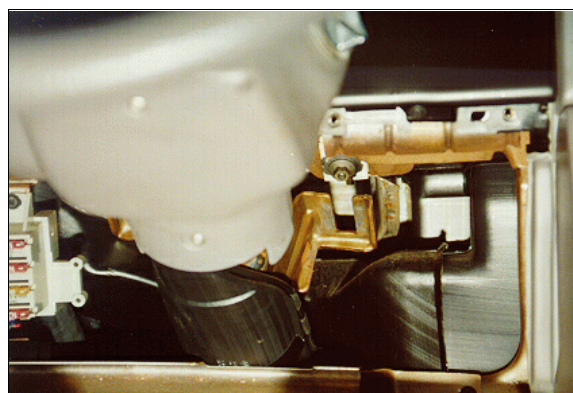
Figure 12: Close-up of case vehicle's steering column shear capsules showing their complete separation (case photo #26)

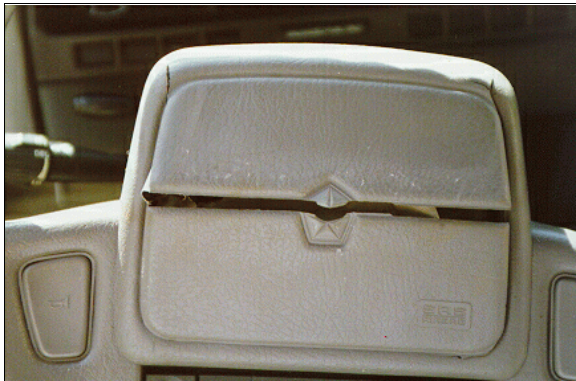
Figure 13: Close-up of suspected cloth transfer on case vehicle driver air bag module's top cover flap (case photo #28)

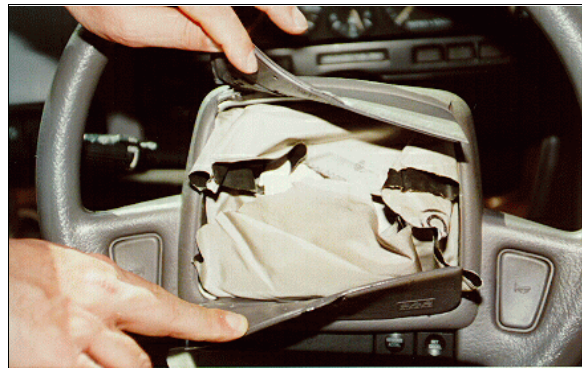
Figure 14: Close-up of interior of case vehicle's driver air bag module after air bag was cut out by family (case photo #29)

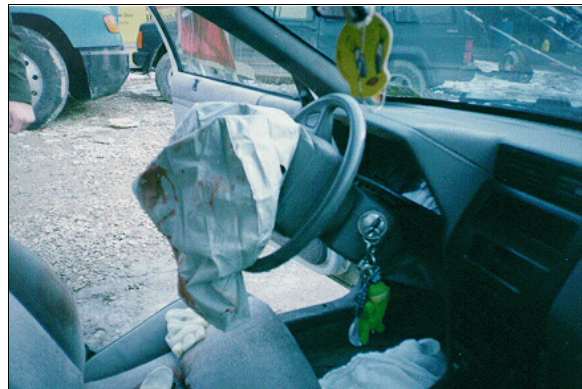
Figure 15: On-scene view of case vehicle's deployed driver air bag showing at least one vent port (case photo #49)

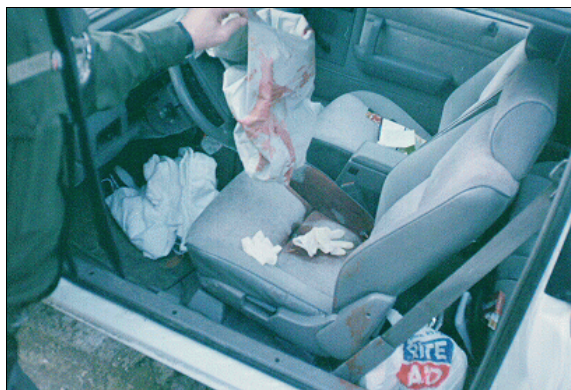
driver was most likely leaning slightly leftward into her turn. Based on the on-scene photographs, her seat track was located near its forward-most position (**Figure 16**), and the tilt steering wheel was located between its middle and upmost positions.

Figure 16: On-scene view showing case vehicle's deployed, blood stained, air bag and front seat positions prior to removal of air bag by family; Note: driver's seat was located at its forward-most position (case photo #47)

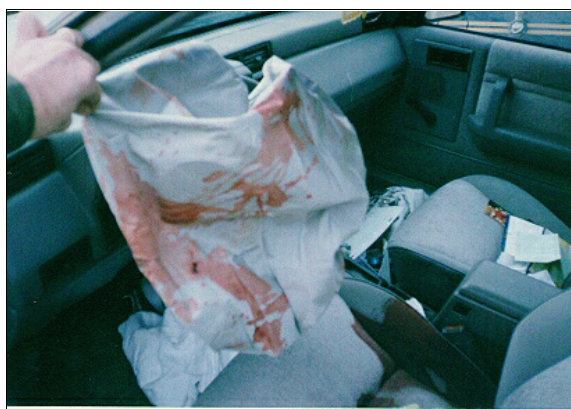
Figure 17: Closer-up on-scene view of case vehicle's blood stained, driver air bag (case photo #48)

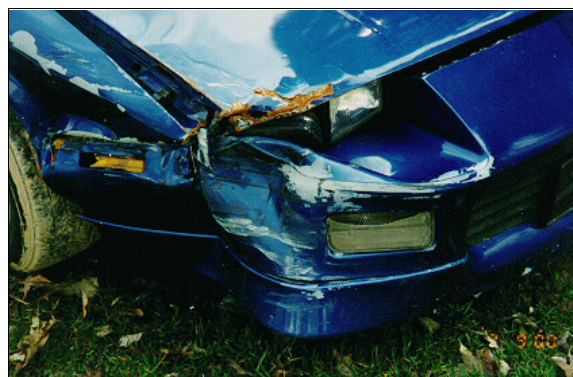
The damage to the Chevrolet from the impact with the case vehicle involved the front right bumper corner with damage extending down the right side to the front right wheel area (Figures 5, 6, and 8 above and Figure 18). Maximum crush for the impact with the case vehicle is estimated as 12 centimeters (4.7 inches). Based on the available photographs, the CDC for the Chevrolet was estimated as: **01-FREE-3 (20)**. The WinSMASH reconstruction program, was not be used on the Chevrolet because there were no crush measurements; however, this contractor's visually estimated Delta V is between 8 km.p.h. (5 m.p.h.) and 14.5 km.p.h. (9 m.p.h.). The Chevrolet was towed due to damage.

Figure 18: Attorney provided close-up photo of Chevrolet's front right corner damage from oblique-angled impact with case vehicle’s front (case photo #43)
