**VERIDIAN ON-SITE AIR BAG RELATED
CHILD PASSENGER FATALITY INVESTIGATION**

VERIDIAN CASE NO. CA00-009

VEHICLE - 1995 FORD THUNDERBIRD LX

CRASH DATE - FEBRUARY, 2000

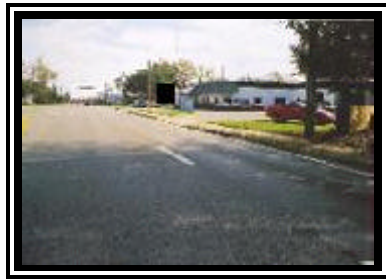
The 26 year old female driver of the 1996 Chevrolet Blazer was operating the vehicle northbound when she entered a parking area and initiated a U-turn to proceed south. She re-entered the roadway and began a diagonal trajectory towards another parking area adjacent to the southbound lanes (**Figure 1**) while reportedly using a cellular phone (to the right ear). This apparently obstructed the driver's peripheral view as she maneuvered the Chevrolet into the southbound lanes. The 26 year old male driver of the 1995 Ford Thunderbird was operating the vehicle southbound in the outboard lane (**Figure 2**) when he observed the Chevrolet Blazer cross his path of travel. Upon recognition of the impending harmful event, he steered right/braked with sufficient force to lock the wheels of the vehicle. This trajectory was evidenced by 10.2 meters (33.5 feet) of pre-impact brake marks documented at the scene.

Figure 1. Southwest approach for the 1996 Chevrolet Blazer.

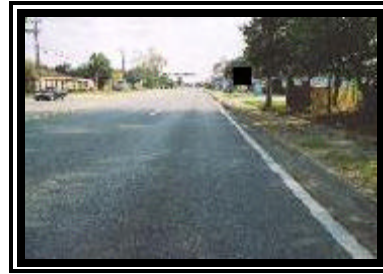
Figure 2. Southbound approach for the 1995 Ford Thunderbird LX.

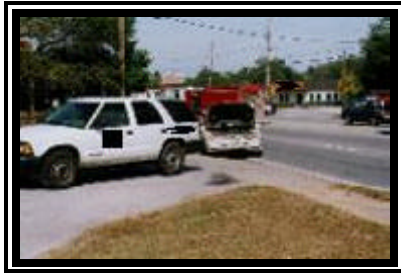
Figure 3. Police photograph (view northeast) showing vehicle final rest positions.

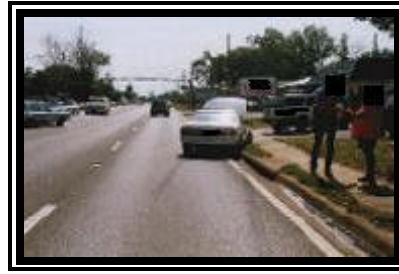
Figure 4. Police photograph (view south) showing vehicle final rest positions.

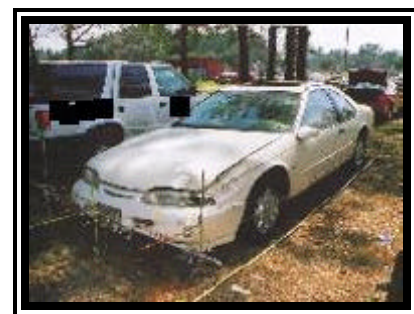
The Ford sustained minor frontal damage as a result of the impact with the Chevrolet Blazer (**Figure 5**). The direct contact damage began at the front left bumper corner and extended 28.0 cm (11.0 in) inboard. The combined direct and induced damage length (Field L) measured 152.0 cm (59.8 in). Although no crush was identified at any of the six *bumper level* measurements, a secondary profile was obtained at the level of the radiator support [11.0 cm (4.3 in) above the level of the bumper] resulting in an

Figure 5. Frontal damage to the 1995 Ford Thunderbird LX.

averaged profile of: C1= 7.0 cm (2.8 in), C2= 0 cm, C3= 0 cm, C4= 0 cm, C5= 0 cm, C6= 0 cm. A rubber transfer was noted to the front left bumper corner which was attributed to the right rear tire of the Chevrolet. The height variance between the vehicles at impact resulted in minor hood displacement with 78.0 cm (30.7 in) of direct contact damage documented rearward along the left side surface of the vehicle. The right front wheel/tire was deflated (not restricted) with notable rim damage attributed to the barrier curb impact. The windshield fractured from interior occupant contact (only).

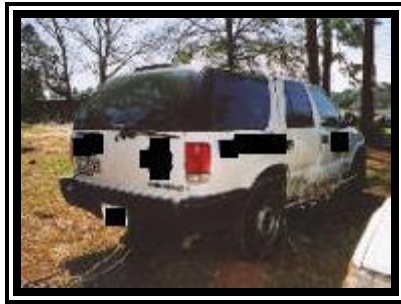
The Chevrolet sustained minor right side damage as a result of the impact with the Ford Thunderbird (Figures 6 & 7). The direct contact damage began 40.0 cm (15.7 in) forward of the right rear axle and extended 64.0 cm (25.2 in) forward. The combined direct and induced damage length (Field L) began 15.0 cm (5.9 in) forward of the right rear axle and extended 93.0 cm (36.6 in) forward. The damage was concentrated below the level of the frame. A scuff mark was noted to the right rear tire (not deflated/restricted) attributed to the front left bumper corner of the Ford. Induced lateral buckling was identified to the upper right rear (door) window frame which measured 7.0 cm (2.8 in). All glazing was undamaged.

Figure 6. Right side damage to the 1996 Chevrolet Blazer.

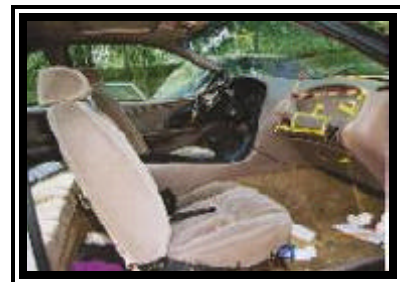
Interior damage to the Ford identified through the vehicle inspection was moderate and was attributed to occupant contact (Figure 8). A scuff mark was documented on the left knee bolster (rigid plastic type). The rear-view mirror separated from the windshield which was fractured and heavily scratched. In addition, a fracture site was identified on the windshield to the left of the rear-view mirror mounting bracket along with a small fracture site to the right mid-windshield area. Light blood spattering was noted along the windshield header and right sunvisor area. A large indentation was documented to the right mid-instrument panel along with multiple scuff marks to the surrounding area. No column compression or loading to the steering wheel rim was identified (tilt column set between the full up and center position). No intrusion of interior components were found in the vehicle.

Figure 8. Interior view of the 1995 Ford Thunderbird LX.

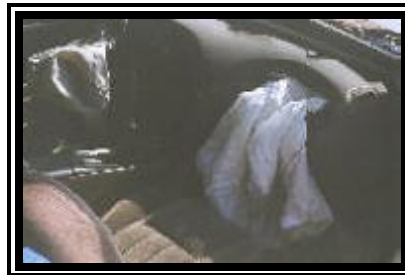
The Ford Thunderbird was equipped with frontal air bags for the driver and right passenger positions. The air bags deployed as a result of the crash (**Figure 9**). The driver air bag module was identified by the Ford part number: F5SB-63043B13-AAJABO with a bar coded lot number of: *1PZ6033I10102*. The air bag was housed in the center of the steering wheel (**Figure 10**) with a horizontally oriented flap tear seam (H-configuration). The flaps were asymmetrical in shape as the upper flap measured 23.5 cm (9.3 in) in width along the upper portion, 17.5 cm (6.9 in) along the lower portion and 12.0 cm (4.7 in) in height. The lower flap measured 17.5 cm (6.9 in) along the upper/lower portion and 7.0 cm (2.8 in) in height. The driver air bag was not available for SCI inspection as it was removed by police for analysis shortly after the crash, however, the police investigator reported no visible contacts on the face of the air bag.

Figure 9. Police photo showing 1995 Ford Thunderbird LX deployed frontal air bags.

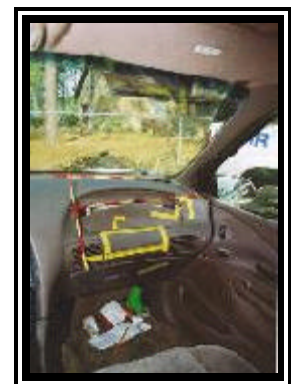
The child passenger was displaced in a forward direction by the pre-crash braking actions of the driver. The barrier curb impact further displaced the child forward as the mid-torso loaded the right mid-instrument panel. This trajectory was evidenced by the indentation and surrounding scuff marks documented to this component (**Figure 12**). This trajectory and contact sequence positioned his head/neck within a close proximity to the mid-mount air bag module. At impact with the Chevrolet, he was forward within the path of the expanding passenger air bag which struck the

Figure 12. Right instrument panel area.

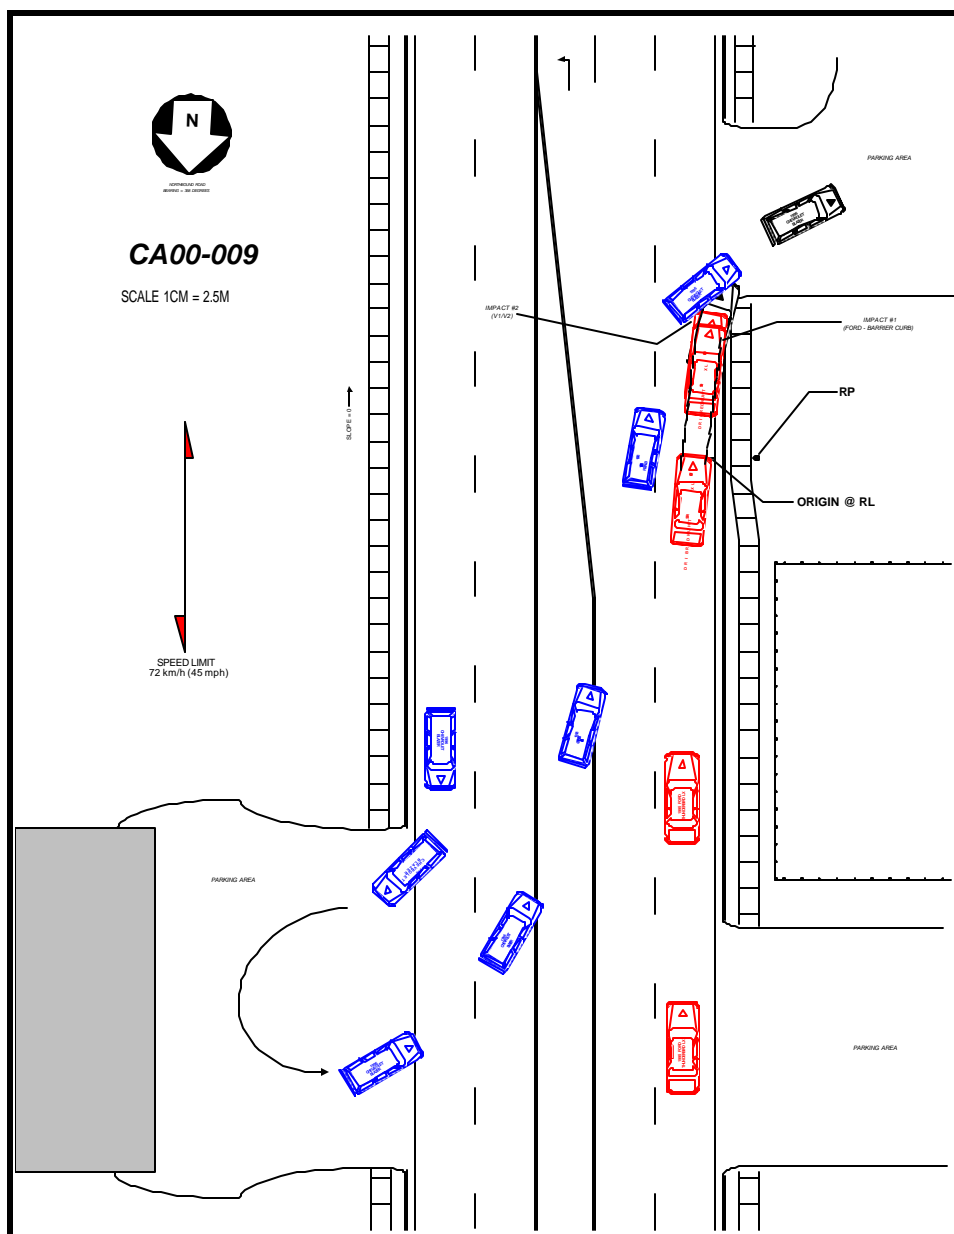
Figure 13. Scene Diagram

This two vehicle crash occurred during the afternoon hours of February, 2000. At the time of the crash, it was daylight with no adverse conditions as the roads were dry. The crash occurred in the southbound lanes of a straight and level north/south five lane (asphalt) roadway (see **Figure 13 - page 8**) which was bordered by 4.5 cm (1.8 in) high barrier curbs. The posted speed limit was 72 km/h (45 mph) with a 4-leg intersection located 41.0 meters (134.5 feet) south of the crash site.
