VERIDIAN ON-SITE AIR BAG FATALITY INVESTIGATION

VERIDIAN CASE NO. CA00-015

VEHICLE - 1992 BUICK ROADMASTER

CRASH DATE - MARCH, 2000

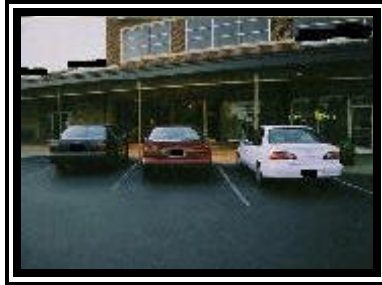
The 57 year old female driver of the 1992 Buick Roadmaster entered the diagonal parking space in the strip mall to shop at a nearby department store (**Figure 1**). Witnesses noted the driver engaged in several activities while parked with the front of the vehicle exposed to the store front area. These included her attempt to consume a bagel and stop a nose bleed. Based on the impending crash, she apparently attempted these activities while the vehicle was running and the automatic transmission selector placed in the “drive” position. The surrogate interview confirmed this as she often “fumbled with her purse or smoked a cigarette” while leaving the automatic transmission selector in the “drive” position and her right foot on the brake pedal.

Figure 1. View north of pre-impact stationary position in parking space.

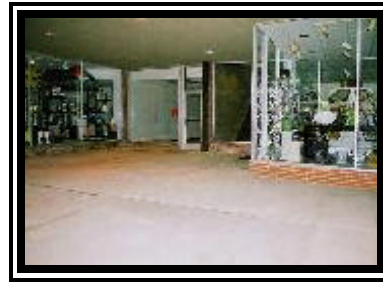
As the driver was attending to these tasks within the vehicle, she became disoriented and inadvertently accelerated the vehicle. The right rear tire broke traction on the asphalt parking lot surface and produced an acceleration mark that continued over a mountable-type curb continuing onto the concrete sidewalk for a distance of 9.8 meters (32.0 feet). It should be noted that the curb displaced the rear of the vehicle slightly in a clockwise direction. The continued acceleration caused the Buick to “fish tail” slightly prior to impact. The vehicle continued in an acceleration mode across the sidewalk into the store front area (**Figure 2**).

Figure 2. Northern approach trajectory into struck store front.

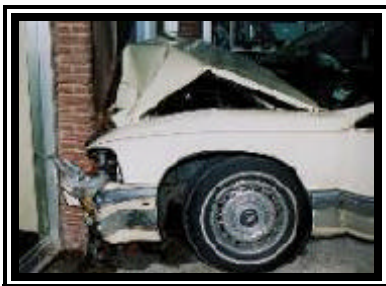
The front left area of the Buick Roadmaster impacted the brick faced pilaster (**Figure 3**) at a WinSMASH computed speed of 29.8 km/h (18.5 mph). The crash resulted in an impact force of 12 o'clock and a barrier equivalent velocity change of 29.5 km/h (18.3 mph) with a respective longitudinal component of -29.5 km/h (-18.3 mph). The speed change exceeded the threshold required for deployment, therefore, the driver's air bag deployed.

Figure 3. Police photo of vehicle and struck pilaster.

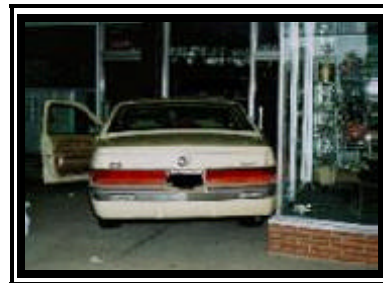
As the vehicle crushed to maximum engagement, the offset left impact induced a slight counterclockwise (CCW) rotation. The right rear quarter panel area side slapped a plate glass window and the corner (aluminum) glazing frame (**Figure 4**). As a result of the 3 o'clock impact force, the Buick sustained minor damage to the side surface. The plate glass window cracked and the corner frame was deflected inward. Although the impact occurred with a yielding object, the barrier algorithm of the WinSMASH program computed a velocity change of 1.7 km/h (1.1 mph) with a matching (negative value) lateral component. The Buick came to rest with the frontal area engaged against the pilaster and the right side surface resting against the struck window frame.

Figure 4. Police photo of vehicle and struck plate glass window/glazing frame.

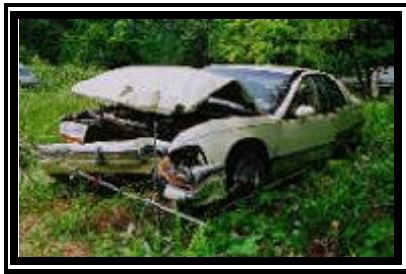
The Buick sustained moderate frontal damage as a result of the impact with the brick pilaster (**Figure 5**). The direct contact damage began 34.0 cm (13.4 in) to the right of the front left bumper corner and extended 28.0 cm (11.0 in) inboard. The impact deformed the full frontal width resulting in a combined direct and induced damage length (Field L) of 136.0 cm (53.5 in). Six crush measurements were documented at the level of the bumper: C1= 25.0 cm (9.8 in), C2= 55.0 cm (21.7 in), C3= 32.0 cm (12.6 in), C4= 18.0 cm (7.1 in), C5= 5.0 cm (2.0 in), C6= 0 cm. The Collision Deformation Classification (CDC) for this initial impact to the Buick was 12-FYEN-2 with a principal direction of force of 0 degrees. The hood was deformed up and rearward from engagement against the pilaster. The left fender was displaced rearward which restricted the left front wheel/tire (not deflated). Reduction in the left side wheelbase measured 10.0 cm (3.9 in). The windshield fractured at the lower left A-pillar area from exterior impact forces (only).

Figure 5. Frontal damage to the 1992 Buick Roadmaster Limited.

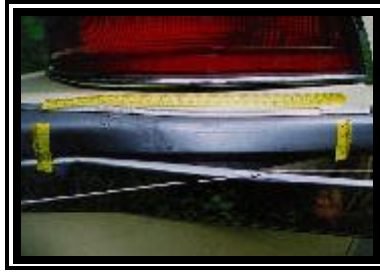
Direct contact damage was also identified along the right rear side surface attributed to the plate glass window/glazing frame impact (Figure 6). The direct contact damage began 10.0 cm (3.9 in) forward of the right rear bumper corner and extended 31.0 cm (12.2 in) forward. Although the deformation was concentrated mainly at the level of the frame, surface scratching was noted above and below the frame level. Six crush measurements were documented at the level of the mid-door: C1= 0 cm, C2= 2.0 cm (0.8 in), C3= 1.0 cm (0.4 in), C4= 0 cm, C5= 0 cm, C6= 0 cm. The CDC for this secondary impact to the Buick was 03-RBEN-1 with a principal direction of force of (+) 90 degrees. Black scuffs and a bright red paint transfer were noted to the front right bumper corner. This damage pattern could not be

matched to the crash scene and was probably pre-existing. Blue paint transfers were found on the upper right quarter panel area with the deformation pattern non-horizontal in nature. This damage pattern was probably from an object that fell from the struck window, however, this could not be verified.

Figure 6. Right rear side surface damage.

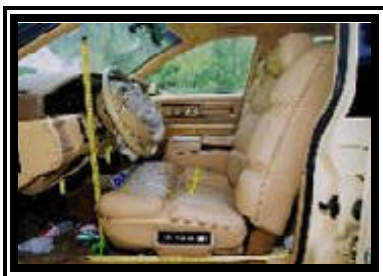
Interior damage to the Buick identified through the vehicle inspection was moderate and was attributed to occupant contact and minimal component intrusion (**Figures 7 & 8**). Scuff marks were documented on the left knee bolster (rigid plastic type). Deformation to the steering wheel rim measured 3.5 cm (1.4 in) at the upper section and 2.0 cm (0.8 in) at the lower section along with 1.0 cm (0.4 in) of column compression. In addition, the tilt lever was fractured at the left side of the column (*column "free floating"*). Blood pooling was noted to the front right seat cushion and center arm rest area. Blood spattering was also noted along the left roof side rail and front/rear left head restraints. A partially eaten bagel was found on the dash with a spilled beverage can and bloody nose tissue discovered on the front left floor area. Longitudinal intrusions into the driver space involved 6.0 cm (2.4 in) of toepan intrusion and 2.0 cm (0.8 in) of instrument panel intrusion.

Figure 7. Interior view.

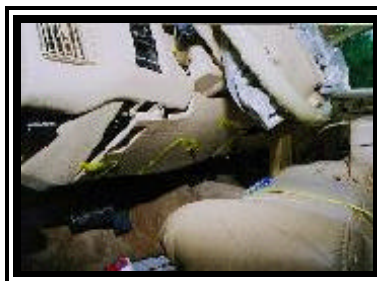
Figure 8. Knee strikes to the driver bolster.

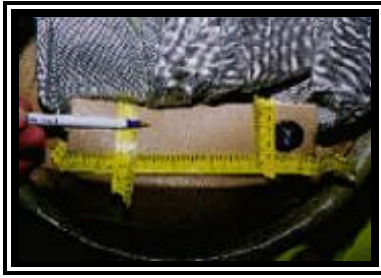
Figure 9. Contact evidence to the lower air bag module cover flap.

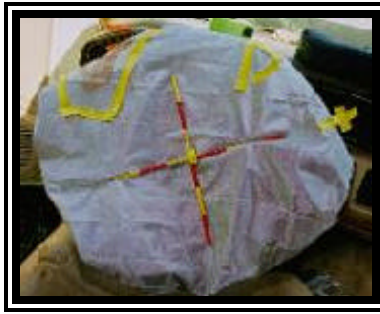
The Buick Roadmaster was equipped with a driver frontal air bag system which deployed as a result of the impact with the brick pilaster. The driver air bag was housed in the center of the steering wheel with a horizontally oriented flap tear seam (H-configuration). The flaps were nearly symmetrical in shape as the upper flap measured 19.5 cm (7.7 in) in width and 5.0 cm (2.0 in) in height while the lower flap measured 19.5 cm (7.7 in) in width and 6.0 cm (2.4 in) in height. Extensive contact evidence was identified on the exterior surface of the module cover flaps which included indentations and multiple longitudinal striations. A hair strand was documented on the upper flap along with skin oil, scuffs and blue fabric transfers to the lower flap (**Figure 9**). The diameter of the driver air bag measured 65.5 cm (25.8 in) in its deflated state (**Figure 10**). Although no contact evidence was found on the face of the air bag, very light yellow fabric transfers were documented on the rear upper left quadrant along with blue fabric transfers to the lower (centered) section (**Figure 11**). Multiple black vinyl transfers were noted to the rear lower section of the air bag from expansion within the module, indicative of an impeded deployment. The bag was vented by two ports located at the 9 o'clock and 3 o'clock sectors on the rear aspect of the air bag. No internal tether straps were present.

Figure 10. 1992 Buick Roadmaster driver air bag.

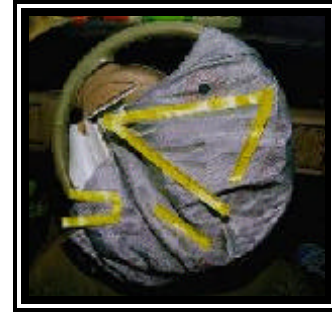
Figure 11. Contact evidence to the aft side of the air bag.

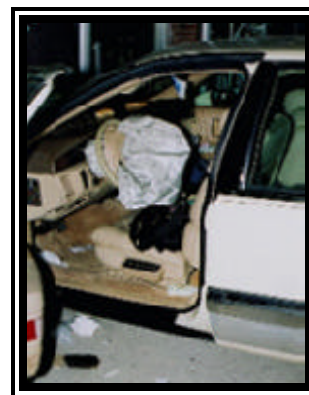
The driver was positioned against the module cover flaps at impact. The cover flaps opened at the designated tear seams and contacted the chest of the driver. Immediately following the cover flap contact, the air bag membrane expanded against the driver. Due to her forward position, the driver restricted the normal deployment path of the air bag. The lower segment of the air bag membrane deployed between the module cover and the steering wheel rim while the upper segment of the bag deployed normally through the cover flaps. Consequently, the air bag was captured between the module cover in a figure 8-type pattern (**Figure 12**).

Figure 12. Police photo of vehicle interior with driver air bag and impeded deployment pattern.

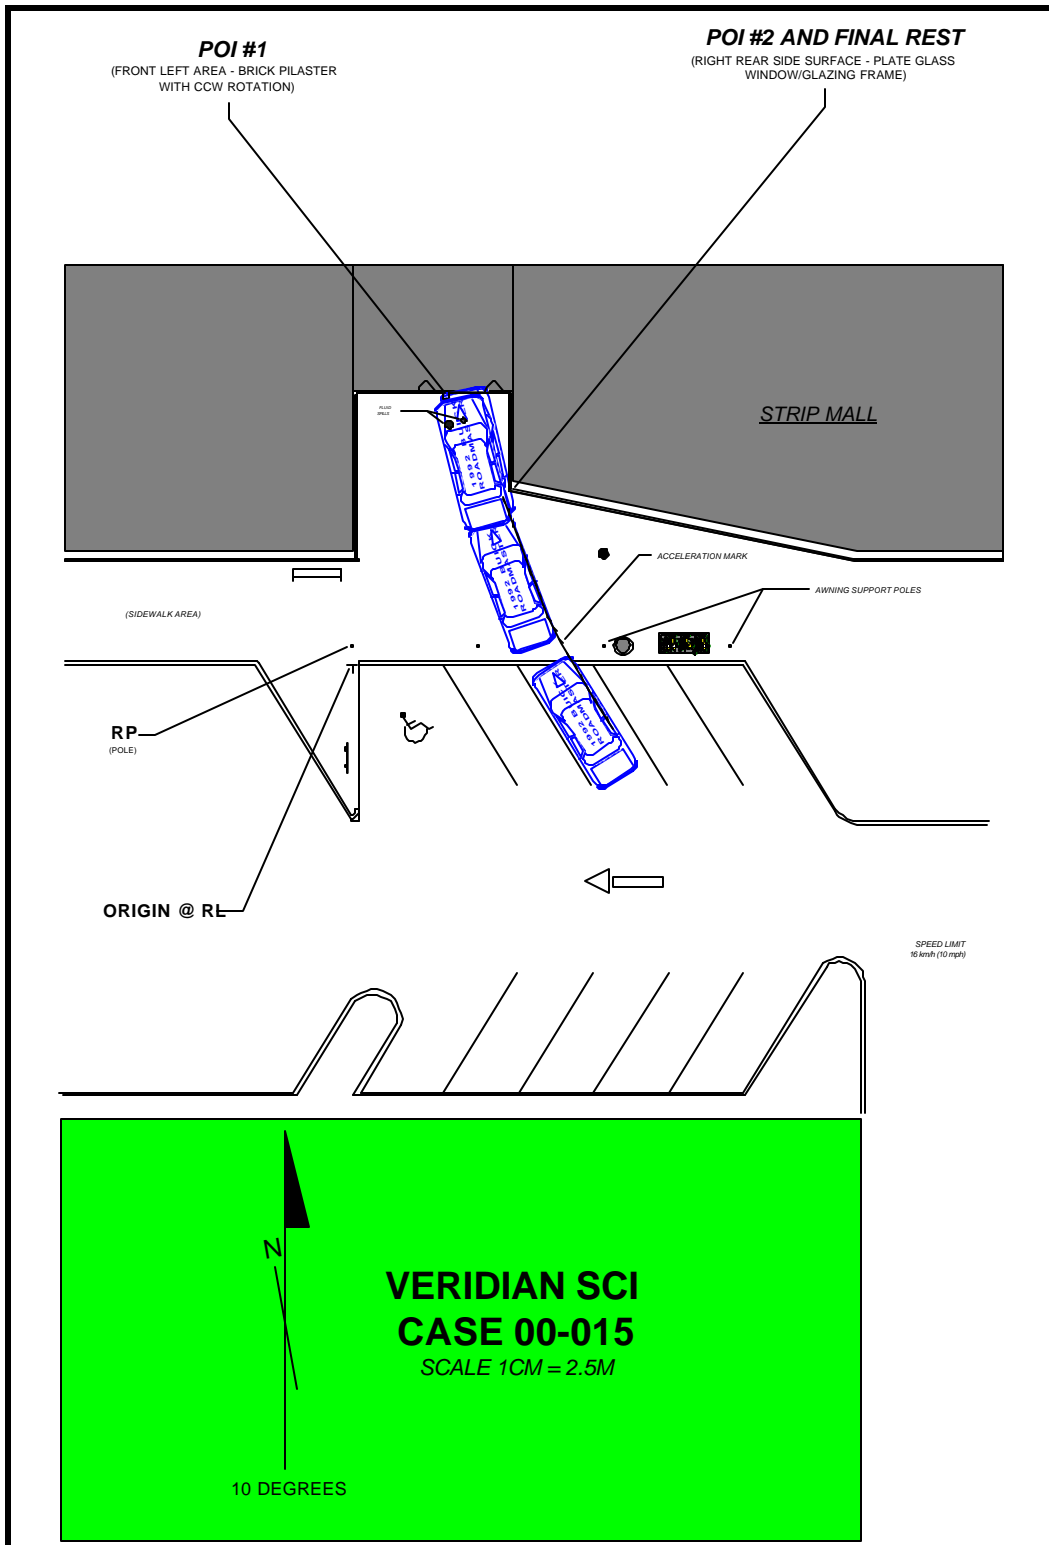
Figure 13. Scene Diagram

This single vehicle crash occurred during the afternoon hours of March, 2000. At the time of the crash, it was daylight with no adverse conditions as the roads were dry. The crash occurred in a strip mall with store fronts located approximately 4.3 meters (14.1 feet) north of the adjacent parking area (**see Figure 13 - page 8**). Small diameter poles supported the awning with brick faced pilasters measuring 30.0 cm (11.8 in) in width and 18.0 cm (7.1 in) in depth protruding from the building. The asphalt parking area was bordered by barrier curbs with diagonal parking spaces 3.1 meters (10.2 feet) apart. The speed limit at the crash site was 16 km/h (10 mph).
