TRANSPORTATION RESEARCH CENTER

ON-SITE AIR BAG INVESTIGATION

CASE NUMBER - IN00-016
LOCATION - MISSOURI
VEHICLE - 1999 CHRYSLER CONCORD LX
CRASH DATE - July, 2000

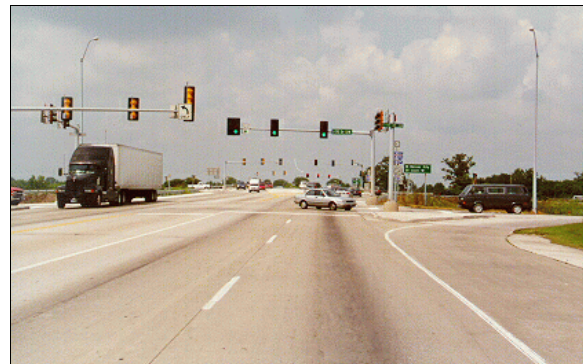
Figure 1: Case vehicle's northbound travel path in outside lane approaching intersection; Note: turning vehicle represents the Ford and stopped vehicle heading westbound on east leg of intersection represents the straight truck (case photo #02)

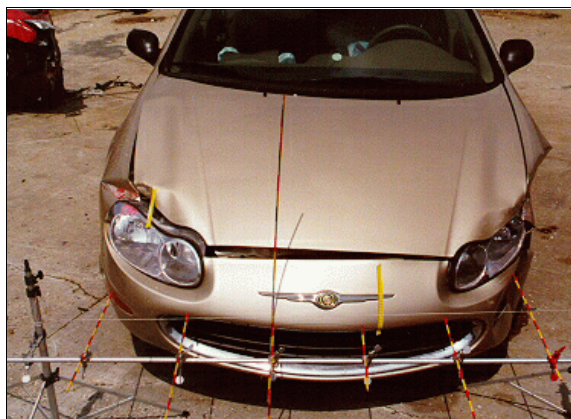
Figure 2: Elevated view of case vehicle's damaged front with tapes indicating start of direct damage; Note: tape at front right corner shows impact with straight truck while tape toward front left side shows impact with the Ford (case photo #15)

The front left of the case vehicle (**Figures 2 and 3**) was impacted by the front of the Ford (**Figure 4**), causing the case vehicle's driver and front right passenger supplemental restraints (air bags) to deploy. As a result of this impact, the case vehicle was subsequently redirected in a northeasterly direction where its front right (**Figure 2** above and **Figure 5** below) impacted the

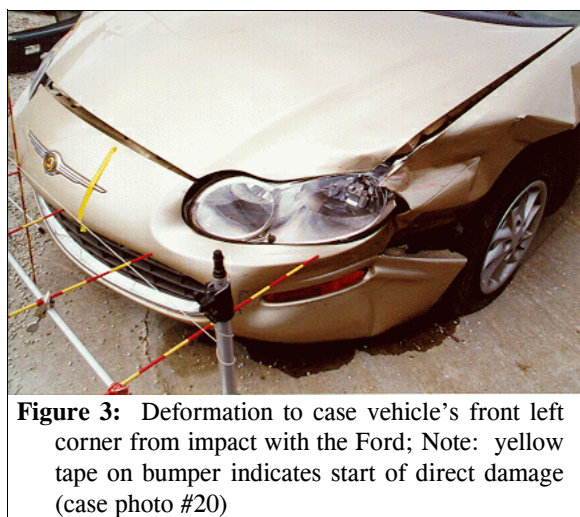
Figure 3: Deformation to case vehicle's front left corner from impact with the Ford; Note: yellow tape on bumper indicates start of direct damage (case photo #20)

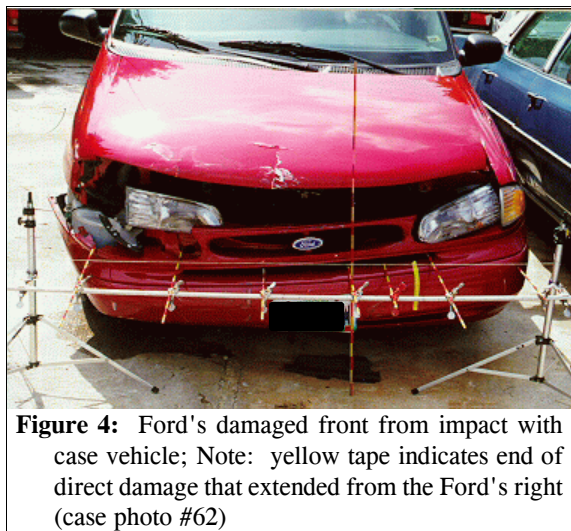
Figure 4: Ford's damaged front from impact with case vehicle; Note: yellow tape indicates end of direct damage that extended from the Ford's right (case photo #62)

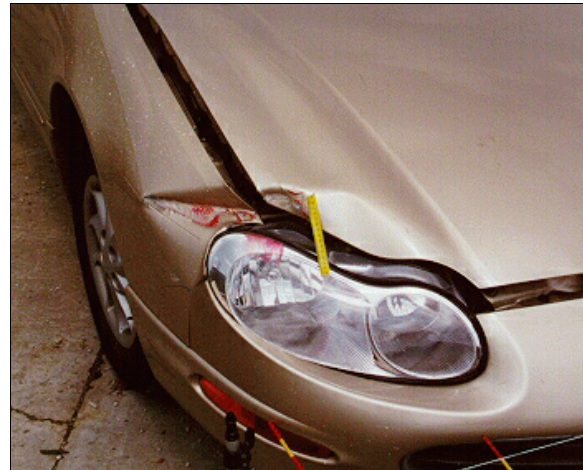
straight truck's left front corner (i.e., most likely left front rather than front left; however, the straight truck was not inspected). The case vehicle came to rest in the westbound left-hand turn lane on the east leg of the intersection, heading northeast. The Ford came to rest in the intersection heading east in the outside northbound through lane. The straight truck remained essentially in its pre-crash position.

Figure 5: Close-up of underride damage to case vehicle's front right corner from impacting stopped the straight truck (case photo #32)

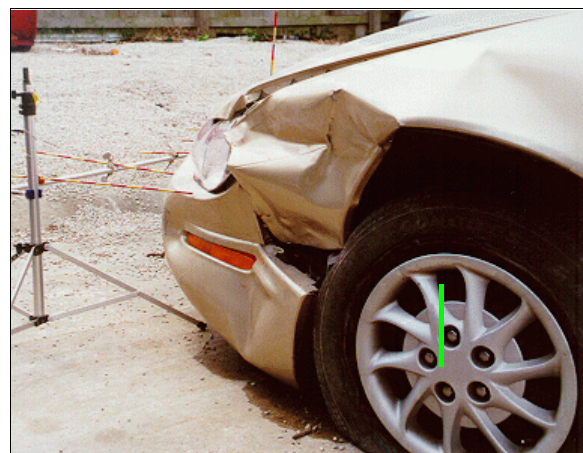
Figure 6: Case vehicle's left front corner showing direct damage extending back to hubcap of left front tire (case photo #25)

Maximum crush was measured as 8 centimeters (3.1 inches) at C_1 . The direct damage also extended down the case vehicle's left side, a measured distance of 108 centimeters (42.5 inches) to the left front hub cap (**Figure 6** above). The case vehicle's secondary impact with the straight truck was an underride type impact to the front right corner above the bumper at the hood level (**Figure 5** above). Direct damage began 67 centimeters (26.4 inches) to the right of the vehicle's center and extended, a measured distance of 18 centimeters (7.1 inches) to the front right bumper corner. The maximum crush from this impact was approximately 7 centimeters (2.8 inches). The wheelbase on the case vehicle's left side was possibly shortened 1 centimeters (0.4 inches) while the right side was neither shortened nor extended. The case vehicle's front bumper fascia, hood, and right and left fenders were directly damaged and crushed rearward. The case vehicle's left front tire was physically restricted and deflated from the initial impact. Both the right and left headlight and turn signal assemblies sustained induced damage as well as both the right and left fenders. The left front wheel cover was directly damage as well.

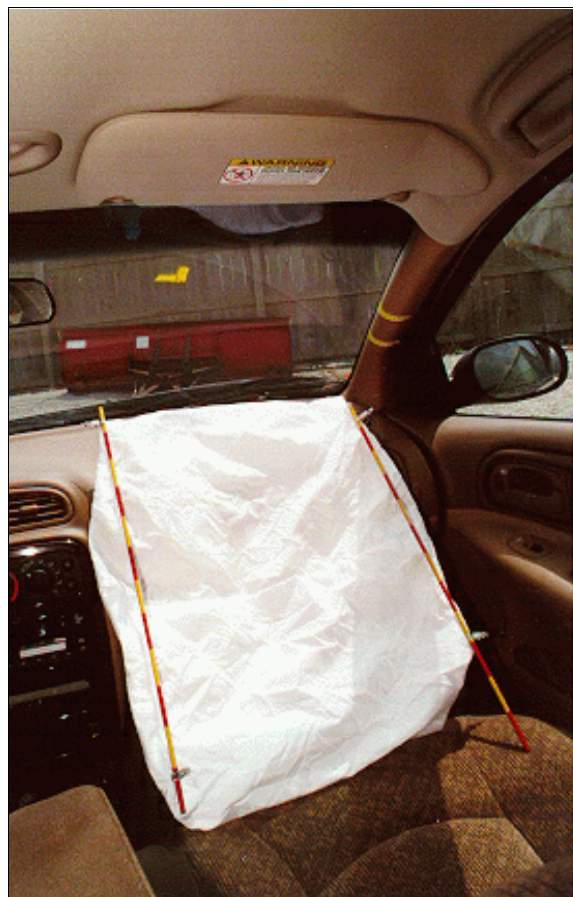
Figure 7: Vertical view of case vehicle's front right passenger seating area showing deployed air bag; Note: highlighted contacts on right "A"-pillar and scuff on windshield (case photo #40)

the right edge of the cover flap, and the deformation was approximately 9 centimeters (3.5 inches) wide. Furthermore, there were several areas of black scuffs and streaks beginning on the top surface of the air bag's fabric indicating that the air bag's deployment path had been restricted from the front right passenger's left leg. The front right passenger's air bag was designed with two tethers, each 7.5 centimeters (3.0 inches) wide, sewn into the center of the front surface near the 3 and 9 o'clock positions (i.e., 7 centimeters (2.8 inches) inward from the side edges and 32 centimeters (12.6 inches) down from the top stitching). The front right air bag had two vent ports, approximately 5 centimeters (2.0 inches) in diameter, located at the 10 and 2 o'clock positions. The deployed front right air bag was rectangular with a height of approximately 62 centimeters (24.4 inches) and a width of approximately 47 centimeters (18.5 inches). An inspection of the front right air bag's fabric did not reveal any obvious evidence of occupant contact to the air bag's front surface (**Figure 7** above).

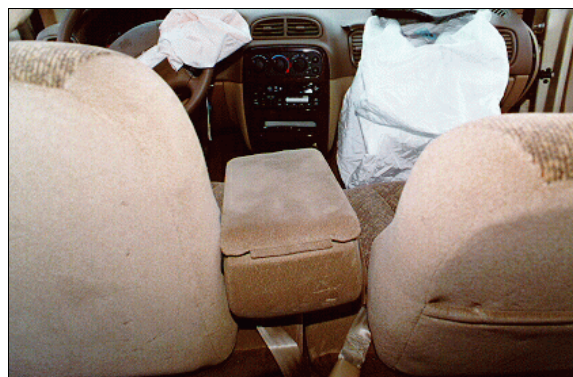
Figure 8: Case vehicle's damaged center arm rest which was bent towards driver's seat from contact by front right passenger's torso (case photo #39)

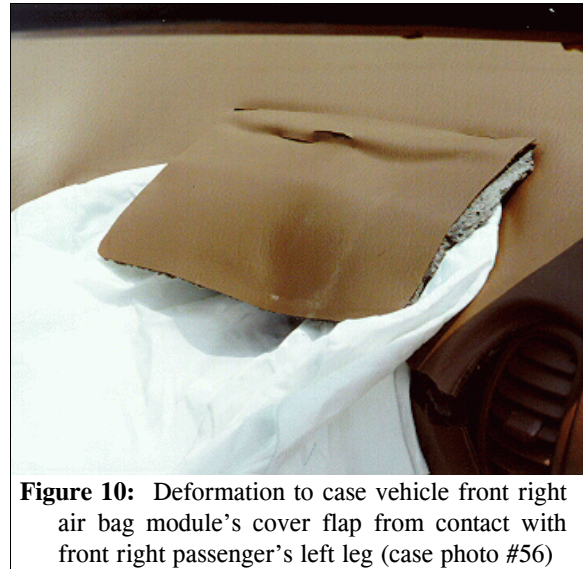
The front right passenger's air bag was located in the top of the instrument panel. There was a single, essentially rectangular, modular tethered cover flap. The cover flap was made of a thick vinyl over a thick cardboard type frame. The flap's dimensions were: 28 centimeters (11.0 inches) at the forward horizontal seam and 18 centimeters (7.1 inches) along both vertical seams. The profile of the case vehicle's instrument panel was flush with the leading edge of the cover flap. An inspection of the front right air bag module's cover flap and air bag fabric revealed that the cover flap opened at the designated tear points, and there was evidence of damage during the deployment to the module's cover flap (i.e., deformed by contact with the front right passenger's left leg—**Figure 10** below). The deformation was located 11 centimeters (4.3 inches) inward from

Figure 10: Deformation to case vehicle front right air bag module's cover flap from contact with front right passenger's left leg (case photo #56)

The front right occupant was transported by ambulance to the hospital. She sustained moderate injuries and was hospitalized for 5 days post-crash. According to the case vehicle’s driver and her medical records, the injuries sustained by the front right passenger included: a trimalleolar fracture to her left ankle and a segmented fracture of her left fibula. Both of these fractures were caused from contact by the front right passenger air bag module’s cover flap.

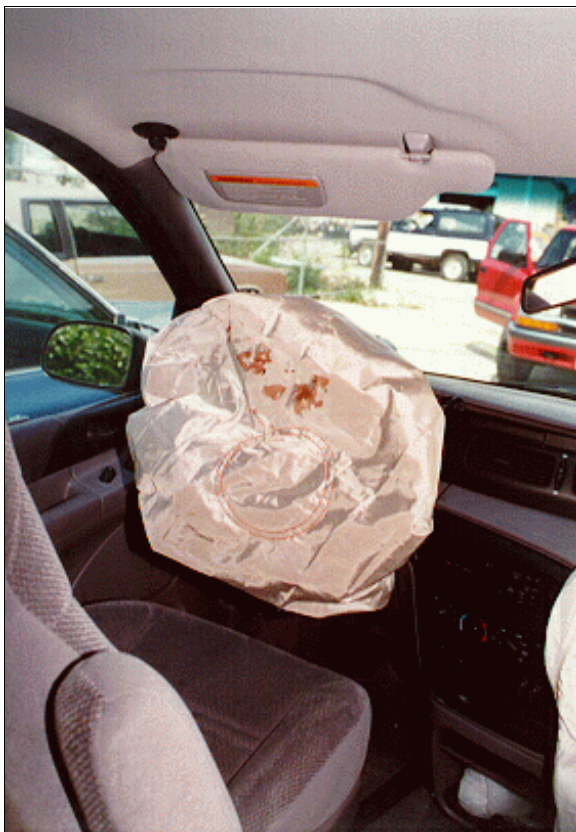
Figure 12: Vertical view of Ford's driver seating area showing deployed air bag with evidence (i.e., blood) of contact (case photo #75)

An inspection of the Ford's interior revealed that there was contact evidence (**Figure 12** above) readily apparent on the Ford's driver air bag. The Ford's driver [89-year-old, White (non-Hispanic) female; unknown height and weight] was restrained by her available, active, three-point, lap-and-shoulder, safety belt system. The driver was transported by ambulance to the hospital. She sustained non-incapacitating-evident (“B”) injuries but her treatment status and injuries are unknown.

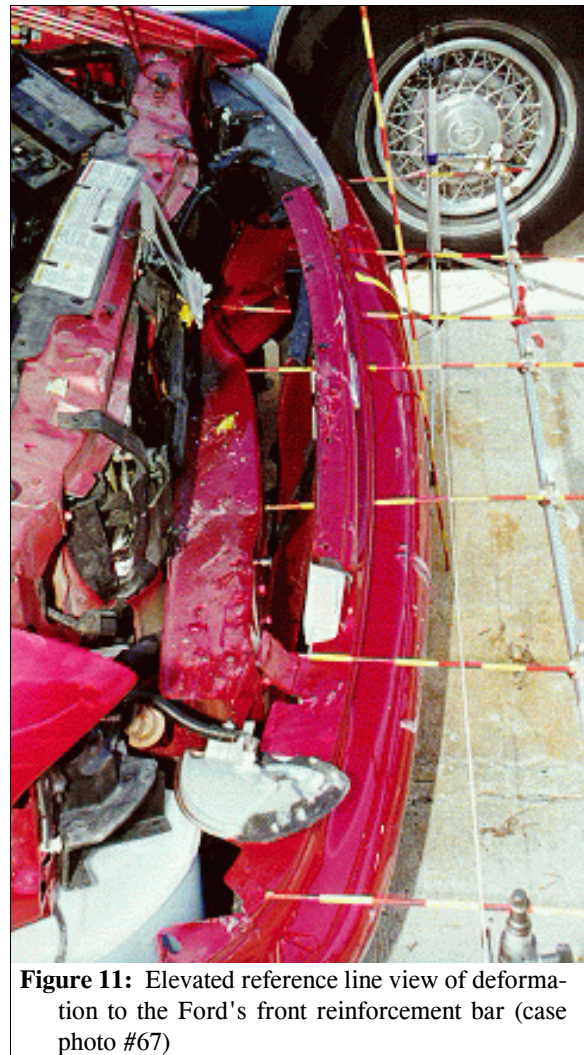
The Ford's contact with the case vehicle involved its entire front. Direct damage began 40 centimeters (15.7 inches) to the left of the Ford's center (**Figure 4** above) and extended, a measured distance of 117 centimeters (46.1 inches), along the front to the front right bumper corner. Residual maximum crush was measured as 20 centimeters (7.9 inches) between C₂ and C₃. The wheelbase on the Ford's left side was shortened 5 centimeters (2.0 inches) while the right side was possibly extended 1 centimeter (0.4 inches). The Ford's front bumper (**Figure 11**), bumper fascia, grille, right turn signal assembly, and hood were directly damaged and crushed rearward (**Figure 4** above). None of the Ford's tires were physically restricted or deflated from the crash. The right headlight and the left headlight and turn signal assemblies sustained induced damage as well as the hood and both the right and left fenders.

Figure 11: Elevated reference line view of deformation to the Ford's front reinforcement bar (case photo #67)
