TRANSPORTATION RESEARCH CENTER

ON-SITE ADULT AIR BAG-RELATED FATALITY INVESTIGATION

CASE NUMBER - IN00-017
LOCATION - IOWA
VEHICLE - 1997 HYUNDAI SONATA GL
CRASH DATE - October, 2000

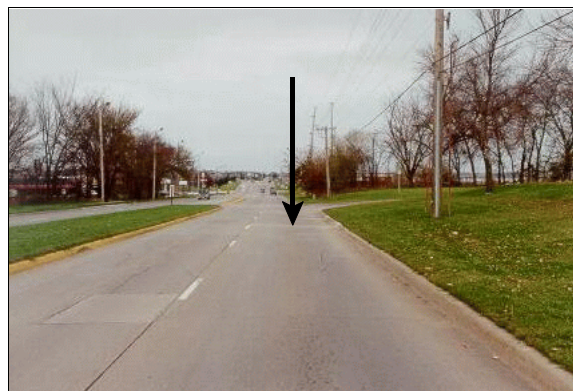
Figure 1: Case vehicle's travel path in outside lane of northbound roadway—arrow marks approximate point of impact (case photo #01)

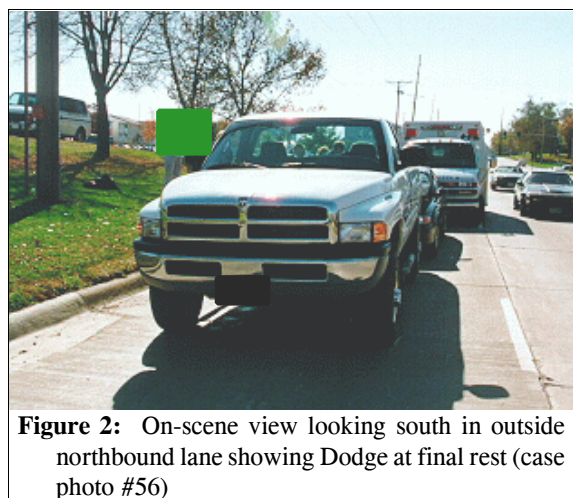
Figure 2: On-scene view looking south in outside northbound lane showing Dodge at final rest (case photo #56)

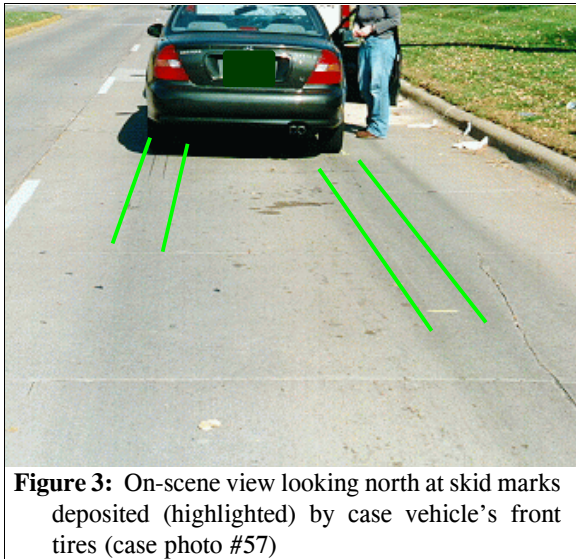
Figure 3: On-scene view looking north at skid marks deposited (highlighted) by case vehicle's front tires (case photo #57)

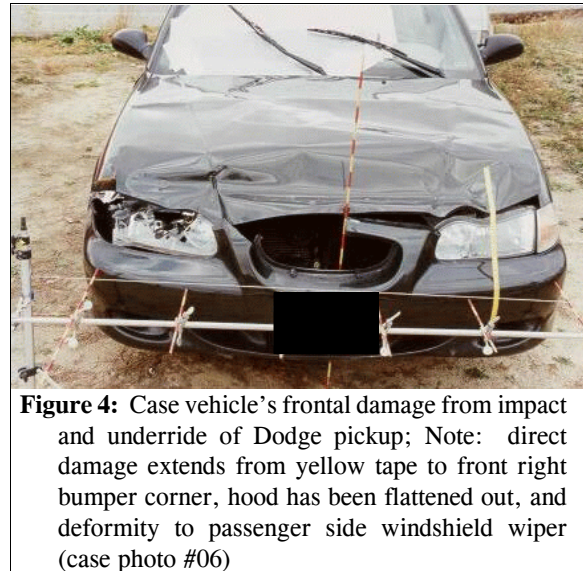
Figure 4: Case vehicle's frontal damage from impact and underride of Dodge pickup; Note: direct damage extends from yellow tape to front right bumper corner, hood has been flattened out, and deformity to passenger side windshield wiper (case photo #06)

The front (**Figure 4** above) of the case vehicle impacted the back of the Dodge (**Figure 5** above), causing the case vehicle's driver and front right passenger supplemental restraints (air bags) to deploy. The case vehicle and the Dodge moved at most only a short distance before coming to rest near the point of impact, heading northward (**Figure 6**).

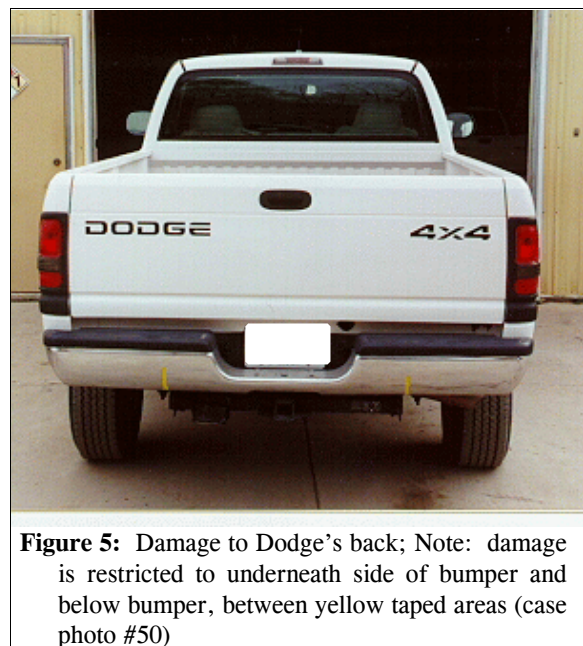
Figure 5: Damage to Dodge's back; Note: damage is restricted to underneath side of bumper and below bumper, between yellow taped areas (case photo #50)

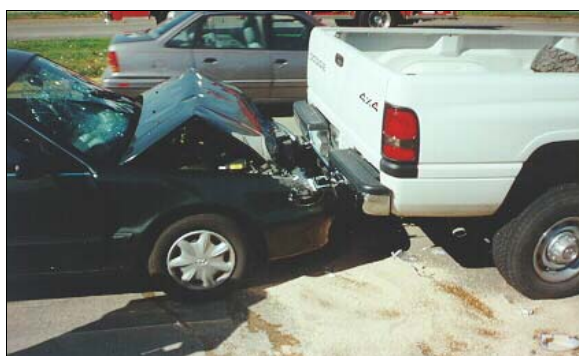
Figure 6: On-scene view looking west at case vehicle's (left) and Dodge's (right) final rest positions (case photo #58)

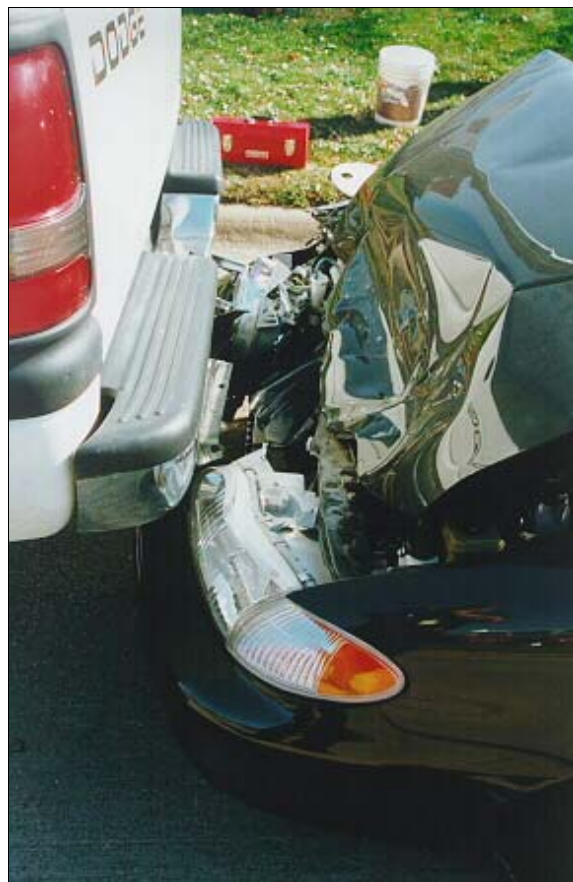
The damage to the case vehicle was primarily above the bumper (**Figure 7**) resembling an underride impact pattern. The underride type damage resulted in the air bag deploying late during the duration of the impact. This late deployment occurred due to the prolonged change in time (Delta T) relative to the change in speed (magnitude of Delta V—i.e., ramp versus spike). Initially the case vehicle was believed to have traveled a measured distance of 114 centimeters (44.9 inches) under the back bumper and bed of the Dodge pick-up truck before contacting the back part of the transmission's differential housing (**Figure 8**). This was later discounted because there was no corresponding evidence (i.e., differential imprint) on the case vehicle.

Figure 7: On-scene view looking east at final rest positions of case vehicle (right) and Dodge (left); Note: uneven damage pattern (case photo #59)

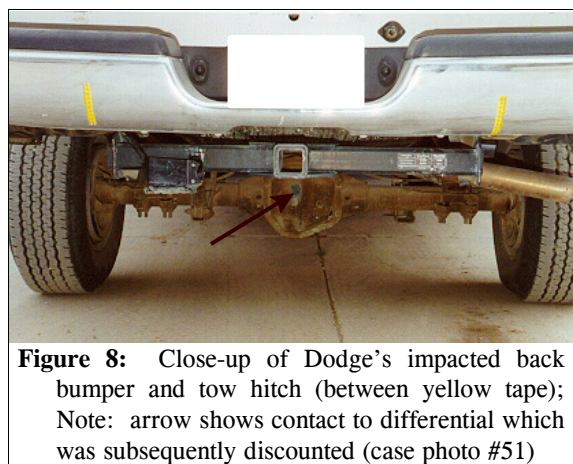
Figure 8: Close-up of Dodge's impacted back bumper and tow hitch (between yellow tape); Note: arrow shows contact to differential which was subsequently discounted (case photo #51)

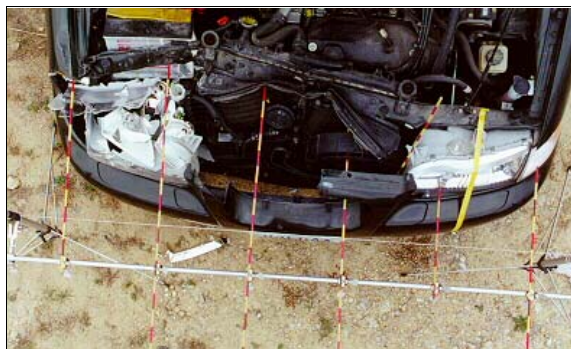
The case vehicle's contact with the Dodge involved the vast majority of its front—primarily above the bumper (**Figures 9 and 10**). Direct damage began 51 centimeters (20.1 inches) left of the vehicle's center and extended, a measured distance of 122 centimeters (48.0 inches), along the front bumper to the front right bumper corner (**Figure 11**). Residual maximum crush at bumper level was a measured as 4 centimeters (1.6 inches) at C₆, and the residual maximum crush above the bumper was measured as 33 centimeters (13.0 inches) from C₄ to C₅. The case vehicle's

Figure 9: Overhead view of case vehicle's frontal damage with contour gauge present showing uneven damage pattern from underriding back of Dodge (case photo #10)

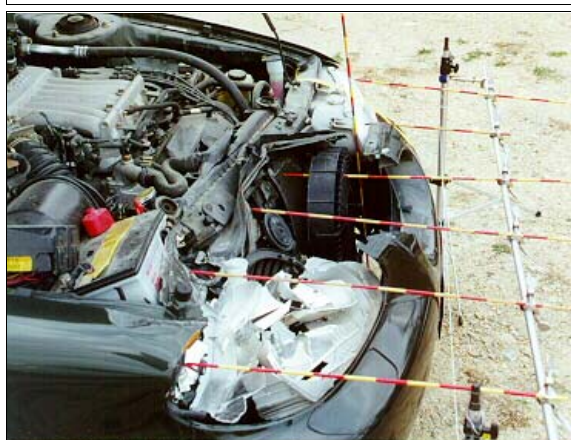
Figure 10: Reference line view from right of case vehicle's uneven frontal damage pattern with contour gauge present (case photo #14)

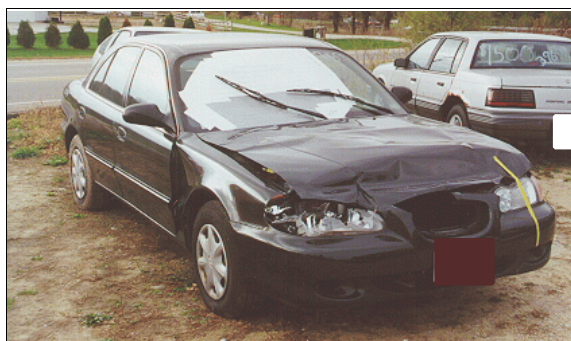
Figure 11: Case vehicle's frontal damage as a result of underriding Dodge; direct damage begins at front right corner and extends to yellow tape; Note: bent hood has been flattened out and right windshield wiper is bent outward at approximately its lower one-third from contact to windshield's glazing by front right passenger's head (case photo #19)

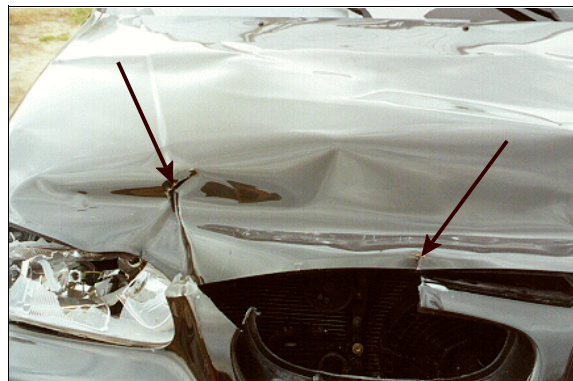
Figure 12: Close-up of creases in case vehicle’s hood from direct contact with Dodge’s tow hitch (case photo #08)

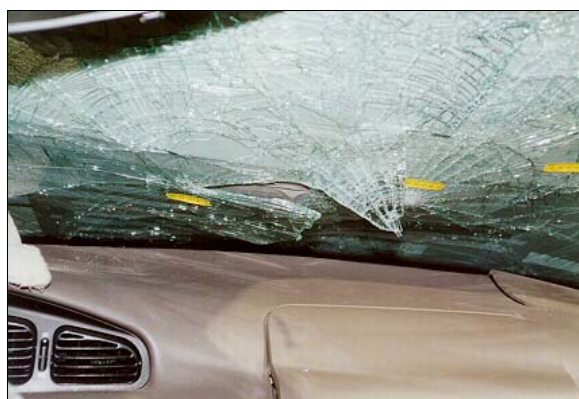
Figure 13: Close-up of case vehicle’s lower right windshield showing cracked and holed glazing from contact by front right passenger’s head and lower portion of right windshield wiper, respectively (case photo #28)

Inspection of the case vehicle’s interior revealed a spider web-type impact to the right windshield’s glazing from contact by the front right passenger’s head (Figure 13 and Figure 14). Furthermore, there was contact to near the left side of the front right sun visor, most likely from the front right passenger’s left hand and a smear toward the top of the right “A”-pillar, most likely from the front right passenger’s right hand. Likewise, there was a smear on the right front window’s glazing also most likely from the front right passenger’s right hand. In addition, there

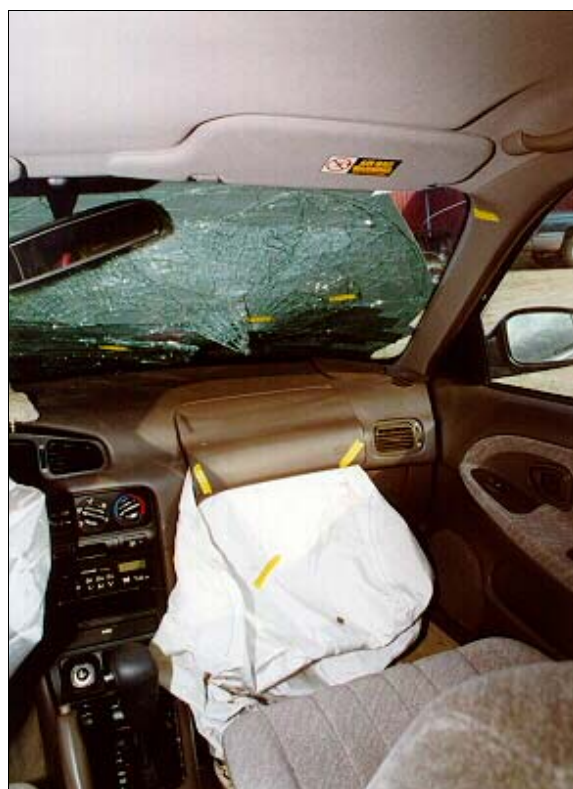
Figure 14: Vertical view of case vehicle’s front right passenger seating area showing contacted (tape) windshield, right “A”-pillar, front right air bag module’s cover flap and top of air bag (case photo #26)

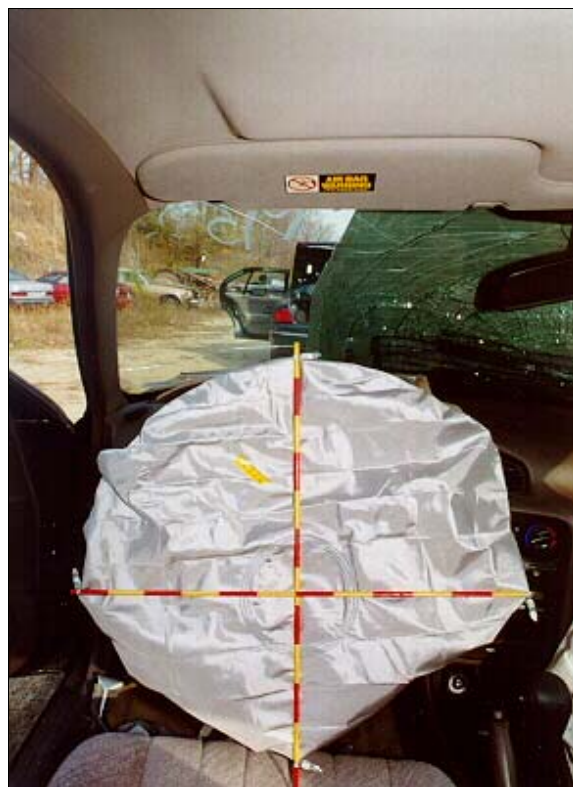
Figure 15: Vertical view of case vehicle's driver seating area and deployed air bag; Note: small area (tape) of contact evidence (case photo #25)

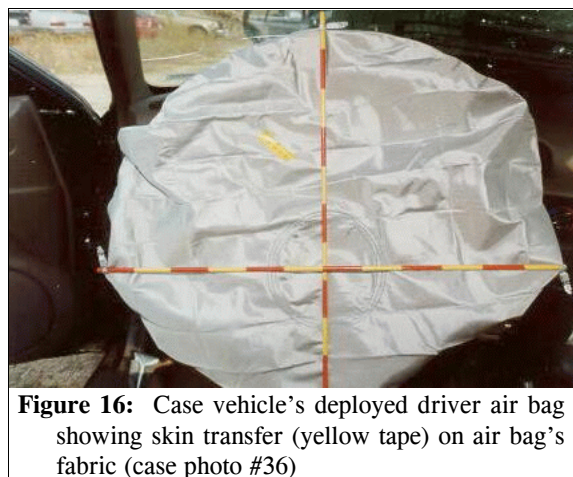
Figure 16: Case vehicle's deployed driver air bag showing skin transfer (yellow tape) on air bag's fabric (case photo #36)

23 centimeters (9.1 inches) down from the top of the air bag and 14-15 centimeters (5.5-5.9 inches) left of center (**Figure 16** above).

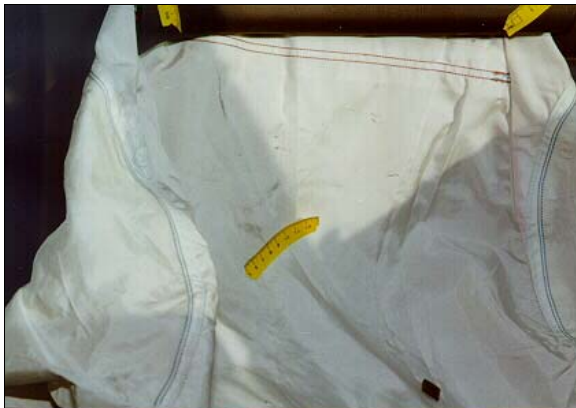
Figure 17: Close-up of small skin transfer to top portion of case vehicle's front right passenger air bag; Note: contacted corners of cover flap at top of photo (case photo #43)

An inspection of the front right passenger's air bag fabric revealed contact evidence readily apparent on the top (**Figure 17**) and front surfaces. On the top surface there was an 8 centimeter (3.1 inch) curvilinear skin transfer. On the front surface there were numerous areas of blood at and between the two tether seams in the middle of the bag (**Figure 18**). Furthermore, there was an obliquely oriented skin transfer [3 centimeters (1.2 inches) high and 29 centimeters (11.4 inches) in width] along the lower leftward portion of the air bag's front surface (**Figure 19** below) that may well have come from contact with the front right passenger's left hand and/or forearm as it was deflected away by the deploying air bag.

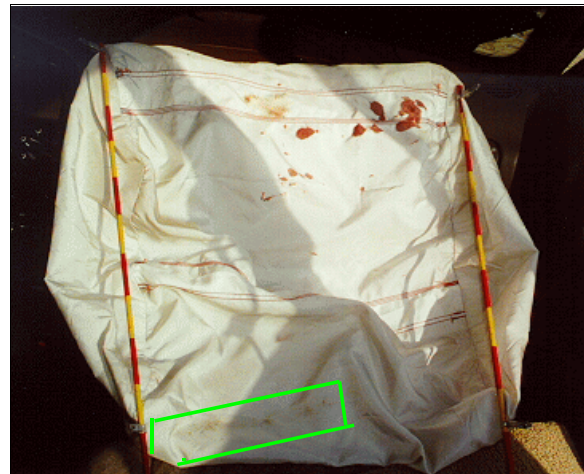
Figure 18: Case vehicle's front right passenger air bag showing blood spots and skin (highlighted) at bottom left portion (case photo #41)

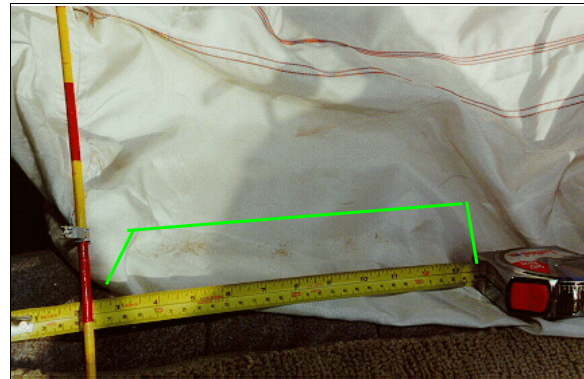
Figure 19: Close-up of large skin transfer to bottom (highlighted) of case vehicle's front right passenger air bag (case photo #42)

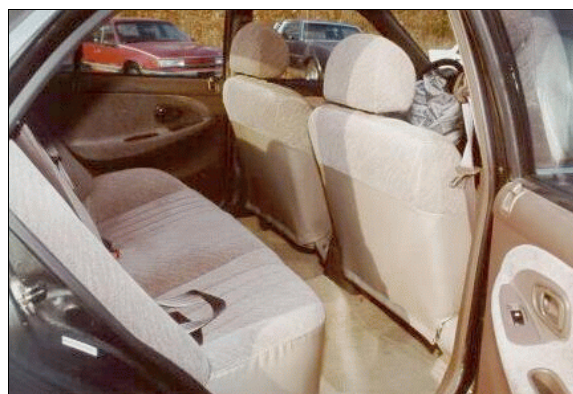
Figure 20: Case vehicle’s back seating area; Note: a makeup transfer was found on the back side of the front right head restraint (case photo #47)
