On-scene Advanced Occupant Protection Systems
Dynamic Science, Inc. / Case Number: DS00-018
2000 Ford Taurus SE 4-door
Texas
June, 2000

1. Report No. DS00-018		2. Government Accession No.		3. Recipient Catalog No.	
4. Title and Subtitle In-Depth Accident Investigation				5. Report Date .

**Dynamic Science, Inc.
Accident Investigation
Case Number: DS00-018**

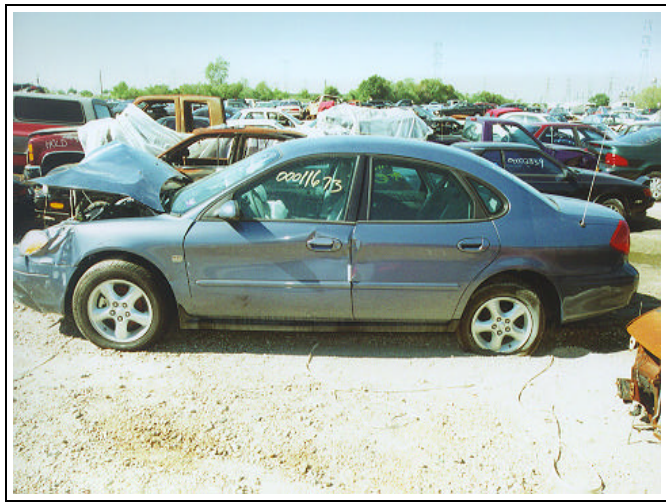
After impact 1, the case vehicle rotated clockwise and the Buick rotated counterclockwise. Impact 2 was a side slap between the left side of the case vehicle (09LYEW2) and the right side of the Buick (04RZEW3). The case vehicle sustained a calculated total delta v of 18.0 km/h (11.2 mph), a longitudinal delta v of 0 km/h (0 mph) and a latitudinal delta v of 18.0 km/h (11.2 mph) as computed by WinSmash⁵. The Buick sustained a total delta v of 18.0 km/h (11.2 mph), a longitudinal delta v of 0 km/h (0 mph) and a latitudinal delta v of -18.0 km/h (-11.2 mph). The results fit the collision model and appear reasonable for both vehicles.

Figure 3. Left side damage to the case vehicle.

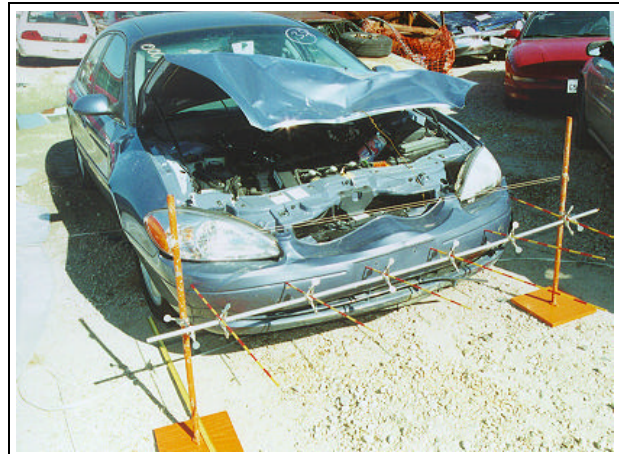
Description:	2000 Ford Taurus SE 4-door Ford dealer loaner
VIN:	1FAFP55S3YGXXXXXX
Odometer:	1,849 km (1,149 miles)
Engine:	3.0 L V6
Reported Defects:	None
Cargo:	None
Damage Description:	Moderate frontal damage to the front bumper, hood, grille area and both front fenders from the 1 st impact. The left driver's door sustained minor damage from the side slap, 2 nd impact. The vehicle was towed from scene.

Figure 7. Front damage to case vehicle.

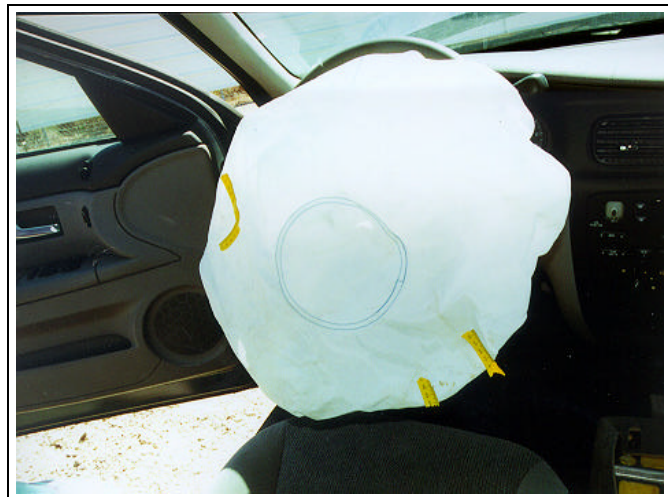
Figure 8. Case vehicle driver's air bag.

On the face of the airbag there were black transfer from the single flap module cover. There was also a 20 cm (7.9 in) long make up contact to the mid-left side of the air bag from interacting with

the unrestrained front right occupant. Neither the air bag nor the single flap module cover sustained any damage.

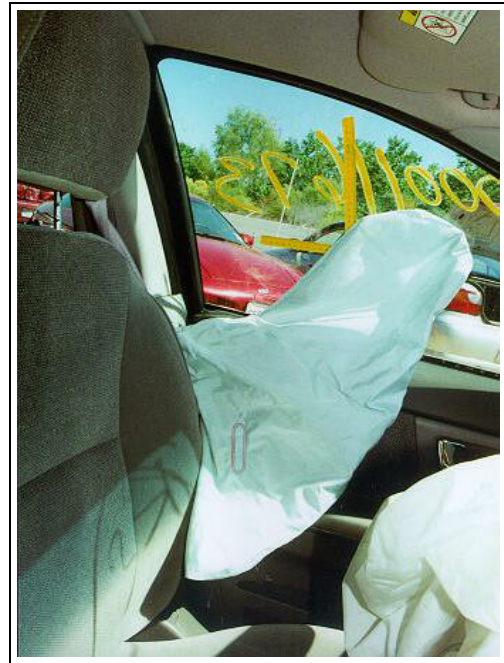
The case vehicle was also equipped with a driver's and front right seat-mounted side air bags. The EDR report indicates that the driver's side air bag deployed at the same time the driver's front airbag deployed—21 ms from time algorithm wakeup to first stage belted deployment attempt. The driver's side air bag appears to have a single tether and no vent ports. The bag is vaguely rectangular in shape and measures 72 cm (28.3 in) high by 35 cm (13.8 in) wide at its base. There was no indication of occupant contact nor any damage to the driver's seat mounted side airbag.

Figure 9. Case vehicle seat mounted side air bag.

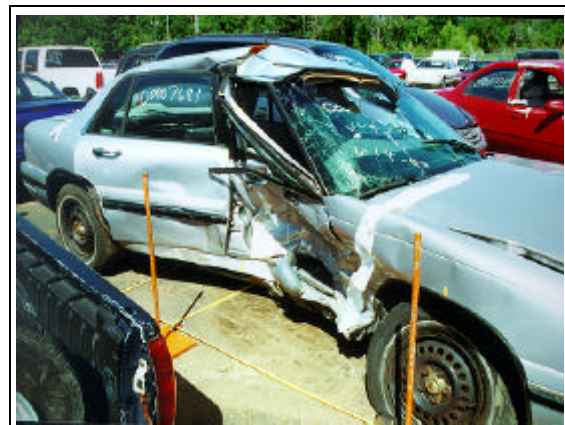
Description: 1997 Buick Le Sabre 4-door
 VIN: 1G4HP52KXVHXXXXXX
 Odometer: 90,705 km (56,363 miles)
 Engine: 3.8 L 6 cylinders
 Reported Defects: None
 Cargo: None
 Damage Description: Severe right side damage from 1st impact. Front right door and B pillar intruded into front right passenger compartment area, and the roof buckled. Front right fender, hood and windshield damage. Moderate right side damage from 2nd impact. Moderate damage to front left door. Front left tire/rim damage.

Figure 10. Exterior damage to Buick-1st impact.

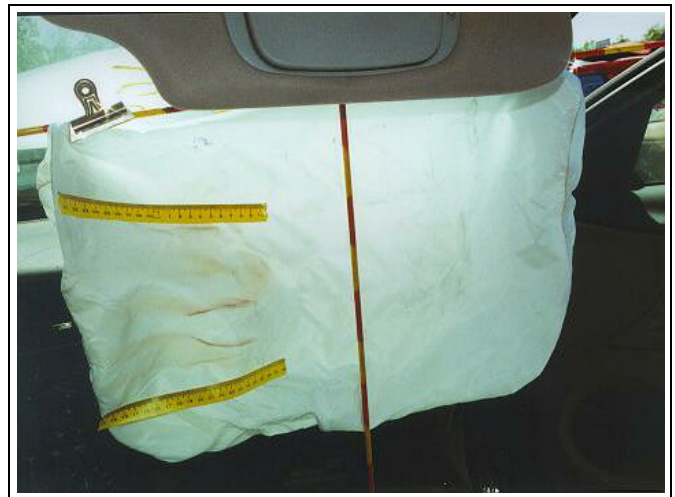
The front right occupant of the case vehicle was seated in a normal, upright fashion. She was not wearing the available lap and shoulder belt. The fabric-covered bucket seat was adjusted to the rear most track position. The seat back angle was reclined slightly rearward. There was pre-impact braking and as a result of being unrestrained, the front right occupant was out of position. As the case vehicle broadsided the Buick, the front right passenger responded to the 340 degree direction of principal force by moving forward and laterally to the left. There was evidence of contact to the mid-left face of the airbag in the form of makeup/lipstick transfer. She also struck the instrument panel with both of her knees sustaining large contusions. When the case vehicle side slapped the right side of the Buick with its left side, the front right occupant responded by moving laterally to the left and struck the rear view mirror and sun visor with her forehead sustaining a contusion to her forehead. She also struck the center instrument panel with her left knee and bent/cracked the center console with her left lower body. As the case vehicle continued rotating clockwise to final rest, the front right occupant moved laterally to the right and rearward into the front right seat. After being treated at the scene, the front right occupant was transported by ground ambulance to a hospital where she was treated and released. She received approximately two months of treatment from a chiropractor.

Figure 11. Case vehicle front right passenger's air bag.

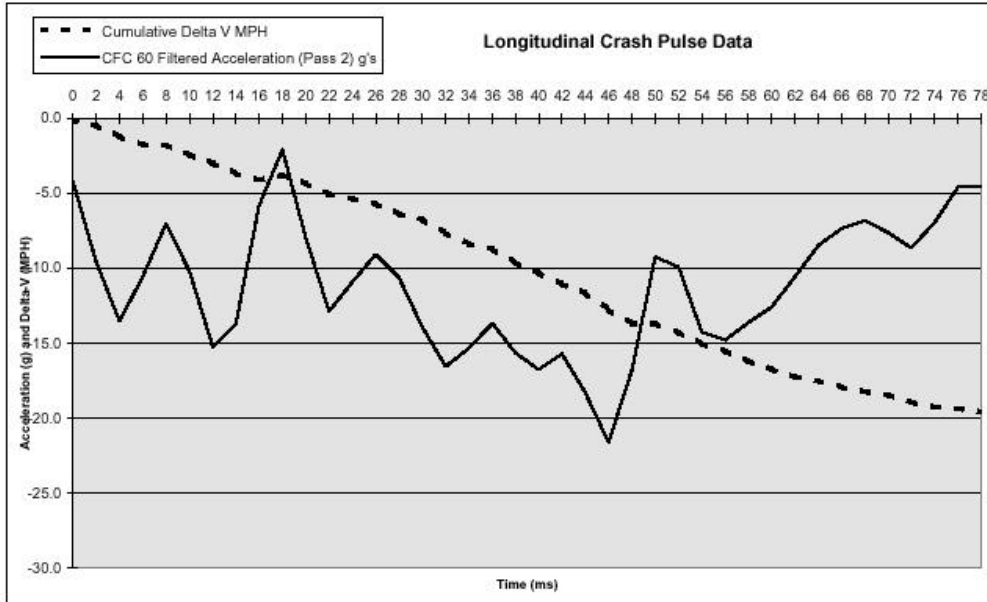
Longitudinal Cumulative Delta-V

Time (ms)	0	10	20	30	40	50	60	70	78
Delta-V (MPH)	-0.2	-2.4	-4.3	-6.7	-10.3	-13.7	-16.7	-18.5	-19.6

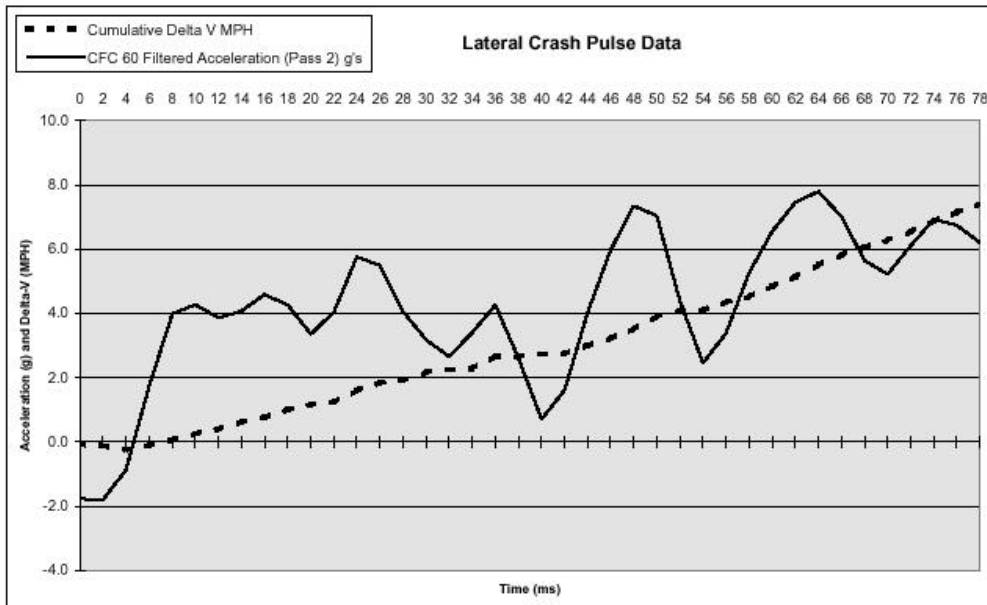
Lateral Cumulative Delta-V

Time (ms)	0	10	20	30	40	50	60	70	78
Delta-V (MPH)	-0.1	0.3	1.2	2.2	2.7	3.9	4.9	6.3	7.4
