ON-SITE ADAPTIVE CONTROL-EQUIPPED VEHICLE INVESTIGATION

CASE NUMBER - IN00-018
LOCATION - INDIANA
VEHICLE - 1997 DODGE RAM 2500
CRASH DATE - October, 2000

March 11, 2003

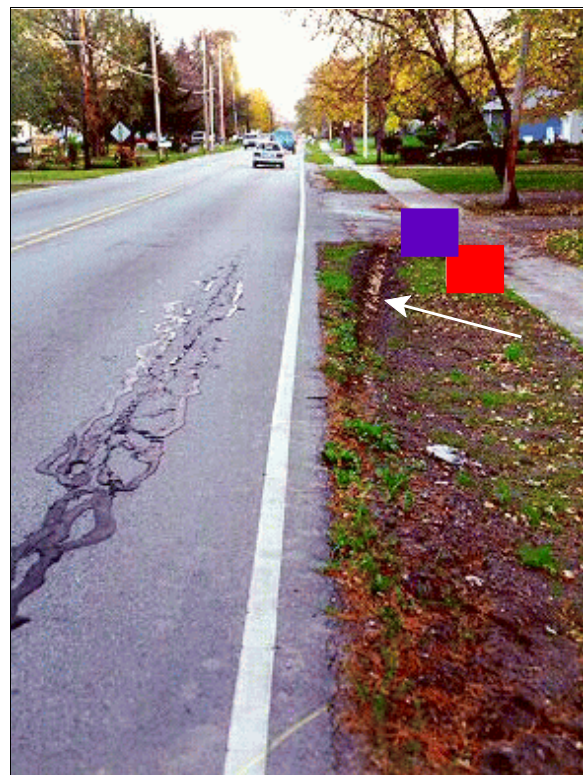
Figure 1: Case vehicle's right roadway departure which precipitated driver's overcorrection during re-entry onto roadway; Note: tire mark on unimproved shoulder (case photo #02)

one lane in both the north and southbound directions). The case vehicle's driver unexplainably departed the right side of the roadway and, as a result, traveled along the west shoulder and roadside (**Figure 1** above). The driver steered to the left and over-corrected, enabling the case vehicle to re-enter the roadway. The case vehicle traveled transversely across both lanes and off the east edge of the roadway, while rotating slightly counterclockwise. The case vehicle continued eastward on the roadside through a residential lawn (**Figure 2**). Just prior to the crash, the case vehicle's driver made no avoidance maneuvers. The crash occurred approximately 15 meters (49.2 feet) from the east edge of the roadway in the front yard of a house owned by the witness to the crash; see **CRASH DIAGRAM** below.

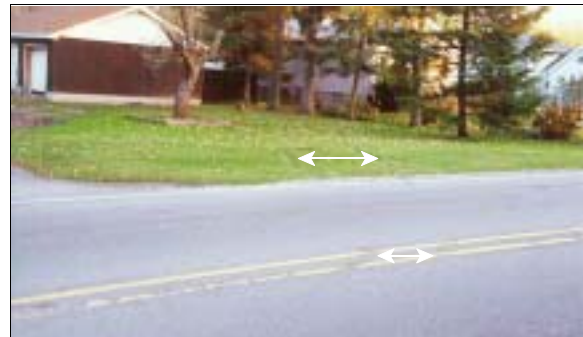
Figure 2: Case vehicle's transverse travel path across road from west shoulder area onto residential lawn and into tree; Note: arrows highlight tire scuffs (case photo #05)

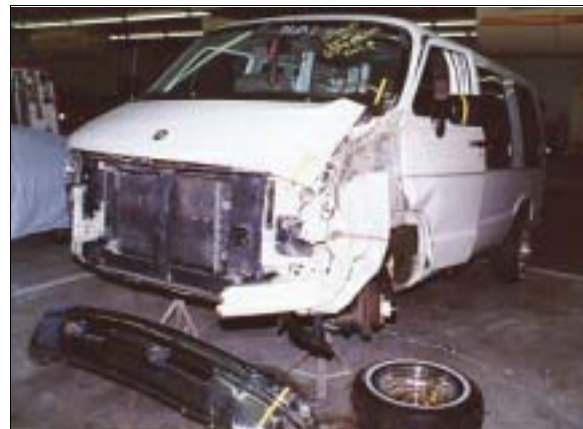
Figure 3: Case vehicle's damaged front left corner viewed from left of front showing narrow corner damage extending down left side; Note: direct contact to left windshield, "A"-pillar, and outside mirror (case photo #26)

Initially the front left bumper corner (**Figures 3 and 4**) of the case vehicle impacted (i.e., a very narrow frontal impact) a large tree (**Figure 5** below). Shortly thereafter, the left front

The case vehicle's contact with the tree involved its front left (very narrow frontal) corner. Direct damage began 9 centimeters (3.5 inches) inward from the front left bumper corner (**Figures 3 and 4** above). Because of the struck tree's angled growth (**Figure 5** above), the direct damage above the bumper was greater than along the bumper and extended from the left fender inwards, a measured distance of 16 centimeters (6.3 inches). There was direct damage contact to the left "A"-pillar and windshield. The direct damage extended along the left side, a measured distance of 79 centimeters (31.1 inches), and continued to the outside rearview mirror. The wheelbase on the case vehicle's left side was shortened 8 centimeters (3.1 inches) while the right side was extended 2 centimeters (0.8 inches). The case vehicle's front bumper, bumper fascia, grille, hood, front left headlight and turn signal assemblies, and left fender were directly damaged and crushed rearward. In addition, the left corner of the windshield was cracked and the left "A"-pillar and outside rearview mirror sustained tree contact. Furthermore, the case vehicle's left front wheel assembly was torn loose from the vehicle and the driver's door and was deformed rearward causing it to be jammed closed (**Figure 3** above and **Figure 6** above).

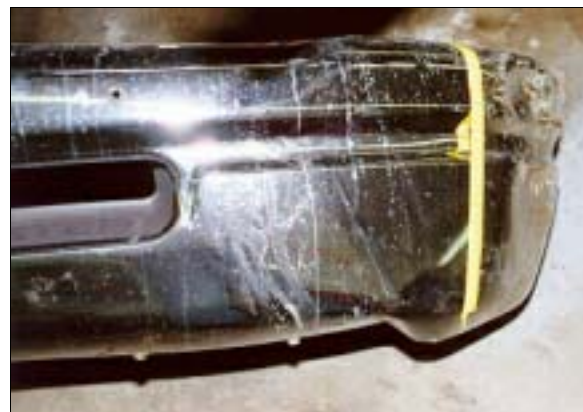
Figure 4: Close-up of direct contact (i.e., yellow tape outwards) to case vehicle's front left bumper corner from tree engagement (case photo #23)

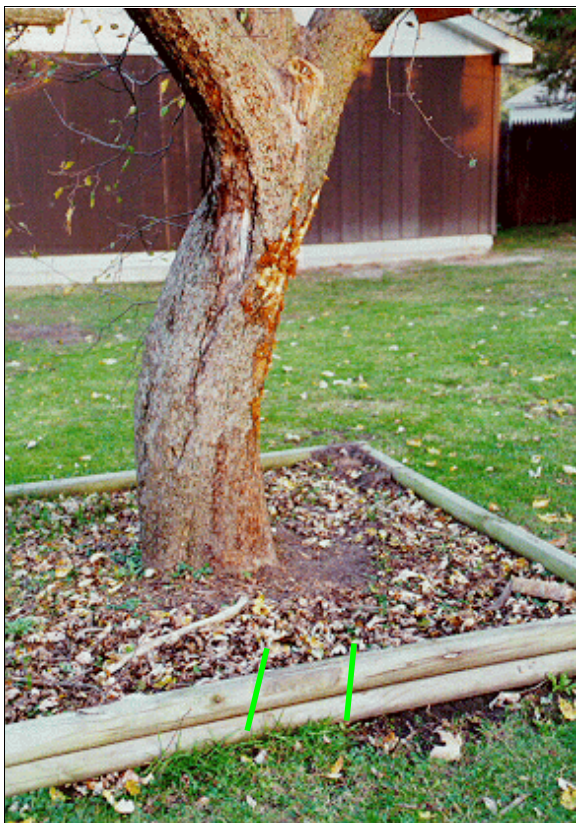
Figure 5: Residential tree struck by case vehicle's front left; Note: left front tire mark highlighted on wood timber (case photo #10)

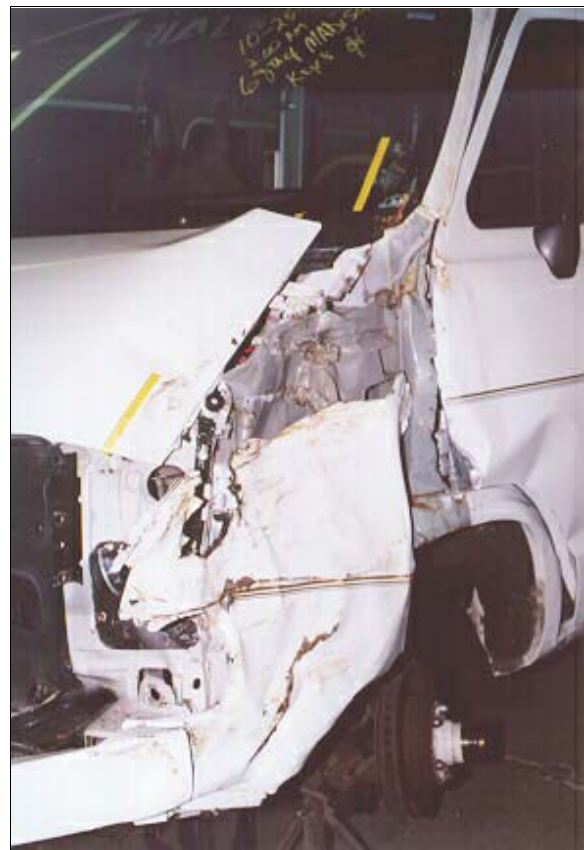
Figure 6: Close-up of case vehicle's narrow front left corner engagement with tree; Note: missing left front wheel and width (i.e., yellow tape) of direct damage (case photo #27)

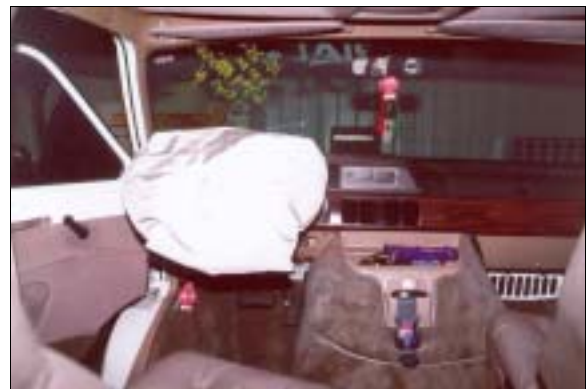
An examination of the case vehicle's interior revealed that there was no visible evidence of occupant contact on the interior surfaces of the case vehicle (**Figure 7**).

Figure 7: Case vehicle's front seating area, greenhouse, interior surface of driver's door, and deployed driver's air bag showing no obvious evidence of occupant contact (case photo #43)

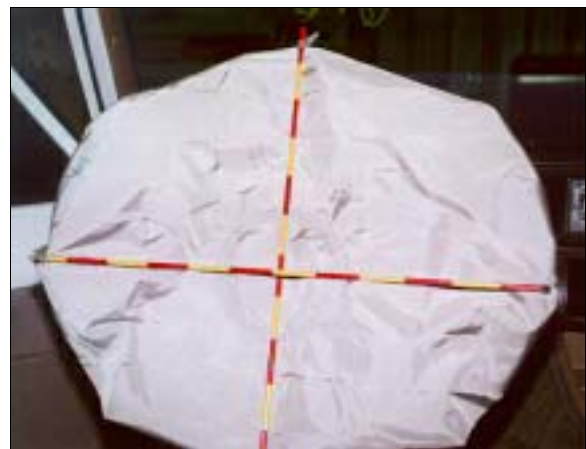
Figure 8: Case vehicle's deployed driver air bag; Note: no evidence of driver contact is visible (case photo #56)

contained a frontal air bags at the driver seating position. The driver’s air bag deployed as a result of the very narrow frontal impact with the tree. The case vehicle’s driver air bag was located in the steering wheel hub. The module cover consisted of asymmetrical “H”-configuration cover flaps made of thick vinyl with overall dimensions of 18 centimeters (7.1 inches) at the horizontal seam and 6.1 centimeters (2.4 inches) vertically for the upper flap and 6.7 centimeters (2.6 inches) vertically for the lower flap. An inspection of the air bag module’s cover flaps and air bag fabric revealed that the cover flaps opened at the designated tear points, and there was no evidence of damage during the deployment to the air bag or the cover flaps. The driver’s air bag was designed with four tethers, each 7.6 centimeters (3.0 inches) wide, sewn interiorly at the 1, 5, 7, and 11 o’clock positions. The driver’s air bag had two vent ports, approximately 3.2 centimeters (1.25 inches) in diameter, located at the 11:30 and 12:30 o’clock positions. The deployed driver’s air bag was round with a diameter of 65 centimeters (25.6 inches). There was no contact evidence readily apparent on the driver’s air bag (**Figure 8** above).

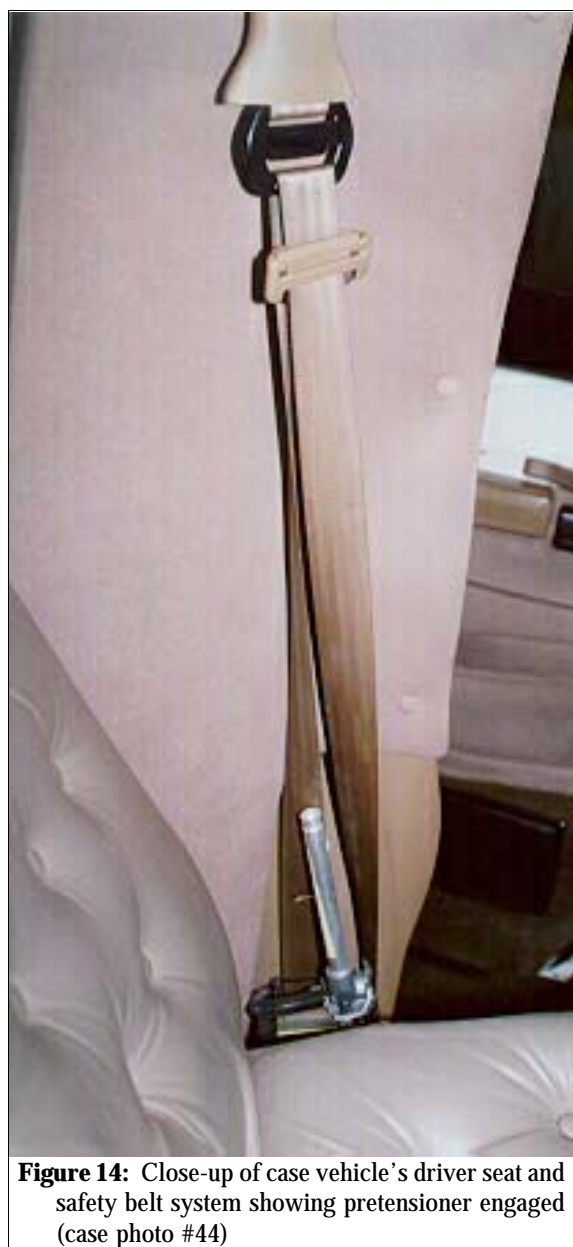
Figure 14: Close-up of case vehicle's driver seat and safety belt system showing pretensioner engaged (case photo #44)

his body. In addition, the inspection of the driver's seat belt webbing, "D"-ring, and latch plate revealed that the pretensioner had fired, and the webbing was taut between the "D"-ring and the floor mounted housing indicating it was not in use at the time of the crash. Furthermore, there was no evidence of loading on any of these belt system components. Photographs taken by this contractor (**Figure 14** above) showed the pretensioner mechanism had worked properly by pulling the slack out of the webbing making it taut.

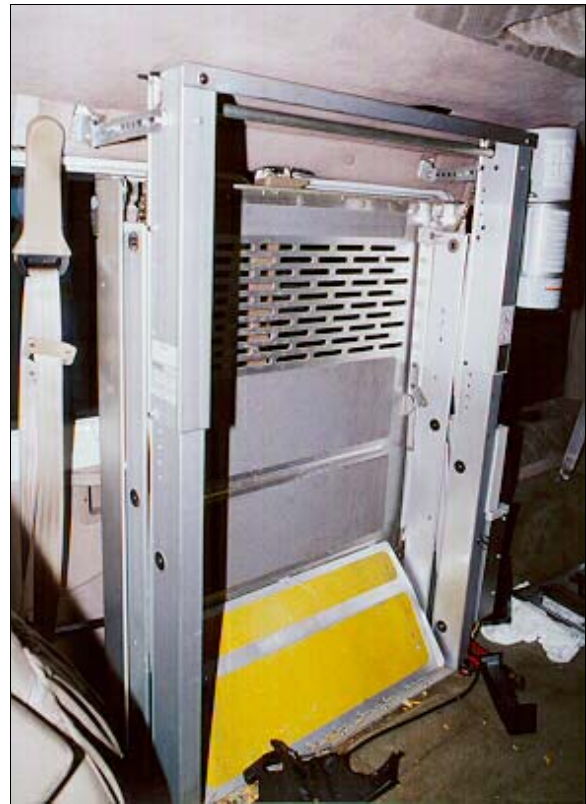
The case vehicle's departure off the west edge of the roadway and down a short incline had no effect on the unrestrained driver's torso. When the driver steered sharply to the left, attempting to get his vehicle back onto the roadway, his over-corrective steering maneuver combined with the nonuse of his available safety belts, resulted in the driver moving to his right while the case vehicle traveled transversely across the roadway. There was extra weight on the case vehicle's right side from the vehicle's wheelchair lift and power swing doors (**Figure 15** and see **SELECTED PHOTOGRAPHS, Figure 17** below). This extra weight may have caused the vehicle to tip further

Figure 17: Close-up of case vehicle's powered wheelchair lift viewed from driver's seating area (case photo #62)
