ON-SITE CHILD AIR BAG-RELATED FATALITY INVESTIGATION

CASE NUMBER - IN00-019
LOCATION - TEXAS
VEHICLE - 1996 FORD CONTOUR GL
CRASH DATE - December, 2000

IN00-019

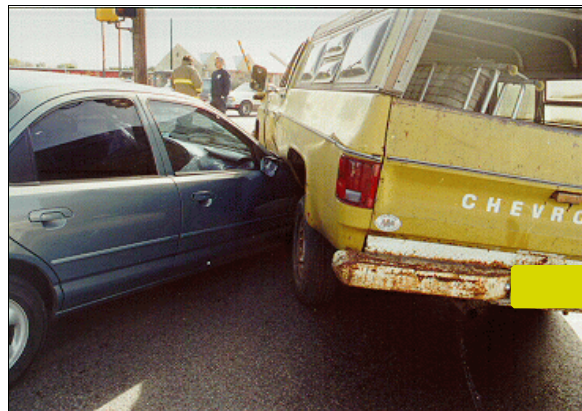
Figure 6: On-scene southeasterly view of case vehicle and Chevrolet pickup at final rest; Note: pickup tilted from being underridden by case vehicle (case photo #76)

The front of the case vehicle impacted the left side of the Chevrolet pickup (**Figures 5 and 6**), causing the case vehicle’s driver and front right passenger supplemental restraints (air bags) to deploy (**Figure 7** below). Upon impact the case vehicle’s front underrode the Chevrolet

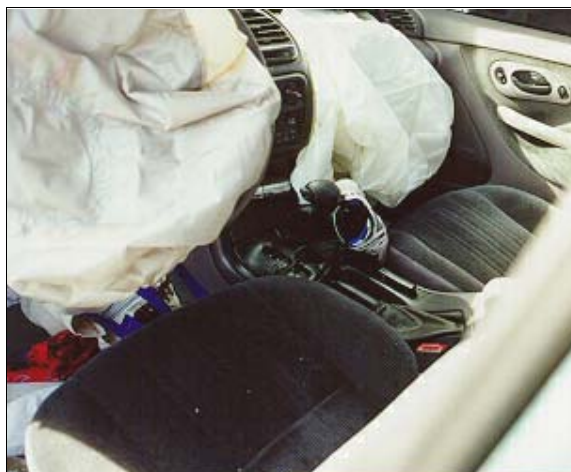
Figure 7: On-scene view of case vehicle's front seating area showing deployed air bags; Note: front right passenger's air bag was cutout and removed prior to inspection (case photo #80)

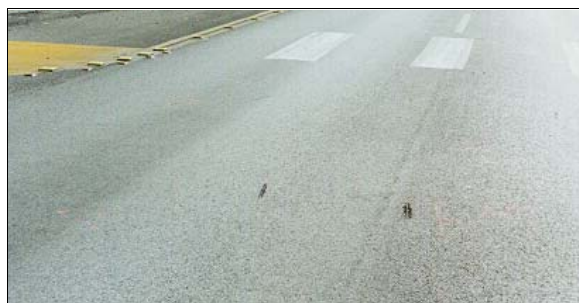
Figure 8: South-southeastward view of gouges in roadway's bituminous surface made by case vehicle's undercarriage as a result of its maximum engagement with Chevrolet pickup (case photo #04)

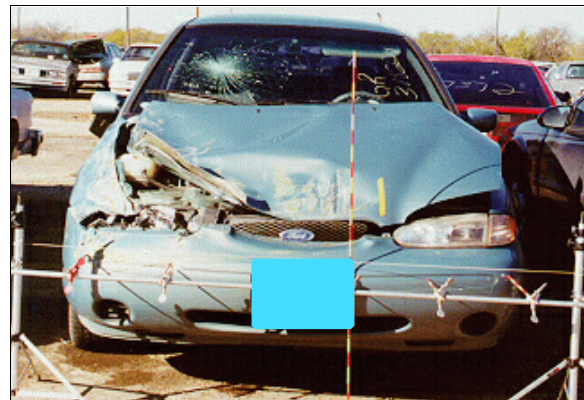
The case vehicle's initial contact with the Chevrolet pickup involved approximately three-fourths of its front (**Figure 10**). Because of the underride type impact, the direct damage began at the right bumper corner and extended, a measured distance of 102 centimeters (40.2 inches), towards the left bumper corner, ending 28 centimeters (11.0 inches) leftward of the case vehicle's center (**Figure 11**). For the frontal impact the residual maximum crush to the bumper was only 1 centimeter (0.4 inches), but as a result of the underride impact, the residual maximum crush above the bumper was measured as 44 centimeters (17.3 inches) at C₆. However, the actual above bumper crush was 71 centimeters (28.0 inches) at C₆. The case vehicle's wheelbase was unaltered from the crash. As a result of the initial impact, the case vehicle's front bumper fascia, grille, hood, front right headlight and turn signal assemblies, and right fender were directly damaged and crushed rearward. The case vehicle's hood was shifted slightly to the left because of the counterclockwise rotation while the hood was partially under the left side of the Chevrolet pickup (**Figure 10**). During the side slap impact, the right front door panel and right outside rearview mirror were directly contacted and crushed inward (**Figure 12** below). None of the case vehicle's tires were damaged, deflated, or physically restricted. No obvious induced damage or remote buckling was noted to the remainder of the case vehicle's exterior.

Figure 10: Case vehicle's frontal deformation with contour gauge present; Note: vertical yellow tape marks end of direct damage and damage is primarily above the bumper (case photo #13)

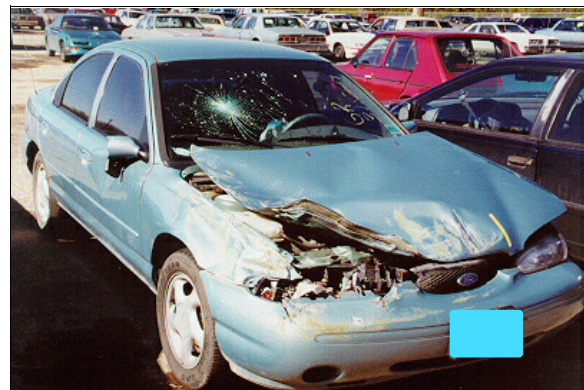
Figure 11: Case vehicle's front right deformation viewed from right of front; Note: underride type damage to hood and right fender (case photo #23)

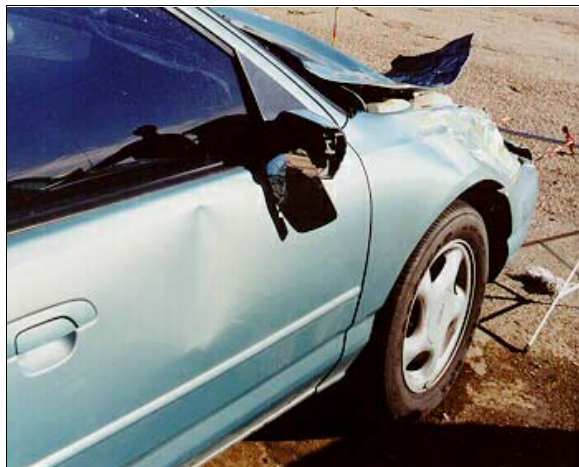
Figure 12: Damage to case vehicle's right front door and outside rearview mirror from side slap type impact with Chevrolet pick-up's left rear wheel, viewed from back of right (case photo #19)

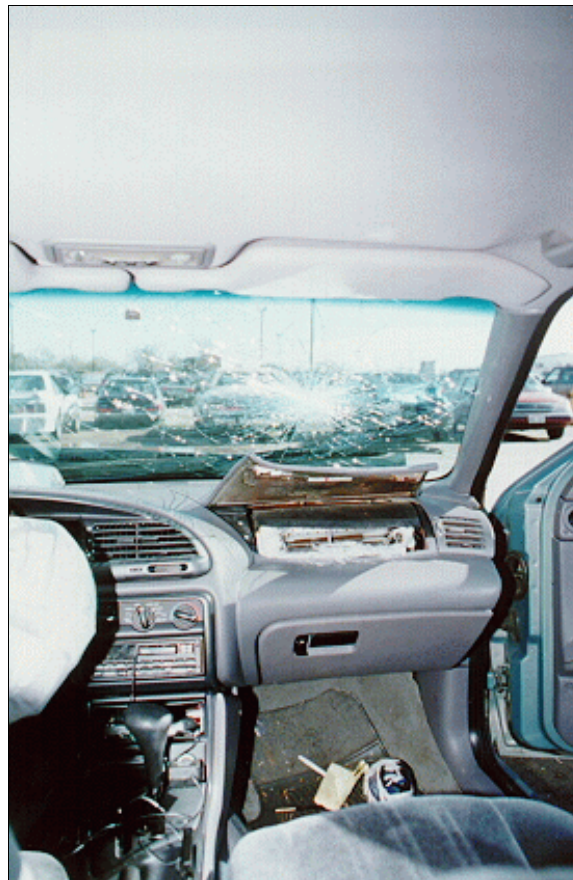
Inspection of the case vehicle's interior revealed that right side of the windshield's glazing sustained a spider web-type impact, with skin/hair present from the front right passenger, and there was associated scuffing to the right "A"-pillar (**Figures 13 and 14**). Furthermore, there was a few small blood spots on the roof over the front right seat and a blood spot on the front right seat's cushion from where the front right passenger came to rest. In addition, there was no integrity loss. Finally, there was no evidence of intrusion to the case vehicle's interior, no evidence of compression to the energy absorbing shear capsules in the steering column, and no deformation to the steering wheel rim.

Figure 13: Case vehicle's front right seating area showing residue of deployed front right passenger air bag (cutout prior to inspection), air bag module's cover flap, spider web-type impact to right windshield's glazing, and blood spots on right roof (case photo #36)

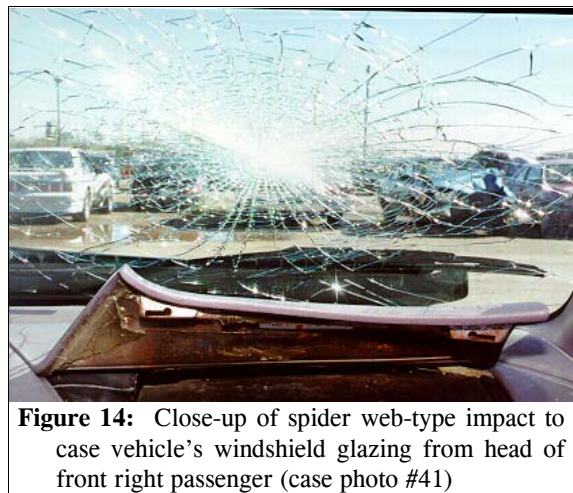
Figure 14: Close-up of spider web-type impact to case vehicle's windshield glazing from head of front right passenger (case photo #41)

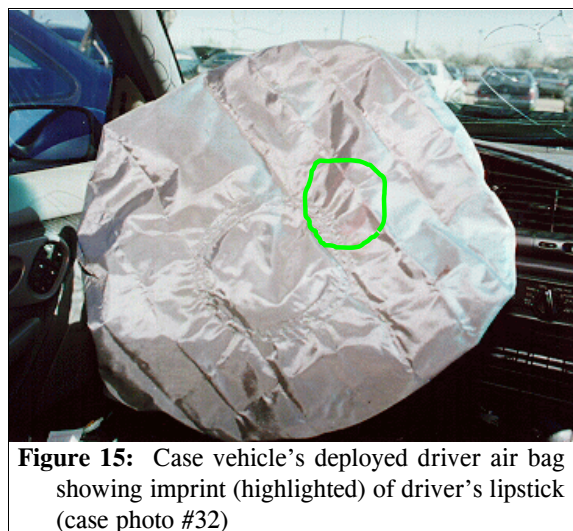
The case vehicle was equipped with a Supplemental Restraint System (SRS) that contained frontal air bags at the driver and front right passenger positions. Both air bags deployed as a result of the frontal impact with the left side of the Chevrolet pickup. The case vehicle's driver air bag was located in the steering wheel hub. The module cover consisted of asymmetrical, hexagonal, essentially "H"-configuration cover flaps made of thick vinyl and at least two sides of each flap was curved. The upper cover flap had a curvilinear top with an overall width of 26 centimeters (10.2 inches) while the bottom horizontal seam measured 19.5 centimeters (7.7 inches). The upper flap was curved vertically and measured 12 centimeters (4.7 inches) along its surface [i.e., there was a 5 centimeter (2.0 inch) distance from the apex of the curved surface to the top curvilinear seam and a 7 centimeter (2.8 inch) distance from the apex to the bottom horizontal seam]. The bottom cover flap measured 19.5 centimeters (7.7 inches) at its top horizontal seam, 21.5 centimeters (8.5 inches) at its bottom horizontal seam, and 7 centimeters (2.8 inches) vertically. An inspection of the air bag module's cover flaps and air bag fabric revealed that the cover flaps opened at the designated tear points, and there was no evidence of damage during the deployment to the air bag or the cover flaps. The driver's air bag was designed with two tethers, each 7.5 centimeters (3.0 inches) in width. The driver's air bag had two vent ports, approximately 2 centimeters (0.8 inches) in diameter, located at the 11:30 and 12:30 o'clock positions. The deployed driver's air bag was round with a diameter of 57 centimeters (22.4 inches). An inspection of the air bag's fabric revealed a lipstick imprint upward from and to the right of center in the upper right quadrant (**Figure 15**). In addition, there was a possible blood spot near the outer edge of the front surface at approximately the 4:30 o'clock position.

Figure 15: Case vehicle's deployed driver air bag showing imprint (highlighted) of driver's lipstick (case photo #32)

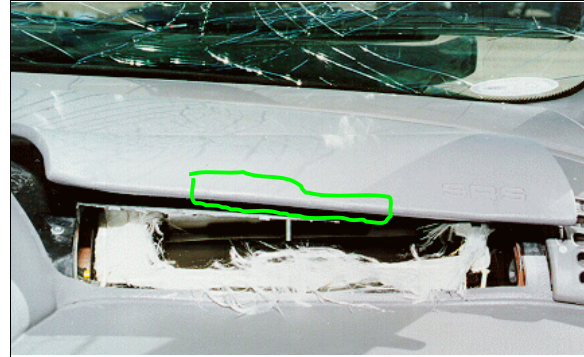
The front right passenger's air bag was located in the top of the instrument panel. There was a single, asymmetrical, quadrilateral, modular cover flap. The cover flap was made of a thick vinyl over a preformed frame and had a pre-shaped fold that angled horizontally across the cover flap, designed to the contour of the case vehicle's instrument panel. The flap's dimensions were: 37 centimeters (14.6 inches) at the forward horizontal seam, 45 centimeters (17.7 inches) at the above mentioned angular fold line (i.e., toward the windshield but not a seam), 21 centimeters (8.3 inches) along the right vertical seam, and 33 centimeters (13.0 inches) along the angled left vertical seam. The top horizontal seam was curvilinear but its length was not measured. The distance from the bottom horizontal seam to the angular fold was measured as 17 centimeters (6.7 inches) at each of the two vertical seams. The profile of the case vehicle's instrument panel resulted in a 13 centimeter (5.1 inch) setback of the leading edge of the cover flap relative to the protruding right instrument panel. An inspection of the front right air bag module's cover flap and air bag fabric revealed that the cover flap opened at the designated tear points, and there was no evidence of damage during the deployment to the air bag. However, there were

slight abrasions to the front portion of the cover flap that most likely resulted from the air bag's fabric being partially redirected back against the cover flap during its deployment as a result of occupant loading. The abrasion started 12 centimeters (4.7 inches) in from the left lower corner and measured 19 centimeters (7.5 inches) across the leading edge of the cover flap (**Figure 16**). The front right passenger's air bag was designed with two tethers, each 7.5 centimeters (3.0 inches) wide and sewn interiorly at the 12 and 6 o'clock positions. The front right air bag had one vent port, approximately 7 centimeters (2.8 inches) in diameter, located at the 10 o'clock position on the front surface. The deployed front right air bag was rectangular with a height of approximately 50 centimeters (19.7 inches) and a width of approximately 70 centimeters (27.6 inches). An inspection of the air bag's fabric revealed no contact evidence readily apparent on the front surface of the air bag (**Figure 17**). However, there was a small area of oil/skin and blood on the lower right side surface of the front right air bag at its seam with the front surface [i.e., 34 centimeters (13.4 inches) below the top surface of the air bag] and a blood spot on the bottom surface of the front right air bag [i.e., 36 centimeters (14.2 inches) behind the front surface and 29 centimeters (11.4 inches) inward from the left side surface of the air bag]. These blood spots most likely resulted from contact with the occupant after the occupant and the case vehicle came to final rest.

Figure 16: Close-up of case vehicle's front right air bag module's cover flap showing small abrasions (highlighted) on flap (case photo #39)

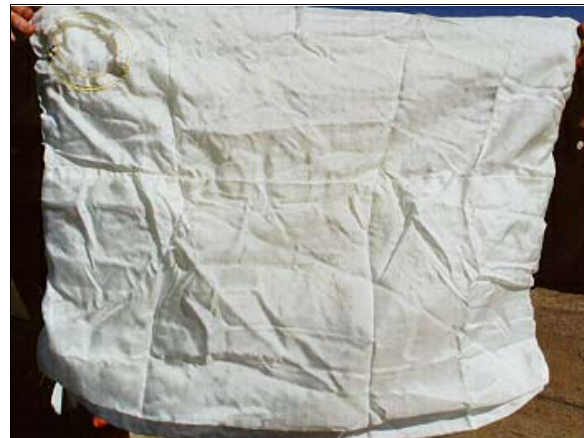
Figure 17: Frontal surface of case vehicle's front right passenger air bag showing no visible evidence of contact (case photo #44)

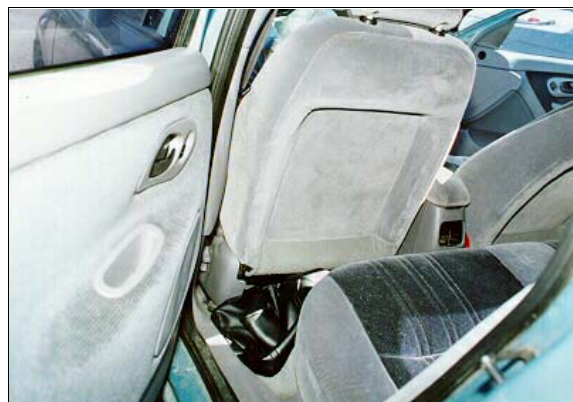
Figure 19: Back surface of case vehicle's driver seat back showing no visible evidence of contact on seat back (case photo #56)

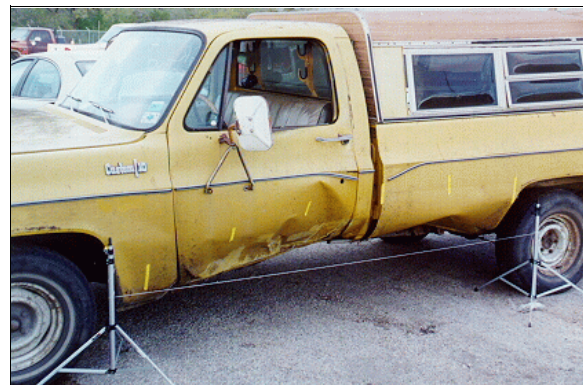
The Chevrolet pickup's initial contact with the case vehicle involved the left side between the front and rear axles (**Figure 20**). Direct damage began 59 centimeters (23.2 inches) behind the left front axle and extended, a measured distance of 249 centimeters (98.0 inches), along the left side (**Figure 21**). Residual maximum crush was measured as 15 centimeters (5.9 inches) between C_2 and C_4 . Because the case vehicle underrode the Chevrolet pickup, there was direct damage to the left frame rail (**Figure 22** below). The case vehicle's penetration resulted in a residual direct damage of 43 centimeters (16.9 inches) at C_4 . The wheelbase on the Chevrolet pickup's left side was extended 2 centimeters (0.8 inches) while the right side remained unchanged. The Chevrolet pickup's left fender, left front door, and left quarter panel were directly damaged and crushed inward. None of the Chevrolet pickup's tires were damaged, deflated, or physically restricted. No obvious induced damage or remote buckling was noted to the remainder of the Chevrolet pickup's exterior.

Figure 20: Chevrolet pickup's damaged left side with contour gauge present viewed from front of left (case photo #59)

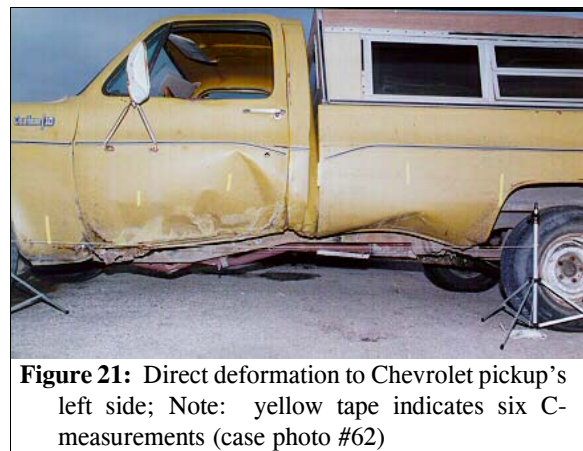
Figure 21: Direct deformation to Chevrolet pickup's left side; Note: yellow tape indicates six C-measurements (case photo #62)

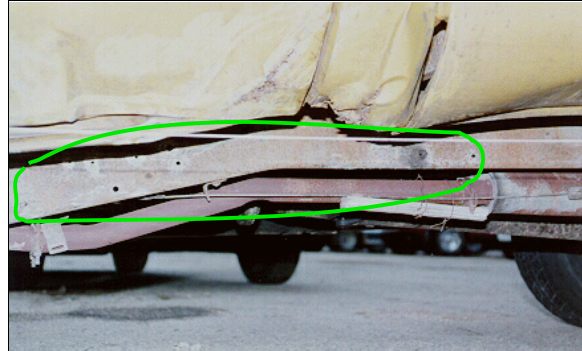
Based on the vehicle inspection, the CDCs for the Chevrolet pickup were determined to be: **10-LZLW-3 (290)** and **09-LBMW-1 (270)** [maximum crush for the primary left side impact was 15 centimeters (5.9 inches)]. The WinSMASH reconstruction program, damage only algorithm, was used on the Chevrolet pickup's highest severity impact. The Total, Longitudinal, and Lateral Delta Vs are, respectively: 14.7 km.p.h. (9.1 m.p.h.), -5.0 km.p.h. (-3.1 m.p.h.), and +13.8 km.p.h. (+8.6 m.p.h.). The Chevrolet pickup was towed, but not due to damage.

Figure 22: Close-up of direct damage to Chevrolet pickup's left frame rail from front bumper of case vehicle (case photo #64)
