**TRANSPORTATION SCIENCES
Crash Data Research Center**

**VERIDIAN ON-SITE CHILD SAFETY SEAT INVESTIAGTION
VERIDIAN CASE NO. CA00-024
VEHICLE: 1990 MERCURY TOPAZ
LOCATION: MARYLAND
CRASH DATE: JULY 2000**

Contract No.
DTNH22-94-D-07058

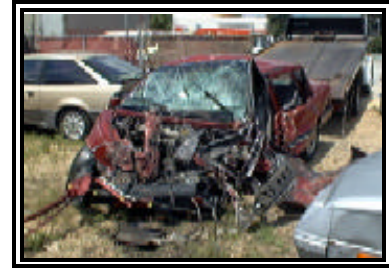
Figure 1. Overall view of the frontal damage to the Mercury Topaz.

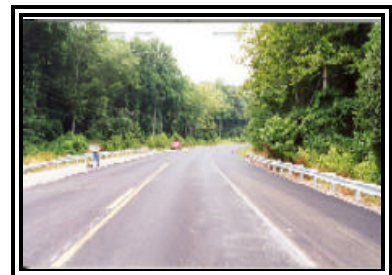
The driver of the Mercury Topaz was transporting her two children, ages 3 years and 16 months. Both children were restrained in child safety seats. The driver was restrained by the automatic shoulder belt, however, she did not wear the manual lap belt. She was traveling in a westerly direction on the two lane state route (**Figure 2**) at an estimated speed of 80 km/h (50 mph). While negotiating a gradual left curve, the driver was possibly distracted by the children which resulted in her failure to maintain her travel lane. The Topaz traveled on a near

Figure 2. Pre-crash trajectory of the Topaz.

straight line trajectory as she entered the left curve and crossed the centerline of the two lane county road into the eastbound travel lane into the path of the dump truck.

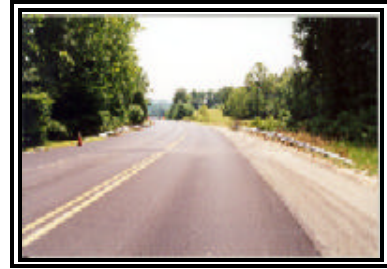
The 1980 Freightliner dump truck was empty and was traveling in an easterly direction. The driver of the dump truck observed the Topaz as it crossed the center line into his path of travel. The driver of the truck steered right and braked the vehicle in an attempt to avoid the impending crash. Skid marks were present on the newly surfaced asphalt road from the rear tires of the dump truck. The investigating officer documented approximately 9.1 m (30') of pre-crash skid marks. The crash schematic is attached as **Figure 15**, on Page 17 of this summary report.

Figure 3. Trajectory of the Freightliner dump truck.

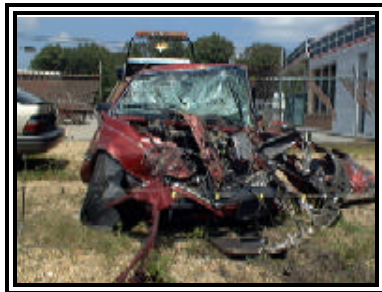
The Mercury Topaz sustained severe damage as a result of its initial offset, head-on crash with the Freightliner dump truck. The impact grossly deformed the frontal structure of the vehicle and resulted in separation of the front bumper fascia, the left third of the bumper beam, upper radiator support, left inner fender structure, hood, left front fender, and the left front wheel, brake, and suspension assembly. The direct contact damage was estimated as originating approximately 20.3 cm (8.0") left of center and extending 53.3 cm (21.0") to the left bumper corner. It should be noted that this value was derived from comparison between the crash vehicle and an exemplar Mercury Topaz. The Collision Deformation Classification (CDC) was 12-FYEW-4 (**Figure 4**). The impact deformed the entire width of the frontal structure resulting in a combined induced and direct contact damage length (Field L) of 77.5 cm (30.5"). A crush profile (**Figure 5**) was documented at the level of the lower radiator support panel and was as follows: C1 = 78.7 cm (31.0"), C2 = 50.8 cm (20.0"), C3 = 34.0 cm (13.4"), and C4 = 21.0 cm (8.25").

Figure 4. Frontal damage to the Topaz.

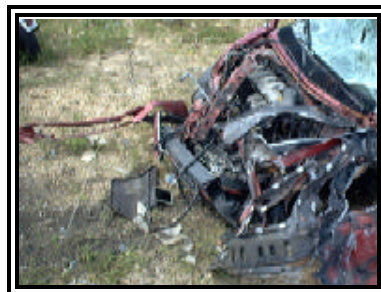
Figure 5. Lateral view documenting the crush profile.

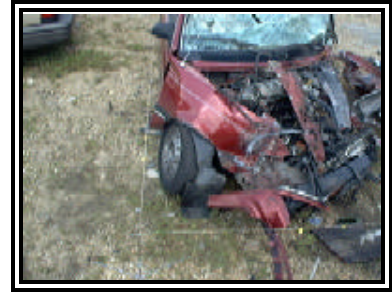
As the Topaz rotated in a CCW direction, the left front tire of the truck engaged the side surface of the vehicle at the leading edge of the right front fender. This subsequent engagement resulted in crush to the right front fender and altered the above documented crush profile by further displacing the fender and its sub-components laterally left. A black tire lug pattern began at the leading edge of the front fender and

extended 38.1 cm (15.0") rearward. Displacement of the fender resulted in an induced damage length of 66.0 cm (26.0") which involved the full damaged length of the fender. The crush profile at this plane was as follows: C1 = 11.7 cm (4.6"), C2 = 24.8 cm (9.75"), C3 = 48.3 cm (19.0"), and C4 = 85.3 cm (33.6") located at the front corner. The CDC for this secondary impact (**Figure 6**) was 03-RFEN-9* (*The side extent of 9 represents an unknown value due to the lateral displacement that resulted from the initial offset configuration. The crush profile presents the overall profile and could not be used for a delta V computation). The left front door latch released during the crash due to the displacement of the left A-pillar. The door was subsequently cut from the vehicle at the hinges by rescue personnel to aid in the extrication of the driver's body. The left rear door was jammed closed while both right side doors remained closed during the crash and were operational post-crash.

Figure 6. Lateral displacement of the right front fender.

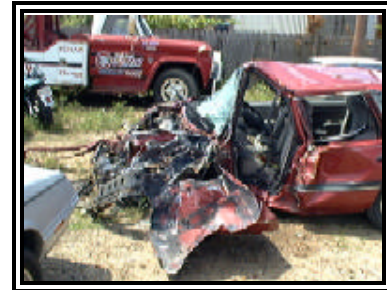
The interior of the Mercury Topaz sustained severe damage that was associated with exterior deformation and passenger compartment intrusion (**Figure 7**). In addition, the driver contacted several interior components that resulted in additional, but minor damage. The interior intrusions are identified in the following table:

Figure 7. Compression of the frontal structure into the driver's compartment.

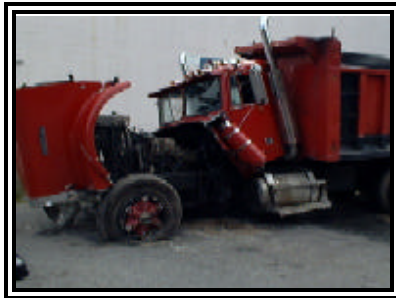
The exterior of the 1980 Freightliner straight (dump) truck sustained severe damage (**Figure 8**) as a result of the initial frontal impact with Mercury Topaz and subsequent frontal impact with the W-beam guardrail. The initial impact with the Mercury Topaz involved the front left and center areas of the truck's front bumper (**Figure 9**). Rubber transfers from the Mercury's left front tire were present on the chrome bumper. The transfers began at the corner and extended 47.0 cm (18.5") inboard. The extent of frontal crush to the bumper was unknown due to the subsequent impacts. The Truck Deformation Classification (TDC) was 12-FLEW-9* with the 9 reflecting an unknown extent zone value.

Figure 8. Front and left side damage to the dump truck.

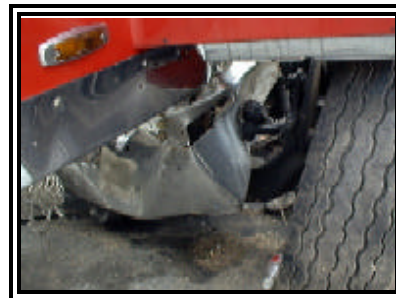
The left front tire was cut from engagement against the right front fender of the Topaz during the secondary impact phase of the crash event. The wheel rim was deformed and abraded circumferentially from both the initial impact and the subsequent events. The TDC for the secondary impact with the Topaz was 12-FLWN-2.

Figure 9. Deflected left corner of the front bumper.

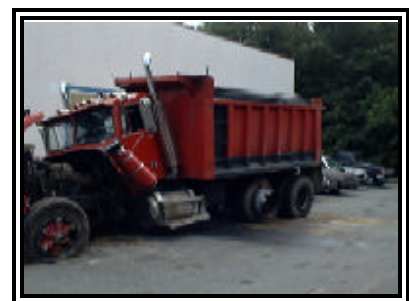
The third impact event with the W-beam guardrail resulted in rearward displacement of the full width left front bumper with subsequent snagging damage to the left fuel tank and the leading outboard drive axle tire and wheel (**Figure 10**). The latter damage resulted from the penetration of the guardrail system. The bumper was deformed 90 degrees and folded between the left front brake chamber and the outer tie rod arm. A abrasive-type mark was present on the leading edge of the aluminum fuel tank and the left outer tire of the forward drive axle was separated from the wheel rim. The wheel rim was dented to a maximum depth of 18.4 cm (7.25").

Figure 10. Fuel tank and tire/wheel damage.

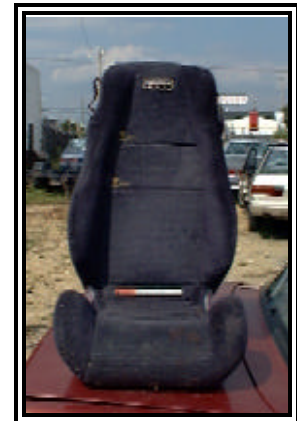
The Mercury Topaz was occupied by two child passengers who were restrained in child safety seats (CSS). The 3 year old female was positioned in the front right of the vehicle and was seated on a Fisher Price Safe Embrace belt positioning booster seat (Figure 11). The investigating officer had removed the CSS from the vehicle and retained the seat in the evidence locker for preservation. The CSS was made available to the SCI investigator and was returned to the vehicle for inspection and placement purposes. Although the CSS appeared to be in new condition, the labels that identified the model number and date of manufacturer were not present on the CSS. This CSS was designed exclusively as a belt positioning booster with the vehicle's belt system serving as the primary restraint for the child passenger. The booster seat was not physically damaged as a result of the crash, however, blood stains were present on the fabric of the seat cushion and seat back areas of the CSS. A warning label located on the outer fabric at the bight of the booster seat stated the following:

Figure 11. Fisher Price Safe Embrace.

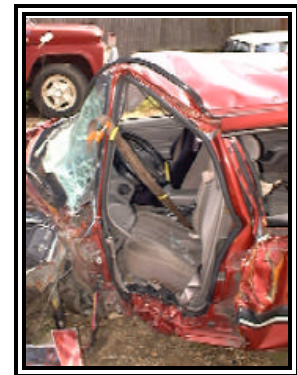
The 22 year old female driver of the Mercury Topaz was seated in a presumed upright driving posture with the seat track adjusted to a mid-to-rear track position and the seat back slightly reclined. The adjustable head restraint was adjusted 1.3 cm (0.5") above the top of the seat back. The driver was reportedly dressed in a bikini and was restrained by the automatic two-point shoulder belt system. She was not restrained by the manual lap belt. Belt usage was supported by loading evidence on the shoulder belt webbing and the post-crash cutting of the belt webbing by rescue personnel. The lap belt was stowed in the outboard retractor and was not damaged by the crash. **Figure 12** is a lateral view of the driver's seated position with respect to the intruding components.

Figure 12. Lateral view of the driver's seated position.

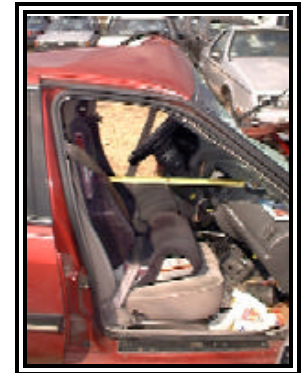
The front right child passenger was seated on a Fisher Price Safe Embrace high-back belt positioning booster seat, restrained by the vehicle’s automatic shoulder belt and the manual lap belt. Both belt systems were equipped with emergency locking retractors. The front right seat track was adjusted to a rear track position with the seat back reclined approximately eight degrees aft of vertical. In this position, the horizontal distance between the forward edge of the booster seat back and the mid instrument panel was 59.1 cm (23.25") as depicted in **Figure 13**.

Figure 13. Front right position with the CSS.

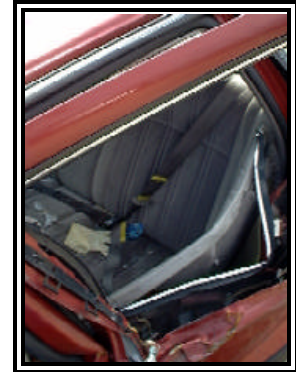
the CSS was not properly secured to the vehicle. The crossbar of the latch plate was abraded from frictional interaction against the belt webbing. The black plastic from the latch plate was transferred onto the webbing at a point that was located 85.1-90.2 cm (33.5-35.5") above the bight of the seat cushion/seat back. The latch plate was found positioned 86.4 cm (34.0") above the seat bight. The child was removed from the vehicle in the CSS, therefore the buckle was released and the webbing was routed back through the belt path to free the CSS from the left rear position.

The CSS was restrained by the continuous loop 3-point lap and shoulder belt of the Mercury Topaz. The specific routing of the belt system through the CSS was also unknown. This belt system consisted of a sliding latch plate with an emergency locking retractor (ELR). A locking clip was required to properly secure the CSS with the vehicle's belt system. There was no locking clip on the belt webbing at the time of inspection and no evidence was present on the webbing to support the use of a clip at the time of the crash. Load induced abrasions were present on the belt webbing at a point that was 85.1-90.2 cm (33.5-35.5") above the seat cushion/seat back juncture (bight). Additional load induced abrasions were present on the crossbar of the latchplate from frictional interaction against the belt webbing (**Figure 14**).

Figure 14. Left rear seated position and the belt loading evidence.

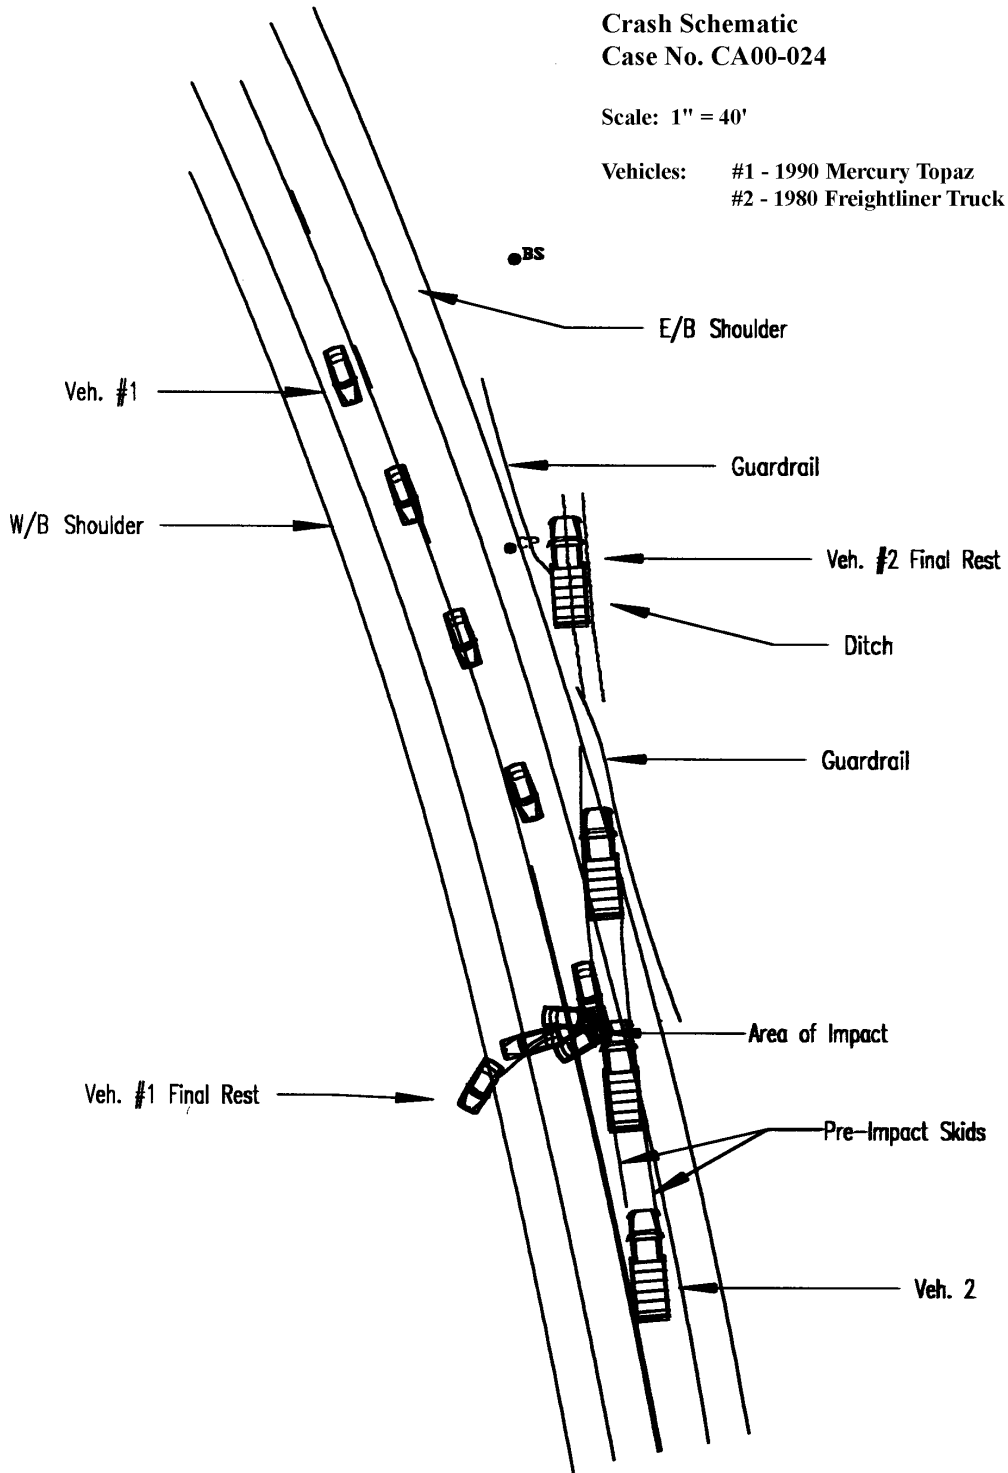
Figure 15. Crash Schematic

**Crash Schematic
Case No. CA00-024**
