**VERIDIAN ON-SITE ADVANCED OCCUPANT
PROTECTION SYSTEM INVESTIGATION
VERIDIAN CASE NO. CA00-025
VEHICLE: 2000 FORD TAURUS LX
LOCATION: MARYLAND
CRASH DATE: APRIL 2000**

Contract No.
DTNH22-94-D-07058

U.S. Department of Transportation
National Highway Traffic Safety Administration
Washington, D.C. 20590

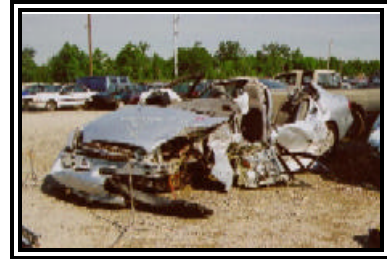
Figure 1. Front left view of the damage to the 2000 Ford Taurus.

optional side impact air bags. As a result of the crash, the Taurus sustained severe front left damage that extended onto the left side plane of the vehicle. The Taurus' frontal air bags deployed and the driver's pretensioner fired as a result of the crash. The driver of the Taurus was extricated from the vehicle by emergency personnel and transported by ambulance to a local hospital where she was evaluated for lower extremity fractures, pelvic fractures, and a closed head injury. She was prepared for transferal to a regional trauma center, however, she expired en route. No autopsy was performed. The front right passenger of the Taurus exited the vehicle without assistance and was ambulatory at the scene of the crash. He was transported by ambulance to a local hospital where he was treated for left ear and facial lacerations. He was diagnosed with a closed head injury with a possible subarachnoid bleed and transferred to a regional trauma center where he was admitted for treatment.

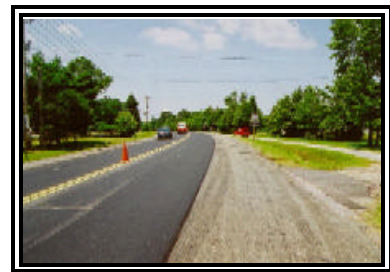
The driver of the Ford Taurus was returning to her residence and was traveling in a westerly direction on the two lane road. She had traversed through a four-leg signalized intersection and entered a left curve relative to her path of travel (**Figure 2**). The driver of the Dodge Stratus was traveling in an easterly direction on the two lane road, opposite of the Ford Taurus. As the driver of the Stratus attempted to negotiate the right curve for east bound traffic, he allowed the vehicle to drift over the centerline and into the path of the Ford Taurus. There were no police reported tire marks at the scene of the crash to support pre-crash braking. It was unknown if either driver attempted to avoid the impending crash. The police crash schematic is included as **Figure 15**, page 12.

Figure 2. Pre-crash trajectory of the Ford Taurus.

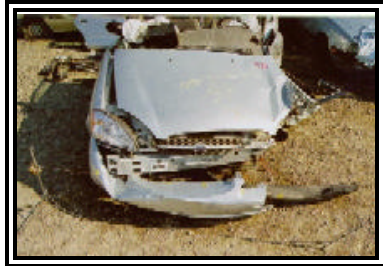
The Ford Taurus sustained severe damage that originated on the front left corner and continued onto the left side plane of the vehicle. The corner impact resulted in 24.1 cm (9.5") of direct contact damage on the frontal plane that began 47.6 cm (18.5") left of center and extended to the left corner of the bumper fascia (**Figure 3**). The impact deformed the full width of the front bumper beam, deflecting the beam to a maximum depth of 57.4 cm (22.6") at the left corner (**Figure 4**). The crush profile at the level of the bumper beam was as follows: C1 = 57.4 cm (22.6"), C2 = 43.7 cm (17.2"), C3 = 28.6 cm (11.25"), C4 = 19.3 cm (7.6"), C5 = 7.3 cm (2.9"), C6 = 0 cm [-2.5 cm (-1.0")].

Figure 3. Frontal view of the Ford Taurus.

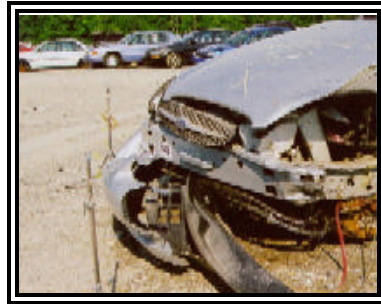
Figure 4. Left profile view of the bumper beam crush.

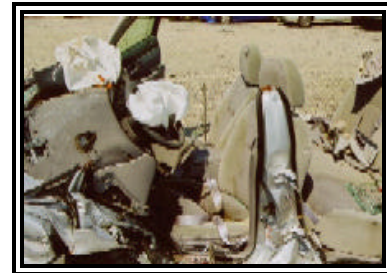
The interior of the Ford Taurus sustained extensive damage that was associated with exterior deformation and resulting intrusion of the driver’s compartment (**Figure 5**), deployment of the AOPS, and occupant contact. Maximum intrusion involved 68.0 cm (26.75") of rearward displacement of the left toe pan. The intruding components, direction and magnitude of intrusion are identified in the following table:

Figure 5. Intrusion into the driver’s position.

<i>Occupant Position</i>	<i>Intruding Component</i>	<i>Direction of Intrusion</i>	<i>Magnitude</i>
Driver	Mid left instrument panel, outboard aspect	Longitudinal	30.2 cm (11.9")
Driver	Mid left instrument panel, inboard aspect	Longitudinal	6.1 cm (2.4")
Driver	Lower mid instrument panel at center console	Longitudinal	13.3 cm (5.25")

<i>Occupant Position</i>	<i>Intruding Component</i>	<i>Direction of Intrusion</i>	<i>Magnitude</i>
Driver	Steering wheel/air bag module	Longitudinal	20.0 cm (7.75")
Driver	Left lower A-pillar	Longitudinal	50.8 cm (20.0)
Driver	Lower left A-pillar and kick panel	Lateral	22.2 cm (8.75")
Driver	Mid left instrument panel	Lateral	4.1 cm (1.6")
Driver	Left toe pan	Longitudinal	67.9 cm (26.75")
Driver	Brake pedal	Longitudinal	37.1 cm (14.6")
Driver	Lower B-pillar	Lateral	21.6 cm (8.5")

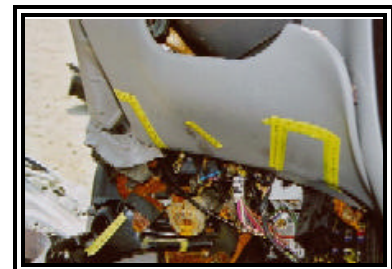
The driver's knees loaded the intruding knee bolster (**Figure 6**). The left knee impacted the bolster at the outboard aspect adjacent to the lower instrument panel. A scuff mark with a surrounding fabric transfer evidenced the contact that was located 53.3-55.9 cm (21.0-22.0") left of the vehicle's centerline. The right knee contacted the bolster 24.1-34.3 cm (9.5-13.5") left of center and 35.6-40.6 cm (14.0-16.0") below the top of the instrument panel. A scuff mark and fabric transfer evidenced the contact point. Located between the knee contacts were several fragments that resulted from the open fracture sites. Her lower left leg loaded and deformed the emergency brake lever that was located adjacent to the left kick panel and the lower A-pillar. The pedal was deflected 3.8 cm (1.5") outboard of its original position.

Figure 6. Knee bolster contacts.

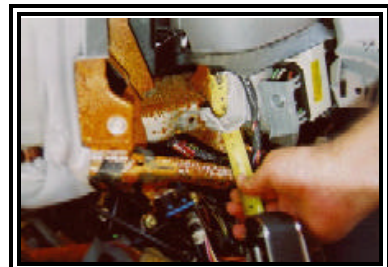
Figure 7. Left shear capsule separation.

The driver loaded through the inflated driver's air bag and compressed the energy absorbing steering column. The left shear bracket (**Figure 7**) was separated approximately 5.7 cm (2.25") while the right shear

bracket was obscured by the intrusion of the toe pan and the adjacent components. The slip coupling of the steering shaft had separated as a result of the intrusion. The steering wheel was not deformed.

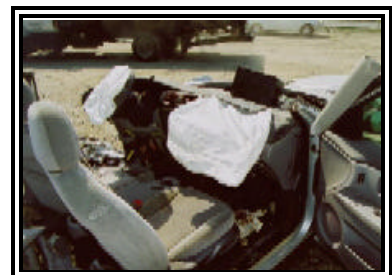
Figure 8. Deployed frontal air bags in the Taurus.

bags deployed (**Figure 8**) and the driver's pretensioner fired as a result of the offset head-on impact sequence with the Dodge Status.

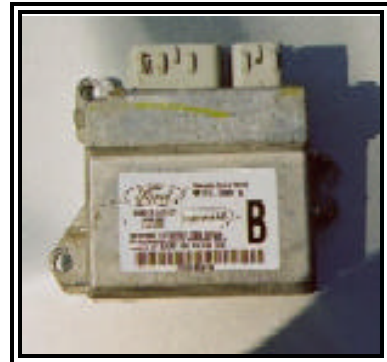
The EDR was removed from the vehicle and forwarded to Ford for download purposes (**Figure 9**). The EDR did not contain crash data. It was determined that the vehicle's electrical system was compromised prior to writing the crash data to memory. This resulted from the corner impact damaging the engine compartment fuse box, the passenger compartment fuse box, and associated wiring. The RCM contains a capacitor, however, this capacitor provides sufficient reserve energy to deploy the AOPS (air bags and pretensioners), but does not retain sufficient power to write the crash data to the EDR's memory.

Figure 9. EDR removed from the Taurus.

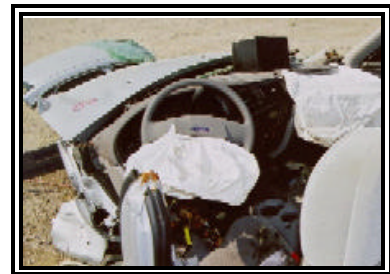
The front left air bag (**Figure 10**) was concealed within asymmetrical H-configuration air bag module cover flaps within the four-spoke steering wheel rim. The horizontal tear seam was 16.5 cm (6.5") in width. The vertical measurements of the upper and lower flaps were 7.0 cm (2.75") and 4.4 cm (1.75") respectively. The driver air bag measured approximately 55.9 cm (22.0") in diameter and was vented by two 2.5 cm (1.0") ports that were located on the back side of the membrane, 8.9 cm (3.5") inboard of the peripheral seam. The air bag was tethered by two wide band tethers at the 12 and 6 o'clock positions. The tethers were sewn to the face of the bag membrane with a 15.2 cm (6.0") diameter reinforcement centered on the face of the air bag. There were no distinct occupant contact points on the air bag or damage to the bag associated with this crash. It should be noted that the Ford Taurus was exposed to the weather elements for a period of three months prior to this on-site SCI investigation.

Figure 10. Deployed front left driver's air bag.

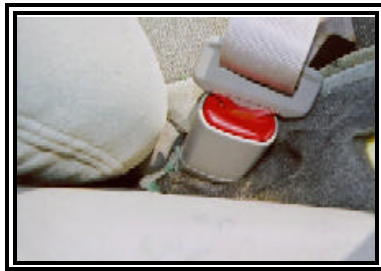
The front belt systems were equipped with seat belt buckle pretensioners. The pretensioners consist of pyrotechnic cylinders that reduce the height of the belt buckle via a cable attached to the cylinder. The cylinders, or pistons, are concealed within a barrel that is mounted longitudinally along the inboard aspect of both seat cushions. The pre-fire length of the barrel is approximately 110 mm (4.3"). The belt systems must be buckled for the pretensioner to fire. The driver of the Ford Taurus was belted while the passenger was unrestrained. Therefore the driver's pretensioner fired (**Figure 11**) in this above threshold crash while the passenger's pretensioner did not fire. The measured travel of the driver's side pretensioner was 60.3 mm (2.375").

Figure 11. Fired driver's buckle pretensioner.

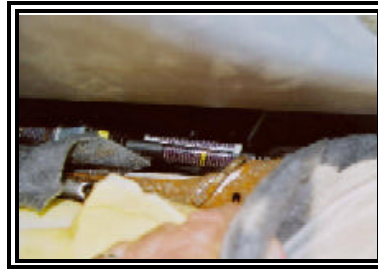
The driver's pretensioner was identified by a bar coded label (**Figure 12**) with the following nomenclature:

Figure 12. Driver's pretensioner barrel identifiers.

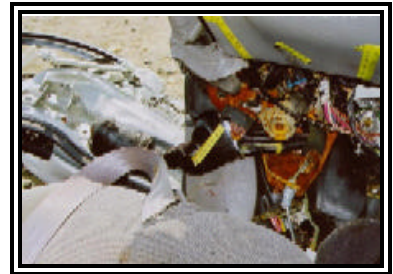
The driver responded to the frontal impact force by initiating a forward trajectory into the rearward intruding frontal components. Her knees loaded the knee bolster as evidenced by scuff and fabric transfers. As a result of the knee loading, the driver sustained bilateral pelvic fractures of the superior and inferior rami. Her feet and lower legs were compressed by the intrusion of the left kick panel, toe and floor pans. The lateral aspect of her left leg loaded the parking brake pedal and left kick panel (panel forward of the A-pillar). The parking brake pedal was deformed to the left. The parking brake pedal, in combination with the intruding kick panel (**Figure 13**) fractured her left tibia and fibula. The driver's head probably impacted the intruding left A-pillar late in the crash sequence as the vehicle was deflected to its right. This probable contact resulted in a closed head injury (NFS) and a left temporal scalp hematoma.

Figure 13. Intruding kick panel and deformed parking brake pedal.

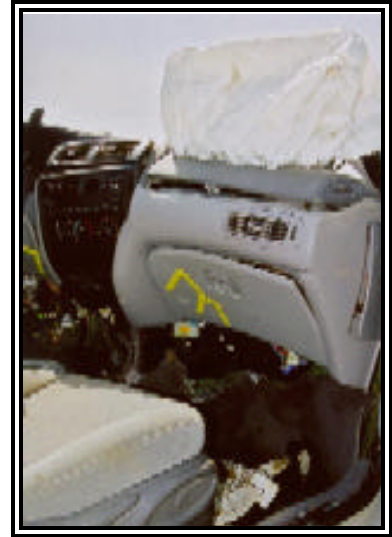
At impact with the Dodge Stratus, the frontal air bag system deployed. The unrestrained front right passenger initiated a forward trajectory and loaded the deployed air bag and the glove box door (**Figure 14**). His loading of the glove box door resulted in two distinct scuff marks with fabric transfers located at the left aspect of the component. The passenger sustained an abrasion over the right knee from contact with the glove box.

The passenger loaded the deployed air bag with his torso and face. The air bag protected the unrestrained passenger from contact against the instrument panel and the windshield. He sustained a laceration of the neck and of the nose that possibly resulted from his air bag contact. There was no evidence of occupant contact to the front right air bag membrane.

Figure 14. Front right passenger loading of the glove box and deployed air bag.

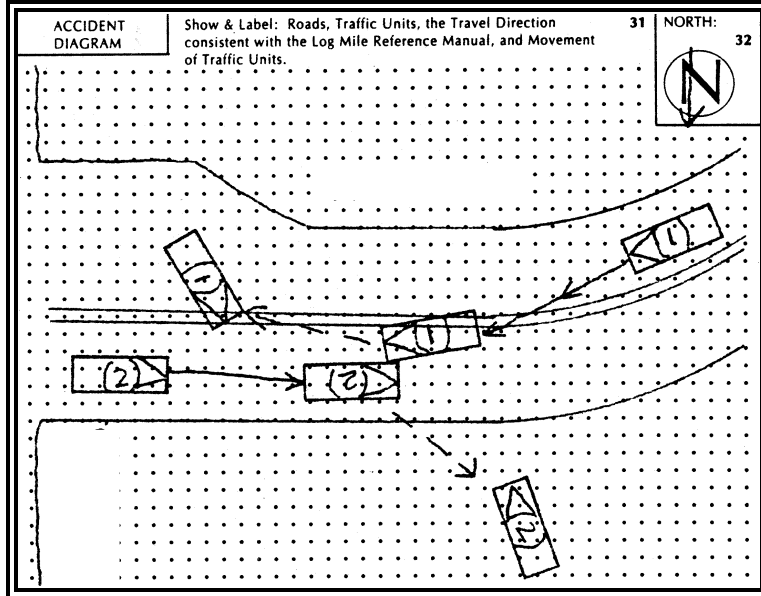
Figure 15. Police Scene Schematic.
