**VERIDIAN ON-SITE REDESIGNED AIR BAG
DEPLOYMENT INVESTIGATION**

VERIDIAN CASE NO. CA00-031

VEHICLE - 2001 CHRYSLER PT CRUISER

LOCATION - STATE OF NEW JERSEY

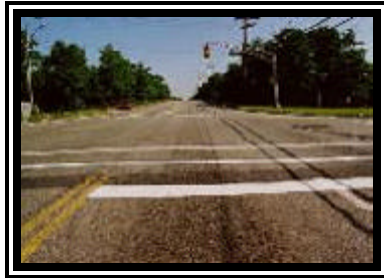
urban 4-leg intersection (**Figure 1**). As he approached the signalized intersection, a southbound (non-contact) large truck was stopped on the inboard travel lane waiting to turn left onto the local street. The Ford driver reported to police that the large truck blocked his view of the oncoming traffic as he proceeded west at a (driver reported speed) of 16 km/h (10 mph). The 47 year old female driver of the 2001 Chrysler PT Cruiser was operating the vehicle southbound in the outboard lane (**Figure 2**) at a (driver reported) speed of 64 km/h (40 mph) when she observed the Ford van cross her path of travel. The Chrysler driver reported no avoidance maneuvers in anticipation of the impending crash.

Figure 1. Northbound approach for the 1996 Ford E-150 cargo van.

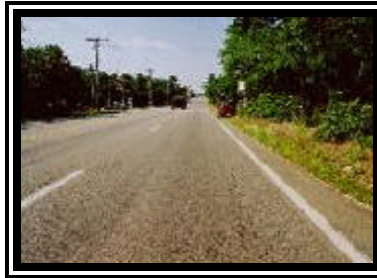
Figure 2. Southbound approach for the 2001 Chrysler PT Cruiser.

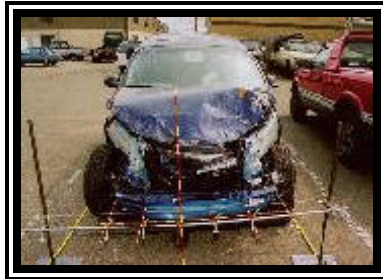
The Chrysler PT Cruiser sustained moderate frontal damage as a result of the impact with the Ford van (**Figures 3 & 4**). The direct contact damage encompassed the entire frontal width resulting in a combined direct and induced damage length (Field L) of 108.0 cm (42.5 in). Six crush measurements were documented at the level of the reinforcement bar (*bumper fascia separation*): C1= 0 cm, C2= 3.0 cm (1.2 in), C3= 9.0 cm (3.5 in), C4= 13.0 cm (5.1 in), C5= 8.0 cm (3.1 in), C6= 4.0 cm (1.6 in). The Collision Deformation Classification (CDC) for this impact to the Chrysler was 11-FDEW-1 with a principal direction of force of (-) 20 degrees. The hood was deformed up and rearward from engagement against the side surface of the Ford van. Direct contact damage was also documented on both fenders which extended rearward to the wheel openings. Reduction in the right side wheelbase measured 3.0 cm (1.2 in). The windshield fractured at the lower left A-pillar area from exterior impact forces (only).

Figure 3. Frontal damage to the 2001 Chrysler PT Cruiser.

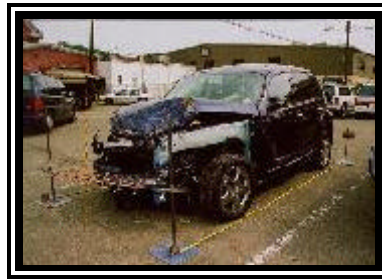
Figure 4. Oblique view.

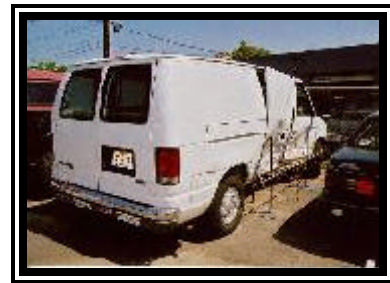
The Ford Econoline 150 cargo van sustained moderate right side surface damage as a result of the impact with the Chrysler PT Cruiser (**Figure 5**). The direct contact damage began 78.0 cm (30.7 in) aft of the right front axle and extended 234.0 cm (92.1 in) rearward. The combined direct and induced damage length (Field L) began 53.0 cm (20.9 in) aft of the right front axle and extended 259.0 cm (102.0 in) rearward. Six crush measurements were documented at the level of the lower door: C1= 0 cm, C2= 23.0 cm (9.1 in), C3= 32.0 cm (12.6 in), C4= 27.0 cm (10.6 in), C5= 18.0 cm (7.1 in), C6= 0 cm. The Collision Deformation Classification (CDC) for this impact to the Ford was 01-RYEW-3 with a principal direction of force of (+) 40 degrees. The right side doors were jammed. The windshield and right front tempered glazing were undamaged.

Figure 5. Right side damage to the 1996 Ford E-150 cargo van.

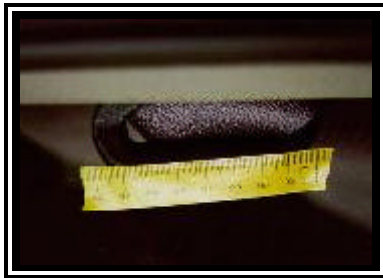
Figure 6. Abrasions to the front left restraint D-ring.

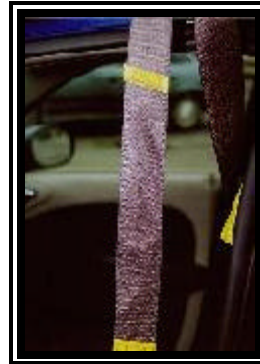
Figure 7. Loading marks to the front left shoulder belt webbing.

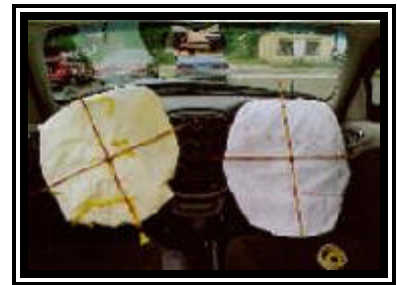
The Chrysler PT Cruiser was equipped with redesigned frontal air bags for the driver and front right passenger positions. The air bags deployed as a result of the crash (**Figure 8**). The driver air bag was housed in the center of the steering wheel with a circular flap tear seam. The flap measured 11.6 cm (4.6 in) in diameter. Although no contact evidence was identified on the module cover flap, makeup transfers were documented on the lower (center) section and left mid-section of the air bag face. Light blood spattering was also noted on the upper right quadrant of the air bag face and rear. The diameter of the driver air bag measured 59.0 cm (23.2 in) in its deflated state (**Figure 9**). The bag was tethered by two internal straps and vented by two ports located at the 10 o'clock and 2 o'clock sectors on the rear aspect of the air bag.

Figure 8. 2001 Chrysler PT Cruiser deployed redesigned frontal air bags.

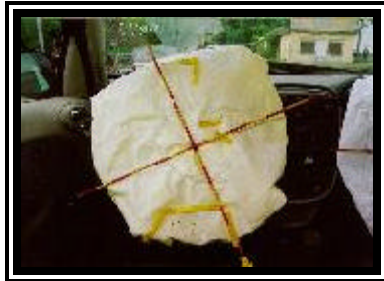
Figure 9. 2001 Chrysler PT Cruiser redesigned driver air bag.

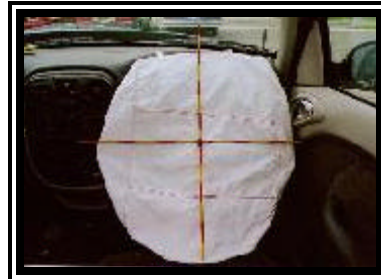
exterior surface of the module cover flap. The passenger air bag measured 44.5 cm (17.5 in) in width and 58.5 cm (23.0 in) in height in its deflated state (**Figure 10**). The bag was tethered by two internal straps and vented by two ports located at the 11 o'clock and 1 o'clock sectors on the side aspect of the air bag.

Figure 10. 2001 Chrysler PT Cruiser redesigned passenger air bag.

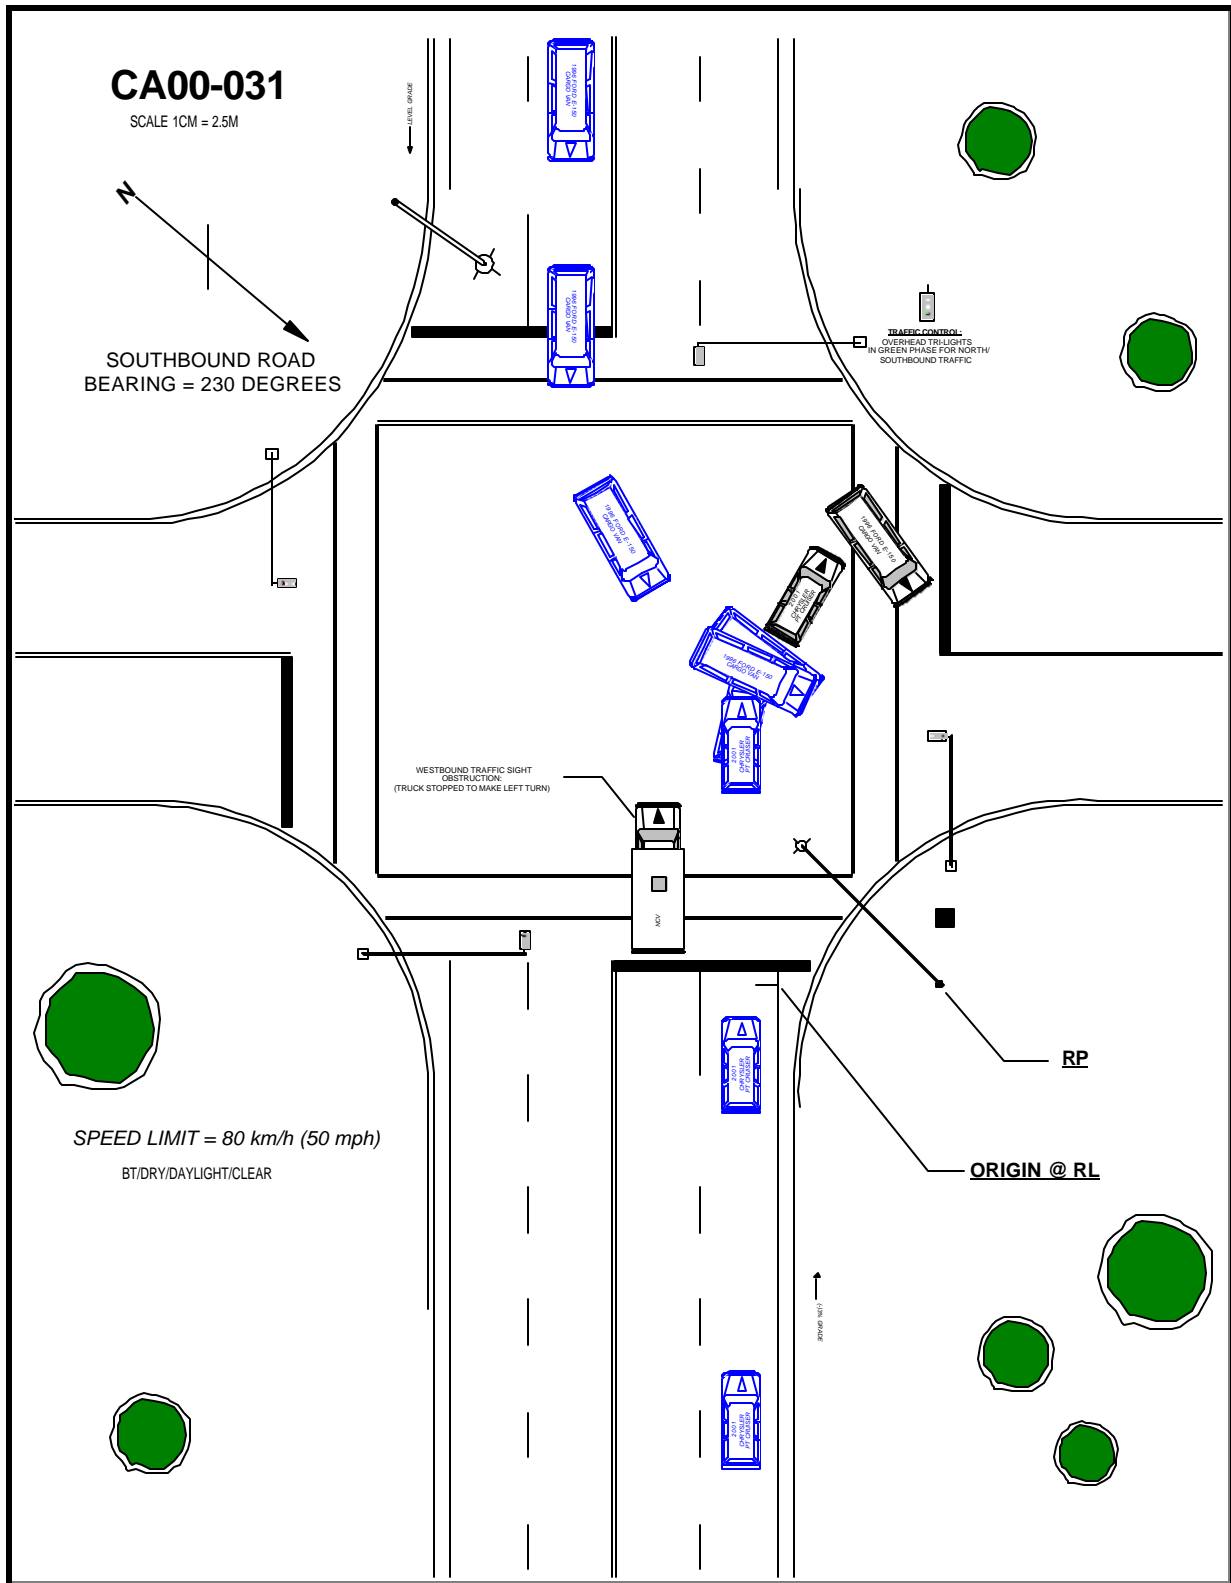
Figure 11. Scene Diagram.

This two vehicle crash occurred during the afternoon hours of August, 2000. At the time of the crash, it was daylight with no adverse conditions as the roads were dry. The crash occurred in the southbound lanes of a 4-leg (straight) urban intersection (**see Figure 11 - page 7**) with a negative grade for southbound traffic. The north/southbound lanes consisted of four asphalt travel lanes bordered by barrier curbs. The east/westbound lanes consisted of two level/asphalt travel lanes also bordered by barrier curbs. Traffic flow through the urban intersection was controlled by an overhead signal system in a green phase for north/southbound traffic. The posted speed limit at the crash site was 72 km/h (45 mph).
