**VERIDIAN REMOTE ADAPTIVE CONTROL/DRIVER FATALITY CRASH  
INVESTIGATION  
SCI TECHNICAL SUMMARY REPORT**

**SCI CASE NO. - CA00-032**

**SUBJECT VEHICLE - 1992 FORD E-150 ECONOLINE VAN**

**CRASH DATE - JUNE 2000**

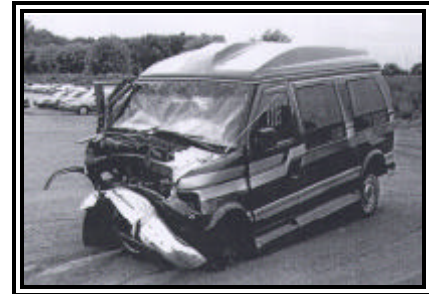
**Figure 1. Damaged 1992 Econoline van**

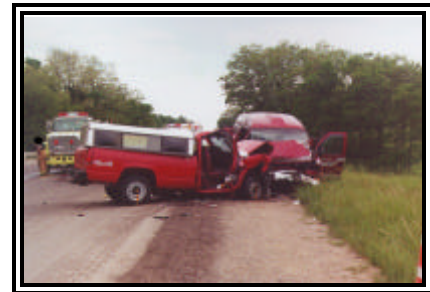
The vehicles impacted in a head-on configuration. Impact resulted in severe damage to both vehicles. The directions of force were in the 12 o'clock sectors for both vehicles. The damage algorithm of the WinSMASH program computed a delta-V of 51.0 km/h (31.7 mph) for the Ford van and a delta-V of 71.0 km/h (44.1 mph) for the Chevrolet pickup truck based on estimated crush profiles. The Ford van's weight made it the dominant vehicle, and the momentum of the van displaced the pickup truck rearward. Based on the police scene schematic, the Ford van traveled forward approximately 5 m (16') and rotated approximately 10 degrees in a CW direction. The Chevrolet pickup truck was displaced rearward approximately 6 m (19') and rotated approximately 60 degrees in a clockwise (CW) direction. The van came to rest in a northbound orientation on the west shoulder and the pickup truck came to rest facing southwest on the west shoulder (**Figure 2**).

**Figure 2. On-scene photograph showing final rest positions**

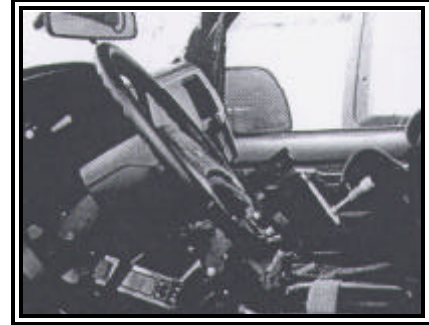
A tri-pin assembly was attached to the steering wheel rim near the 6 o'clock position (**Figure 4**). The system allowed the driver to insert his wrist between two pins, and grip the third with his hand. Since the driver had limited use of his upper extremities, the system facilitated steering by means of a zero-effort control. It was not known if modifications were made to the power steering. A VGB tri-pin assembly was also used for the throttle/brake system (**Figure 5**). A vertical bracket that measured approximately 60 cm (24") in height and 25 cm (10") front-to-back was mounted slightly inboard of the left front door. The tri-pin was mounted on the top rear aspect of the bracket. The system allowed the driver to place his wrist through the two rear pins and grip the forward pin with his left hand. The throttle was engaged by pushing the tri-pin forward, and pulling rearward would apply the brakes. The throttle/brake system was a low-effort system. Based on a conversation with the modification company, the throttle/brake engagement could be configured for either direction, based on the individual prescription. The throttle/brake system had an integrated rocker switch at the lower aspect and lateral movement would activate the respective directional signals on the vehicle. The van was also equipped with elbow pad controls for the horn and emergency wipers.

**Figure 4. View of steering wheel tri-pin device**

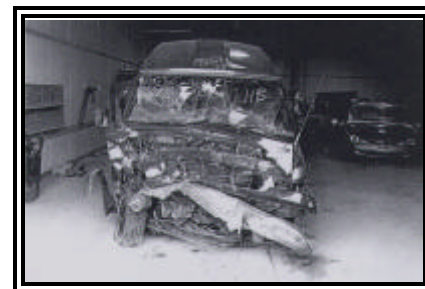
Exterior damage to the 1992 Ford E-150 Econoline van was based on police photographs and insurance company photographs. The van sustained severe frontal damage as a result of the impact with the Chevrolet pickup truck (**Figure 7**). The direct damage began slightly inboard of the front left bumper corner and extended laterally across the bumper to the front right bumper corner. The combined direct and induced damage involved the entire frontal width of the vehicle. The maximum longitudinal crush was located at the front right bumper corner and was estimated to be approximately 56 cm (22"). The front bumper was displaced rearward and upward on the right aspect. The left

**Figure 7. View of frontal damage to the 1992 Ford Van**

corner of the bumper was displaced forward and downward. The bumper cover was separated from the bumper. The radiator supports and engine components were crushed rearward. The hood was displaced and buckled rearward, and fractured on the right and left aspects. The left front fender sustained minor induced buckling, and the right front fender was crushed rearward. The right A-pillar was displaced rearward and the right front door and right side swinging doors were displaced from induced damage (**Figure 8**). The impact resulted in the rearward displacement of the right front wheel which shortened the right wheelbase by 21 cm (8") based on police measurements. The Collision Deformation Classification (CDC) for the impact was 12-FDEW-4. Six crush measurements were estimated from the insurance photographs along the front bumper and were as follows: C1 = 0.0 cm, C2 = 13 cm (5"), C3 = 40 cm (16"), C4 = 38 cm (15"), C5 = 53 cm (20"), C6 = 56 cm (22").

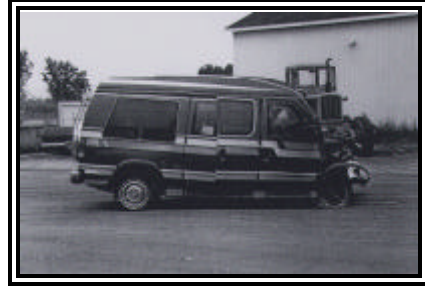
**Figure 8. Right side view of damaged 1992 Ford van**

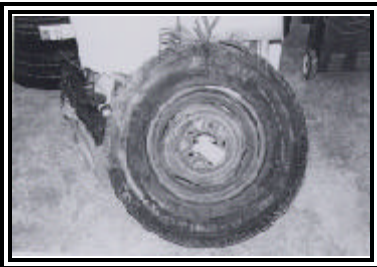
The left front tire sustained tread separation prior to the crash which resulted in the driver's control loss of the vehicle (**Figures 9-11**). The investigating officer noted tire fragments south of the crash scene and rubber deposits on the left front fender. The left front tire was a General AmeriWay XT All Season P235/75R15 tire.

**Figure 9. Damaged left front tire**

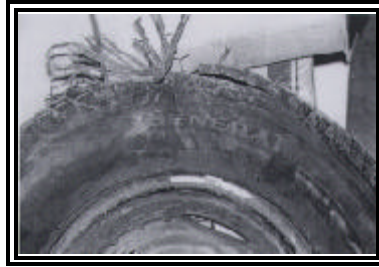
**Figure 10. Closeup view of tire damage**

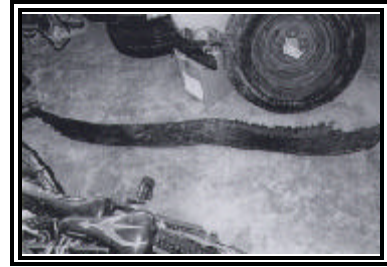
**Figure 11. View of separated tire tread**

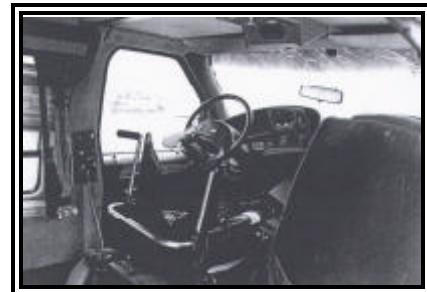
Interior damage to the 1992 Ford E-150 Econoline van was based on police and insurance company photographs. The windshield was fractured from impact forces. The van sustained moderate interior damage as a result of intrusion and occupant contact (**Figure 12**). The left instrument panel was displaced from the crash forces and probable contact from the driver. The center and right aspects of the instrument panel were also displaced from crash forces. Probable longitudinal intrusions included the left, center, and right instrument panel, left toe pan, right toe pan, and right A-pillar. The wheelchair lift was displaced as a result of the

**Figure 12. Interior view of the front left area**

crash, however, it was not visible in the on-scene police photographs. Based on the remote nature of this case and available photographs, it was not known which way the lift was displaced in the crash or if the mounting hardware separated. The displaced wheelchair lift was visible in the insurance company photographs and had been placed on the floor behind the front seat area.

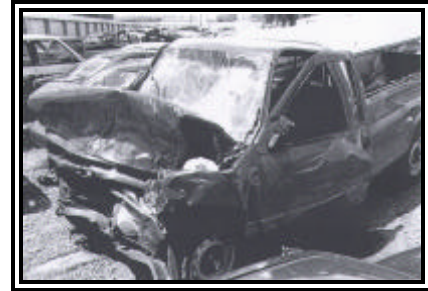
The exterior damage to the 1992 Chevrolet K-1500 pickup truck was based on police and insurance company photographs. The vehicle sustained severe frontal damage as a result of the impact with the Ford E-150 van (**Figure 13**). The direct damage began at the front left bumper corner and extended laterally to the front right bumper corner. The combined direct and induced damage also involved the entire frontal width of the pickup truck. The maximum crush was located at the front right bumper corner and was estimated to be approximately 90 cm (35"). The bumper and radiator supports were crushed rearward. The hood was buckled and folded. The left and right front fenders were crushed rearward and the right fender sustained outward buckling. The frontal crush displaced the front wheels rearward. Based on police measurements, the post-crash left wheelbase was shortened by 28 cm (11") and the right wheelbase was shortened 31 cm (12"). Both A-pillars were displaced and the roof side rails of the cab were deformed slightly upward. Both side doors were displaced from induced damage. The frame appeared to be deformed as a result of the impact. The CDC for the impact with the Ford E-150 van was 12-FDEW-4.

**Figure 13. View of frontal damage to the 1992 Chevrolet pickup truck**

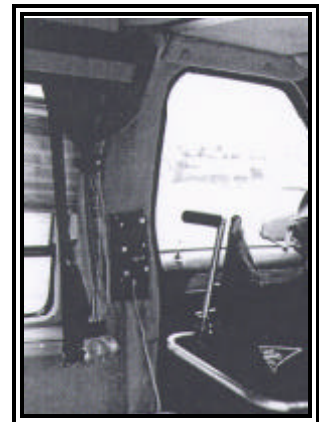
The 1992 Ford E-150 Econoline van was equipped with a modified manual 2-point shoulder belt for the driver. A separate manual 2-point lap belt was installed on the wheelchair frame, that was installed by the wheelchair manufacturer. It was not known if the 2-point wheelchair restraint was designed for vehicle safety or to maintain the occupant's posture. The length, width, and structure of the wheelchair restraint was not known. The fixed-length 2-point shoulder belt was anchored to the left roof side rail approximately 13 cm (5") aft of the left B-pillar and configured with a locking latch plate (**Figure 14**). An approximate 1 m (3') section of webbing configured with a buckle was anchored to the floor on the inboard aspect of the driver's seat. This configuration allowed the latch plate to engage with the buckle across the driver's lower torso area so the slack could be adjusted at the locking latch plate. The 2-point shoulder belt reportedly remained buckled all the time, and the driver regularly "drove" the wheelchair into the E-Z Lock mechanism, which allowed the 2-point shoulder belt to be positioned across his left shoulder and chest. An aftermarket padded sleeve

**Figure 14. View of 2-point shoulder belt mounted aft of the left B-pillar**

was present on the shoulder belt at the time of the crash. A manual 3-point lap and shoulder belt was available for the front right passenger. The investigating officer reported that the belt webbing showed stretch marks from loading of the front right passenger. The webbing was cut by rescue personnel to remove the occupant from the van.
