**ADVANCED OCCUPANT PROTECTION SYSTEM STUDY (AOPSS)**

**VERIDIAN CASE NO. CA00-042**

**VEHICLE - 2000 FORD TAURUS LX**

**CRASH DATE - AUGUST, 2000**

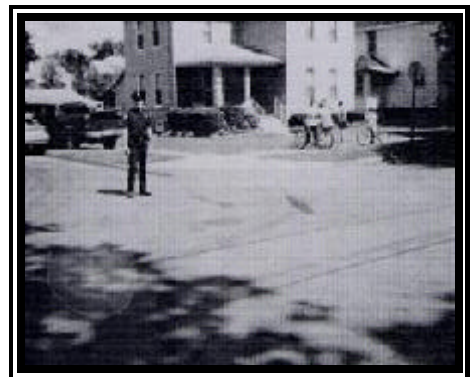
The 70 year old female driver of the 2000 Ford Taurus LX was operating the vehicle northbound at a (driver reported) speed of 56 km/h (35 mph) when she failed to observe the stop sign or westbound Ford pickup truck as she proceeded straight through a rural 4-leg intersection (**Figure 1**). She reported no avoidance maneuvers in anticipation of the impending crash.

**Figure 1. Police photograph showing northwest view of intersection.**

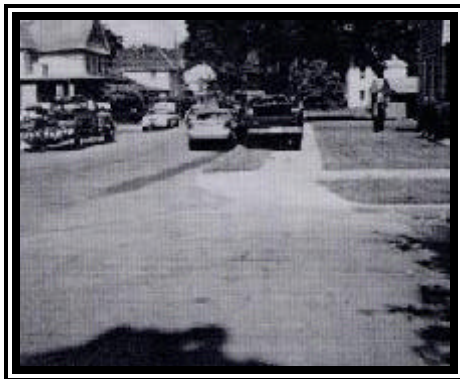
At this point, both vehicles began their respective post-impact trajectories towards the northwest sector of the intersection as the right rear side surface of the Ford Taurus struck ("sideslapped") the left rear side surface of the Ford pickup truck which resulted in moderate damage to each vehicle. The missing vehicle algorithm of the WinSMASH reconstruction program computed velocity changes of 13.8 km/h (8.6 mph) for the subject vehicle and 10.6 km/h (6.6 mph) for the Ford pickup. The respective latitudinal components were of -13.8 km/h (-8.6 mph) and 10.6 km/h (6.6 mph). This secondary impact resulted in deployment of the Ford Taurus' right front side impact air bag. Both vehicles sustained contact to final rest in the northwest sector of the intersection facing west (**Figures 2 & 3**).

Figure 2. Police photo west showing vehicle final rest positions.

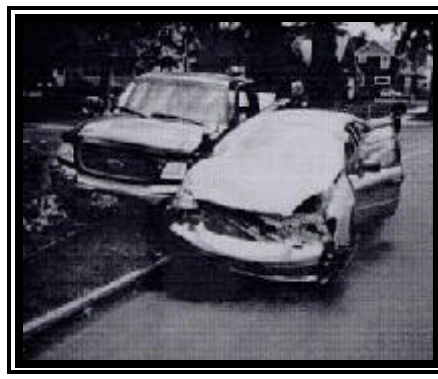
Figure 3. Police photo east showing vehicle final rest positions.

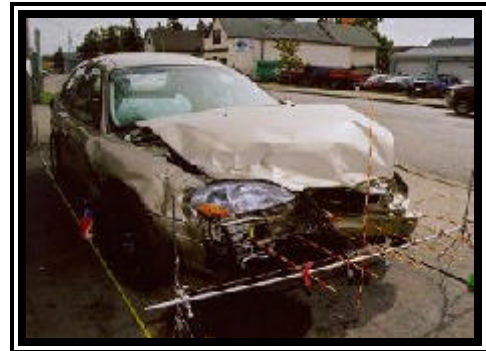
The 2000 Ford Taurus LX sustained moderate frontal damage as a result of the impact with the 1999 Ford F-150 pickup truck (**Figure 4**). The direct contact damage began at the front right bumper corner and extended 93.0 cm (36.6 in) inboard. The impact deformed the full frontal width resulting in a combined direct and induced damage length (Field L) of 131.0 cm (51.6 in). Six crush measurements were documented at the level of the reinforcement bar (*bumper fascia separation*): C1= 1.0 cm (0.4 in), C2= 9.0 cm (3.5 in), C3= 13.0 cm (5.1 in), C4= 19.0 cm (7.5 in), C5= 21.0 cm (8.3 in), C6= 11.0 cm (4.3 in). The Collision Deformation Classification (CDC) for this initial impact to the Ford was 81-FZEW-1 with a principal direction of force of (+) 30 degrees (principal direction of force incremented to reflect end structure shift to the left). The hood was deformed up and rearward from engagement against the side surface of the Ford pickup truck. An indentation was noted to the front reinforcement bar attributed to the left front bumper corner of the Ford pickup truck. The grille and left headlight assembly fractured and separated from the vehicle during the crash sequence. The fenders were displaced to the left due to 12.0 cm (4.7 in) of end structure shift. This damage pattern restricted the left front wheel/tire (not deflated) and produced additional induced damage along the left front door area. The windshield was fractured along the lower right A-pillar from exterior impact forces only. Reduction in the left side wheelbase measured 12.0 cm (4.7 in) as the right wheelbase was elongated 3.5 cm (1.4 in). Direct contact damage was also documented along the right fender area attributed to sustained contact during vehicle spinout (*and accurately separated from impact #2 damage*).

**Figure 4.** Front right damage to the 2000 Ford Taurus LX.

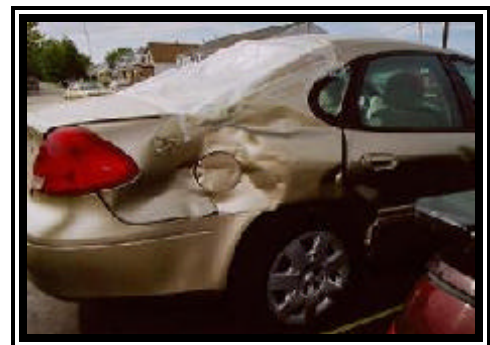
Direct contact damage was also documented along the right side surface attributed to the secondary (sideslap) impact (**Figure 5**). The direct contact damage began 54.0 cm (21.3 in) forward of the right rear bumper corner and extended 310.0 cm (122.0 in) forward. The combined direct and induced damage length (Field L) began 20.0 cm (7.9 in) forward of the right rear bumper corner and extended 244.0 cm (96.1 in) forward. Six crush measurements were documented at the level of the mid-door: C1= 0 cm, C2= 13.0 cm (5.1 in), C3= 6.0 cm (2.4 in), C4= 4.0 cm (1.6 in), C5= 2.0 cm (0.8 in), C6= 0 cm. The CDC for this secondary impact to the Ford Taurus was 03-RZAW-2 with a principal direction of force of (+) 90

**Figure 5.** Secondary impact damage to the right rear side surface.

degrees. Pocketing was noted aft of the right rear axle with surface scratching extended forward to the right A-pillar. A rubber transfer was documented to the right rear door attributed to the left rear wheel/tire on the Ford pickup truck. Induced damage disintegrated the (tempered) back light glazing.

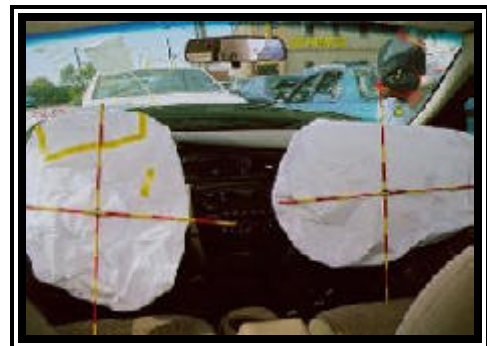
The Ford Taurus was equipped with redesigned frontal air bags for the driver and front right passenger positions. The air bags had deployed as a result of the crash (**Figure 6**). The driver air bag was identified by the following part number: TXM000860908 with a bar coded lot number of: P5206000-00D. The air bag was housed in the center of the steering wheel with a horizontally oriented flap tear seam (H-configuration). The flaps were nearly symmetrical in shape as the upper flap measured 16.5 cm (6.5 in) in width and 6.5 cm (2.6 in) in height while the lower flap measured 16.5 cm (6.5 in) in width and 4.6 cm (1.8 in) in height. No contact evidence was identified on the exterior surface of the module cover flaps. The diameter of the driver air bag measured 53.0 cm (20.9 in) in its deflated state (**Figure 7**). The bag was tethered by two internal straps and vented by two ports located at the 11 o'clock and 1 o'clock sectors on the rear aspect of the air bag. Makeup transfers were documented at the upper right quadrant of the air bag face along with lipstick transfers to the lower right quadrant. Multiple vinyl transfers were also identified at the upper right quadrant on the rear aspect of the air bag from expansion within the module. The vehicle was also equipped with a driver's seat track positioning sensor. This driver was seated within a 10.2 cm (4.0 in) zone of full forward, therefore, the frontal air bag system's first stage only deployed.

**Figure 6. 2000 Ford Taurus LX deployed frontal air bags.**

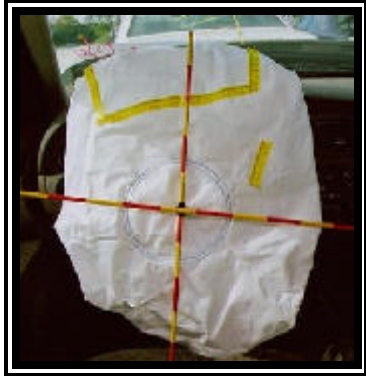
**Figure 7. 2000 Ford Taurus LX deployed driver air bag.**

At impact, the driver initiated a forward and slightly lateral trajectory in response to the 1 o'clock impact force and loaded the manual restraint and deployed driver air bag. Contact to the deployed air bag was confirmed by the makeup transfers documented to the face of the air bag membrane. Although the driver complained to police of pain to the chest and stomach, she disclosed to the SCI investigator only a small laceration to the posterior aspect of the left forearm from contact to an unknown component. She subsequently initiated a lateral trajectory in response to the 3 o'clock impact force and probably loaded the center armrest with no resulting injury reported. The driver was transported by ambulance to a local hospital for treatment and released. The Advanced Occupant Protection System provided additional protection against further contact to the steering wheel hub/rim, and potential serious injury.

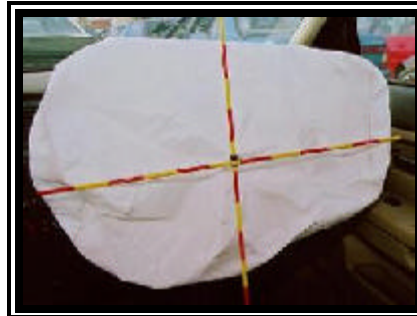
The front right passenger air bag was identified by the following part number: \*TS02081N1172\* with a bar coded lot number of: \*P5202880-00A\*. The front right passenger air bag deployed from the right top instrument panel area with a single cover flap design hinged at the forward aspect. No contact

evidence was identified on the air bag or exterior surface of the module cover flap. The cover flap was rectangular in shape and measured 27.7 cm (10.9 in) in width and 9.0 cm (3.5 in) in height. Multiple black vinyl transfers were noted across the face of the air bag from expansion within the module. The passenger air bag measured 57.2 cm (22.5 in) in width and 50.4 cm (19.8 in) in height in its deflated state (**Figure 8**). The bag was vented by two ports located at the 10 o'clock and 2 o'clock sectors on the side aspect of the air bag. No internal tether straps were present.

**Figure 8. 2000 Ford Taurus LX deployed passenger air bag.**

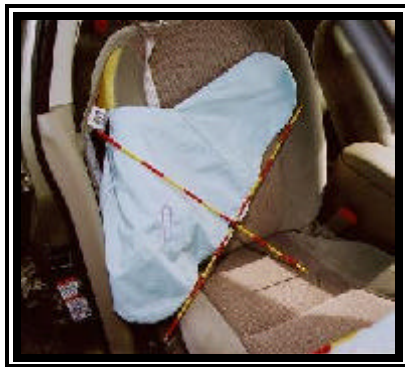
The Ford was also equipped with side impact air bags for the front seated positions. The air bag modules were housed in the outboard side aspect of the front seat backs. The right front side impact air bag deployed as a result of the secondary impact with the Ford pickup truck. The air bag module was identified by the following part number: FAA\*KSR0003249142\*. The “L” shaped air bag membrane measured 34.5 cm (13.6 in) in width and 69.0 cm (27.2 in) in height in its deflated state (**Figure 9**). The bag was tethered by one vertical stitch pattern along the mid-portion of the membrane (no vent ports present). No contact evidence was identified on the air bag.

**Figure 9. 2000 Ford Taurus LX deployed right front side impact air bag.**

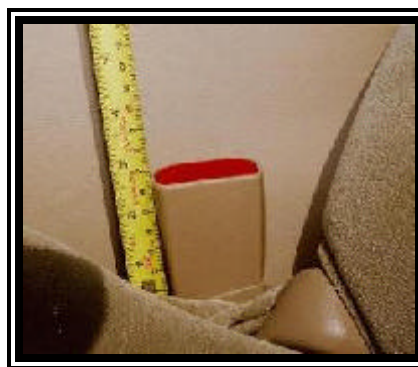
The driver's restraint system also included a buckle pretensioner mounted longitudinally alongside the seat cushion (**Figure 10**). The activation of this pretensioner resulted in 6.0 cm (2.4 in) of piston movement. The piston pulls a cable which lowers the height of the buckle assembly, reducing slack in both the lap and shoulder belt webbing. The front right seated position was not occupied, therefore, the buckle pretensioner did not fire.

**Figure 10. Driver restraint activated buckle pretensioner.**

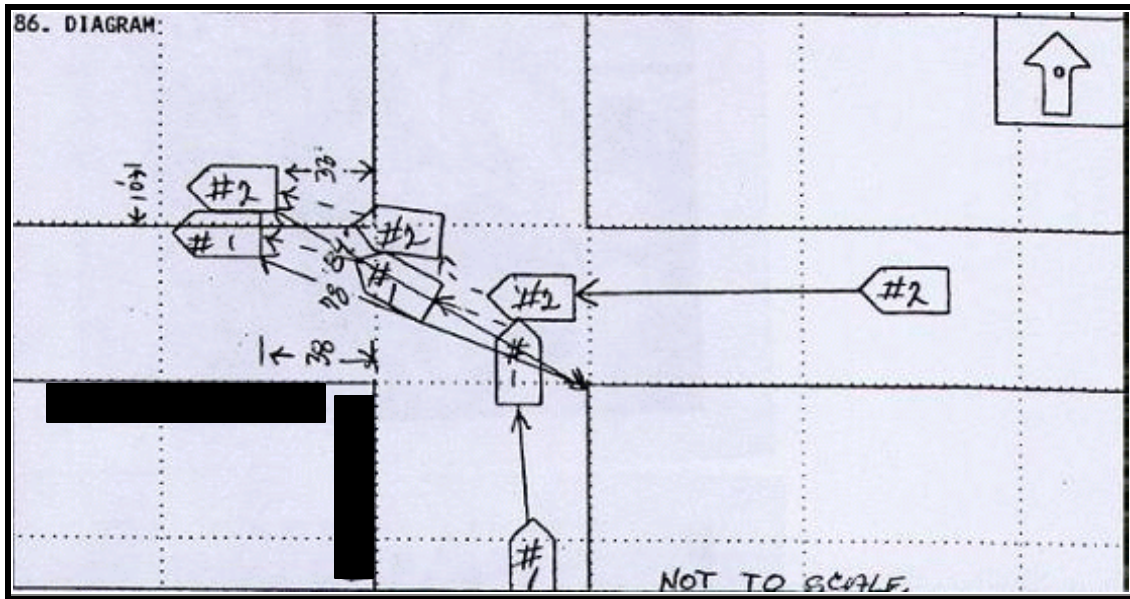
Figure 11. Police Report Scene Diagram.

This two vehicle crash occurred during the morning hours of August, 2000. At the time of the crash, it was daylight with no adverse conditions as the roads were dry. The crash occurred at a straight and level 4-leg rural intersection (see **Figure 11 - page 7**) which had a posted speed limit of 40 km/h (25 mph). Traffic control consisted of stop signs for north/southbound traffic. The asphalt roadway was bordered by barrier curbs and residential driveways.

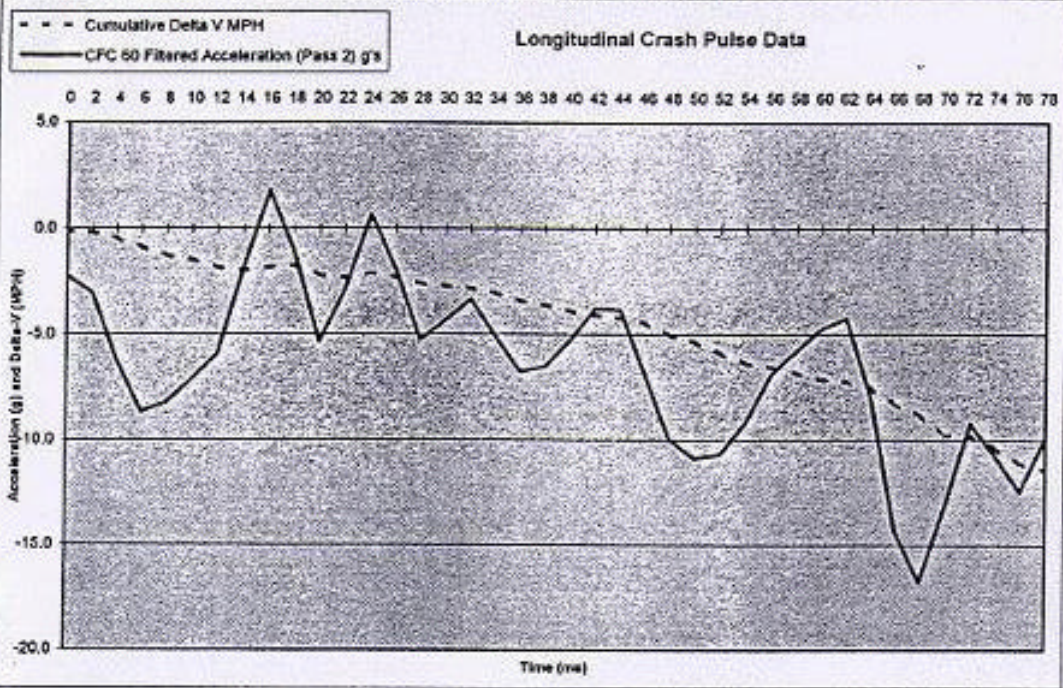
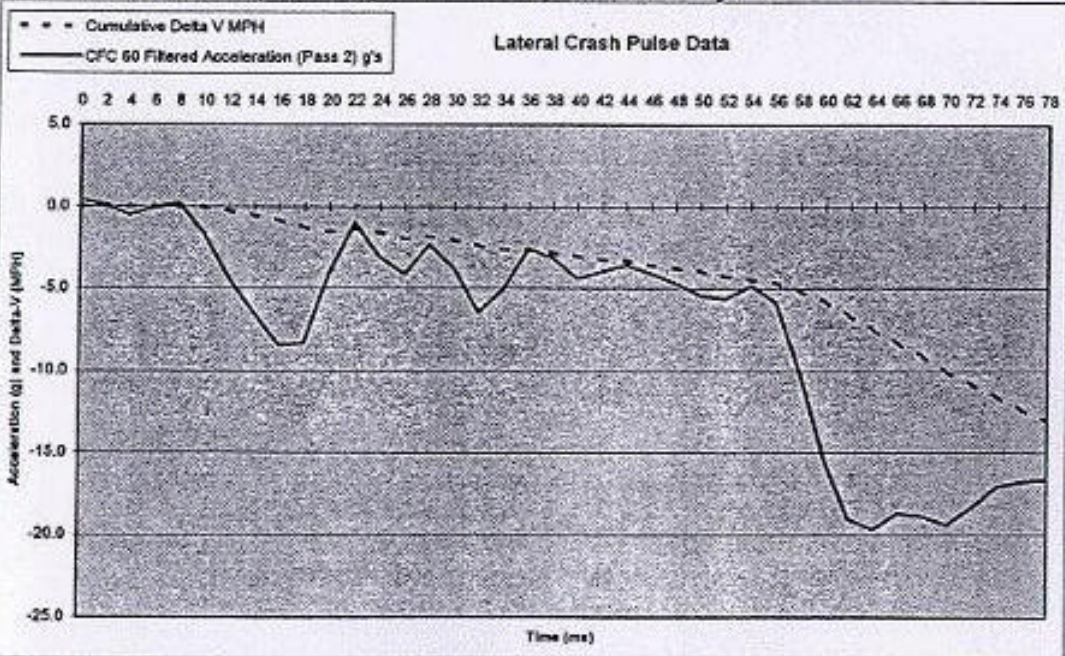
Figure 13. 2000 Ford Taurus LX EDR report.

Time (ms)	0	10	20	30	40	50	60	70	78
Delta-V (MPH)	-0.1	-1.5	-2.2	-2.7	-3.9	-5.4	-7.2	-9.8	-11.5

Time (ms)	0	10	20	30	40	50	60	70	78
Delta-V (MPH)	0.0	0.0	-1.6	-2.0	-3.0	-4.0	-5.8	-10.1	-13.1
