VERIDIAN ON-SITE AIR BAG NON-DEPLOYMENT INVESTIGATION

NASS/SCI COMBO CASE NO. 2001-12-116A

VEHICLE - 2000 GMC SONOMA PICKUP TRUCK

CRASH DATE - JULY, 2001

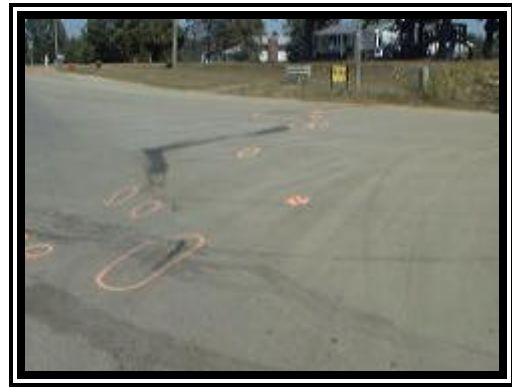
of 65.8 km/h (40.9 mph) for the subject vehicle and 64.5 km/h (40.1 mph) for the struck Oldsmobile. Respective longitudinal components were -64.8 km/h (-40.3 mph) and -60.6 km/h (-37.7 mph). The GMC's Event Data Recorder (EDR) logged a deployment event with a longitudinal element of -38.8 km/h (-24.1 mph) at the 110 millisecond interval (see Figures 10-12, page 9). Both vehicles rotated counterclockwise as the Oldsmobile subsequently came to rest in the northeast sector of the intersection facing southwest and the GMC came to rest perpendicular to the centerline facing northeast. Post-impact trajectories and final rest positions were evidenced by the gouge marks and tire marks documented at the crash site (Figure 3).

Figure 3. Northeast view of the crash site showing the impact related physical evidence.

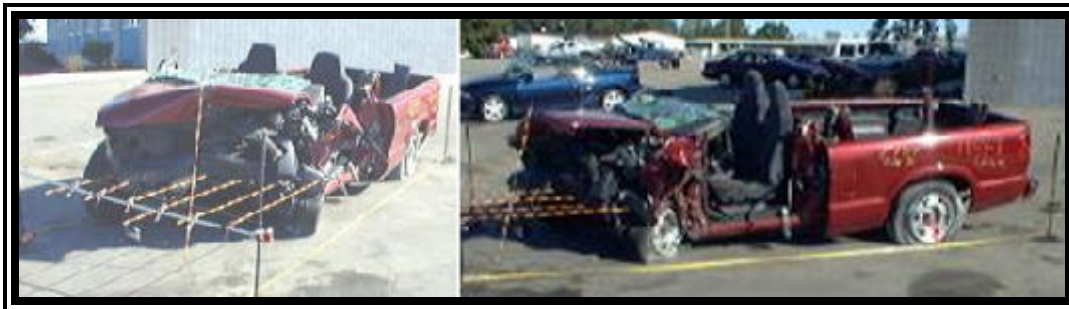
The 2000 GMC Sonoma pickup truck (V2) sustained severe frontal damage (Figure 4) as a result of the impact with the 1989 Oldsmobile Delta 88 (V1). The direct contact damage began at the front left bumper corner and extended 72.0 cm (28.3 in) inboard. The impact deformed the entire front end width resulting in a combined direct and induced damage length (Field L) of 110.0 cm (43.3 in). Although contrasting damage patterns allowed for the separate and accurate assignment of Collision Deformation Classifications (CDCs), overlapping damage protocol was utilized as six crush measurements were documented at the level of the bumper: C1= 116.0 cm (45.7 in), C2= 99.0 cm

(39.0 in), C3= 78.0 cm (30.7 in), C4= 67.0 cm (26.4 in), C5= 38.0 cm (15.0 in), C6= 18.0 cm (7.1 in). *Inconsistencies were identified in NASS field documentation of the subject vehicle, which may explain the large variance between the WinSMASH computed velocity change and the GMC's EDR summary.* The CDC assigned to this secondary impact to the GMC was 12-FYEW-5 with a principal direction of force of (-)10 degrees. The hood was deformed up and rearward from the impact force. Rearward displacement of the left fender restricted/deflated the left front wheel/tire and door opening. Moderate bed to cab contact was noted on each side. The windshield was fractured in multiple locations from exterior impact forces only. The left door, windshield, and roof were removed by fire department personnel during driver extrication activities post-crash. Reduction in the left side wheelbase measured 58.0 cm (22.8 in) as elongation in the right side wheelbase measured 5.0 cm (2.0 in).

Figure 4. Impact #2 front left damage to the 2000 GMC Sonoma pickup truck (V2).

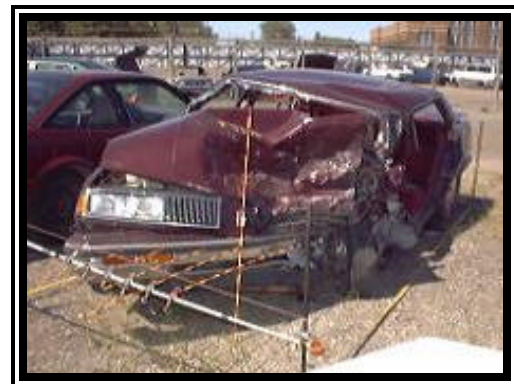
The 1989 Oldsmobile Delta 88 Royale (V1) sustained severe frontal damage (**Figure 5**) as a result of the impact with the 2000 GMC Sonoma pickup truck (V2). The direct contact damage began at the front left bumper corner and extended 108.0 cm (42.5 in) inboard. The impact deformed the entire front end width resulting in a combined direct and induced damage length (Field L) of 57.0 cm (22.4 in). Six crush measurements were documented at the level of the bumper: C1= 145.0 cm (57.1 in), C2= 68.0 cm (26.8 in), C3= 49.0 cm (19.3 in), C4= 30.0 cm (11.8 in), C5= 13.0 cm (5.1 in), C6= 0 cm. The CDC assigned to this impact to the Oldsmobile was 11-FYEW-5 with a principal direction of force of (-)20 degrees. The hood was deformed up and rearward from the impact force. The left fender was displaced rearward

Figure 5. Impact #2 front left damage to the 1989 Oldsmobile Delta 88 Royale (V1).

which restricted/deflated the left front wheel/tire and door opening. Outward buckling of the left front door and window frame was noted which resulted in significant integrity loss, however, exact measurements were unknown due to removal of both left side doors by rescue personnel post-crash. Additional extrication damage was noted to the backlight (disintegrated) and roof support pillars (cut). Induced contact damage produced moderate roof buckling at the left A and B-pillars. Reduction in the left side wheelbase measured 71.0 cm (28.0 in) while elongation of the right side wheelbase measured 22.0 cm (8.7 in).

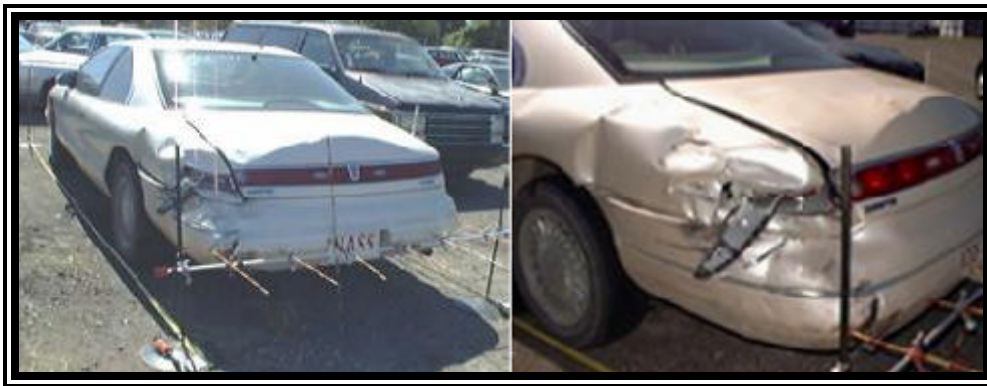
The 1995 Lincoln Mark VIII (V3) sustained minor rear left damage (**Figure 6**) as a result of the initial impact with the 2000 GMC Sonoma pickup truck (V2). The direct contact damage began at the rear left bumper corner and extended 36.0 cm (14.2 in) inboard. The impact deformed the entire rear end width resulting in a combined direct and induced damage length (Field L) of 150.0 cm (59.1 in). Six crush measurements were documented at the level of the bumper: C1= 2.0 cm (0.8 in), C2= 1.0 cm (0.4 in), C3= 2.0 cm (0.8 in), C4= 0 cm, C5= 0 cm, C6= 0 cm. The CDC assigned to this impact to the Lincoln was 06-BLEE-2 with a principal direction of force of (+)170 degrees. The rear left turn signal lens was fractured with induced contact damage extending forward to the left rear axle. No wheelbase reduction was identified.

Figure 6. Impact #1 rear left damage to the 1995 Lincoln Mark VIII (V3).

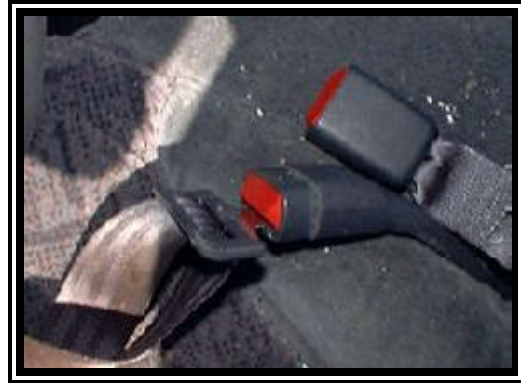
sensitive). Loading evidence consisted of fabric transfers to the shoulder belt webbing along with heavy abrading to the latchplate and D-ring. The driver restraint was cut by rescue personnel during driver extrication activities post-crash (**Figure 7**). The front right seating position was equipped with a 3-point manual lap and shoulder belt system which consisted of a continuous loop belt webbing with a sliding latchplate and a retractor equipped with an inertial and switchable lock mechanism. The center seat was equipped with a 2-point manual lap belt and a locking latchplate. The GMC was not equipped with seat belt pretensioners.

Figure 7. GMC driver manual restraint cut during post-impact driver extrication activities.

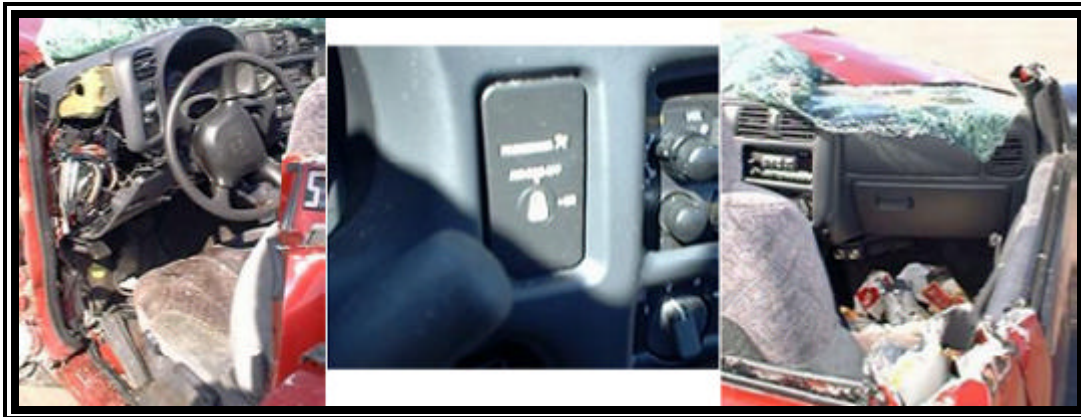
The 2000 GMC Sonoma was equipped with redesigned frontal air bags for the driver and front right passenger positions. The driver frontal air bag failed to deploy as a result of the impact with the 1989 Oldsmobile Delta 88 Royale. The vehicle was equipped with a front right passenger air bag cutoff switch which was found in the “off” position (**Figure 8**). The driver air bag was housed in the center of the steering wheel with a vertically oriented flap tear seam (I-configuration). The front right passenger air bag was housed in the right mid-instrument panel area with a single cover flap design hinged at the top aspect.

Figure 8. 2000 GMC Sonoma pickup truck non-deployed driver redesigned frontal air bag with the front right passenger air bag cutoff switch found in the “off” position.

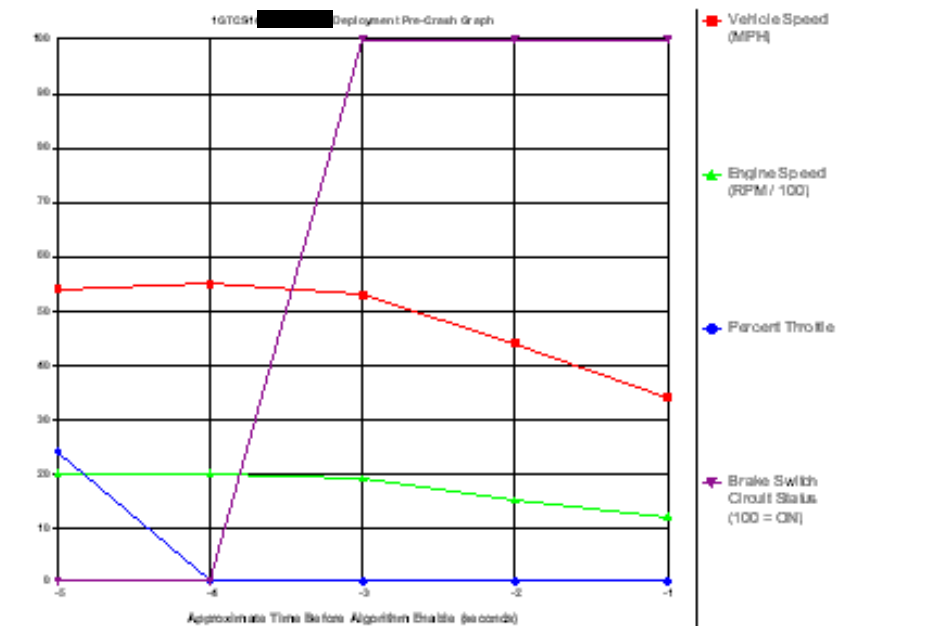
Figure 10. 2000 GMC Sonoma pickup truck EDR report (deployment event).

a deployment event at ignition cycle number 3172. The system status at deployment reflected the driver’s belt switch circuit status as “buckled” and the front right passenger air bag as “suppressed”. As the vehicle and engine speed decreased from 86.9 km/h (54.0 mph) to 54.7 km/h (34.0 mph) during the five second pre-crash interval, the brake switch circuit status went from “off” to “on” three seconds prior to algorithm activation.
