SCI/NASS COMBINATION CASE REPORT

CASE NUMBER - NASS-2001-73-041B

VEHICLE - 1994 GMC SAFARI

CRASH DATE - March 2001

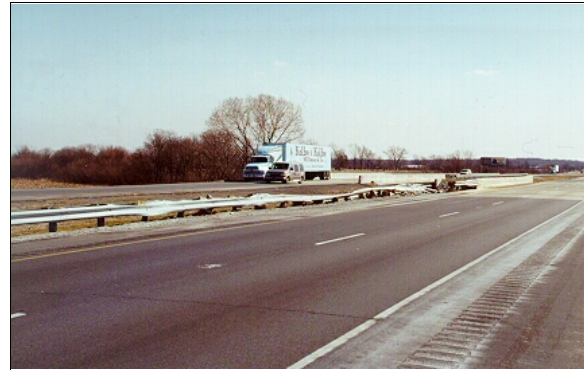
Figure 1: Southeast view of southbound roadway and median guardrail damaged by tractor-trailer

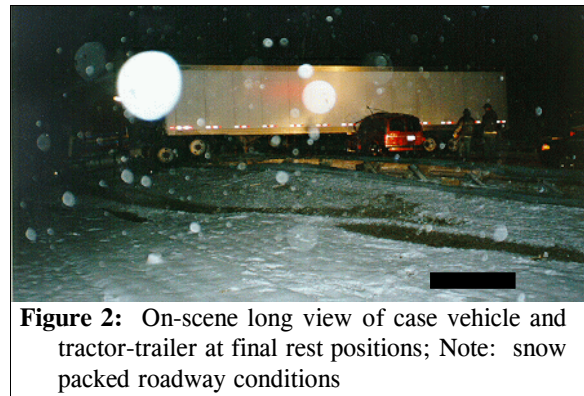
Figure 2: On-scene long view of case vehicle and tractor-trailer at final rest positions; Note: snow packed roadway conditions

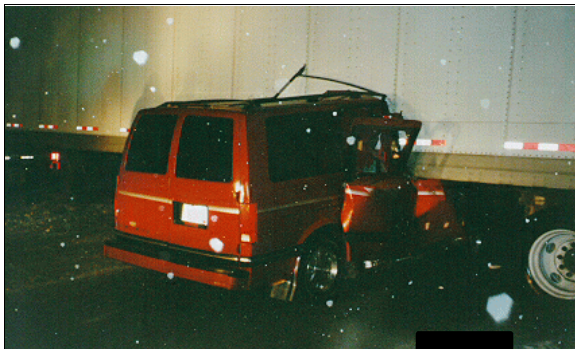
The front (primarily greenhouse) of the case vehicle impacted, in a perpendicular orientation, the left side of the semi-trailer and underrode it (**Figures 3 and 4**). Because of the severe underride, the case vehicle's driver air bag did not deploy. The case vehicle came to rest heading south while the tractor-trailer was heading east.

Figure 3: On-scene view of case vehicle at final rest lodged underneath semi-trailer's left side

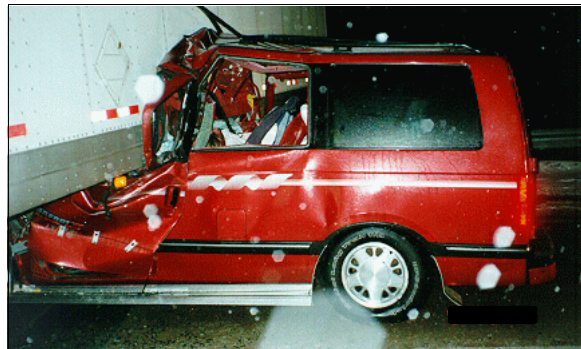
Figure 4: On-scene view of case vehicle's final rest position lodged under semi-trailer's left side

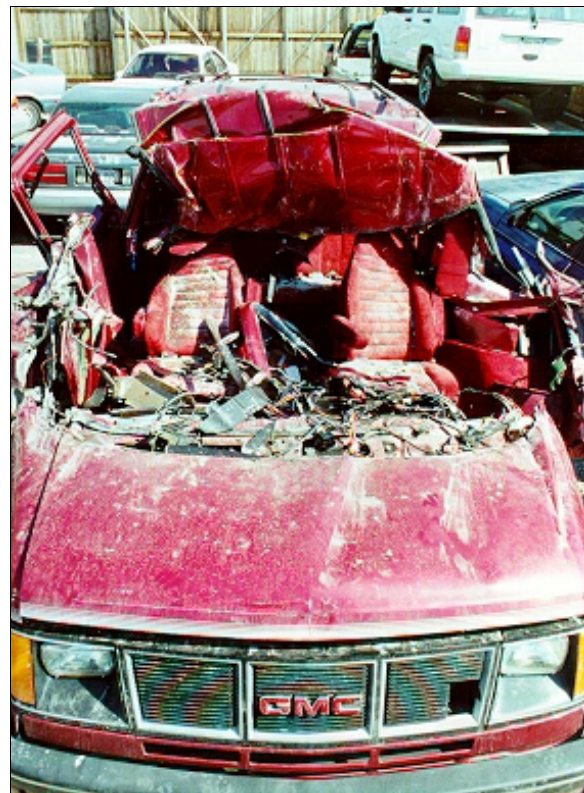
Figure 5 Front overhead view of deformation to case vehicle's greenhouse area; Note: no direct damage to bumper or grill

The case vehicle's contact with the side of the semi-trailer involved the entire front end above the bumper, starting at the leading edge of the hood (**Figure 5**). The direct damage width was 179 centimeters [70.5 inches]. The severe underride damage extended from the front edge of the hood rearward through the windshield and A-pillar to the B-pillar (**Figure 6**). Maximum crush was 224 centimeters [88.2 inches]. The case vehicle's front overhang, wheelbase, and rear overhang remained unchanged. The case vehicle's hood, windshield, left and right A-pillars, left and right front window glazing, left and right second seating area window glazing, left and right front doors, and roof were crushed rearward. None of the case vehicle's tires were physically restricted and/or deflated from the crash. There was integrity loss through the windshield, both front door windows, both second seating area windows, and both front doors. The integrity loss to both front doors was from failures of both A-pillars which were separated from the front fenders. Both front door structures were pulled/torn rearwards, with rivets torn out (**Figures 7 and 8**).

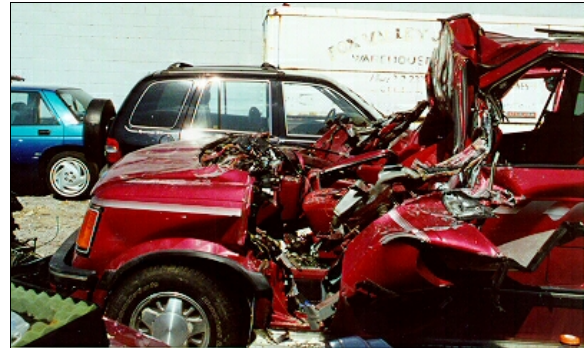
Figure 6: Case vehicle's greenhouse area; Note: A-pillar failure and top of dash torn away

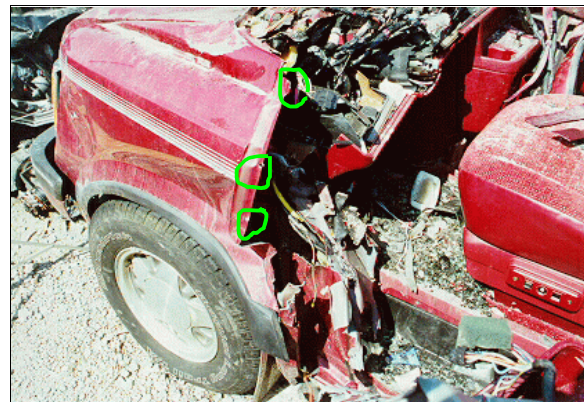
Figure 7: Additional view of case vehicle's left A-pillar failure and integrity loss; Note: rivet holes (highlighted) in sheet metal

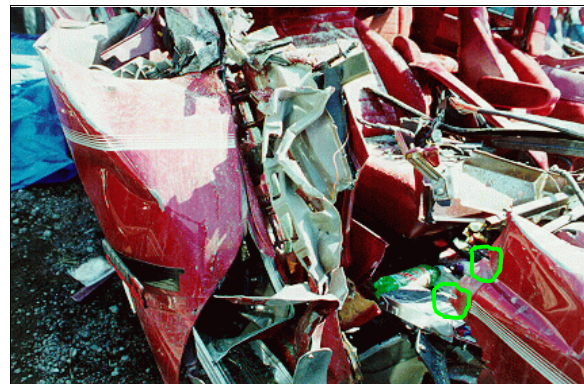
Figure 8: Right A-pillar pushed rearward against right B-pillar; Note: rivet holes (highlighted) in sheet metal

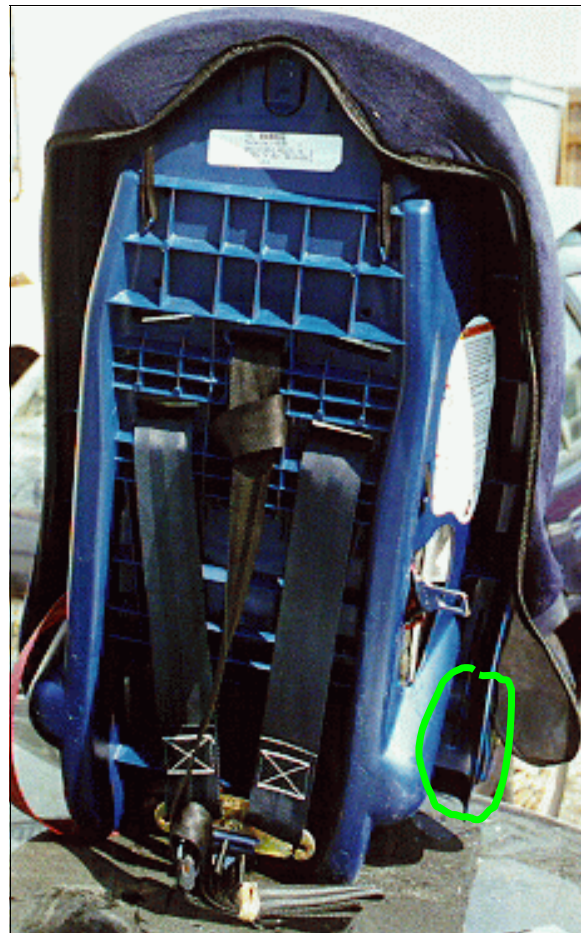
Figure 10: Back of Graco FFCSS used by case vehicle's second seated left passenger; Note: stress (highlighted) marks

The 4-year-old's FFCSS showed no wear and tear on the padding or shell because it was so new. There were numerous areas of stress evidence on the plastic shell of the FFCSS. The primary areas of stress were to both of the side openings used for the seat belt path (**Figure 11**). The right side belt opening also showed a squared indentation/stress mark from the corner of the seat belt tongue. The seat belt tongue also showed corresponding stress evidence. The other stress areas were toward the base of the FFCSS near the front right. This most likely occurred when this portion was being compressed against the seat cushion as the FFCSS lifted/tilted forward at maximum engagement.

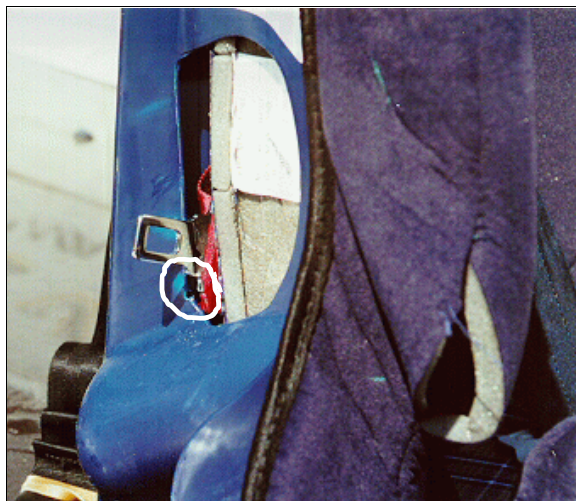
Figure 11: Stress and indentation from seat belt buckle on plastic shell of FFCSS used by case vehicle's second seated left passenger

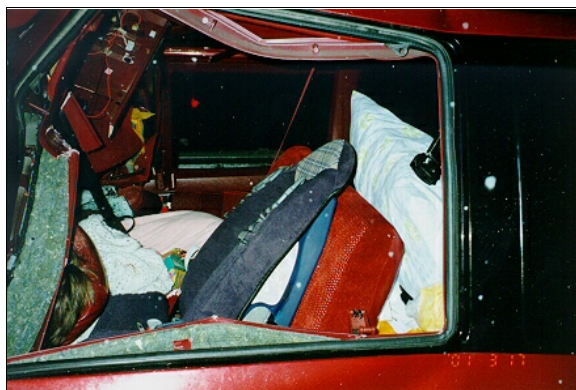
The case vehicle second seated left passenger (4-year-old female, white, non-Hispanic, 99 centimeters, 16 kilograms [39 inches, 35 pounds]) was restrained in her forward facing child safety seat (FFCSS) which was secured by her available, active, continuous loop, three-point, lap-and-shoulder, safety belt system with locking latch plate. The inspection of the her FFCSS and the seat belt webbing, D-ring, and latch plate showed significant evidence of loading, and there were several areas of stress on the plastic shell of the FFCSS (**Figure 12**).

Figure 12: On-scene view of case vehicle's second seated left passenger area showing FFCSS in post-crash position; Note: identical FFCSS in right position removed along with toddler to hospital

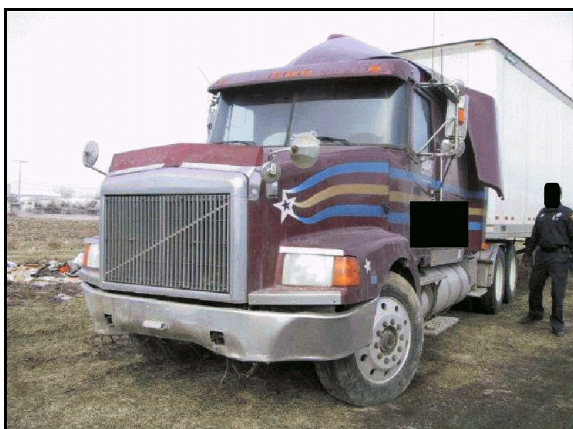
Figure 13: Tractor, front bumper damage due to guardrail impact

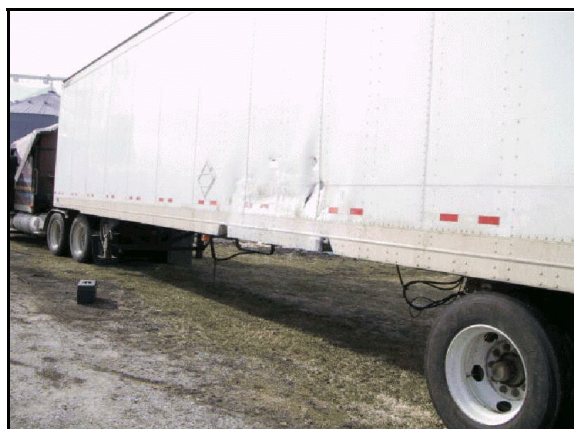
Figure 14: Left side of trailer showing area of direct contact from case vehicle
