Advanced Occupant Protection System/Combination Case
Dynamic Science, Inc. / Case Number: 2001-75-113A
2001 Toyota Avalon
Colorado
October, 2001

1. Report No. 2001-75-113A		2. Government Accession No.		3. Recipient Catalog No.	
4. Title and Subtitle Combination Accident Investigation				5. Report Date

Dynamic Science, Inc.
Accident Investigation
Case Number: 2001-75-113A

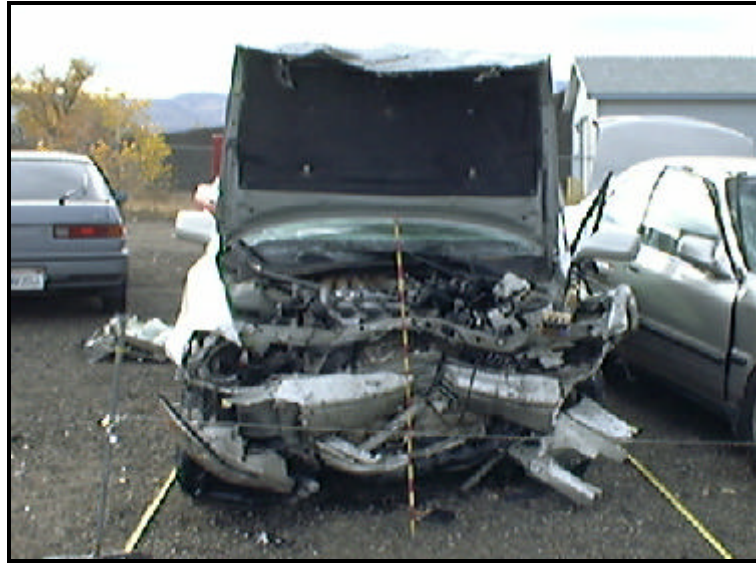
Figure 2. Front view, case vehicle (Toyota)

The case vehicle sustained a longitudinal delta v of -75 km/h (-47 mph) at impact. Both front air bags in the case vehicle deployed at this point. The other vehicle sustained a longitudinal delta v of -78 km/h (-48 mph) and a lateral delta v of 45 km/h (28 mph). The case vehicle sustained 158 cm (62 in) of direct contact across the front end. The maximum crush occurred 15 cm (6 in) to the right of C3 and had a depth of 82 cm (32 in). The other vehicle sustained 98 cm (39 in) of direct contact across the front end. The maximum crush occurred at C1 and had a depth of 89 cm (35 in.).

The case vehicle had longitudinal intrusion through the toe pan and instrument panel. The upper half of the steering wheel rim was deformed by occupant contact.

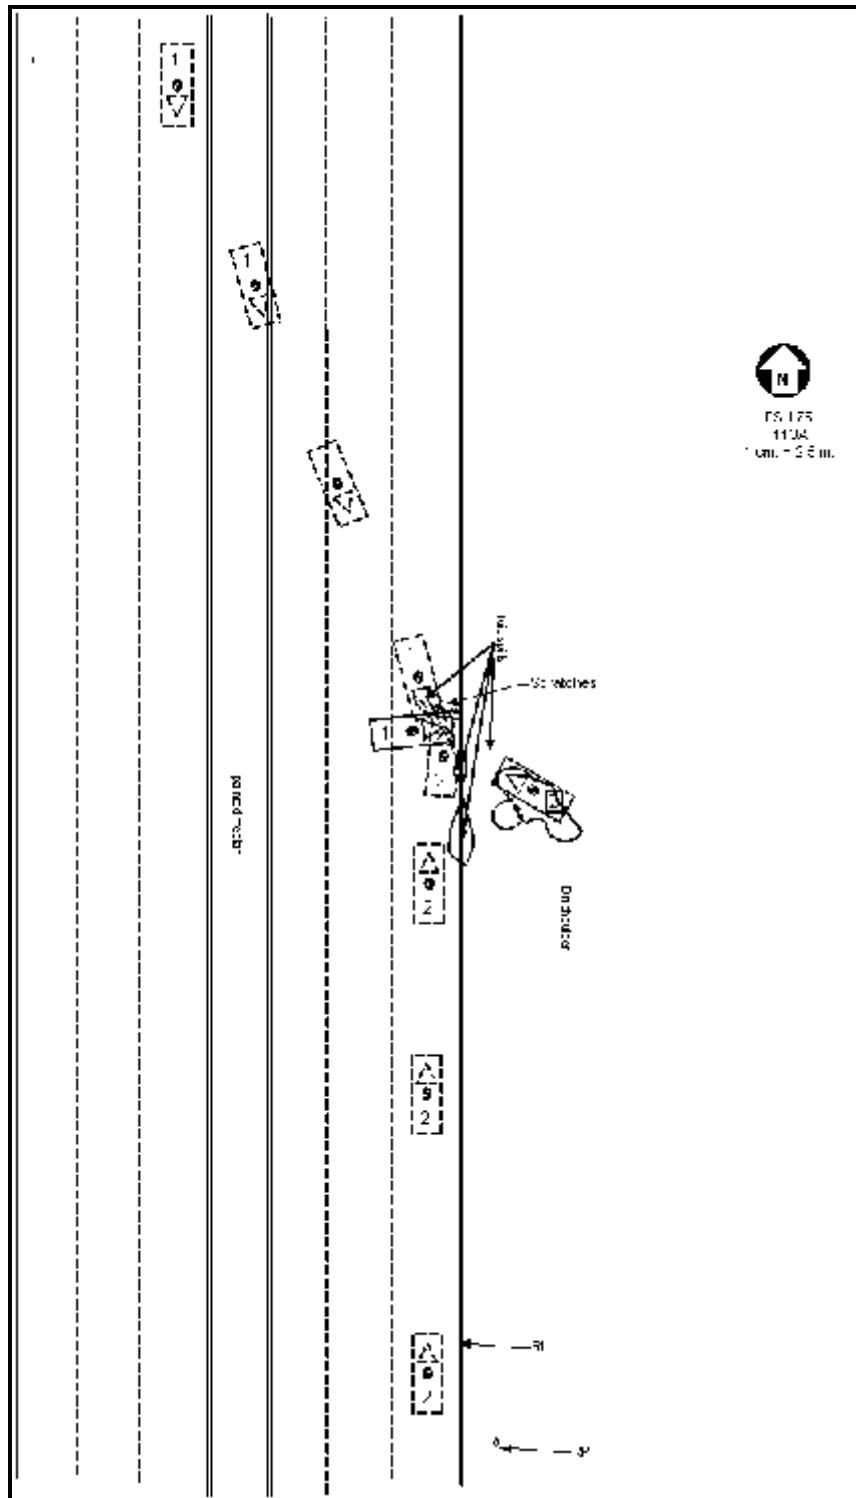
Figure 4. Scene diagram (heading for V1 should be 140 degrees)

The other vehicle was traveling northbound in the second lane from the right. The case vehicle was initially traveling southbound. For reasons not known, the driver of the case vehicle crossed over into the path of the case vehicle. The front of the other vehicle (11FDEW4) struck the front of the case vehicle (12FDEW4). The case vehicle rotated in a counterclockwise direction and came to rest off the roadway facing northwest. The other vehicle was pushed into a clockwise rotation and came to rest on the roadway facing east. Both vehicles were towed from the scene due to damage.

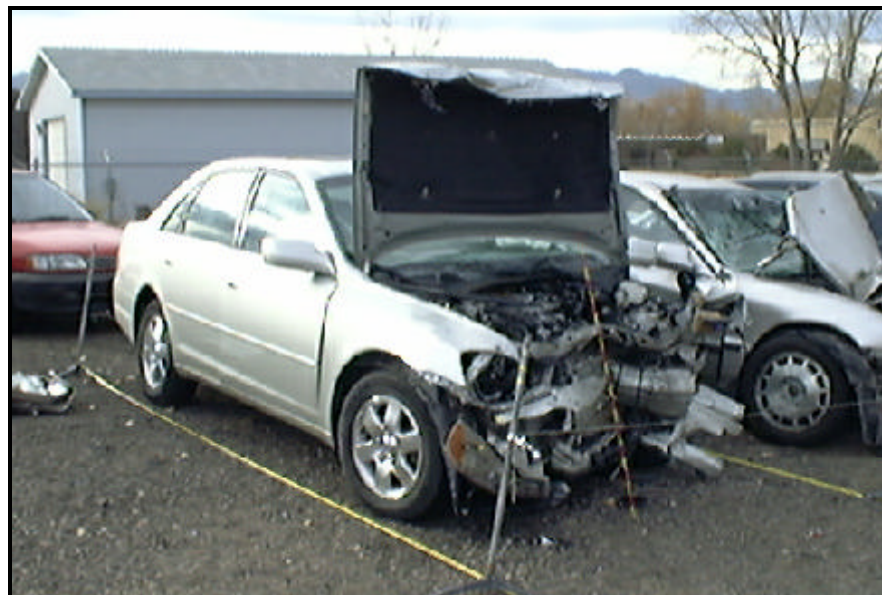
Figure 5. Front right, case vehicle (Avalon)

Description:	2001 Toyota Avalon four-door sedan	
VIN:	4T1BF28B81Uxxxxxx	
Odometer:	Unknown	
Engine:	3.0 L 6 cyl.	
Reported Defects:	None	
Cargo:	14 kg (31 lbs)	
Damage Description:	Major front end damage.	
CDC:	12FDEW4	
Delta V:	Total	76 km/h (47 mph)
	Longitudinal	-75 km/h (-47 mph)
	Latitudinal	-13 km/h (-8 mph)
	Energy	265,427 joules (195,771 ft lbs)

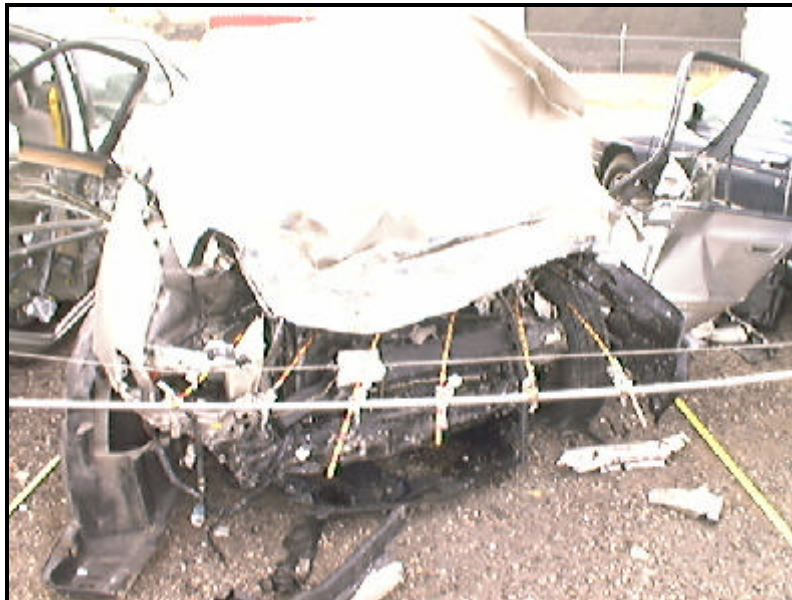
Figure 6. Front, other vehicle (Accord)

Description: 1996 Honda Accord four-door sedan
VIN: 1HGCD563XTAxxxxx
Odometer: Unknown
Engine: 2.16 L 4 cylinder
Reported Defects: None
Cargo: None
Damage Description: Major front end damage.
CDC: 11FDEW4
Delta V:
Total 90 km/h (56 mph)
Longitudinal -78 km/h (-48 mph)
Latitudinal 45 km/h (28 mph)
Energy 265,637 joules
(195,926 ft-lbs)

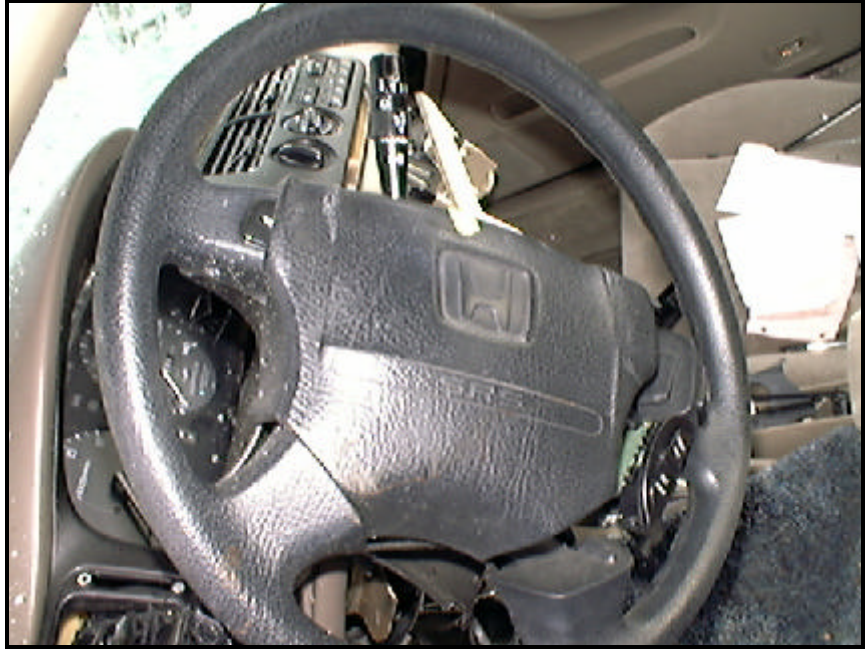
Figure 7. Air bag module, other vehicle

Description: This case was originally initiated in response to a report of an air bag non-deployment with fatal injuries in a 1996 Honda Accord. It has been determined that the air bags did not deploy because they were not replaced after a previous crash.

to a salvage yard. It was sold at an auction to a dealer. It was purchased by the father of the deceased driver of the Honda. This party made repairs that were sufficient to certify the vehicle as "roadworthy" in the state of Colorado. The list of repairs do not include replacement of the air bag. To make a vehicle roadworthy the party must certify that the vehicle meets the requirements set forth in state statutes 42-4-201 through 233. These statutes were reviewed and there does not appear to be any requirement to replace the air bag. The party that signed the certification was listed as the owner of the Honda vehicle at the time of the crash.

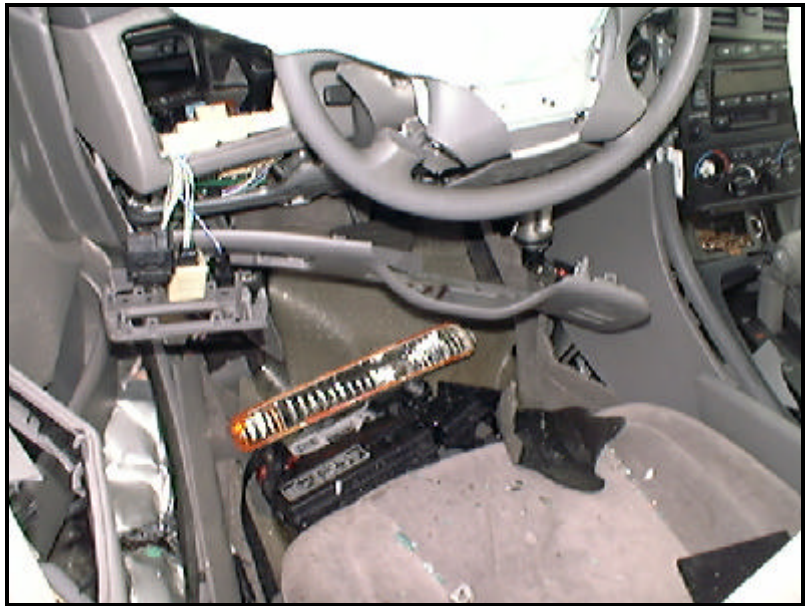
Figure 8. Lower steering wheel rim and knee bolster

At impact, the driver responded to the 12 o'clock direction of force by moving straight forward loading the lap and shoulder belt. The driver's knees engaged and deformed the knee bolster. The driver's chest, rotated slightly to the right by the torso belt, engaged the air bag/steering wheel—deforming the steering wheel and causing the rib and sternum fractures. The driver's head continued forward, hyper flexing, as the driver essentially wrapped himself around the steering wheel and the torso belt. The hyper flexion likely caused the cervical spine and brain stem injuries.

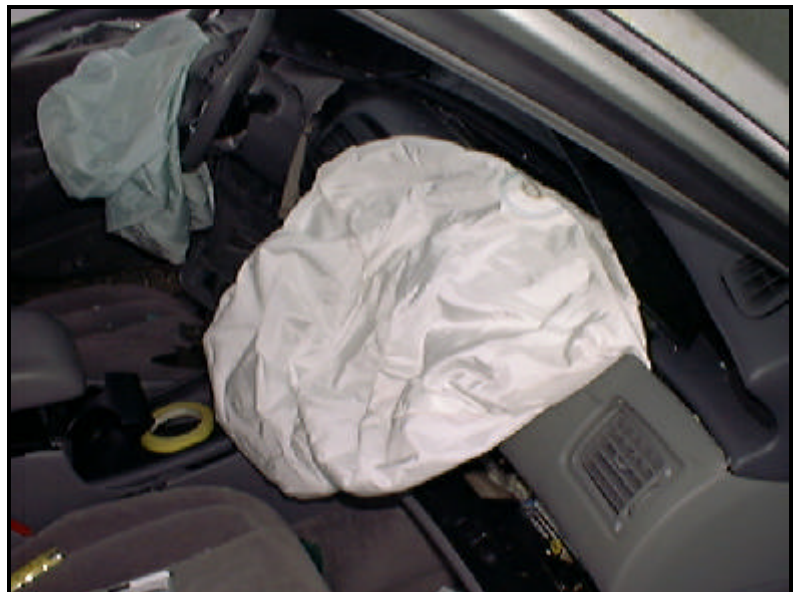
Figure 9. Frontal air bags/deformed steering wheel

The case vehicle was equipped with a driver's air bag and a front right passenger's air bag. The driver's air bag was circular in shape and measured 55 cm (22 in) and had circular vent ports at the 10 and 2 o'clock positions. The air bag had two tethers. Neither the air bag nor the H-configuration air bag module cover were damaged. The front right passenger's air bag was rectangular in shape and measured 43 cm (17 in) high by 52 cm (21 in) wide and had circular vent ports at the 9 and 3 o'clock positions. There were no tethers. There was no damage or visible contact to the air bag or the module cover.
