### **ON-SITE REDESIGNED AIR BAG INVESTIGATION**

CASE NUMBER - IN01-002  
LOCATION - MINNESOTA  
VEHICLE - 1999 FORD CROWN VICTORIA  
POLICE INTERCEPTOR  
CRASH DATE - October, 2000

1. <i>Report No.</i> IN01-002		2. <i>Government Accession No.</i>		3. <i>Recipient's Catalog No.</i>	
4. <i>Title and Subtitle</i> On-Site Redesigned Air Bag Investigation Vehicle - 1999 Ford Crown Victoria Police Interceptor Location - Minnesota			5. <i>Report Date:</i> March 12, 2003

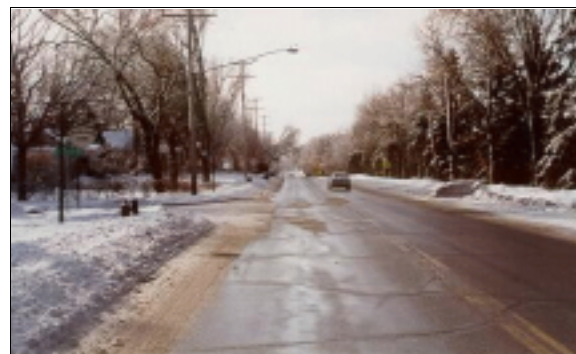
**Figure 1:** Southward view in northbound lane from beyond intersecting roadway showing case vehicle's northbound travel path from hill crest to impact in Tee intersection (case photo #05)

The case vehicle's city roadway was straight and level (i.e., actual slope was 0.7%, negative to the north) at the area of impact. As noted above there was a hill crest south of the "Tee" intersection. The northbound roadway had a 2.2% grade negative to the north (i.e., a downgrade

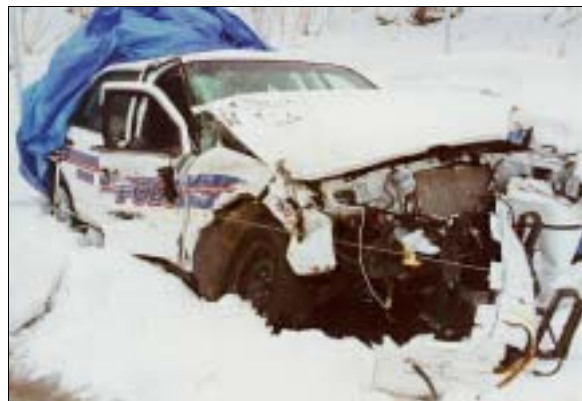
The right front bumper corner of the case vehicle (**Figure 2** and **Figure 3**) was impacted by the front (**Figure 4** below) of the Excursion (Note: the Excursion had been salvaged prior to this contractor's involvement). The initial impact resulted in the case vehicle being redirected in a northwesterly direction where it subsequently departed the west edge of the north-south roadway, and impacted a tree (**Figure 5** below) with its front (**Figure 6** below), causing the case vehicle's driver and front right passenger

**Figure 2:** Case vehicle's damaged right front viewed from right of front which resulted from impact with Excursion's front; Note: frontal damage from tree impact (case photo #17)

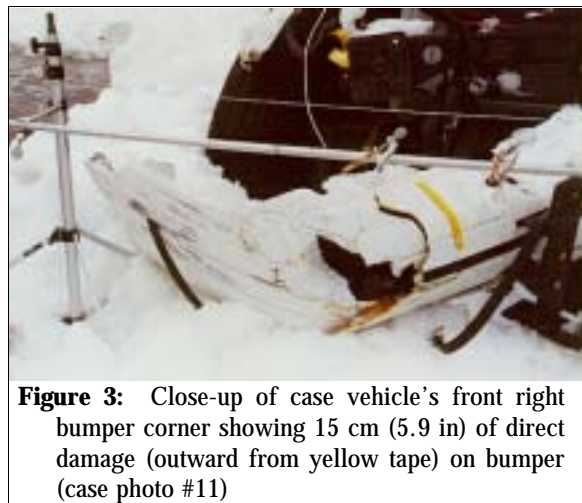
**Figure 3:** Close-up of case vehicle's front right bumper corner showing 15 cm (5.9 in) of direct damage (outward from yellow tape) on bumper (case photo #11)

The case vehicle's contact with the Excursion (1<sup>st</sup> event) involved its right front side. Direct damage was also present on the front bumper, and the direct damage began at the front right bumper corner and extended 15 centimeters (5.9 inches) inward from the bumper corner (**Figure 3** above). On the right side, the direct damage began at the right front bumper corner and extended, a measured distance of 245 centimeters (96.5 inches), rearward to just behind the right "B"-pillar [i.e., 73 centimeters (28.7 inches) forward of the right rear axle]. In addition, there was direct contact to the case vehicle's right "A"-pillar (**Figure 9**) from the hood of the Excursion as it raked down the right side (**Figure 4** above). Maximum crush was measured as 22 centimeters (8.7 inches) at C<sub>5</sub>. The case vehicle's impact with the tree was to the front left. Direct damage began 10 centimeters (3.9 inches) inward from the front left bumper corner and extended 25 centimeters (9.8 inches) along the front bumper towards the vehicle's center. The residual maximum crush for the tree impact was measured as 60 centimeters (23.6 inches) between C<sub>1</sub> and C<sub>2</sub> (**Figure 6** above). The case vehicle's front end was shifted to the left approximately 8 centimeters (3.1 inches). The wheelbase on the case vehicle's left side was shortened 17 centimeters (6.7 inches) with the right side remaining essentially unaltered. As a result of the impacts, the case vehicle's front bumper, bumper fascia, grille, hood, radiator, right and left headlight and turn signal assemblies, right and left fenders, right front and rear doors, roof, and right "A"-pillar were directly damaged and crushed either rearward or inward or both. The right front door glazing was disintegrated from the initial impact, and the

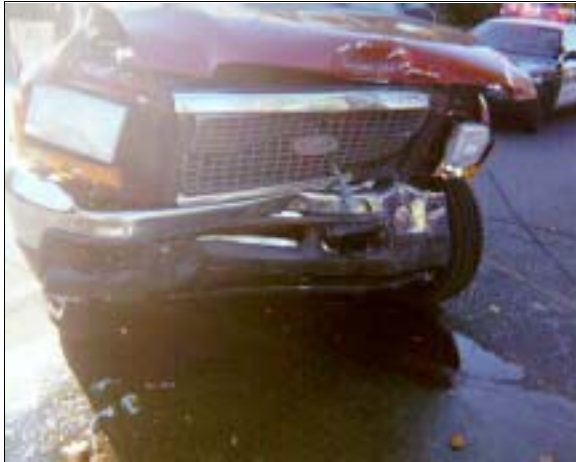
**Figure 4:** On-scene view looking southeast at Excursion’s frontal damage; Note: direct contact to front edge of hood from impacting case vehicle’s right “A”-pillar (case photo #39)

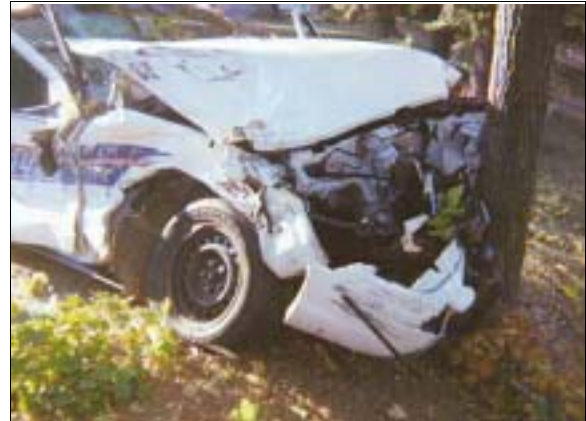
**Figure 5:** On-scene close-up view looking south at case vehicle’s final rest position off west side of roadway against struck tree (case photo #38)

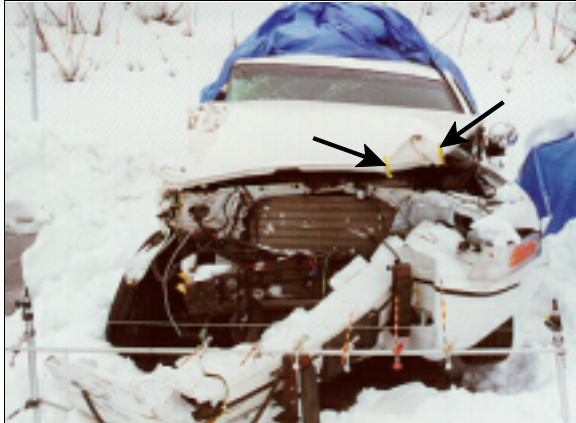
**Figure 6:** Case vehicle’s frontal deformation from both impacts; Note: tree impact (highlighted by yellow tape and arrows) and outward movement of front right bumper (case photo #09)

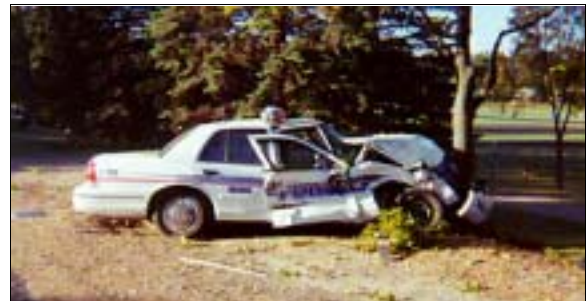
**Figure 7:** On-scene view looking south-southwest at case vehicle’s final rest position off west side of roadway against a tree (case photo #44)

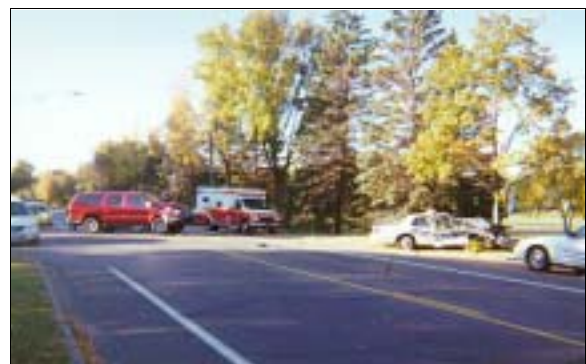
supplemental restraints (redesigned air bags) to deploy. Upon impacting the tree, the case vehicle rotated approximately 30 degrees counterclockwise prior to coming to rest partially against the struck tree, off the west side of the road, and heading in a northwesterly direction (**Figure 7**). The Excursion came to rest straddling the northbound lane with its front in the southbound lane, but still within the “Tee”-intersection, heading in a northwesterly direction (**Figure 8** below).

**Figure 8:** On-scene view looking in a south-southwesterly direction at final rest positions of the case vehicle—against a tree off the west side of the roadway, and the Excursion—straddling the northbound lane (case photo #40)

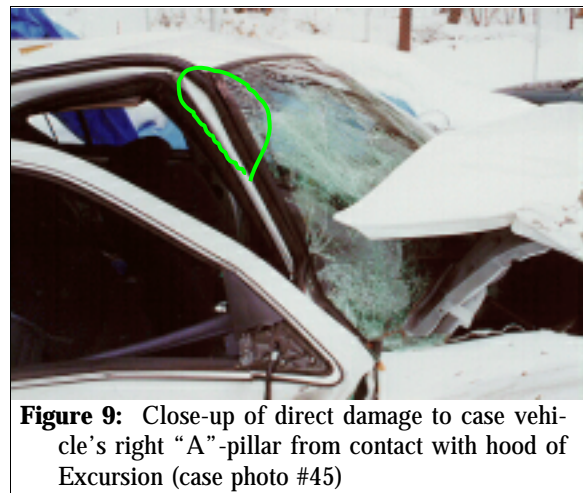
**Figure 9:** Close-up of direct damage to case vehicle's right "A"-pillar from contact with hood of Excursion (case photo #45)

windshield's glazing was cracked from both impacts as well as from the case vehicle's hood being pushed rearward into it. The case vehicle's left and right front tires were physically restricted, and the right front tire was deflated. The hood and left fender sustained induced damage as well and there was remote buckling to the roof near the right "A"-pillar area. No obvious induced damage or remote buckling was noted to the remainder of the case vehicle's exterior.

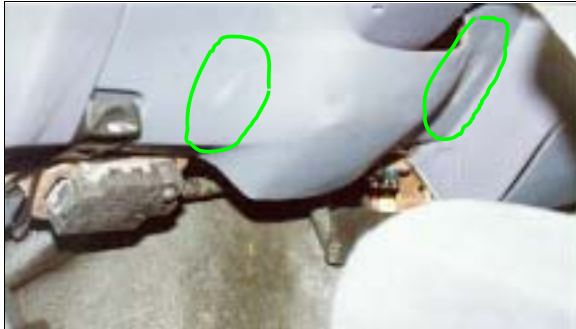
**Figure 10:** Knee contacts (highlighted) on case vehicle's driver knee bolster (case photo #23)

Inspection of the case vehicle's interior revealed that there were knee contacts to the driver's knee bolster (**Figure 10**). Furthermore, the right "A"-pillar and right instrument panel were intruded inward (i.e., both longitudinally and laterally), resulting in the front right passenger's air bag module being angled inward (**Figure 11**) and, as a consequence, the air bag's normal deployment path was altered. Finally, the shear capsules on the case vehicle's steering column were collapsed approximately 3 centimeters (1.2 inches) on both sides with the right side collapse being slightly greater than the left side collapse (**Figure 12**).

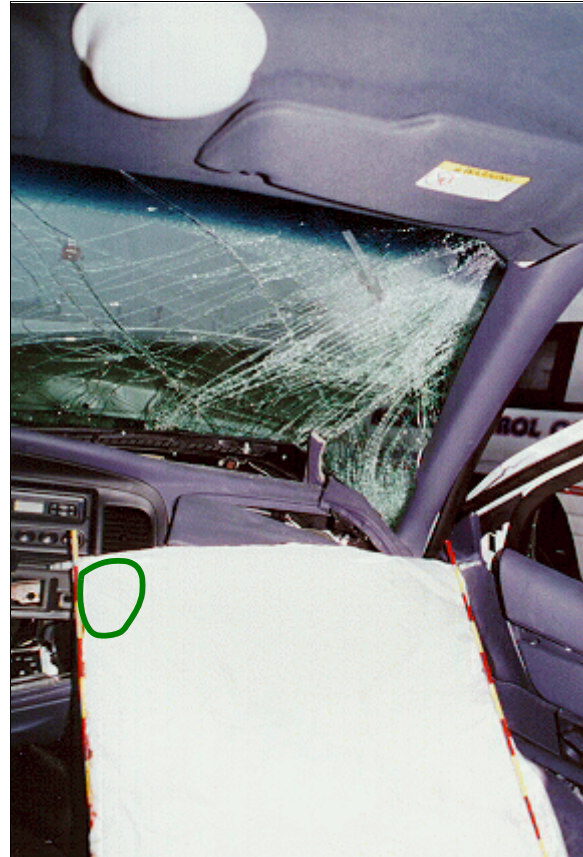
**Figure 11:** Vertical view of case vehicle's deployed front right passenger air bag; Note: intruding right instrument panel and "A"-pillar which deformed the cover flap (case photo #28)

The front right passenger's air bag was located in the middle of the instrument panel. There was a single, essentially rectangular, modular cover flap. The cover flap was made of a thick vinyl over a thick cardboard type frame. The flap's dimensions were 39 centimeters (15.4 inches) at the lower horizontal seam and 15 centimeters (5.9 inches) along both vertical seams. The profile of the case vehicle's instrument panel resulted in a 4 centimeter (1.6 inch) setback of the leading edge of the cover flap relative to the protruding right instrument panel. An inspection

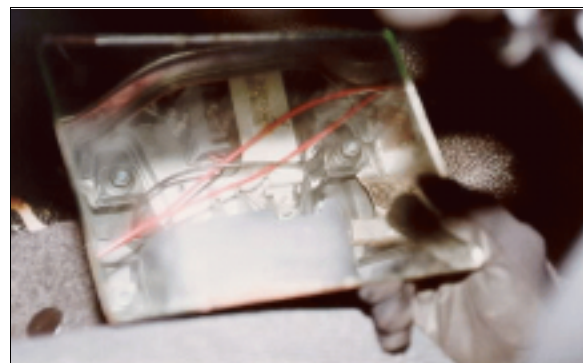
**Figure 12:** Under instrument panel view using mirror of case vehicle's shear capsule, indicating movement to steering column from loading by driver (case photo #24a)

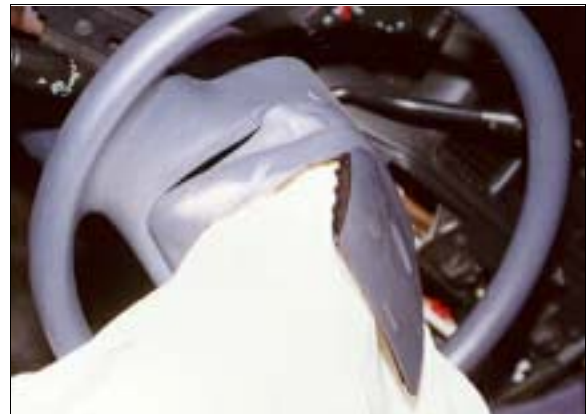
The case vehicle was equipped with a Supplemental Restraint System (SRS) that contained frontal redesigned air bags at the driver and front right passenger positions. Both frontal air bags deployed as a result of the frontal impact with a tree. The case vehicle's driver air bag was located in the steering wheel hub. The module cover consisted of a single, essentially rectangular, cover flap made of thick vinyl with overall dimensions of 14.5 centimeters (5.7 inches) at the top horizontal seam and 12 centimeters (4.7 inches) vertically. An inspection of the air bag module's cover flaps and the air bag fabric revealed that the cover flaps opened at the designated tear points and left side of the module cover was partially pulled away from the hub (**Figure 13**), most likely because the air bag's deployment path was momentarily blocked. In addition, there was no evidence of damage during the deployment to the air bag or the cover flap themselves. The driver's air bag was designed with four tethers, each approximately 6 centimeters (2.4 inches) in width and sewn, relative to the center of the air bag, at the 8, 10, 2, and 4 o'clock positions. The driver's air bag had two vent ports, approximately 1.5 centimeters (0.6 inches) in diameter, located at the 11 and 1 o'clock positions. The deployed driver's air bag was round with diameter 58 centimeters (22.8 inches). An inspection of the driver's air bag fabric revealed no contact evidence readily apparent on the driver's air bag, but there were black scuffs on the air bag from the flap cover that most likely occurred during the air bag's inhibited deployment (**Figure 14**).

**Figure 13:** Close-up of case vehicle's steering wheel showing air bag module partially separated from hub during air bag's deployment (case photo #25)

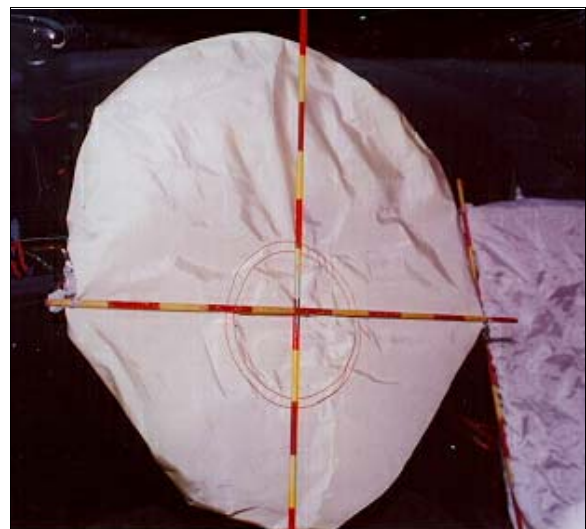
**Figure 14:** Case vehicle's driver air bag showing no visible evidence of contact but a number of black scuff marks (case photo #26)

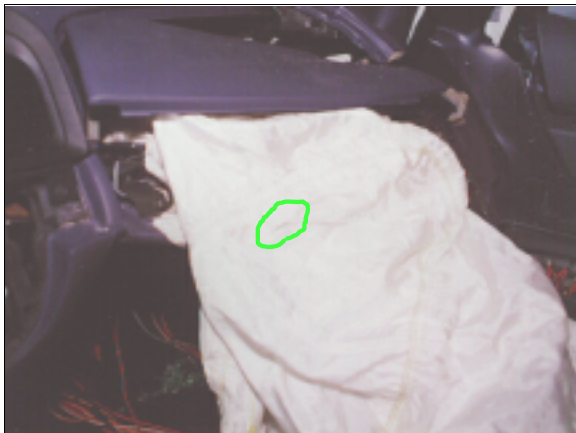
of the front right air bag module's cover flaps and air bag revealed that the cover flap opened at the designated tear points even though the module cover flap had been distorted by intrusion from the case vehicle's impact with the Excursion (**Figure 11** above). Furthermore, there was no evidence of damage during the deployment to the cover flap. The inspection of the front right air bag revealed that during the deployment a black scuff resulted on the left side surface (**Figure 15**) and, in addition, there was what appeared to be snagging—although barely visible, in the air bags fabric on the upper left side of the front surface, most likely from contacting the case vehicle's mounted laptop computer. The front right passenger's air bag was designed without any tethers. The front right air bag had one vent port, approximately 6 centimeters (2.4 inches) in diameter, located at the 8:30 o'clock position. The deployed front right air bag was rectangular with a height of approximately 58 centimeters (22.8 inches) and a width of approximately 64 centimeters (25.2 inches). An inspection of the front right passenger's air bag fabric revealed only a small area of blood smear, located 3 centimeters (1.2 inches) down from the top seam on the upper left corner of the air bag's front surface (**Figure 16**).

**Figure 15:** Case vehicle's front right passenger's air bag showing black scuff mark (highlighted) on right side of air bag from contact with black laptop computer or docking station (case photo #30a)

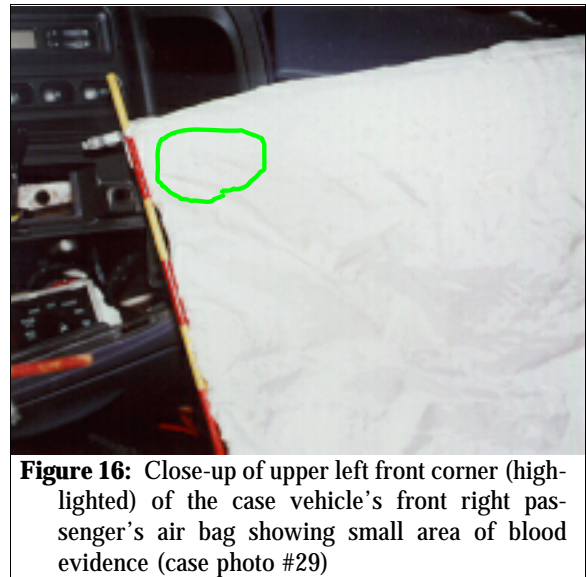
**Figure 16:** Close-up of upper left front corner (highlighted) of the case vehicle's front right passenger's air bag showing small area of blood evidence (case photo #29)

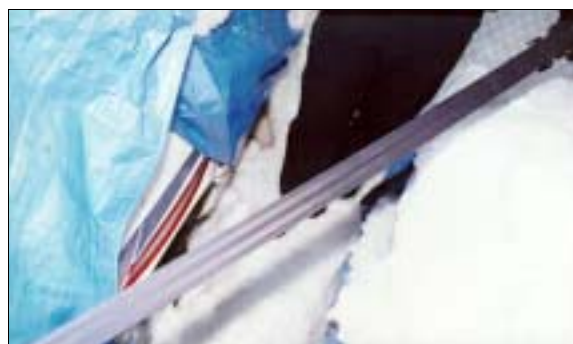
In this contractor's opinion, the case vehicle's driver was not using his available, active, three-point, lap-and-shoulder, safety belt system. According to the case vehicle's driver, he was definitely wearing his seat belt, but he had no belt pattern bruising and/or abrasions to his body. In addition, the inspection of the driver's seat belt webbing, "D"-ring, and latch plate showed no evidence of loading or blood smears (**Figure 17** and **Figure 18** below). The case vehicle's driver indicated that he was bleeding profusely, post-crash, from his nose and mouth and that there was blood all over his shirt. Based on this contractor's experience and the lack of physical evidence, it is this contractor's opinion that the case vehicle's driver was not restrained.

**Figure 17:** Webbing from case vehicle's driver safety belt system showing no visible evidence of loading or blood on webbing (case photo #31)

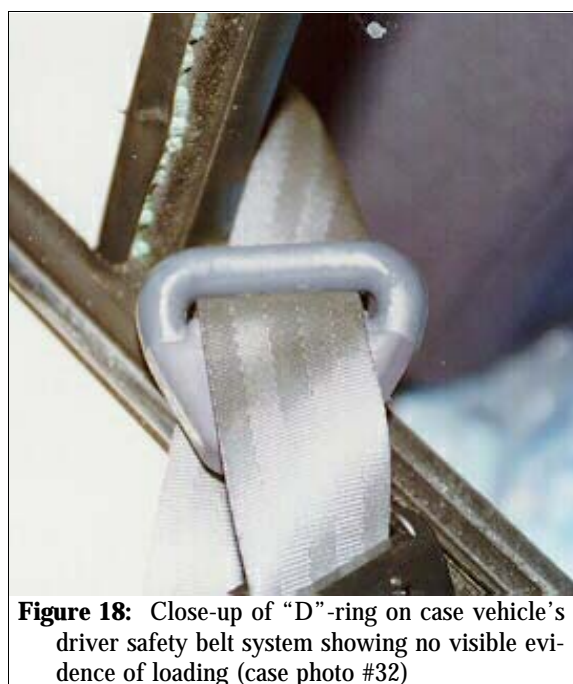
**Figure 18:** Close-up of "D"-ring on case vehicle's driver safety belt system showing no visible evidence of loading (case photo #32)

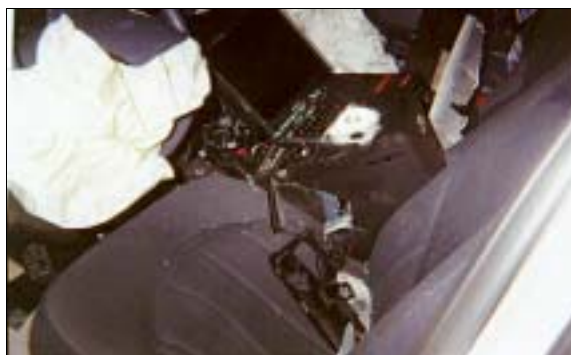
The case vehicle's laptop computer was positioned in its docking station near the center instrument panel, which was immediately adjacent to the now intruded right instrument panel. The case vehicle's impact with the tree caused both air bags to deploy. The deploying front right passenger air bag contacted the back right corner of the laptop computer and docking station, lifting the laptop off its docking station and propelling it into the face of the case vehicle's driver (**Figures 19 and 20**). The impact with the tree resulted in the case vehicle's driver moving forward into the right side of the deploying driver's air bag and re-contacting the driver's knee bolsters. Because of the driver's posture prior to impacting the tree (i.e., leaning forward and to his right), the deploying driver's air bag impacted the left side of the driver's chest, while leaving his face open for contact by the propelled laptop. Because of his close proximity to the driver's air bag module, the air bag's deployment was slightly inhibited, causing a portion of the air bag's plastic module on the steering wheel hub to be partially pulled away from its housing (**Figure 13** above). According to the case vehicle's driver, at final rest he remained, restrained, in his seat near his original seating position, bleeding from the nose and mouth. He called for assistance prior to exiting his squad car to check on the driver and occupants of the Excursion.

**Figure 19:** Post-crash view of case vehicle's front seating area showing damage to laptop computer and specially equipped center floor console (case photo #43)

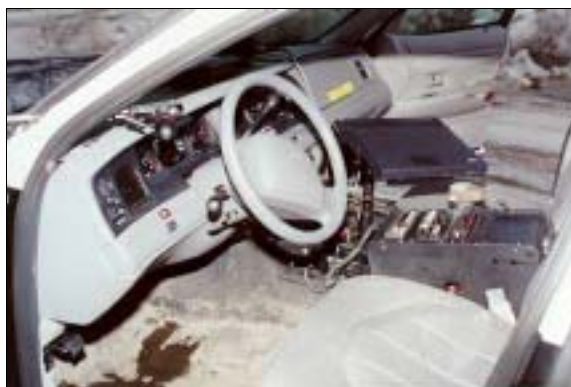
**Figure 20:** Interior view of an exemplar, undamaged Ford Crown Victoria, police vehicle showing laptop's position in docking station (case photo #47)

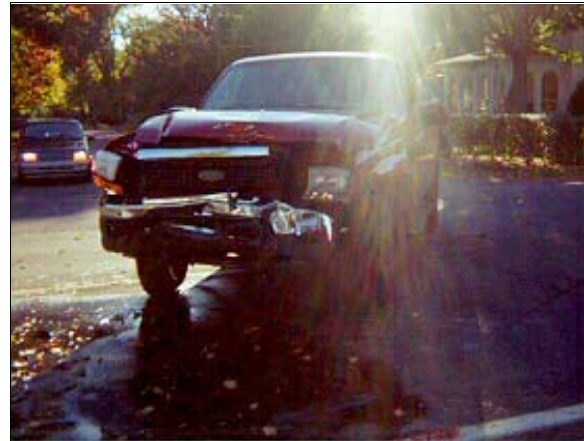
The Excursion's front contacted (**Figure 21**) the case vehicle's right front corner. The case vehicle continued across the Excursion's front in an end-swiping motion that resulted in direct contact continuing down the case vehicle's right side and caused the Excursion to rotated clockwise. The Excursions's hood (**Figure 4** above) directly contacted the case vehicle's right "A"-pillar. Based on the available photographs, the CDC for the Excursion was estimated as: **11-FYEW-2 (320)**. The WinSMASH reconstruction program, missing vehicle algorithm, was used on the Excursion's highest severity impact. The Total, Longitudinal, and Lateral Delta Vs are, respectively: 10.1 km.p.h. (6.3 m.p.h.), -8.7 km.p.h. (-5.4 m.p.h.), and + 5.0 km.p.h. (+ 3.1 m.p.h.). In this contractor's opinion, based on the available photographs, these results appear low (**Figure 5** above). The Excursion was towed due to damage.

**Figure 21:** On-scene view looking east at Excursion's frontal damage; Note: Excursion's front has been shifted toward right (case photo #39a)
