ON-SITE AIR BAG INVESTIGATION

CASE NUMBER - IN01-004
LOCATION - ARIZONA
VEHICLE - 2000 CHEVROLET CORVETTE
CRASH DATE - February, 2001

1. <i>Report No.</i> IN01-004		2. <i>Government Accession No.</i>		3. <i>Recipient's Catalog No.</i>	
4. <i>Title and Subtitle</i> On-Site Redesigned Air Bag Investigation Vehicle - 2000 Chevrolet Corvette Location - Arizona			5. <i>Report Date:</i> January 30, 2002; April 23, 2002

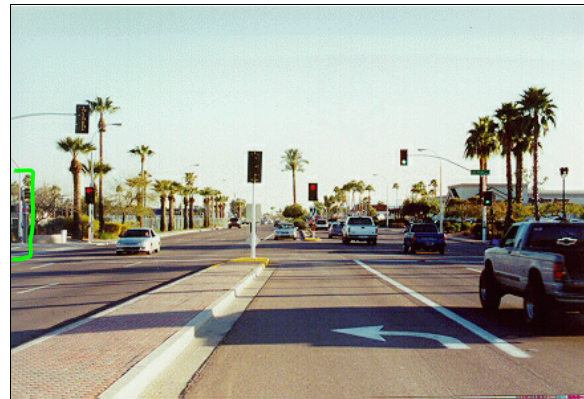
The case vehicle was stopped (**Figure 1**) at a four-leg intersection, heading south in the left-hand turn lane of a seven-lane, divided, city trafficway and was waiting for a traffic signal to change (i.e., both the north and southbound roadways had three through lanes and opposing left-hand turn lanes at the intersection). The case vehicle suddenly accelerated into the intersection while turning left. According to the case vehicle's driver, he was experiencing an on-going medical condition (i.e., diabetes) which caused him to become incapacitated, lose control, and essentially make no avoidance maneuvers prior to the crash.

Figure 1: Case vehicle's southbound travel path in left-hand turn lane prior to stopping at intersection; Note: struck signal pole (highlighted) at far left of photo (case photo #01)

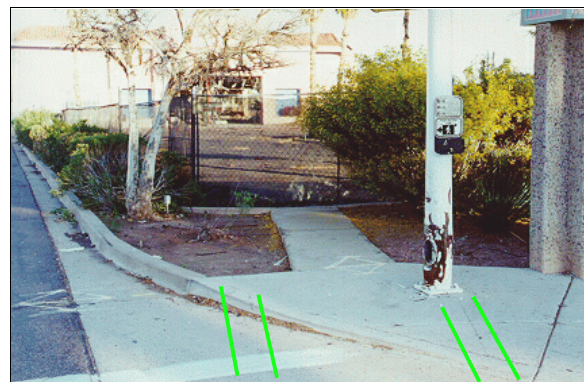
Figure 2: Case vehicle's east-southeastward travel path into southeast corner of intersection showing impacts with signal pole, small tree (torn away), and fence/fence post; Note: tire marks (highlighted) leading into signal pole (case photo #07)

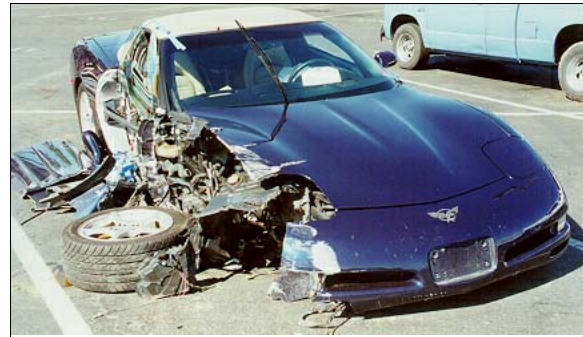
Figure 3: Deformation to case vehicle's front right showing damage extending down right side with right front tire torn off (case photo #33)

The case vehicle's initial contact with the traffic signal pole involved the front right corner (Figure 3 above). Direct damage began 57 centimeters (22.4 inches) to the right of the bumper's center and extended, a measured distance of 23 centimeters (9.1 inches) outward to the bumper's corner. Direct damage extended down the right side to the right front door hinges (Figures 4 and 5 above), a measured 169 centimeters (66.5 inches). The case vehicle's fiberglass body was disintegrated from the front right bumper rearwards to the right "A"-pillar. Because the right front wheel was torn off, it is unknown whether the case vehicle's wheelbase on the right side would have otherwise been shortened. On the other hand, the wheelbase on the left side was not shortened. The case vehicle's front bumper fascia, hood (right side), right headlight and turn signal assemblies, and right fender were directly damaged and crushed rearward. The light assemblies and fender were torn off. The right front door panel was torn away as well (Figures 3 and 4 above). The case vehicle's right front tire was damaged and the rim bent (Figure 7). The case vehicle's second impact involving the small tree also involved the front bumper. Because of the case vehicle's impact with the fence and fence post, the exact location of the tree impact could not be distinguished along the front bumper. Based on the inspection, there were scratches but no measurable deformation to the case vehicle's front bumper fascia from its impact with the fence, fence post, and/or tree.

Based on the vehicle inspection, the CDCs for the case vehicle were determined to be: **12-FREW-6 (0)** for the signal pole impact and **12-FDEW-1 (0)** for the fence/fence post impact. No reconstruction program was used on this crash because the primary impact was out-of-scope for the NASS, CDS, WinSMASH protocol and the protocol requires that actual vehicular crush measurements be obtained for the other two impacts. However, this contractor's visually estimated Delta V for the signal pole impact is between 21 km.p.h. (13 m.p.h.) and 27 km.p.h. (17 m.p.h.). The visually estimated crash severity to the case vehicle from the fence/fence post

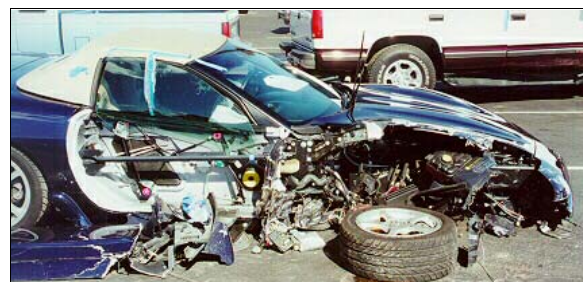
Figure 4: Case vehicle's right deformation; Note: right front door panel peeled away and right front tire assembly torn off (case photo #28)

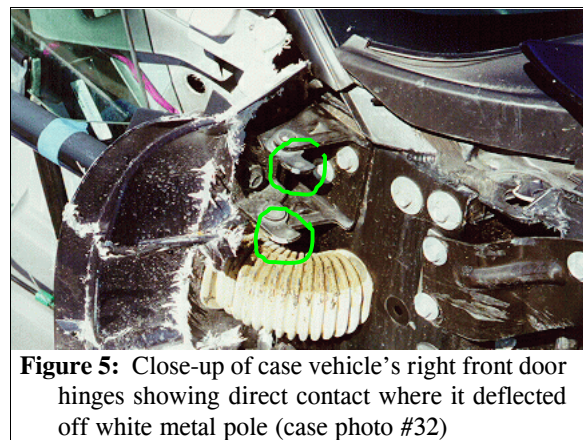
Figure 5: Close-up of case vehicle's right front door hinges showing direct contact where it deflected off white metal pole (case photo #32)

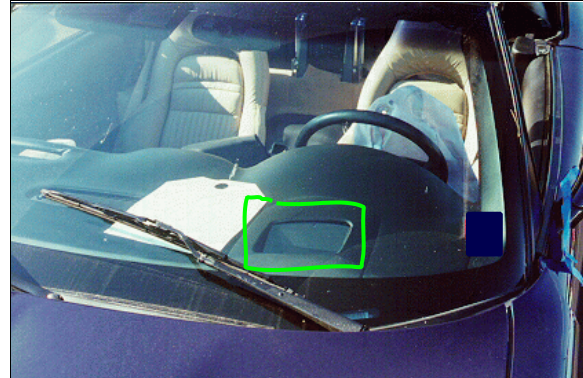
Figure 6: Case vehicle's "Heads Up Instrument Display" projector (highlighted) in dash (case photo #37)

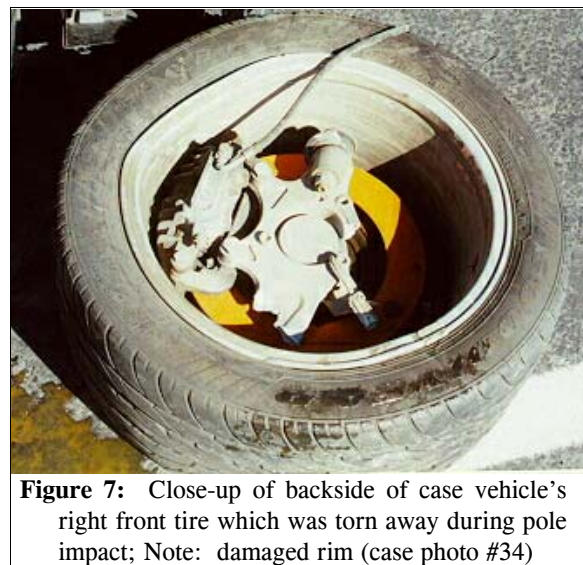
Figure 7: Close-up of backside of case vehicle's right front tire which was torn away during pole impact; Note: damaged rim (case photo #34)

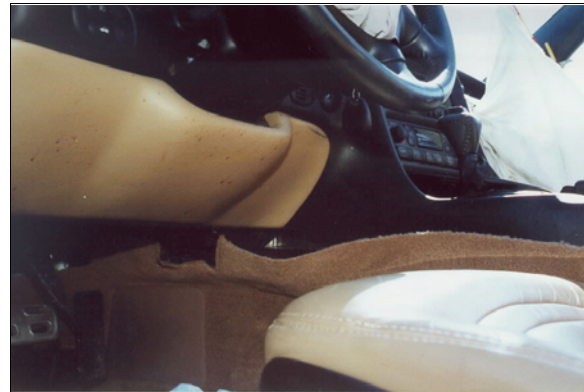
Inspection of the case vehicle's interior revealed a probable knee contact on the knee bolster (Figure 8), just to the right of the steering column and without any obvious deformation, and blood evidence along the left roof side rail. There was no visible sign of intrusion to the case vehicle.

Figure 8: Knee bolster for case vehicle's driver showing probable knee contact on right side of steering column (case photo #40)

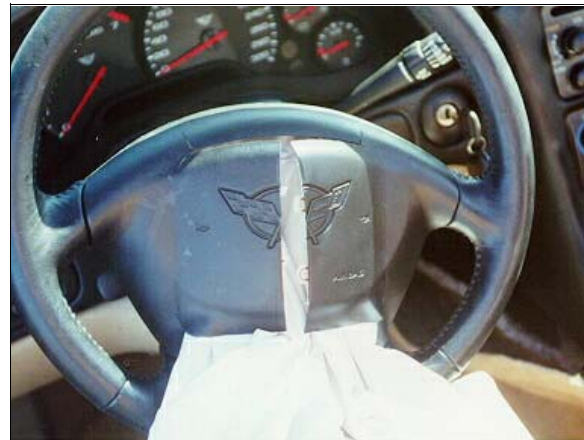
The case vehicle was equipped with a Supplemental Restraint System (SRS) that contained frontal air bags at the driver and front right passenger positions. Both air bags deployed as a result of the front right corner impact with the traffic signal pole. The case vehicle's driver air bag was located in the steering wheel hub. The module cover consisted of symmetrical "I"-configuration cover flaps made of thick vinyl with overall dimensions of 7.5 centimeters (3.0 inches) at the left and right horizontal seams and 13.5 centimeters (5.3 inches) vertically. An inspection of the air bag module's cover flaps and air bag fabric revealed that the cover flaps opened at the designated tear points, and there was no evidence of damage during the deployment to the air bag or the cover flaps (Figure 9). The driver's air bag was designed with two tethers, each 11 centimeter (4.3 inch) wide, sewn vertically to the interior of the air bag between the 11-7 and 1-5 o'clock positions. The driver's air bag had two vent ports, approximately 1 centimeter (0.4 inches) in diameter, located at the 11:30 and 12:30 clock positions. The deployed driver's air bag was round with a diameter of 63 centimeters (24.8 inches). Inspection of the driver's air bag revealed no readily apparent evidence of occupant contact (Figure 10); however, there were some black scuffs associated with air bag's interaction with the interior surface of the cover flaps.

Figure 9: Close-up of case vehicle's driver air bag module showing deployed air bag and opened cover flaps (case photo #55)

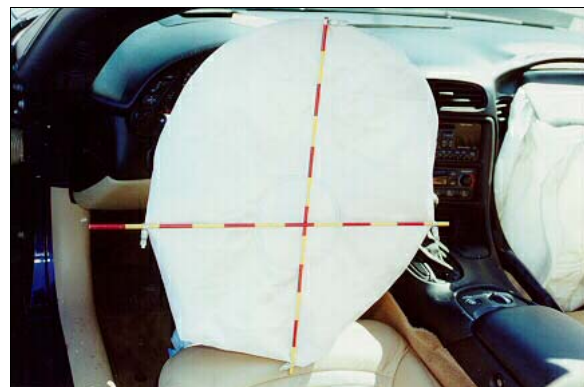
Figure 10: Case vehicle's deployed driver air bag showing no visible evidence of contact; however, black scuffs from cover flaps were present (case photo #56)

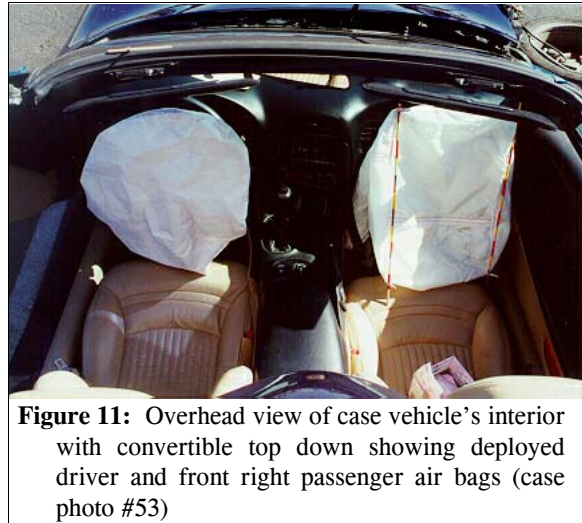
The front right passenger's air bag was located in the middle of the instrument panel. There was a single, essentially rectangular, modular cover flap. The cover flap was made of a thick vinyl over a thick cardboard type frame. The flap's dimensions were 26.5 centimeters (10.4 inches) at the lower horizontal seam and 18.5 centimeters (7.3 inches) along both vertical seams. The profile of the case vehicle's instrument panel resulted in a 1.5 centimeter (0.6 inch) setback of the leading edge of the cover flap relative to the protruding right instrument panel. An inspection of the front right air bag module's cover flap and air bag fabric revealed that the cover flap opened at the designated tear points, and there was no evidence of damage during the deployment to the air bag or the cover flap. The front right passenger's air bag was designed with one tether, 40 centimeters (15.7 inches) wide and it extended across the entire front surface of the air bag. The front right air bag had no vent ports. The deployed front right air bag was essentially square, with a height of approximately 42 centimeters (16.5 inches) and a width of approximately 40 centimeters (15.7 inches). Inspection of the front right air bag did not reveal any readily apparent contact evidence (**Figure 11**).

Figure 11: Overhead view of case vehicle's interior with convertible top down showing deployed driver and front right passenger air bags (case photo #53)

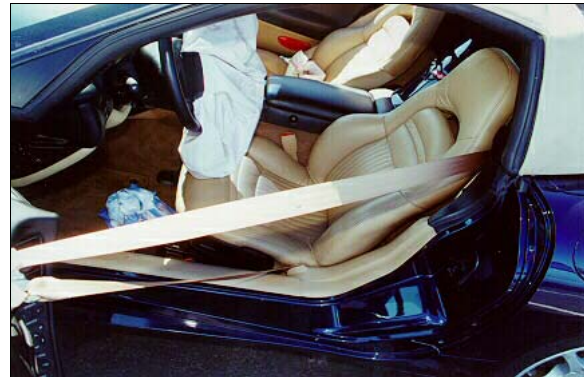
The case vehicle's driver was not using his available, active, three-point, lap-and-shoulder, safety belt system. In addition, the inspection of the driver's seat belt webbing, "D"-ring, and latch plate showed no evidence of loading (**Figure 12**).

Figure 12: Case vehicle's driver seat belt webbing showing no evidence of usage during the crash (case photo #41)

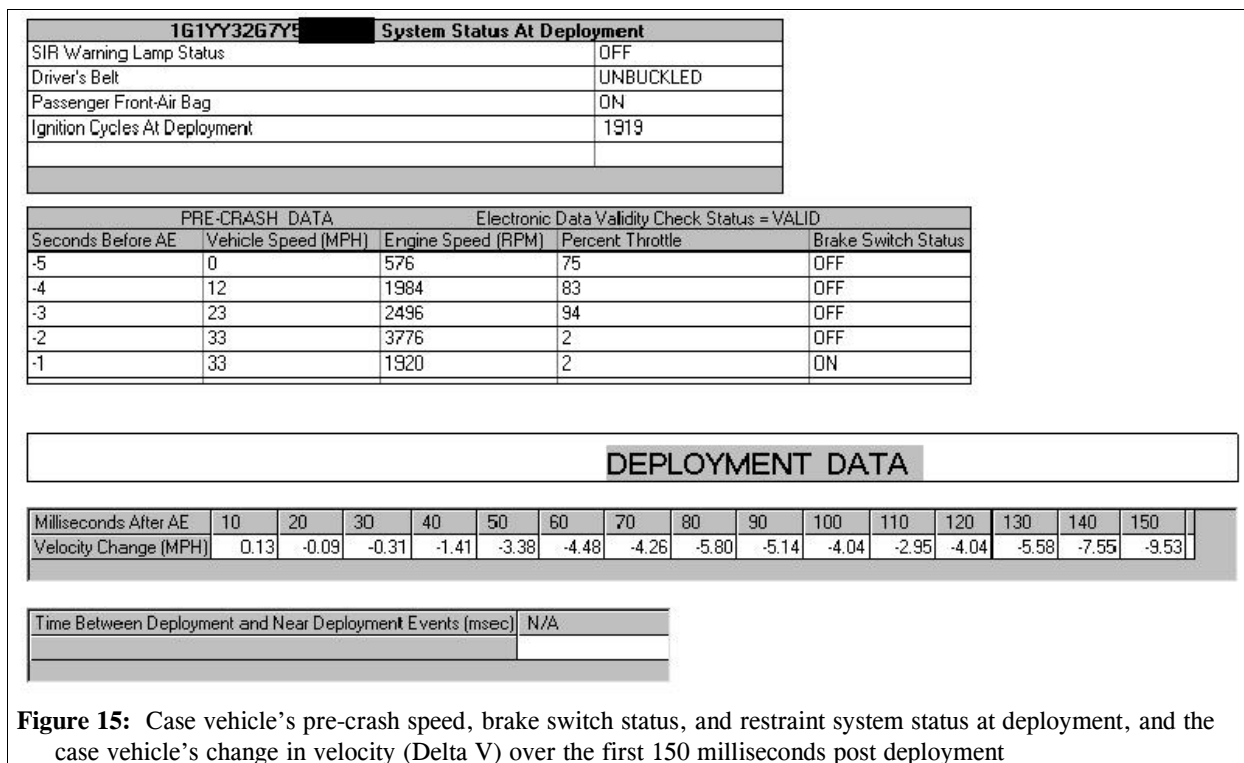
As previously mentioned the case vehicle was equipped with an Event Data Recorder (EDR). The data downloaded from the case vehicle's EDR shows the case vehicle's travel speed, engine RPM, percent throttle, and brake switch status for the 5 seconds preceding the Algorithm Enable. Other information downloaded from the EDR included the Delta V, SIR warning lamp status, driver's seat belt buckle status, and the case vehicle's ignition cycle at deployment. Downloaded data of interest indicated the following: the case vehicle's driver accelerated from 0 to 53 km.p.h. (0-33 m.p.h.) during the 5-seconds preceding the crash; the driver's belt status was "**unbuckled**" (which corroborates this investigator's conclusion following the interior inspection); and the Delta V was only 15.3 km.p.h. (9.53 m.p.h.); see **EVENT DATA RECORDER GRAPHS (Figures 15 through 17)** below. This investigator believes that the recorded Delta V seems low considering the right front wheel assembly was torn away from case vehicle's frame.

Figure 15: Case vehicle’s pre-crash speed, brake switch status, and restraint system status at deployment, and the case vehicle’s change in velocity (Delta V) over the first 150 milliseconds post deployment

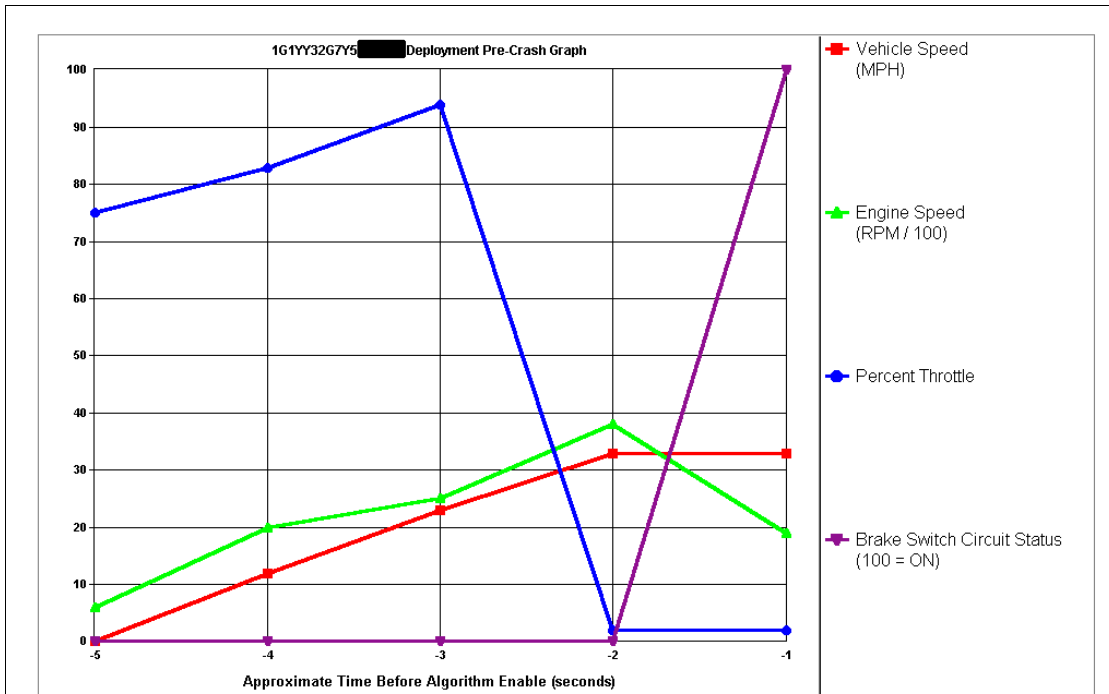
Figure 16: Just prior to the crash the case vehicle had accelerated rapidly to approximately 53 km.p.h. (33 m.p.h.) when the brake was activated one second prior to deployment

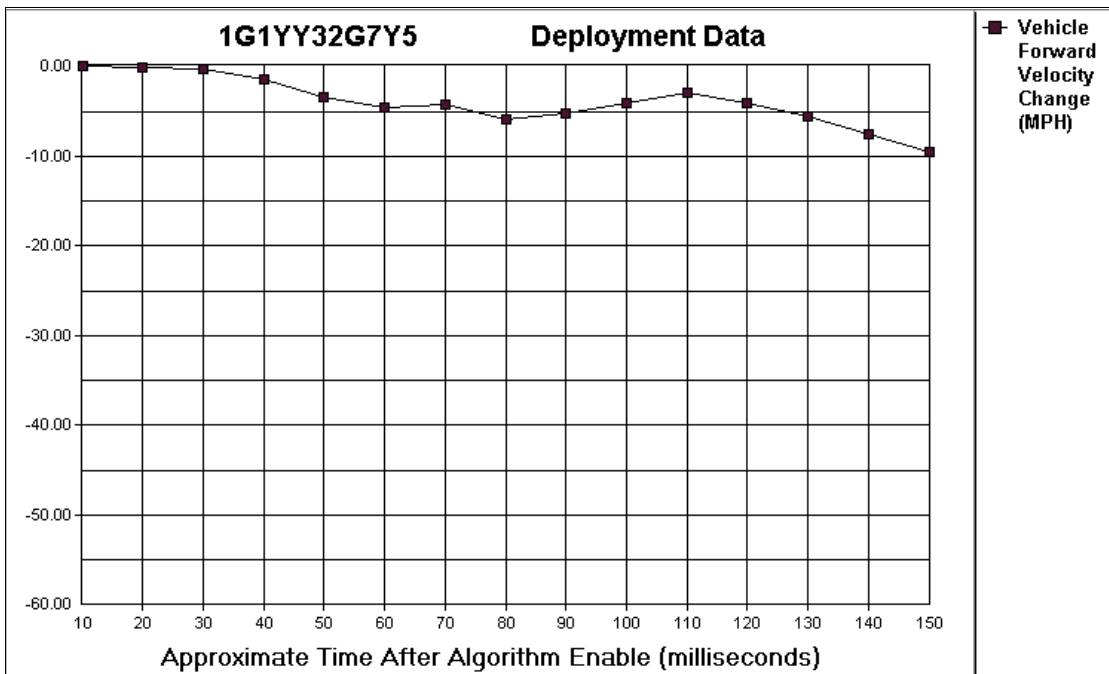
Figure 17: The case vehicle sustained a velocity change of approximately 9.5 km.p.h. (5.9 m.p.h.) during the first 150 milliseconds after deployment
