ON-SITE AIR BAG INVESTIGATION

CASE NUMBER - IN01-010
LOCATION - Illinois
VEHICLE - 1996 PLYMOUTH VOYAGER
CRASH DATE - April 2001

1. Report No. IN01-010		2. Government Accession No.		3. Recipient's Catalog No.	
4. Title and Subtitle On-Site Air Bag Fatality Investigation Vehicle - 1996 Plymouth Voyager Location - Illinois			5. Report Date: July 1, 2002

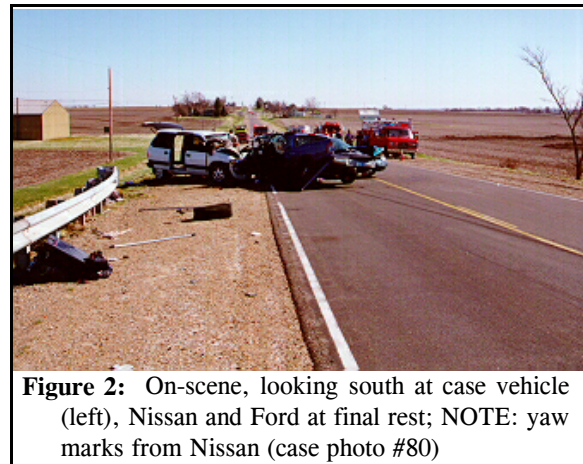
The southbound Nissan pickup was traversing the overpass, having just crested the rise and beginning the downhill slope. The northbound Oldsmobile was just beginning to travel up the slope when the Nissan came over the centerline. The police investigators speculated that the gusting wind may have caused a problem for the Nissan's driver, but there was insufficient evidence to support a definitive conclusion as to whether the wind gusts were strong enough to push the Nissan sideways. The front left corner and left side of the Nissan impacted the left side of the Oldsmobile (event #1) in a shallow, swiping-type engagement, with the Nissan's front left corner snagging and tearing off the Oldsmobile's left rear wheel and tire. The Oldsmobile rotated counterclockwise approximately 180 degrees and came to rest 36.4 meters [120 feet] north of the point of impact, on the east gravel shoulder heading south. The sideswipe caused the Nissan to go into a slight counterclockwise yaw while continuing to travel south in the northbound lane, where it impacted the case vehicle approximately 27 meters [90 feet] south of the first impact (event #2). The case vehicle and the Nissan both were rotating counterclockwise when the front of the Ford struck the right rear side of the Nissan (event #3) (**Figures 1 and 2**).

Figure 2: On-scene, looking south at case vehicle (left), Nissan and Ford at final rest; NOTE: yaw marks from Nissan (case photo #80)

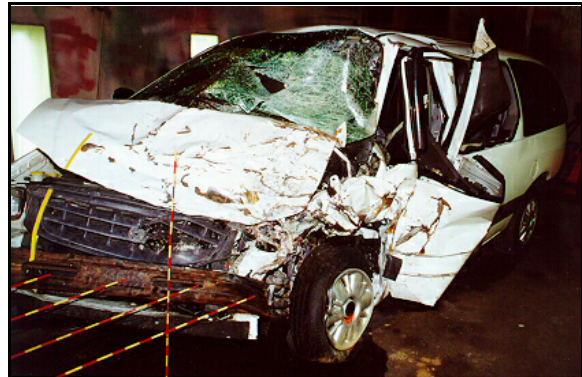
The case vehicle sustained direct contact damage across the left three-quarters of its front, measured as 120 centimeters [47.2 inches], with induced damage across the entire front (**Figure 3**). Maximum crush was 133 centimeters [52.4 inches] on the engine hood, with 118 centimeters [46.5 inches] crush at the front left bumper corner (**Figure 4**). The front left bumper, the left part of the grille, the headlamp assembly and the left fender were displaced rearward, the left front wheel/tire assembly was pushed against the left A-pillar and the lower left A-pillar was displaced rearward such that the A-pillar was vertical (instead of sloping toward the front of the vehicle), causing upward buckling of the left windshield header, the left side rail and the roof (**Figure 9**). The engine hood was crushed and pushed rearward and contacted the upper left A-pillar and the left half of the windshield, fracturing the windshield and causing a large hole near the lower center. The glazing in the left first and second windows was disintegrated. The driver's door was compressed and buckled outward as the left A-pillar was pushed rearward, but remained latched. The wheelbase was shortened 64 centimeters [25.2 inches] on the left and lengthened 13 centimeters [5.1 inches] on the right.

Figure 3: Case vehicle's front and left side damage (case photo #18)

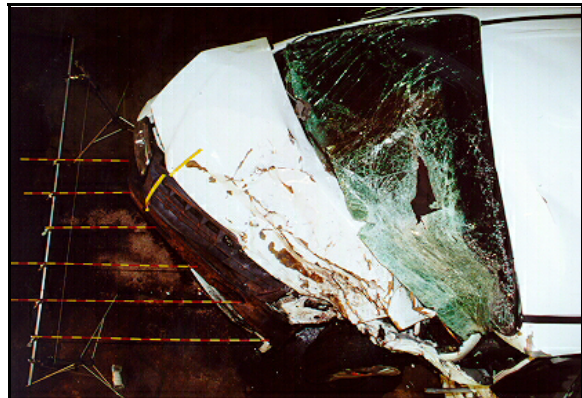
Figure 4: Overhead view of case vehicle's front end deformation (case photo #14)

The CDC for the case vehicle's single impact (event #2) was determined to be: **11-FDEW-6 (340)**. The WinSMASH reconstruction program, damage only algorithm based on the measured crush profile of both vehicles, was used on the case vehicle's highest severity impact. The Total, Longitudinal, and Lateral Delta Vs are, respectively: 52 km.p.h. [32.3 m.p.h.], -49 km.p.h. [-30.4 m.p.h.], and +18 km.p.h. [+11.1 m.p.h.]. The Barrier Equivalent Speed (BES) was 63 km.p.h. [39.1 m.p.h.]. These results appear reasonable.

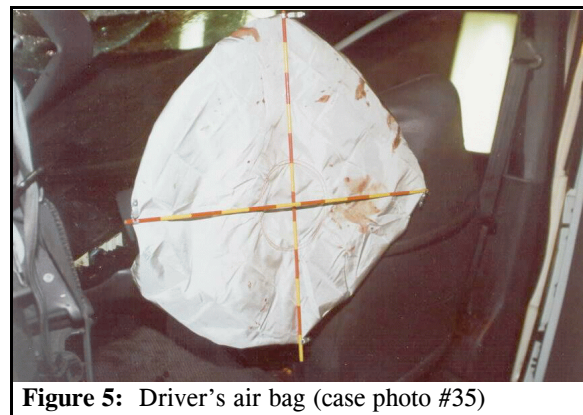
The case vehicle was equipped with driver and front right passenger front air bags. The driver's air bag was in the steering wheel hub, with the module's cover flaps in the H-configuration. The flaps opened at the seams and there was no damage apparent on the air bag or cover flaps. The deployed air bag was round, with a diameter of 62 centimeters [24.4 inches], and had two tether straps each 7 centimeters wide located at the 11-1 and 7-5 o'clock positions, and no vent ports (**Figure 5**). The module cover flaps were 17 centimeters [6.7 inches] horizontally, with the top flap 3 centimeters [1.2 inches] and the bottom flap 8 centimeters [3.1 inches] vertically. The front of the driver's air bag had a scrub of skin near the center, with blood droplets and smears on the front.

Figure 5: Driver's air bag (case photo #35)

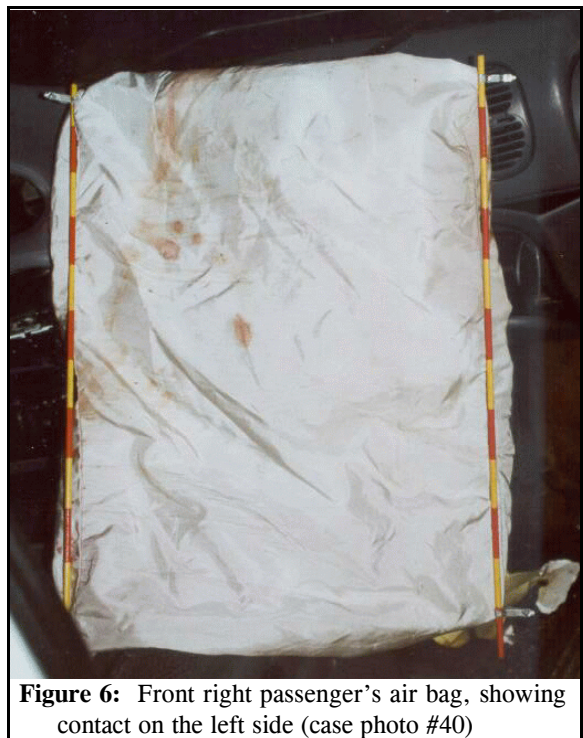
The front right passenger's air bag was located in the front of the instrument panel, with the module's cover flaps in the H-configuration. The flaps were composed of a thin fiberboard material covered with a vinyl-like skin. The flaps measured 28 centimeters [11.0 inches] horizontally, with the upper flap 7 centimeters [2.8 inches] and the lower flap 5 centimeters [2.0 inches] vertically. The flaps opened at the seams and there was no damage apparent on the lower flap. The upper flap, however, was torn from the middle of the center seam upward to the hinge, dividing the flap into two pieces (**Figure 7**). The left half of the upper flap showed skin abrasions.

Figure 6: Front right passenger's air bag, showing contact on the left side (case photo #40)

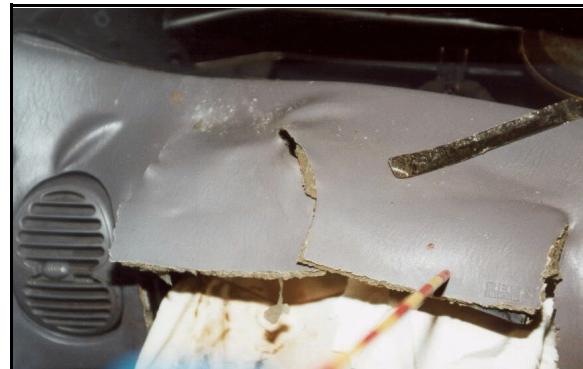
It seems apparent that the left half of the upper cover flap caught the front right passenger under the chin, causing the flap to tear as the unobstructed right half was forced open by the expanding air bag. The front surface of the deployed air bag measured 47 centimeters [18.5 inches] horizontally and 57 centimeters [22.4 inches] vertically and was designed with no tether straps or vent ports. The air bag fabric had skin abrasions and blood smears on the left edge of the front, extending onto the top, and showed pinkish cloth transfers on the bottom (the front right passenger was wearing a red tee shirt) (Figure 6).

Figure 7: Front right passenger air bag module's torn upper cover flap (case photo #37)

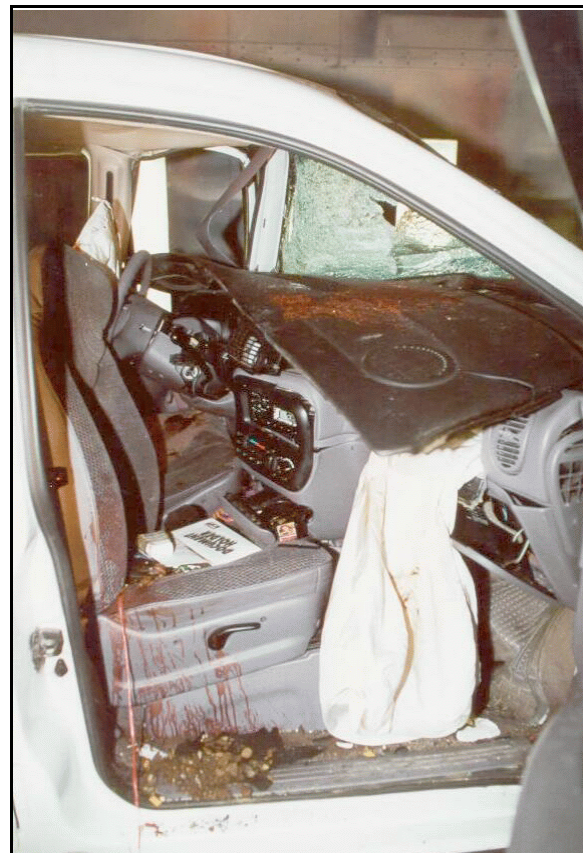
Immediately prior to the crash the case vehicle's front right passenger was seated in a slightly reclined posture with his back against the seat back, both his feet hanging down above the floor, however, the exact position of his hands is unknown. The seat was a box-mounted van-type bucket seat, with the seat track located between the middle and rearmost positions, and the seat back was upright (Figure 8).

Figure 8: Front right passenger's seat area; NOTE, top surface of instrument panel entirely loose, blood on the top of the instrument panel shows final rest of decapitated head, blood on the seat shows final rest of torso (case photo #30)

belts, the front right passenger moved forward and leftward, putting him directly in front of the front right air bag module just prior to impact. The force of the case vehicle’s impact with the Nissan caused his torso and abdomen to be pressed against the right instrument panel and glove box door as the case vehicle decelerated. Based on the contact evidence on the front right passenger’s air bag module the cover flap (**Figure 7**), the deploying cover flap caught him under his chin, lifting his head and tearing his neck open with the air bag expanding and subsequently completing the decapitation. As the case vehicle rotated counterclockwise, his body moved to the right and the air bag propelled him rearward, into the seat back. At final rest, his body was found between the front right seat and the front right door. His head came to rest between the windshield and the plastic instrument panel, which buckled upwards from the impact (**Figure 8**).

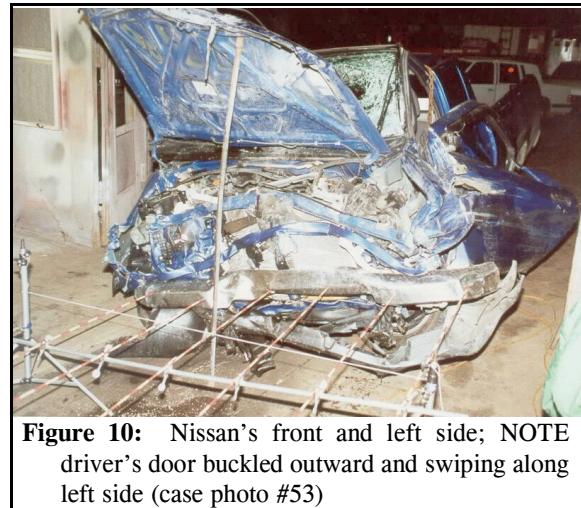
The Nissan was involved in all four of the crash events. The CDC for its most severe impact (with the case vehicle) is **01-FDEW-3 (030)** (event #2). Maximum crush was measured as 73 centimeters [28.7 inches] at the front left corner, but this includes overlapping damage from the first event (**Figure 10**). The WinSMASH reconstruction program, damage only algorithm based on the measured crush profile of both vehicles, was used on the Nissan's highest severity impact. The Total, Longitudinal, and Lateral Delta Vs are, respectively: 63 km.p.h. [39.1 m.p.h.], -55 km.p.h. [-34.2 m.p.h.], and -32 km.p.h. [-19.9 m.p.h.]. Because of the overlapping damage, this should be regarded as a borderline reconstruction, but the results appear reasonable.

Figure 10: Nissan's front and left side; NOTE driver's door buckled outward and swiping along left side (case photo #53)

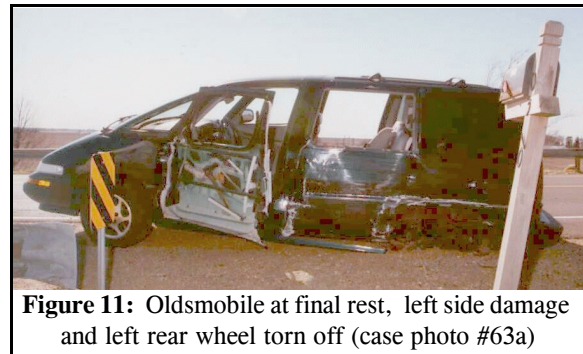
The Oldsmobile was involved in the first event only and did not make contact with the case vehicle. The CDC was determined to be: **12-LDEW-1 (350)**. This was a swiping-type impact, but included snagging and tearing off the left rear wheel and tire assembly (**Figure 11**). This contractor estimates that this was an impact of moderate severity (9 - 16 km.p.h. [15 - 25 m.p.h.]) for the Oldsmobile.

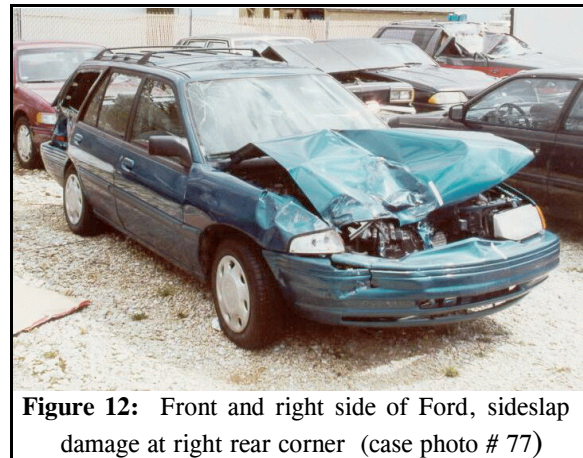
The Ford was involved in two impacts with the Nissan (events 3 and 4) and did not make contact with the case vehicle. The CDCs were determined to be: **01-FDEW-1 (020)** and **03-RBEW-2 (090)**. Because the Ford’s impacts did not

involve the case vehicle, the WinSMASH reconstruction program was not used. The Ford's frontal impact is estimated as low severity (14 - 23 km.p.h. [9 - 14 m.p.h.]) and the sideslap as minor severity (1 - 13 km.p.h. [1 - 8 m.p.h.]).
