On-scene Investigation / Vehicle versus Power Pole
Dynamic Science, Inc. / Case Number: DS01-011
2001 Toyota Prius Hybrid
California
March, 2001

1. Report No. DS01-011		2. Government Accession No.		3. Recipient Catalog No.	
4. Title and Subtitle In-Depth Accident Investigation				5. Report Date	
				6. Performing Organization Report No.

Dynamic Science, Inc.
Accident Investigation
Case Number:DS01-011

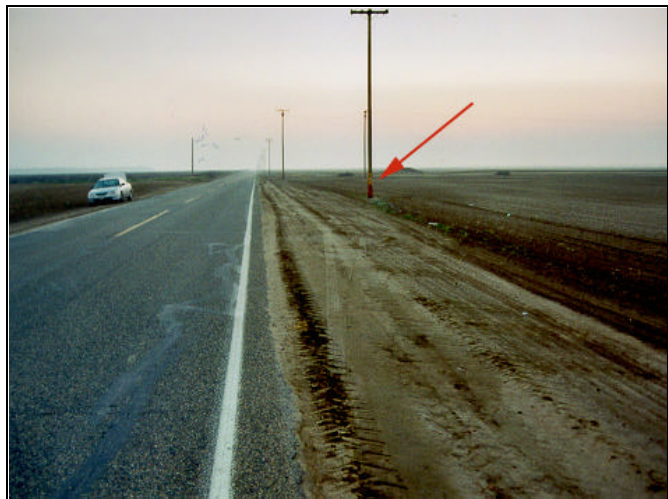
Figure 1. Approach to impact with pole-east.

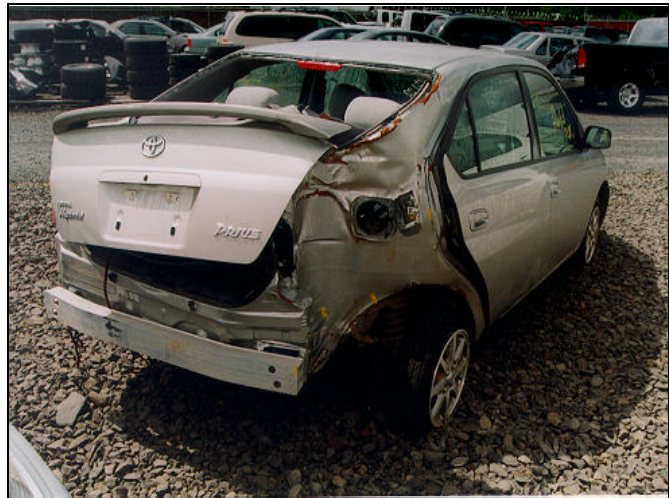
The case vehicle was assigned a Collision Deformation Classification (CDC) of 03RBEN3 with a Principle Direction of Force (PDOF) of 090 degrees. The combined direct and induced damage width was 80.0 cm (31.5 in.) [CRASH L = 80.0 cm (31.5 in.)], and the maximum crush depth was 48.5 cm (19.1 in.) located at C₄. The Delta V for the case vehicle was computed using WinSmash version 2.12 and the pole option with size and stiffness coefficients derived from the case vehicle's wheelbase. WinSmash calculated a total delta v of 29.0 km/h (18.0 mph), a longitudinal

Figure 2. Damage to case vehicle.

Damage Description: Severe lateral crush to the right rear fender beginning just forward of the right rear axle and extends rearward to the right rear bumper corner. Both rear door jammed shut. Rear left door forced open by investigator. Minor longitudinal intrusion of the 2nd seat back.

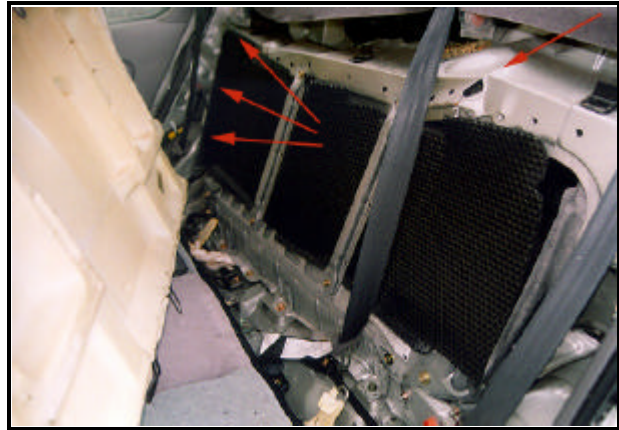
1. There were no indications of electrolyte spillage from the propulsion battery.
2. There was no movement or damage of the battery pack. The frame directly in front of the traction battery—behind 2nd seat back was damaged.
3. The electrical isolation test was partially conducted. There is a circuit near the power cable that prevents access to power unless the ignition switch is in the “ON” position and the vehicle is running. In this case, internal 12v power was available and the engine did crank over but would not start. The net result was that there was no propulsion battery voltage external of the battery system. There were no indications of any arcing, fire, or component meltdown.

Figure 5. Damage to frame directly in front of traction battery.

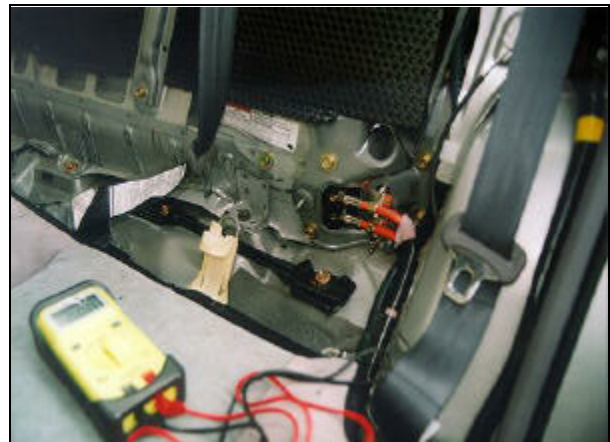
Figure 6. Traction battery voltage.

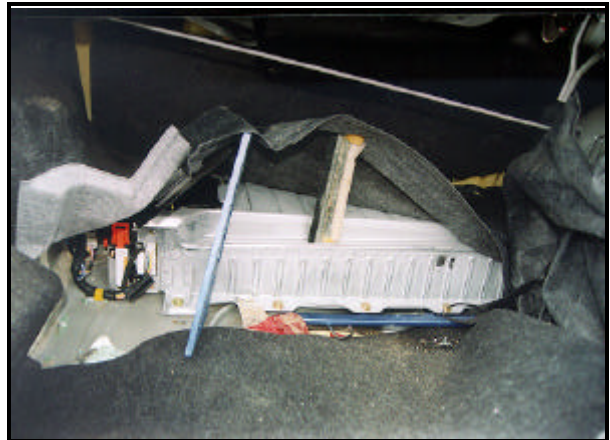
Figure 7. Battery pack in trunk—no spillage.

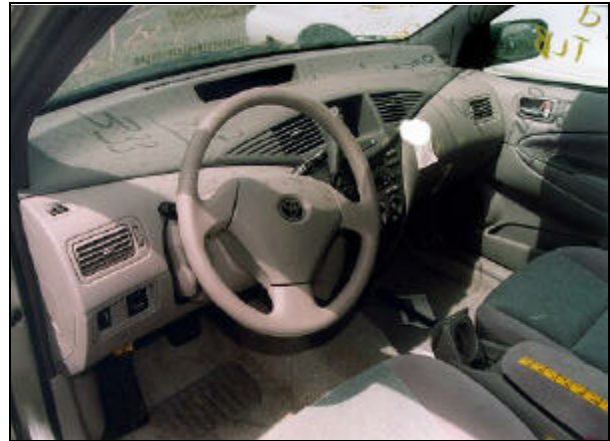
Figure 8. Driver's air bag.

In this crash, the driver was wearing the lap and shoulder belt. At impact, the pretensioner for the driver's belt did not fire and neither of the frontal air bags deployed.

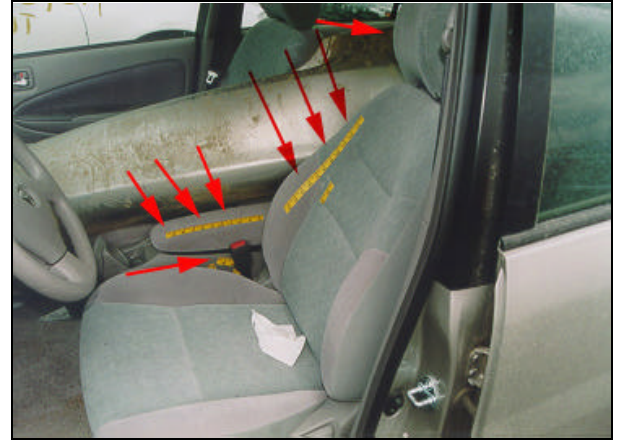
On impact with the power pole, the restrained driver responded to the 03 o'clock direction of force by moving to the left. The driver loaded the seat belt—causing the abdominal pain. Her lateral movement to the right also deformed the seat back. Flying glass from the disintegrated backlight contacted her hands and probably caused a laceration to her right hand and as she unbuckled the seat belt, blood was deposited on the center console area.

Figure 9. Driver's seat—deformed seat back and blood deposited on center console.
