On-scene Investigation / Vehicle to Vehicle  
Dynamic Science, Inc. / Case Number: DS01-012  
2001 Toyota Prius  
California  
March, 2001

**Dynamic Science, Inc.**  
**Accident Investigation**  
**Case Number:DS01-012**

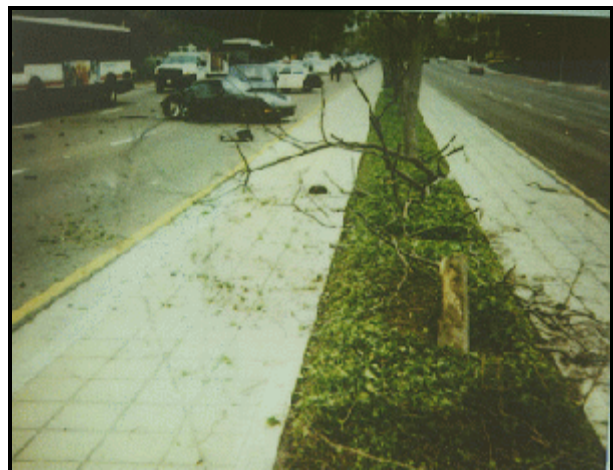
**Figure 1.** Struck tree in foreground, final rest for Porsche in background.

The driver of the Porsche lost control of his vehicle after hitting a patch of water in the roadway. The vehicle veered to the left, over-rode the center median and struck a narrow tree with its left side. The Porsche continued on and entered the westbound roadway. The rear of the Porsche struck the left front of the case vehicle (11FLEE9). The case vehicle sustained a longitudinal delta v of -10.9 km/h (-6.8 mph) and a lateral delta v of 6.3 km/h (3.9 mph)<sup>1</sup>. The forces were sufficient to deploy both frontal air bags and to fire the driver's seat belt pretensioner.

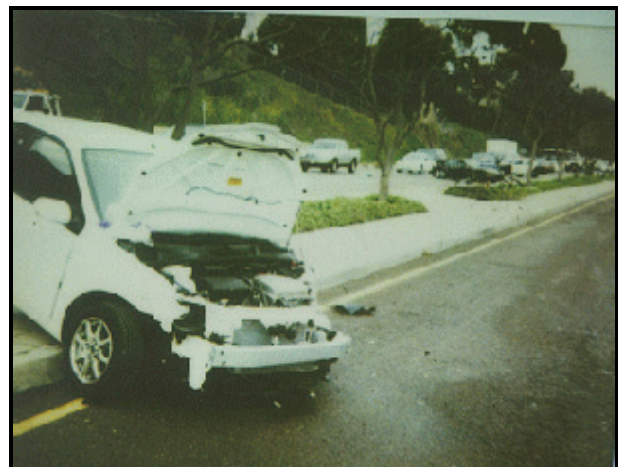
**Figure 2.** Final rest, case vehicle.

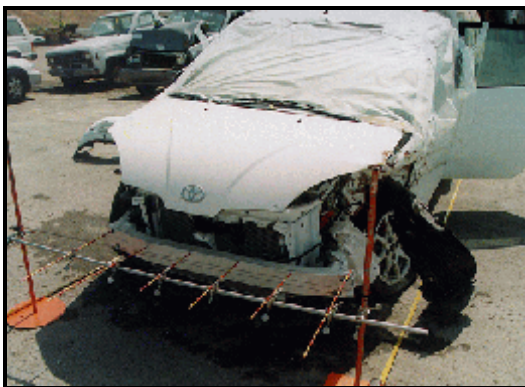
Description:	2001 Toyota Prius four-door hybrid electric	
VIN:	JT2BK12U0100xxxxxx	
Odometer:	Unknown	
Engine:	Engine: 1.5 L 4 cylinder gasoline Traction battery: Nickel hydride metal	
Reported Defects:	None	
Cargo:	None	
Damage Description:	Moderate crush to left side beginning at left front corner and extending to driver's door. Driver's door jammed shut. Moderate crush to right side beginning at front corner and extending along most of the fender. Vehicle declared a total loss by insurance company.	
CDC:	Impact 1 (Porsche): 11FLEE9 Impact 2 (Volkswagen): 01FREE6	
Delta V (Impact 1):	Total	12.6 km/h (7.9 mph)
	Longitudinal	-10.9 km/h (-6.8 mph)
	Latitudinal	6.3 km/h (3.9 mph)
	Energy	14,152 joules (10,438 ft-lbs)

**Figure 4.** Front left, showing first impact.

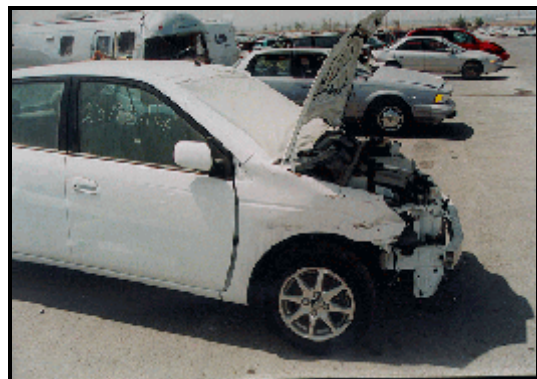
The case vehicle was pushed to the right and struck the left side of the Volkswagen (01FREE6). The Porsche continued eastbound and contacted the third other vehicle—the Volkswagen Cabriolet. The Volkswagen was diverted to the right, rotated counterclockwise, and struck a curb with its right rear tire.

**Figure 5.** Right side, case vehicle, showing second impact.

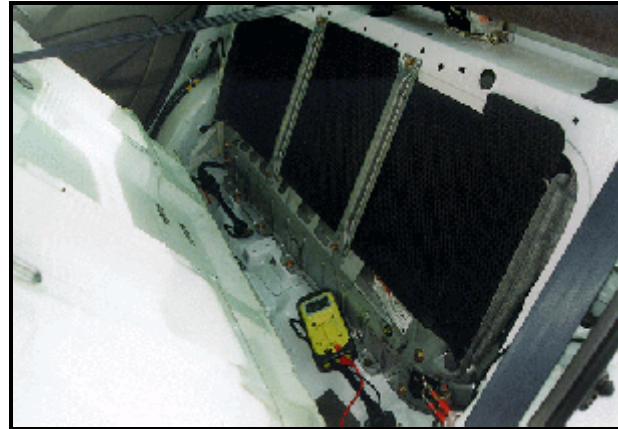
1. There were no indications of electrolyte spillage from the propulsion battery.
2. There was no movement of the battery module.
3. The electrical isolation test was partially conducted. There is a circuit near the power cable that prevents access to power unless the ignition switch is in the “ON” position and the vehicle is running. In this case, the initial impact had gone through the left hand fuse block and there was no internal 12v power available. There was also no key available. The net result was that there was no propulsion battery voltage external of the battery system. There were no indications of any arcing, fire, or component meltdown.

**Figure 6.** Front side of traction battery

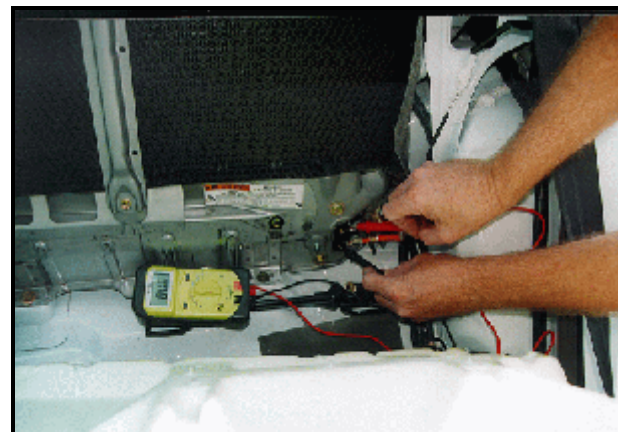
**Figure 8.** Traction battery voltage

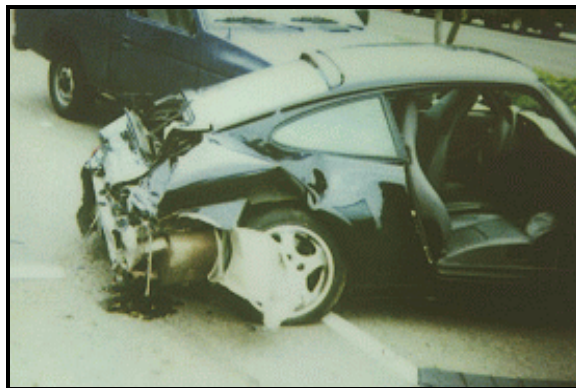
Description:	1996 Porsche 911	
VIN:	Unknown	
Odometer:	Unknown	
Engine:	Unknown	
Reported Defects:	None noted	
Cargo:	Unknown	
Damage Description:	Moderate lateral crush along entire rear bumper. Moderate lateral crush to left side, primarily the driver's door. According to interviewee, vehicle was declared a total loss.	
CDC:	Impact 1 (tree): 09LFEN1 Impact 2 (Prius): 07BDEW1 Impact 4 (Nissan): 09LPEW1	
Delta V (Impact 2):	Total	12.5 km/h (7.8 mph)
	Longitudinal	8.9 km/h (5.5 mph)
	Latitudinal	8.9 km/h (5.5 mph)
	Energy	19,081 joules (14,073 ft-lbs)

**Figure 9.** Exterior, rear and right side.

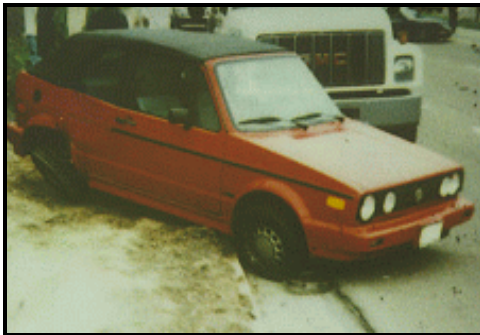
Description:	Unknown year Volkswagen Cabriolet	
VIN:	Unknown	
Odometer:	Unknown	
Engine:	Unknown	
Reported Defects:	None noted	
Cargo:	Unknown	
Damage Description:	Light contact damage to left side. Right rear wheel pushed inward due to contact with the curb.	
CDC:	Impact 3 (Prius): 07LPEW1 Impact 5 (curb): 02RPWN1	
Delta V:	Total	Unknown
	Longitudinal	Unknown
	Latitudinal	Unknown
	Energy	Unknown

**Figure 11.** Exterior, right side.

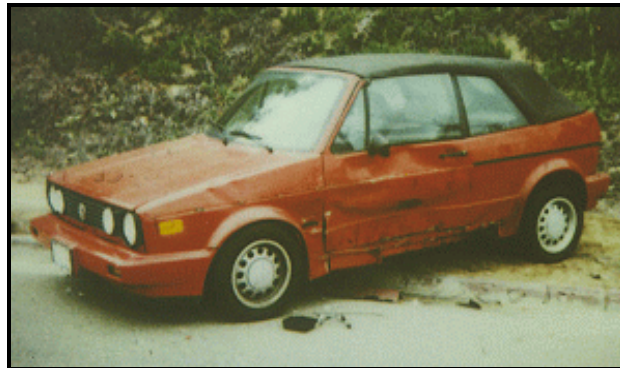
**Figure 10.** Exterior, left side.

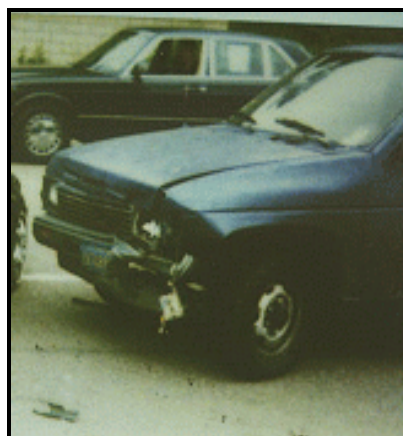
Description:	1986 Nissan pickup	
VIN:	Unknown	
Odometer:	Unknown	
Engine:	Unknown	
Reported Defects:	None noted	
Cargo:	Unknown	
Damage Description:	Moderate frontal contact to bumper and grille. Towed from the scene.	
CDC:	Impact 4 (Porsche): 12FDEW1	
Delta V:	Total	Unknown
	Longitudinal	Unknown
	Latitudinal	Unknown
	Energy	Unknown

Figure 12. Exterior, front left.

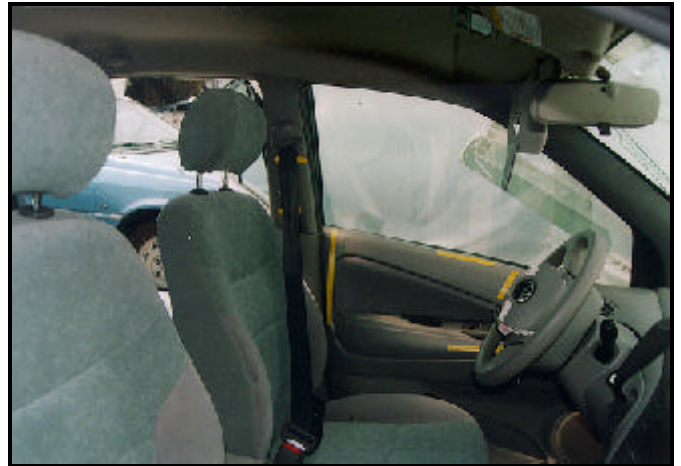
**Figure 13.** Driver's seated area

At the first impact, the restrained driver responded to the 11 o'clock direction of force by moving forward and to the left. The seat belt pretensioner fired. The driver engaged the deployed air bag with his face—causing the neck strain. His right knee contacted the lower instrument panel—causing a small contusion. At the second impact, he responded to the 1 o'clock direction of force by moving forward and to the right.

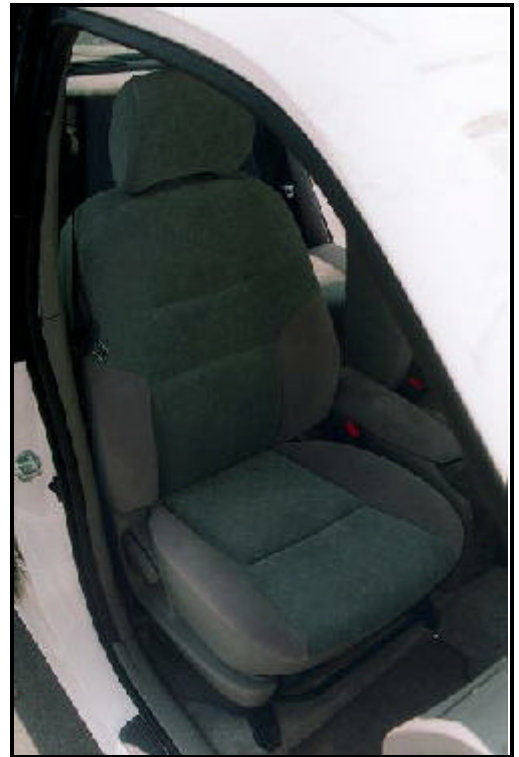
At the first impact, the unrestrained front right occupant responded to the 11 o'clock direction of force by moving forward and to the left. Her left side contacted the center console, causing the left hip abrasion and possibly the rib fracture on the left side. At the second impact, she responded to the 1 o'clock direction of force by moving forward and to right. Her right side contacted the door and right side glass, causing the head contusion and right hip abrasion. As she moved forward, both knees struck the instrument panel, causing the abrasion to the left knee and the contusion to the right knee.

**Figure 14.** Front right passenger seating area
