ON-SITE AIR BAG INVESTIGATION

CASE NUMBER - IN01-018
LOCATION - NEBRASKA
VEHICLE - 1997 OLDSMOBILE SILHOUETTE
CRASH DATE - June, 2001

1. <i>Report No.</i> IN01-018		2. <i>Government Accession No.</i>		3. <i>Recipient's Catalog No.</i>	
4. <i>Title and Subtitle</i> On-Site Child Safety Seat Investigation Vehicle - 1997 Oldsmobile Silhouette Location - Nebraska			5. <i>Report Date:</i> September 25, 2002

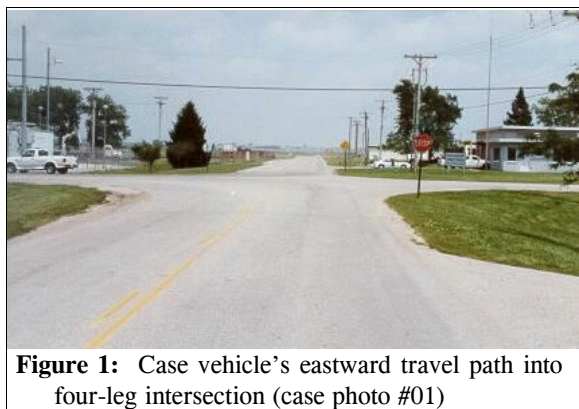
Figure 1: Case vehicle's eastward travel path into four-leg intersection (case photo #01)

The case vehicle was traveling east in the eastbound lane of a two-lane, undivided, city street (**Figure 1**) and was approaching a partially controlled four-leg intersection, intending to continue traveling eastbound (i.e., only the east and west legs of the intersection were controlled by regulatory **STOP** signs). The Buick was traveling north in the northbound through lane of a three-lane, undivided, city street (**Figure 2**) and was approaching the same partially controlled intersection, intending to continue traveling northbound (i.e., there was one through lane in both the north and southbound directions and one opposing left-hand turn lane on both the north and south legs of the intersection). Upon entering the intersection, the case vehicle's driver observed the Buick and accelerated, in an attempt to avoid the crash. The Buick's driver braked, attempting to avoid the crash (**Figure 2**). The Buick deposited 11.0 meters (36.2 feet) of left side skid marks and 14.9 meters (49.0 feet) of right side skid marks. The crash occurred in the four-leg intersection of the two roadways; see **CRASH DIAGRAM** below.

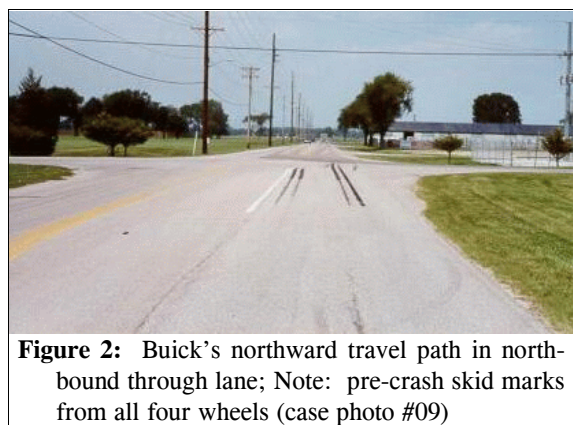
Figure 2: Buick's northward travel path in northbound through lane; Note: pre-crash skid marks from all four wheels (case photo #09)

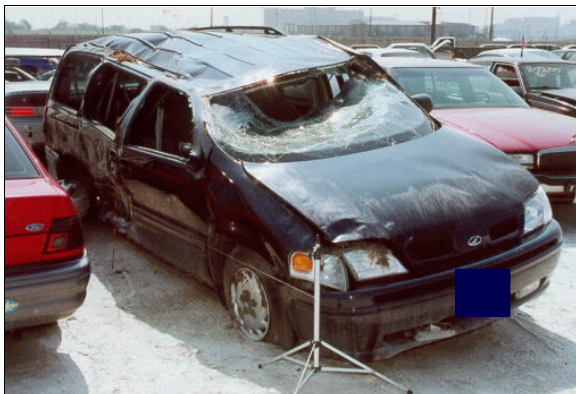
Figure 3: Case vehicle viewed from front right showing rollover and right side impact damage; Note: holed windshield (case photo #29)

The right side (**Figures 3 and 4**) of the case vehicle, from approximately the "B"-pillar back, was impacted by the front of the Buick (**Figure 5**).

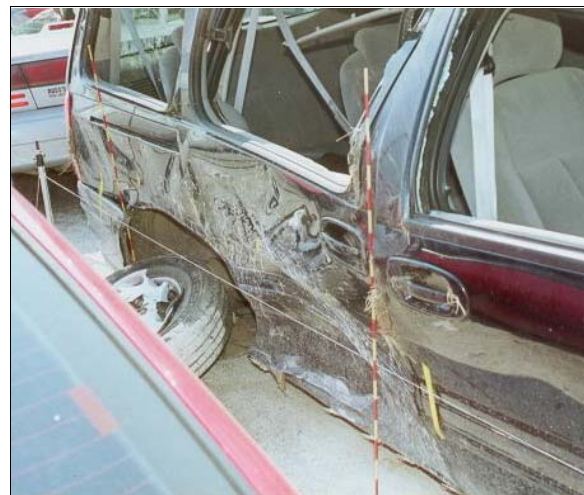
Figure 4 Close-up of case vehicle's right side damage from impact with Buick; Note: broken off right rear tire on ground (case photo #27)

The right side impact knocked off the case vehicle's right rear wheel and disintegrated the glazing from the two rearmost windows (**Figure 4** above). As a result, the case vehicle rotated approximately 45 degrees clockwise and was heading southeast, while its center of gravity traveled in an east-northeasterly direction (**Figure 6** above). The case vehicle traveled an additional 25.1 meters (82.5 feet) prior to centrifugal forces causing the case vehicle to roll over two quarter turns toward the driver's side. The rollover occurred just prior to departing the north edge of the east-west roadway (**Figure 7**). The case vehicle slid, first, on its right roof rail and, second, on its upper right side for approximately 10 meters (32.8 feet) prior to turning another quarter turn onto its right side, for less than 1 meter (3.3 feet), prior to flipping another quarter turn back onto all four wheels. As the case vehicle was rolling over, it also continued to rotate clockwise as it traversed the grassy roadside. The case vehicle's supplemental restraints (air bags) did not deploy as a result of the either the right side impact or the subsequent rollover event.

The case vehicle's contact with the Buick involved the back two-thirds of the right side with the direct and induced damage beginning just forward of the right "B"-pillar (**Figure 4** above). Direct damage began 148 centimeters (58.3 inches) rearward from the right front axle and extended rearward, a measured distance of 203 centimeters (79.9 inches). Residual maximum crush was measured as 15 centimeters (5.9 inches) at C₅. The wheelbase on the case vehicle's left side was shortened 1 centimeter (0.4 inches) while the right side was extended 2 centimeters (0.8 inches). The case vehicle's right front and rear doors and right quarter panel were directly damaged and crushed inward from the initial impact. In addition, the case vehicle's right rear tire was torn off and deflated during the impact with the Buick (**Figure 4** above).

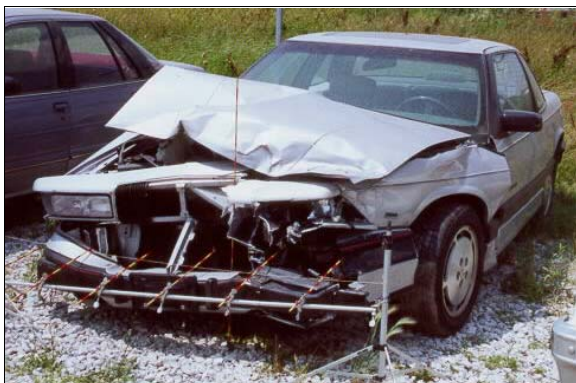
Figure 5: Frontal damage to Buick from impacting case vehicle's right side (case photo #57)

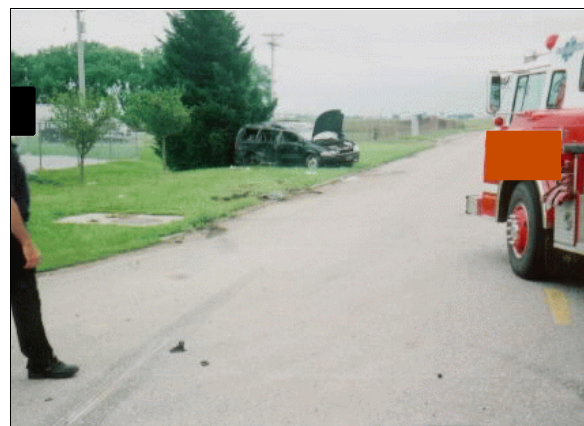
Figure 6: On-scene east-northeasterly view showing case vehicle's tire marks leading to rollover and final rest positions (case photo #66)

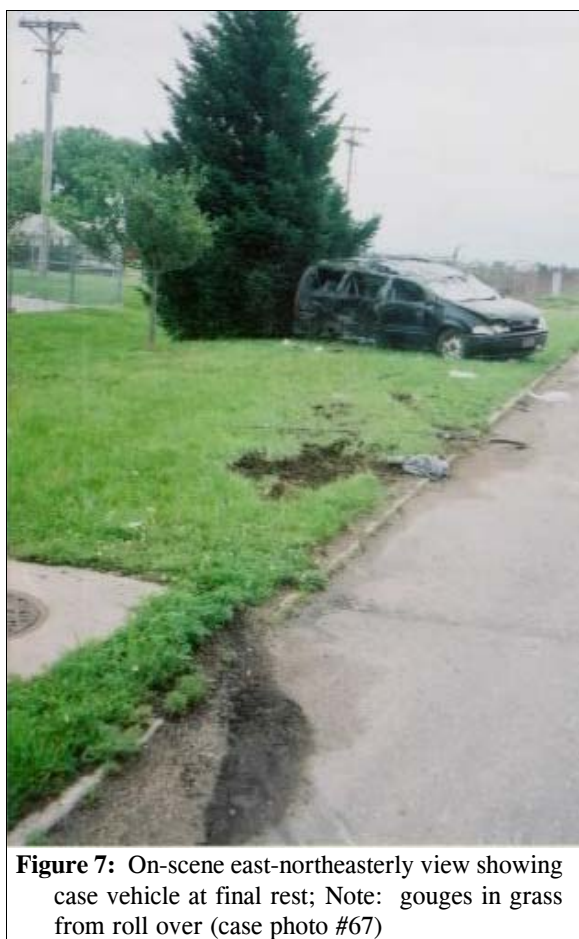
Figure 7: On-scene east-northeasterly view showing case vehicle at final rest; Note: gouges in grass from roll over (case photo #67)

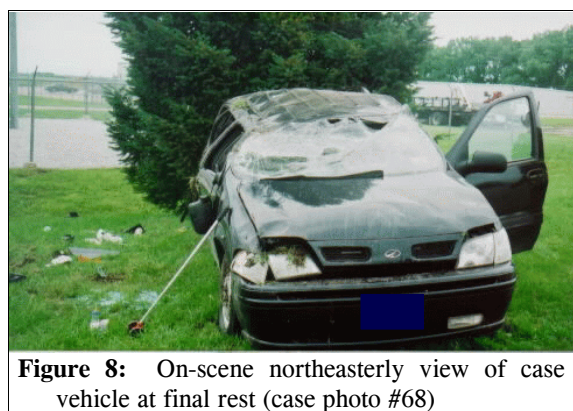
Figure 8: On-scene northeasterly view of case vehicle at final rest (case photo #68)

rotated inward at the bottom from the rollover event. The crash resulted in induced damage to the hood, grille, right front door, right fender, and right headlight and turn signal assemblies. As mention above, the glazing in the case vehicle's back two right windows was disintegrated during the initial impact with the Buick while the rollover event disintegrated the right front window glazing and caused the windshield's glazing to be "holed" (Figure 8 above).

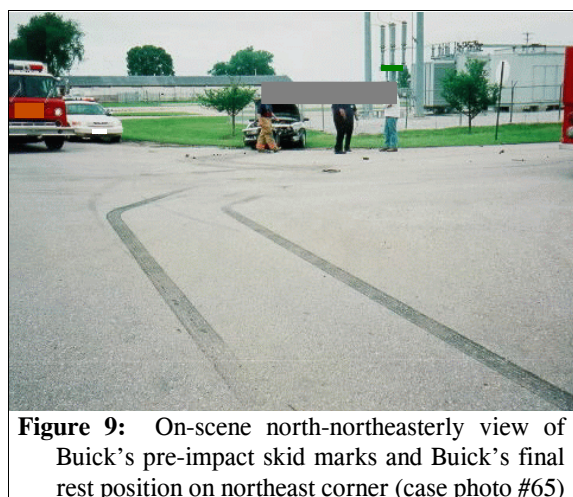
Figure 9: On-scene north-northeasterly view of Buick's pre-impact skid marks and Buick's final rest position on northeast corner (case photo #65)

degrees clockwise after impacting the case vehicle and came to rest off the northeast corner of the intersection heading south-southwestward (**Figure 9** above).

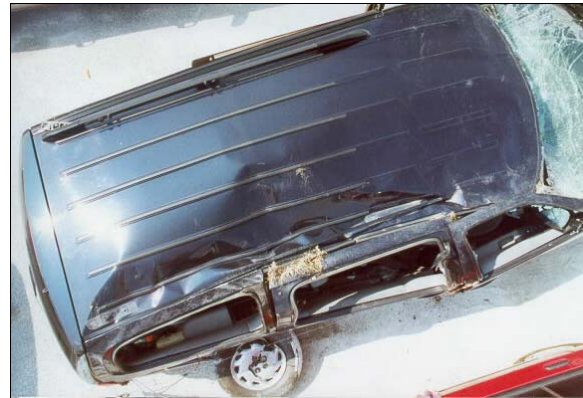
The rollover event (2nd event) caused direct damage to the right half of the roof and the entire right side (**Figure 10** below). Furthermore, there was direct damage laterally across the roof at the windshield header and laterally across the front of the hood. The case vehicle's left side remained unscathed from the rollover event. Maximum crush from the rollover was measured as 30 centimeters (11.8 inches) vertically near the right roof rail. The case vehicle's hood, right roof, windshield header area, and entire right side were directly damaged and crushed downward and/or inward during the rollover. Furthermore, the case vehicle's left rear tire was

Figure 10: Overhead view of rollover damage to case vehicle's top and right side; Note: dis-integrated glazing on entire right side (case photo #25)

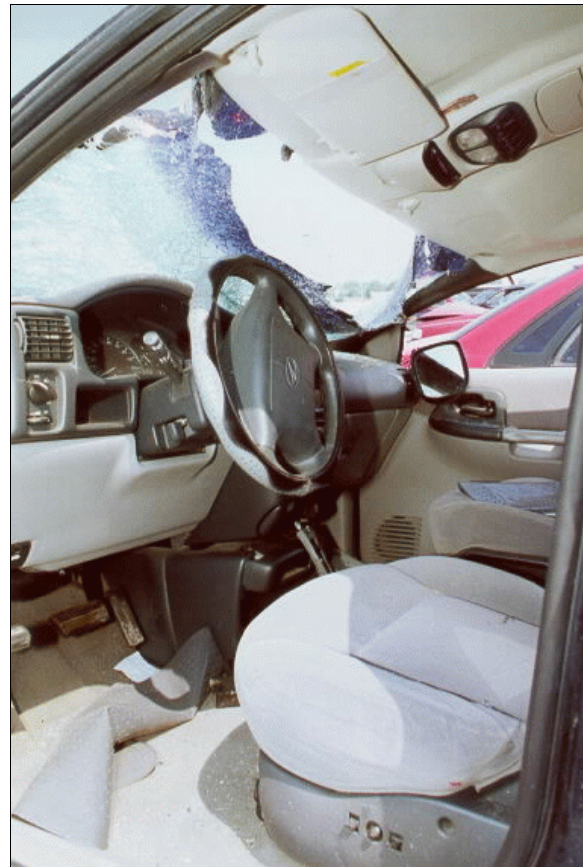
Figure 11: Vertical view of case vehicle's front seating area showing non-deployment of air bags; Note: driver's contact (yellow tape) to sun visor (case photo #31)

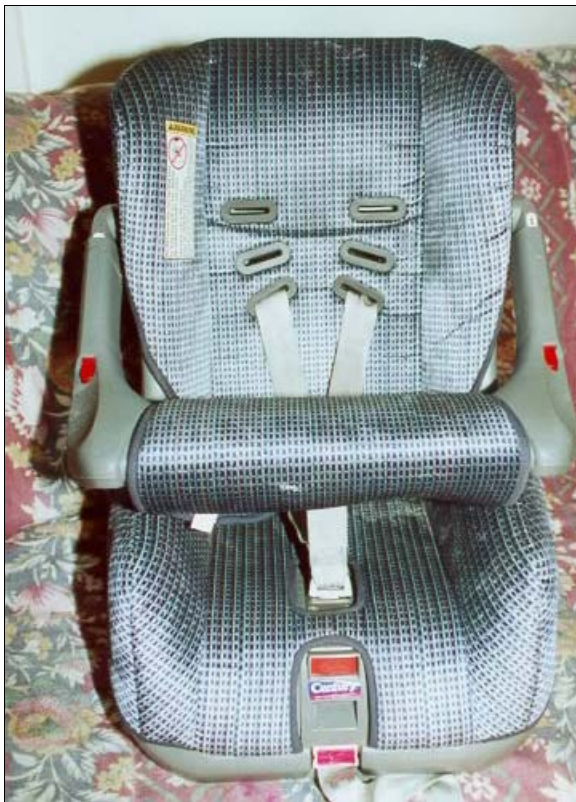
Figure 12: Convertible child safety seat used by case vehicle's second seat left passenger; Note: harness straps in bottom slots and should have been in top slots (case photo #61)

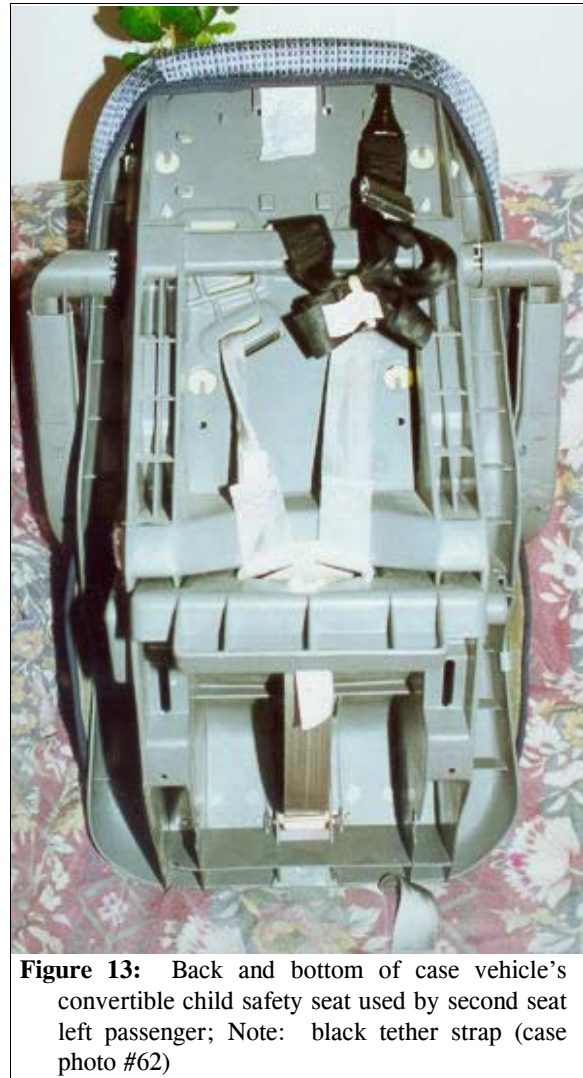
Figure 13: Back and bottom of case vehicle's convertible child safety seat used by second seat left passenger; Note: black tether strap (case photo #62)

child's legs. The convertible child safety seat was equipped with an optional tether, which was not connected and hanging to the back of the plastic shell (**Figure 13** above). The convertible child safety seat showed very little wear and tear to the padding or shell. There was only one visible area of stress evident on the plastic shell of the child seat. This evident area of stress was on the bottom portion of the child seat, which would have been positioned on the seat cushion (**Figure 14** and **Figure 15**).

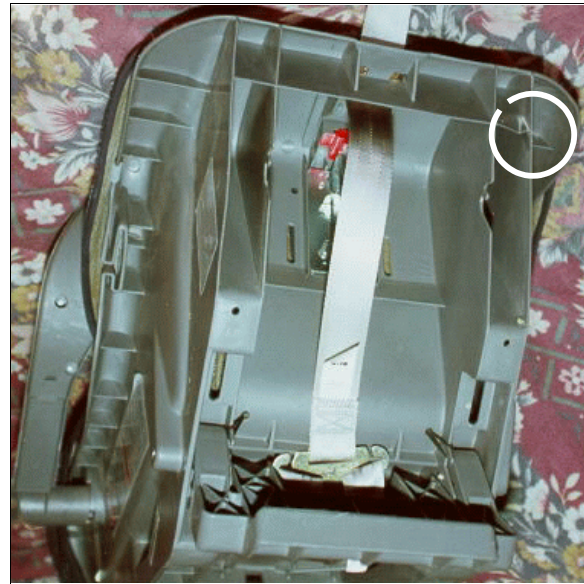
Figure 14: Bottom of case vehicle's convertible child safety seat used by second seat left passenger, highlighting stressed area (case photo #63)

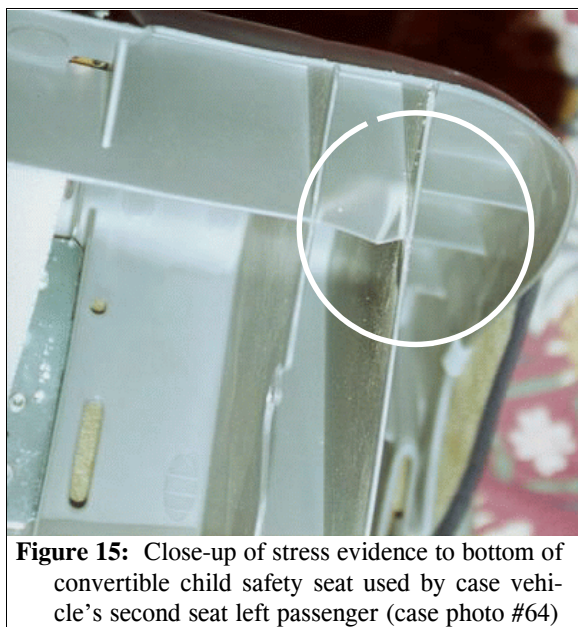
Figure 15: Close-up of stress evidence to bottom of convertible child safety seat used by case vehicle's second seat left passenger (case photo #64)

The case vehicle's second seat left passenger (i.e., son) was restrained in a child seat which was secured by the available, active, three-point, lap-and-shoulder, safety belt system (**Figure 14**). Furthermore, the inspection of the second seat left passenger's seat belt webbing, "D"-ring, and latch plate showed evidence of loading (**Figure 15** and **Figure 16** below).

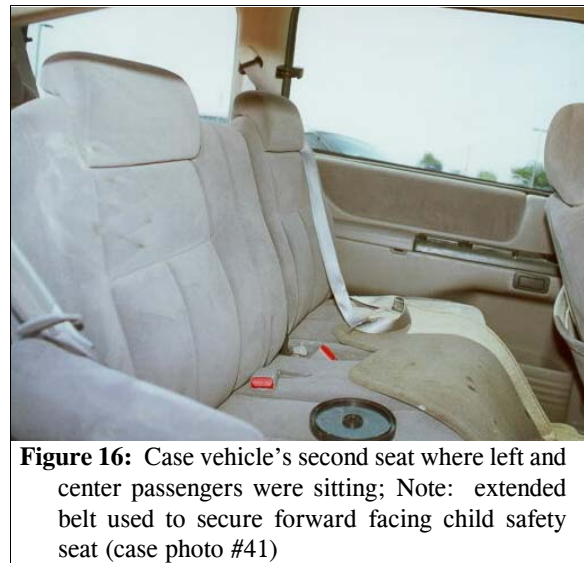
Figure 16: Case vehicle's second seat where left and center passengers were sitting; Note: extended belt used to secure forward facing child safety seat (case photo #41)

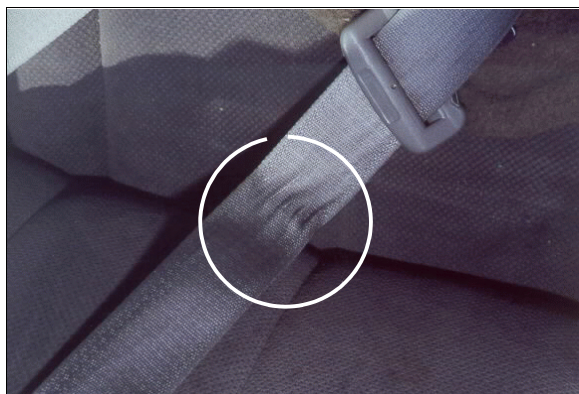
Figure 17: Close-up of loading evidence on webbing of case vehicle's second seat left passenger seat belt (case photo #45)

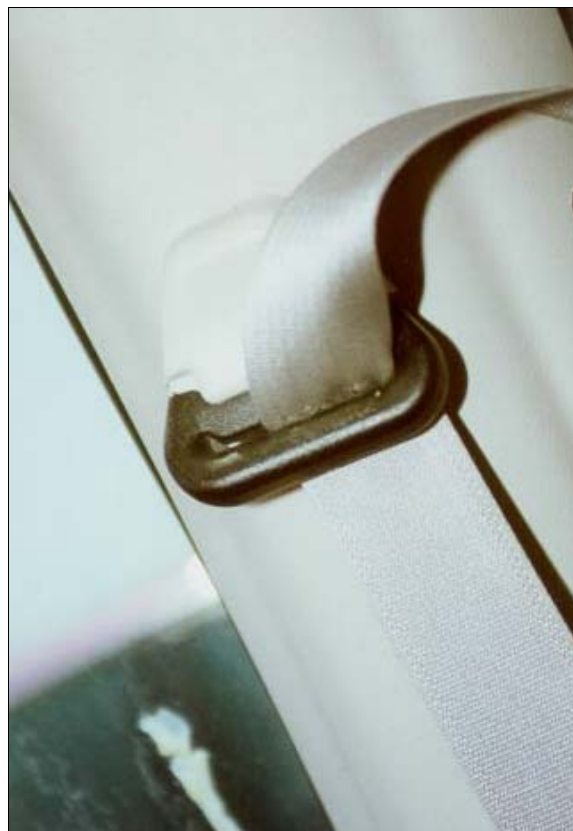
Figure 18: Close-up of "D"-ring for case vehicle's second seat left passenger showing friction rub and particles caused by loading (case photo #43)

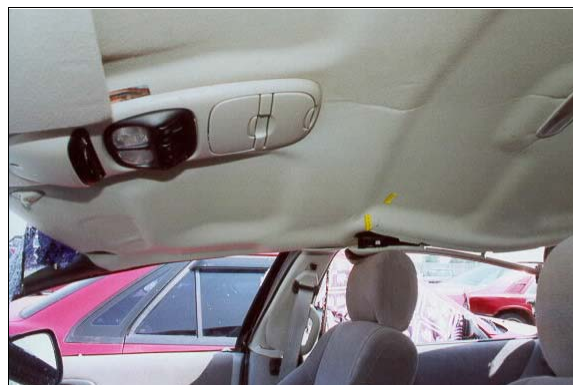
Figure 19: Case vehicle's right side roof rail and probable avenue of ejection for second seat passenger; Note: tape on roof indicates blood spots (case photo #30)

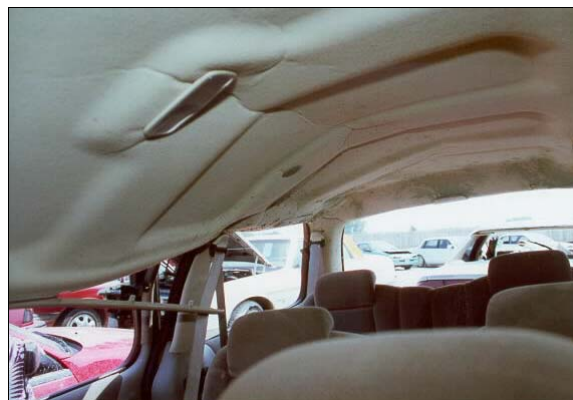
The case vehicle's back left passenger was not using his available, active, three-point, lap-and-shoulder, safety belt system. In addition, the inspection of the back left passenger's seat belt webbing, "D"-ring, and latch plate showed no evidence of usage during this crash. As a result, he was also ejected from the vehicle during the rollover event, again, most likely through the disintegrated right side glazing (**Figure 20**).

Figure 20: Right side of case vehicle's roof showing intrusion and probable avenue of ejection for back left seat passenger (case photo #48)

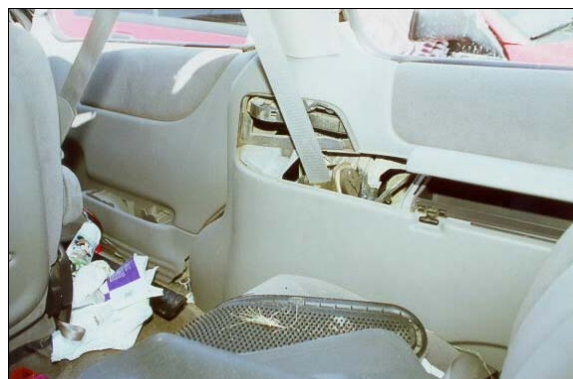
Figure 21: Case vehicle's right rear door and back seat interior panels showing absence of visible contact evidence during rollover and ejection by case vehicle's second and third seat passengers; Note: panel covering second seat's safety belt retractor has been knocked out (case photo #40)

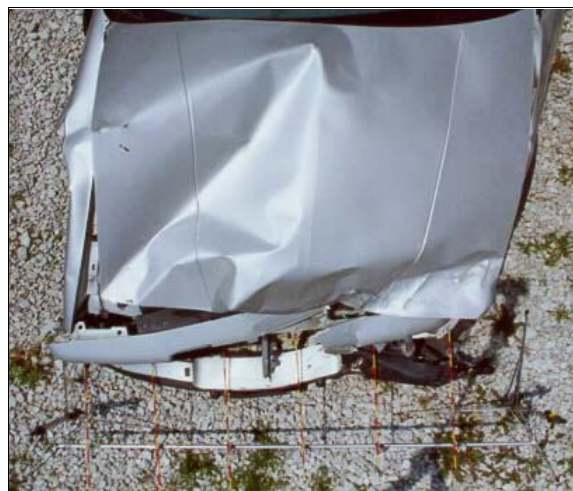
Based on the vehicle inspection, the CDC for the Buick was determined to be: **91-FDEW-2 (320)**. The Buick's front was shifted to the right (**Figure 22**) greater than 12.7 centimeters (5 inches) resulting in an increment of 80 to the Direction of Principal Force (i.e., 11+80=91). The WinSMASH reconstruction program, damage only algorithm, was used on the Buick's highest severity impact. The Total, Longitudinal, and Lateral Delta Vs are, respectively: 18.1 km.p.h. (11.2 m.p.h.), -13.8 km.p.h. (-8.6 m.p.h.), and +11.6 km.p.h. (+7.2 m.p.h.). The Buick was towed due to damage.

Figure 22: Overhead view of Buick's frontal deformation from impacting case vehicle's right side (case photo #52)
