**TRANSPORTATION SCIENCES  
CRASH DATA RESEARCH CENTER**

**ADVANCED OCCUPANT PROTECTION SYSTEM STUDY  
2000 FORD TAURUS INVESTIGATION**

**VERIDIAN CASE NO. CA01-020**

**CRASH DATE - JANUARY 2001**

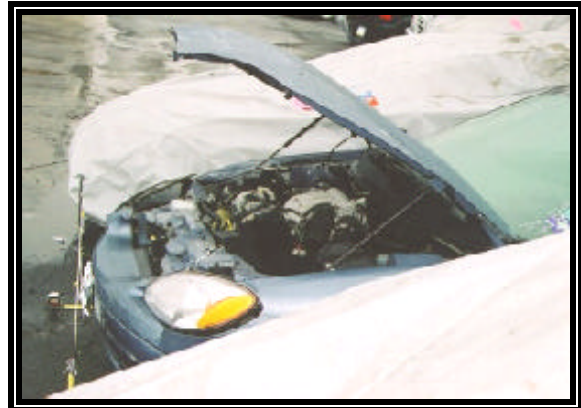
**Figure 4** is a left lateral view of the frontal deformation. The front bumper sustained 118.1 cm (46.5 in) of direct contact damage. The direct contact began 63.5 cm (25.0 in) left of center and ended 54.6 cm (21.5 in) right of center. The structure of the front bumper was shifted 5.8 cm (2.3 in) to the right as a result of the force of the 11 o'clock impact. The energy of the crash was managed primarily by the vehicle's bumper and structures forward of the cowl. The measured crush profile was as follows: C1=10.9 cm (4.3 in), C2=7.9 cm (3.1 in), C3=7.6 cm (3.1 in), C4=5.1 cm (2.0 in), C5=6.6 cm (2.6 in), C6=10.2 cm (4.0 in). The imprint of the Jeep's right front rim was identified on the bumper fascia. The center of the imprint was located 35.6 cm (14.0 in) right of center. The right front door was restricted by the deformation of the right front fender. The right rear door was jammed shut. There was no change on the wheelbase dimensions. The Damage Algorithm of the WINSMASH model calculated a total delta V of 13.3 km/h (8.3 mph) for the Taurus. The longitudinal and lateral components were -11.5 km/h (-7.2 mph) and 6.7 km/h (4.2 mph), respectively. The calculated delta V seemed underestimated based on SCI field experience. A more probable delta V for the Taurus was in the range of 16 to 19 km/h (10 to 12 mph). The Collision Deformation Classification (CDC) was 11-FDEW-1.

**Figure 4:** Left lateral view across the front plane.

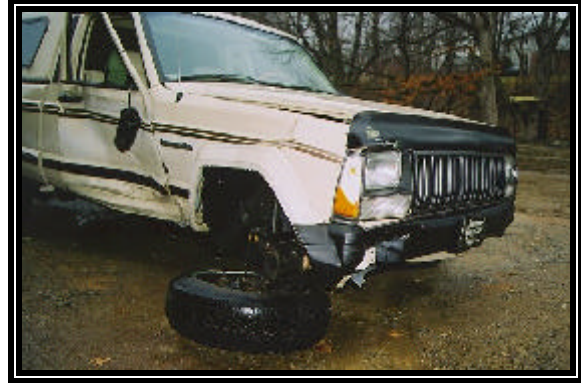
**Figure 5:** Jeep Comanche right side damage.

The vehicle's right side damage began at the right front bumper corner and extended 213 cm (84 in) rearward to the location of the B-pillar. The maximum deformation was approximately centered on the right door and measured 13 cm (5 in). The right door was jammed shut by the deformation and the glazing disintegrated on impact. The force of the impact displaced the right front wheel from the axle. The total delta V calculated by the Damage Algorithm of the WINSMASH model was 15.7 km/h (9.8 mph). The CDC was 02-RYEW-3.

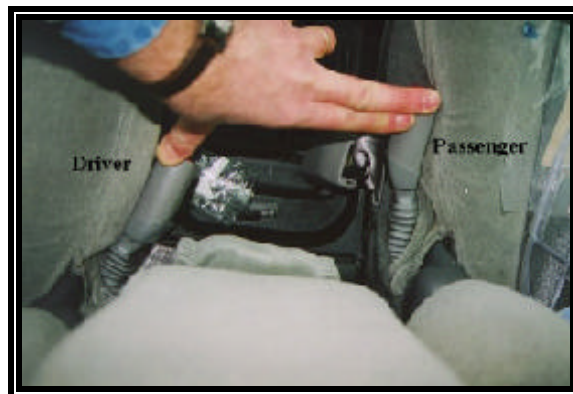
**Figure 6:** View of the fired pre-tensioners.

anchorage (D-ring) was positioned 2.5 cm (1.0 in) below full up. There was no evidence of loading to the restraint webbing or hardware. The right buckle pre-tensioner had fired, Figure 6. The piston barrel measured 71 mm (2.8 in). This measurement indicated approximately 39 mm (1.5 in) of slack was removed by the fired pre-tensioner. All the evidence identified during the inspection indicated the front right passenger was restrained during the crash.

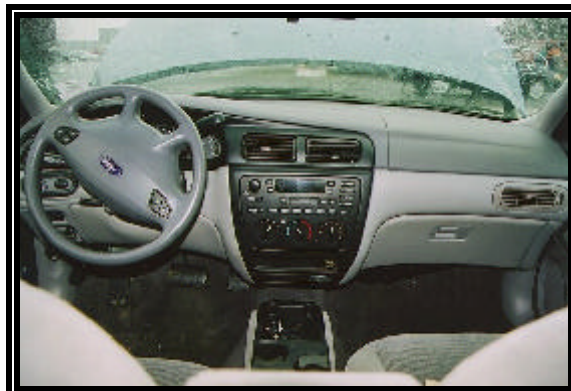
**Figure 7** is a view of the front occupant space of the subject vehicle. There was no intrusion or interior damage associated to the forces of the crash. No points of occupant contact could be identified. The absence of interior occupant contacts was directly related to the proper use of the vehicle's manual 3-point restraint.

**Figure 7:** View of the front interior.
