**VERIDIAN REMOTE SIDE IMPACT INFLATABLE
OCCUPANT PROTECTION SYSTEM INVESTIGATION
VERIDIAN CASE NO. CA01-021
VEHICLE: 2000 BMW 328Ci
LOCATION: NEW JERSEY
CRASH DATE: DECEMBER 2000**

Contract No.
DTNH22-94-D-07058

<p>14. <i>Sponsoring Agency Code</i></p>	
<p>15. <i>Supplementary Notes</i> Remote investigation of a side impact crash that involved a 2000 BMW 328Ci.</p>			
<p>16. <i>Abstract</i> This remote investigation focused on the performance of the side impact inflatable occupant protection system of a 2000 BMW 328Ci, 2-door coupe that was involved in a single vehicle run-off-road crash with breakaway luminaire pole. The impact was located on the driver's door and deployed the door mounted side impact air bag and the Head Protection System (HPS), tubular head air bag. The driver sustained multiple abdominal injuries and pelvic fractures. He was admitted to a regional trauma center for six days for treatment of his injuries.</p>			
<p>17. <i>Key Words</i> Remote investigation Side impact air bag deployment Head Protection System (HPS)</p>		<p>18. <i>Distribution Statement</i> General Public</p>	
<p>19. <i>Security Classif. (of this report)</i> Unclassified</p>	<p>20. <i>Security

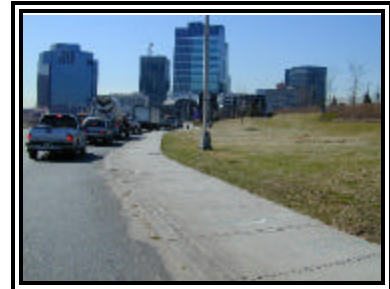
The 25 year old adult male driver of the BMW was traveling in a southerly direction on the outboard lane of the four lane highway at an unknown rate of speed. As he entered the right curve, the driver lost directional control of the BMW and departed the roadway in a clockwise yaw (**Figure 3**). In the area of the road departure, the barrier curb was approximately 5-8 cm (2-3") in height, therefore the curb did not alter the vehicle's trajectory or damage the alloy wheels or tires.

Figure 3. Point of departure and struck luminaire.

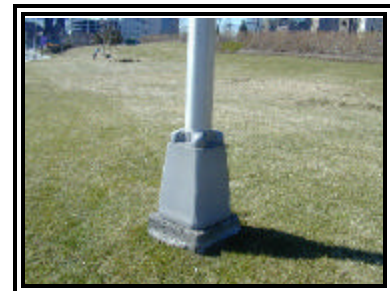
The left door area of the BMW impacted the luminaire in a near broadside configuration. The lateral impact force was within the 9 o'clock sector with a Collision Deformation Classification (CDC) of 09-LPAW-4. The impact fractured the frangible base (**Figure 4**) of the pole. Although the base fractured, the barrier algorithm of the WinSMASH program was used to compute a total velocity change of 31.4 km/h (19.5 mph) with a lateral component of 31.0 km/h (19.2 mph). As a result of the lateral impact, the left door mounted side impact air bag and the left HPS deployed. There was secondary damage at the left A-pillar area of the vehicle, however, based on the remote nature of this investigation, this damage could not be associated with the crash event.

Figure 4. Replaced frangible base.

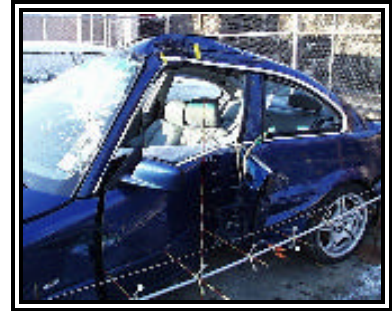
The 2000 BMW 328Ci sustained moderately severe left side damage (**Figure 5**) from its impact with the breakaway pole. The direct damage was located on the rear third aspect of the left door and was documented at a length of 22.0 cm (8.7"). Maximum crush was 42 cm (16.5") located at the mid aspect of the door. The damage extended vertically from the sill to the roof side rail which bowed the vehicle. The combined induced and direct damage length extended from the left A-pillar to the leading edge of the left rear wheel opening.

Figure 5. Left side damage from the pole impact.

Components damaged by the impact included the left door, sill, floor, roof and roof side rail. The Collision Deformation Classification was 09-LPAW-4.

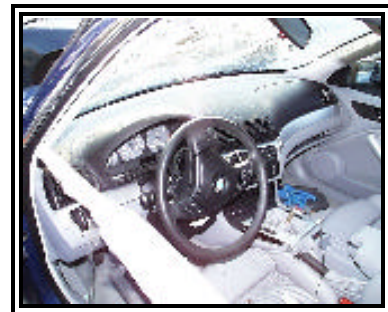
The BMW was equipped with dual-stage frontal air bags for the driver and right passenger positions (**Figure 6**). In addition, the frontal system included seat belt buckle pre-tensioners. Due to the lateral impact, the frontal air bag system did not deploy. The driver air bag was housed in a typical configuration within the 3-spoke steering wheel rim. The front right passenger air bag was in a top mount position within the right instrument panel area and concealed by a single cover flap.

Figure 6. Non-deployed frontal air bags.

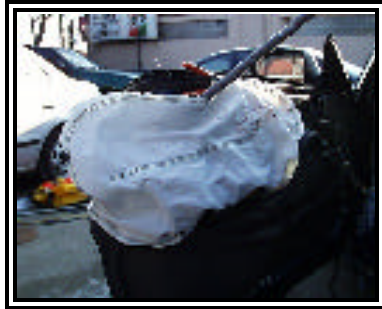
Supplemental side impact protection consisted of door mounted side impact air bags and tubular head air bags (HPS) for the driver and front right passenger. The left side torso bag and the left HPS deployed as a result of the pole impact sequence. The door mounted side impact air bag was concealed by a single cover flap in the door trim panel, above the level of the armrest. The air bag module within the door, was concealed by symmetrical H-configuration flaps. The air bag membrane was approximately 48 cm in length and 21 cm in height (**Figure 7**). There was no damage or contact evidence on the side impact air bag.

Figure 7. Deployed door mounted side impact air bag.

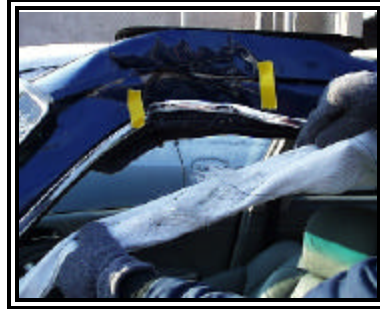
The HPS air bag deployed from the left roof side rail (**Figure 8**). The head liner separated from the side rail trim panel to allow for the deployment of the HPS. The HPS air bag was approximately 84 cm in length and 5 cm in diameter. The bag was tethered at both the A- and C-pillars. The mid aspect of the HPS was lacerated from probable with the shattered side glass and the struck pole. Although the driver probably contacted the HPS during the crash sequence, there was no evidence of occupant contact.

Figure 8. Deployed HPS with lacerations to membrane.

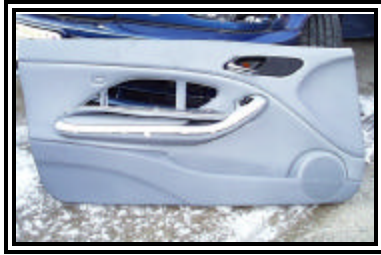
At impact, the left side impact air bag and left HPS deployed. The driver initiated a lateral trajectory into the path of the intruding left side interior components. His left pelvic region loaded the intruding left door panel and the armrest (**Figure 9**) which resulted in multiple pelvic fractures, fractures of the transverse processes of L1-L3, anterior subluxation of L5 on S1, and a small left retroperitoneal hematoma with hematuria. The intrusion of the left side components displaced the driver against the center armrest (**Figure 10**). Contact with the interior components was evidenced by scuff marks. His left knee contacted the left aspect of the knee bolster, however, no injury resulted.

Figure 9. Left door panel and side air bag cover flap.

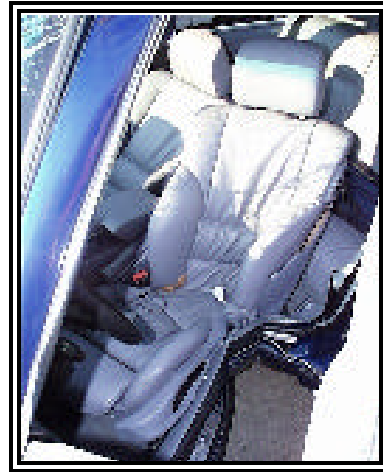
Maximum intrusion was approximately 30 cm (12") located at the mid aspect of the left door and sill of the vehicle. Additional intrusions included 28 cm of left side rail displacement, 4 cm of lateral displacement of the left A-pillar, and 23 cm of sill displacement. The intrusion crushed the driver's seat cushion laterally and rotated the seat back in a counterclockwise direction.

Figure 10. Compressed driver's seat cushion.
