ON-SITE CHILD SAFETY SEAT INVESTIGATION

CASE NUMBER - IN01-022
LOCATION - TEXAS
VEHICLE - 1997 CHEVROLET SUBURBAN
CRASH DATE - July 2001

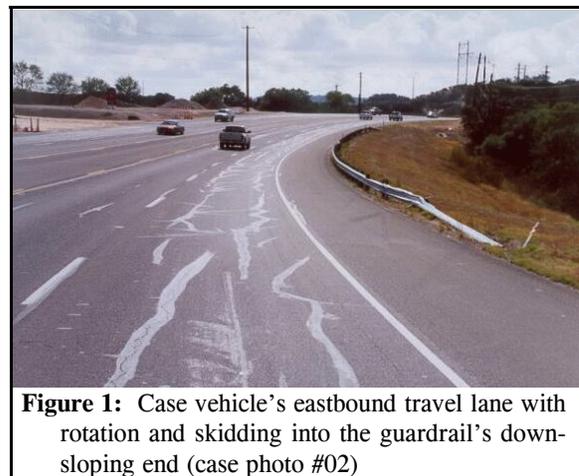
Figure 1: Case vehicle's eastbound travel lane with rotation and skidding into the guardrail's down-sloping end (case photo #02)

maneuvers. The crash occurred along the south edge of the outside eastbound lane (**Figure 1**). The Honda's impact to the case vehicle resulted in the case vehicle losing control and rotating approximately 180 degrees clockwise. The case vehicle continued in a southeasterly direction, going off the roadway and impacting the down-sloping end treatment of the steel W-beam guardrail (event #2). The case vehicle began to roll over (event #3), impacted a delineator post (event #4) and rolled over onto the grassy incline on the roadside beyond the guardrail. Both vehicles deposited tire marks leading into the guardrail (**Figure 2**)

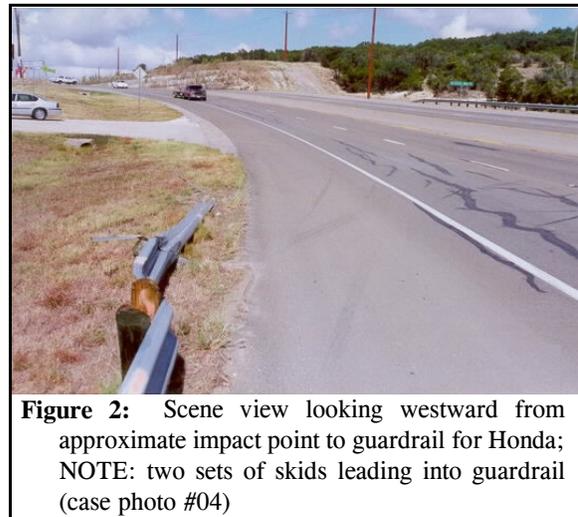
Figure 2: Scene view looking westward from approximate impact point to guardrail for Honda; NOTE: two sets of skids leading into guardrail (case photo #04)

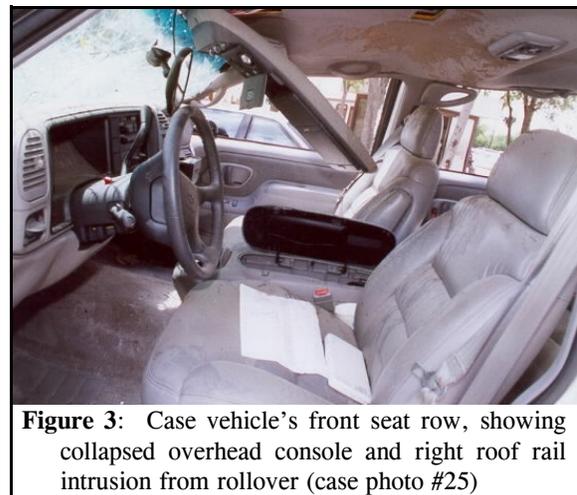
Figure 3: Case vehicle's front seat row, showing collapsed overhead console and right roof rail intrusion from rollover (case photo #25)

Both the retractor housing brackets for the outside third seat positions were pulled out from the roof and hanging down (**Figure 7**). The case vehicle had a moderate amount of intrusion by the roof, overhead center console, right roof rail, windshield header, and windshield (**Figure 3**).

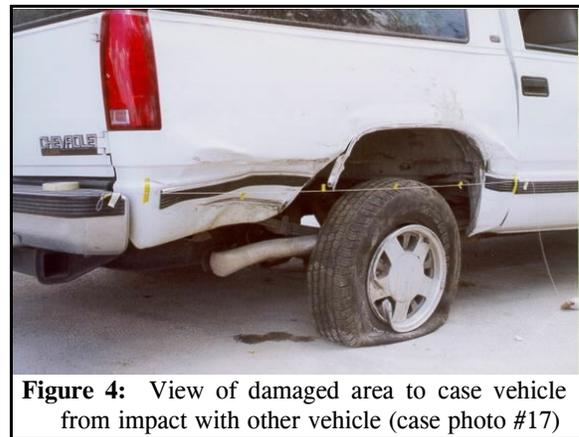
The case vehicle's contact with the Honda involved the right rear quarter panel (**Figure 4**). Direct damage began 60 centimeters [23.6 inches] rearward of the right rear axle and extended forward a measured distance 172 centimeters [67.7 inches] ending at the right rear door. Maximum crush for the impact with the Honda was measured as 14 centimeters [5.5 inches] between C3 and C4. The case vehicle's contact with the guardrail involved the left rear quarter panel and wheel (**Figure 5**). Direct damage began 59 centimeters [23.2 inches] rearward of the left rear axle and extended forward a measured distance of 170 centimeters [66.9 inches], ending at the left rear door. Maximum crush for the impact with the guardrail was measured as 11 centimeters [4.3 inches] between C4 and C5. The case vehicle's rollover involved the front half of the top surface. Direct damage began at the front edge of the hood and extended rearward a measured distance of 270 centimeters [106.3 inches], ending just beyond the right B-pillar (**Figure 6**). Maximum crush was measured as 17 centimeters [6.7 inches]. The case vehicle's wheelbase on both sides was shortened 2 centimeters [0.8 inches]. The case vehicle's hood, roof, left and right rear quarter panels were directly damaged and crushed inward. The case vehicle's left front and both rear tires were damaged and deflated but none of the tires were physically restricted. Remote buckling was also found on the roof and hood.

Figure 4: View of damaged area to case vehicle from impact with other vehicle (case photo #17)

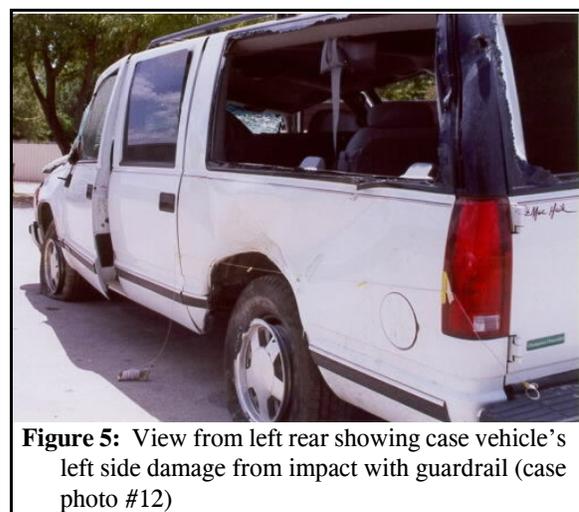
Figure 5: View from left rear showing case vehicle's left side damage from impact with guardrail (case photo #12)

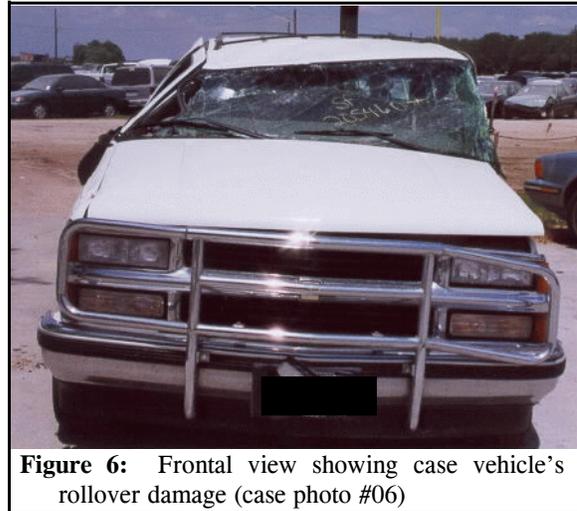
Figure 6: Frontal view showing case vehicle's rollover damage (case photo #06)

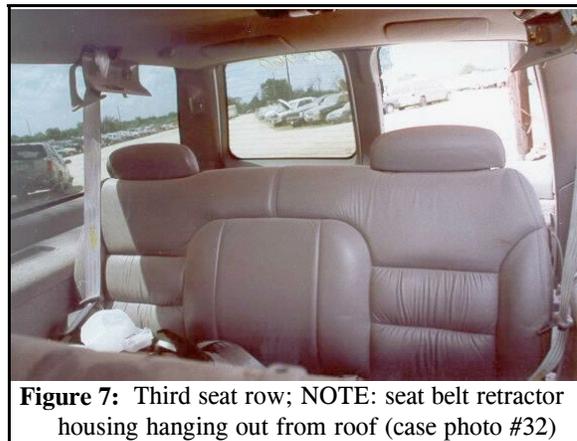
Figure 7: Third seat row; NOTE: seat belt retractor housing hanging out from roof (case photo #32)

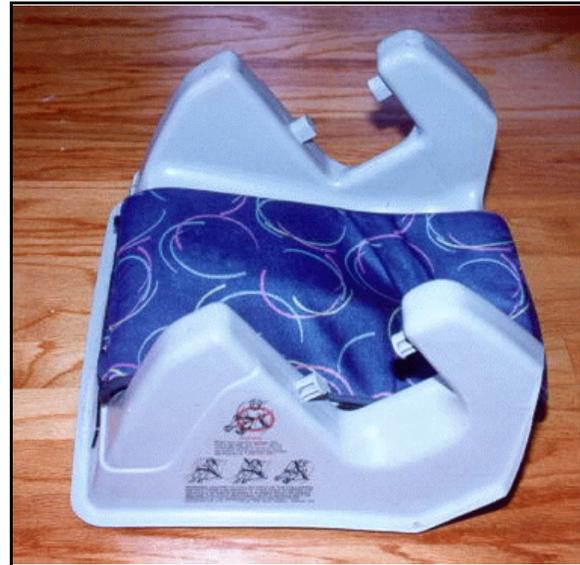
Figure 8: Belt-positioning booster seat in use at the time of the crash (case photo #37)

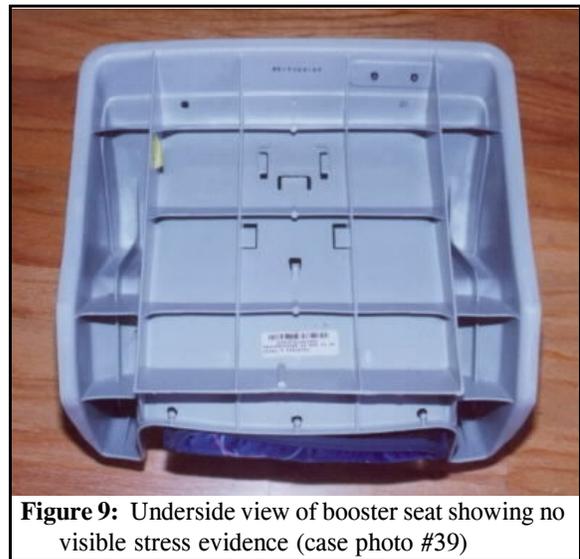
The child safety seat used by the case vehicle's third seated left passenger was a belt positioning booster Child Safety Seat (CSS) manufactured by Evenflo on August 30, 1995 and was identified by model name "Sidekick" (model number 244187P1). The seat was not designed with any type of harness or tether. It was, however, designed with a shield, which was not in use at the time of the crash. The forward facing child seat showed very little wear to the padding or shell (**Figure 8**). There were no visible areas of stress evidence to the plastic shell of the CSS (**Figure 9**).

Figure 9: Underside view of booster seat showing no visible stress evidence (case photo #39)

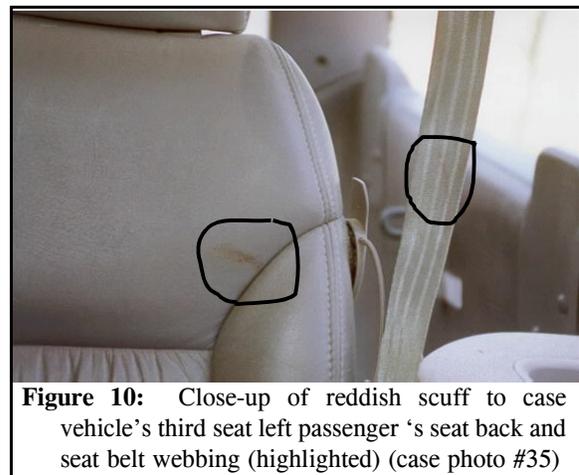
The case vehicle's third seated left passenger was seated in his belt-positioning booster seat restrained by his available, active, three-point, lap-and-shoulder, safety belt system. There was evidence of belt pattern abrasions on his neck, and inspection of his seat belt webbing and latch plate showed evidence of loading. In addition, there was a reddish smear (possibly blood) to the seat back and the seat belt webbing of the third seat passenger (**Figure 10**).

Figure 10: Close-up of reddish scuff to case vehicle's third seat left passenger's seat back and seat belt webbing (highlighted) (case photo #35)

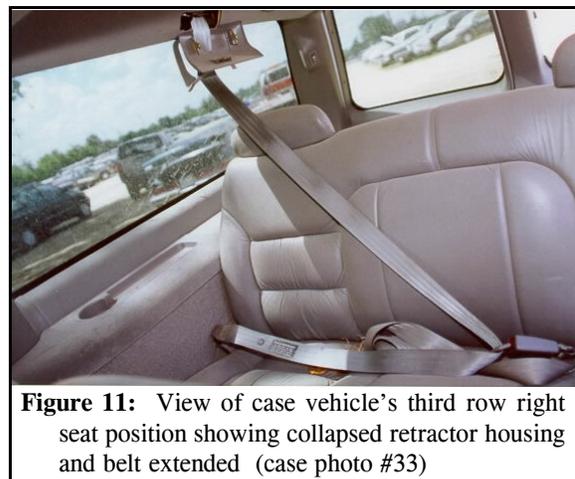
Figure 11: View of case vehicle's third row right seat position showing collapsed retractor housing and belt extended (case photo #33)

The case vehicle's third seated right passenger was restrained by her available, active, three-point, lap-and-shoulder, safety belt system. An inspection of her seat belt restraint showed evidence of recent usage only to the buckle portion. As previously mentioned, the roof anchored seat belt retractor housing was hanging down (**Figure 11**).

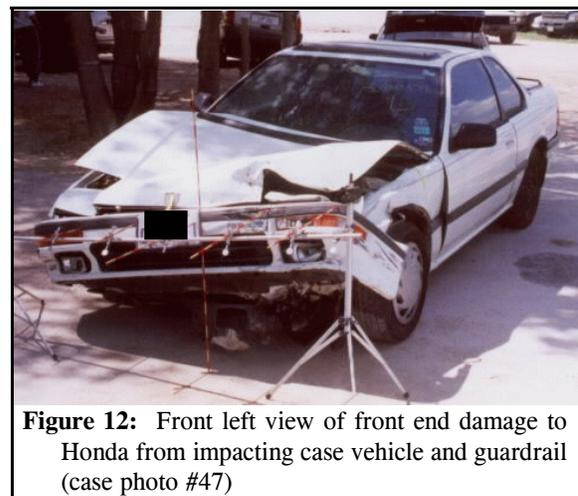
The Honda's contact with the case vehicle involved the front left half of the bumper and left front fender (**Figure 12**). The exact location of where the direct damage began for the impact with the case vehicle is unknown because of the overlapping damage from this vehicle's impact with the guardrail. There was direct contact down the left side of the Honda from impact with the case vehicle which extended 115 centimeters [45.3 inches] rearward, to just beyond the left front tire. The overall maximum crush to the Honda's front end was measured as 23 centimeters [9.1 inches] at C1. The Honda's contact with the guardrail also involved the front left half of the bumper and front end. The overall direct damage began 3 centimeters [1.2 inches] left of center (toward passenger side) and extended to the right a measured distance of 74 centimeters [29.1 inches], ending at the bumper corner. The case vehicle's hood, bumper, grille, and left fender were directly damaged and crushed rearward. The Honda's left front tire was damaged and deflated but none of the tires were physically restricted. The windshield glazing had several stress fractures. The case vehicle had no visible intrusion from outside the vehicle (locked). The Honda was towed due to damage.

Figure 12: Front left view of front end damage to Honda from impacting case vehicle and guardrail (case photo #47)
