**VERIDIAN REMOTE AIR BAG RELATED  
ADULT DRIVER FATALITY INVESTIGATION  
VERIDIAN CASE NO. CA01-027  
VEHICLE: 1992 MAZDA MAITA  
LOCATION: VIRGINIA  
CRASH DATE: JUNE 1994**

14. <i>Sponsoring Agency Code</i>	
15. <i>Supplementary Notes</i> Remote investigation of a moderate severity frontal crash that resulted in deployment of the driver air bag system in a 1992 Mazda Miata and the subsequent death of the 36 year old female driver.

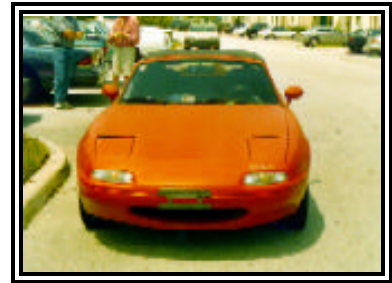
This remote investigation focused on the injury mechanisms and the cause of death for a 36 year old female driver of a 1992 Mazda Miata (**Figure 1**). The Mazda was equipped with a frontal air bag system for the driver's position that deployed as a result of front right impact with a fire hydrant. The driver was found in the vehicle with the engine running and the air bag system deployed. She was in a semi-coherent state and was transported by ambulance to a local hospital where she was treated and released approximately two hours following the crash. A family member found the driver at her residence in a semi-conscious state approximately 10 hours following her discharge from the hospital. She was transported by ambulance to the local hospital where she was admitted for treatment of cervical and closed head injuries and multiple thrombosis. Her condition deteriorated and she expired five days following the crash. A 23 year old male front right passenger of the Mazda fled the scene prior to police arrival.

**Figure 1. Frontal view of the repaired 1992 Mazda Miata.**

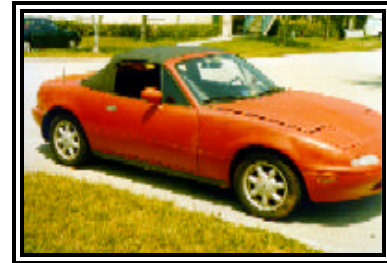
There were no photographs of the frontal impact damage available for this remote investigation. **Figure 2** is an image of the repaired Mazda that obtained six years following the crash. Based on the insurance company damage estimate and the Police Accident Report (PAR), the impact involved the front right aspect of the vehicle. The Mazda was repaired and retained by the family owner. The damage repair invoice noted that the major replacement parts consisted of the front bumper fascia, the bumper reinforcement beam, the right headlamp assembly, hood, right front fender, and the radiator support panel. In addition to the body damage, the steering wheel, air bag control module, and three front mounted crash sensors were replaced resulting in a total repair cost of \$6,994.58. The estimated Collision Deformation Classification (CDC) was 12-FRE9-9. (Columns 6 and 7 of the CDC were unknown due to the lack of the specific frontal location and extent of the damage.)

**Figure 2. Right frontal view of the repaired Mazda Miata.**

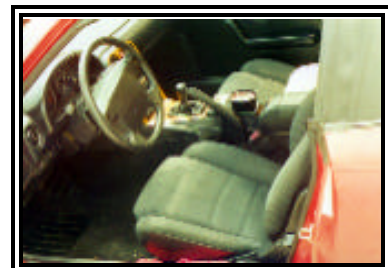
There was no reported intrusion of the passenger compartment. The deployed air bag and steering wheel were replaced as previously noted. The damage estimate also identified the replacement of the steering shaft, however, it was unknown if this was a result of exterior crash forces or the result of occupant loading. **Figure 3** is an overall view of the vehicle's interior and the repaired air bag system.

**Figure 3. Overall view of the driver's compartment.**

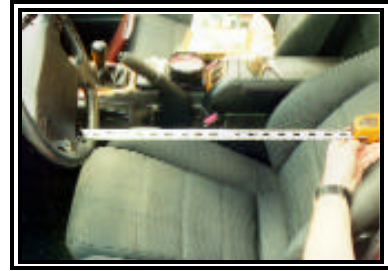
The 36 year old female driver of the Mazda Miata was seated in an unknown track position and was in an unknown driving posture at the time of the crash. **Figure 4** is a view of the driver's compartment with the seat track adjusted to the full rear position. It was presumed that she was positioned forward with respect to the steering wheel assembly based on the nature and location of her injuries. The driver was dressed in a sweater and skirt, and was wearing a watch with a stretch-metal band, a faux pearl necklace, earrings or a pendent, and a scarf that possibly wrapped or was loosely tied around her neck. The driver was not wearing the manual belt system as determined from observations of the first responders, injury data, and family member statements to the investigating police agency.

**Figure 4. Profile view of the driver's compartment with the seat track adjusted to the full rear position.**
