REMOTE ALLEGED INADVERTENT AIR BAG DEPLOYMENT REPORT

CASE NUMBER - IN-01-027
LOCATION - MISSISSIPPI
VEHICLE - 1999 OLDSMOBILE ALERO GL
INCIDENT DATE - September, 2001

February 28, 2003

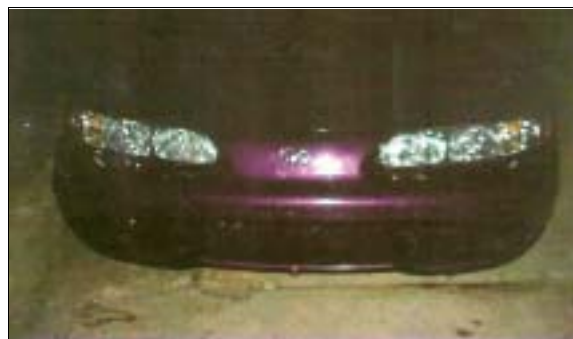
Figure 1: Elevated, attorney-provided photo of case vehicle's front showing no obvious evidence of impact damage (case photo #01)

The investigating law enforcement officer discovered no front plane damage to the case vehicle, nor did he find any undercarriage damage¹ (**Figure 1** above). All information collected by the investigating law enforcement officer was verified by the individual hired to download the EDR data (**Figure 2**), with one exception. This outside consultant discovered a contact area on the left rocker panel under the driver's left front door² (**Figure 3**). However, he was unable to determine whether that contact area was recent or old. Based on the photographic evidence provided by the GM's consultant, there was undercarriage damage, but the damage was to both front frame rails and the front crossbar member (**Figure 4** below). The case vehicle's driver does not recall striking anything in the two years she has owned the vehicle that would have caused such damage. She was not the original purchaser of the case vehicle. In this contractor's opinion, undercarriage damage exists, but the origin and time sequence of the damage is undeterminable.

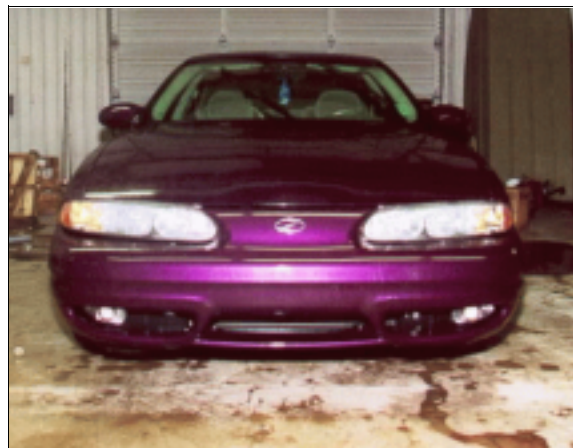
Figure 2: GM consultant's photo of case vehicle's undamaged front (case photo #03)

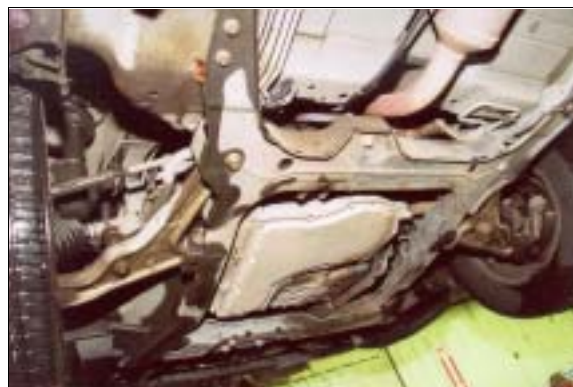
Figure 3: GM consultant's photo of case vehicle's middle and front undercarriage areas viewed from back showing no obvious contacts to undercarriage beyond frontal area (case photo #19)

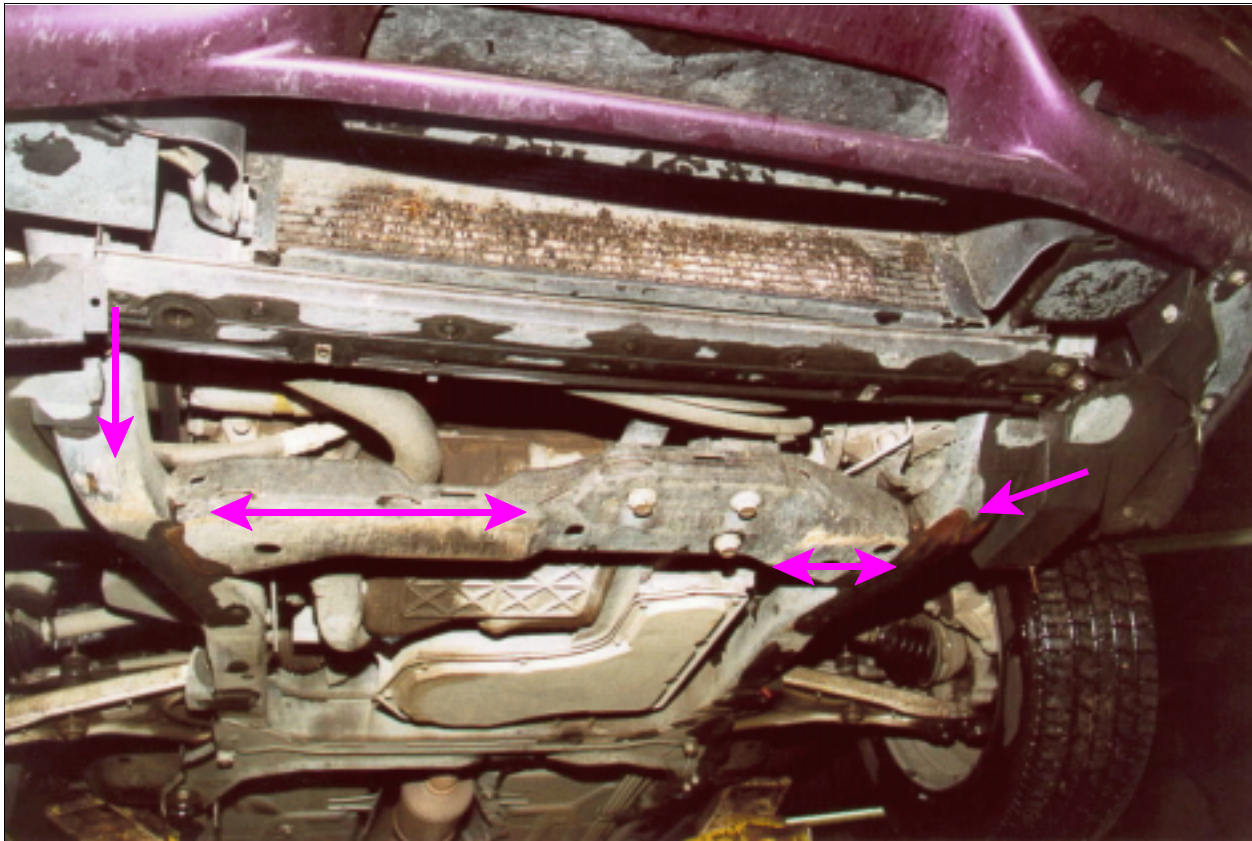
² Based on the photographs obtained from the GM's consultant subsequent to this contractor's conversation with him, this contractor must have misunderstood the consultant's remark because the available photographs clearly demonstrate undercarriage scraping on both front frame rails and the front crossbar member. Furthermore, there was no photographic evidence of damage underneath the rocker panel for the driver's left front door.

Figure 4: GM consultant's photo of case vehicle's front undercarriage area showing significant scrapes across entire frontal frame members; Note: left front wheel on right of photo (case photo #09)

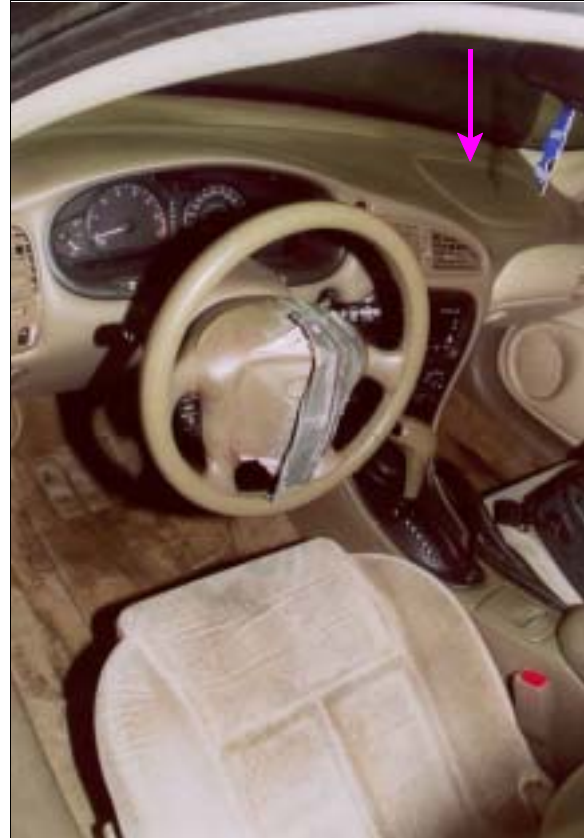
It was driven from the scene of the inadvertent deployment. According to the case vehicle's driver, she was traveling approximately 72-80 km.p.h. (45-50 m.p.h.) just prior to the incident. Without a verifiable impact, no reconstruction program could be run. Again, without a verifiable impact, no damage severity could be described or assessed. All that can be stated with certainty is that the case vehicle's driver air bag deployed and the front right passenger air bag did not deploy (**Figure 5** below), with no discernible front plane damage.

Figure 5: GM consultant's photo of case vehicle's driver seating area showing steering wheel hub from which driver's air bag deployed and non-deployed front right passenger air bag module (case photo #07)

Because the front right air bag module did not deploy (**Figure 5**), no information is available concerning the existence, number, and size of tethers or vent ports, and the shape or size of the front right passenger's air bag cannot be described.

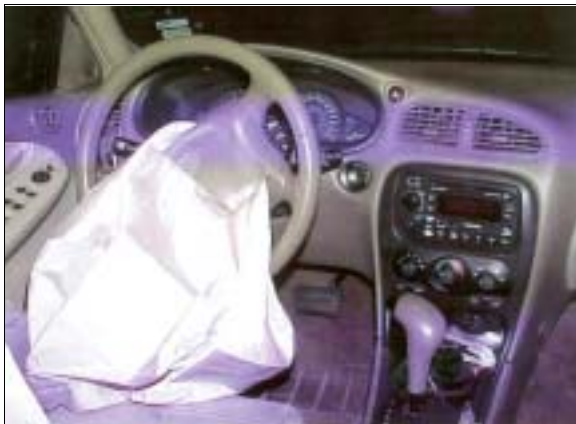
The case vehicle was equipped with a Supplemental Restraint System (SRS) that contained frontal air bags at the driver and front right passenger positions. Only the driver's air bag deployed inadvertently as the case vehicle was traveling down the roadway. The case vehicle's driver air bag was located in the steering wheel hub. Based on the photographs provided by the attorney (**Figure 6**) and by GM's consultant (**Figure 5**), the air bag module was designed with "I"-configuration cover flaps, and it appears that the cover flaps opened at their designated tear points. Furthermore, there was no visible evidence of damage during the deployment to the air bag or the cover flap. Because this case is a remote investigation, the existence, number, and size of tethers or vent ports could not be assessed nor could the size of the driver's air bag be described. However, the air bag appears to be circular in shape (**Figure 7**). The investigating police officer made no mention of any evidence of contact or damage to the air bag's fabric. Furthermore, no visible driver contact points can be discerned in the available photographs of the air bag's fabric (**Figures 6 and 7**).

Figure 6: Attorney-provided photo of case vehicle's driver seating area and center console showing deployed driver air bag and no obvious evidence of occupant contact (case photo #02)

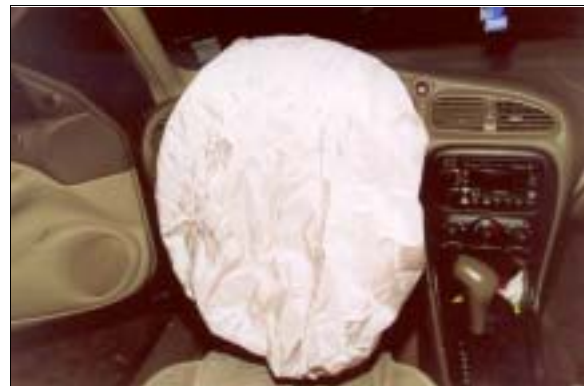
Figure 7: GM consultant's photo of case vehicle's deployed driver air bag showing no obvious evidence of occupant contact (case photo #08)

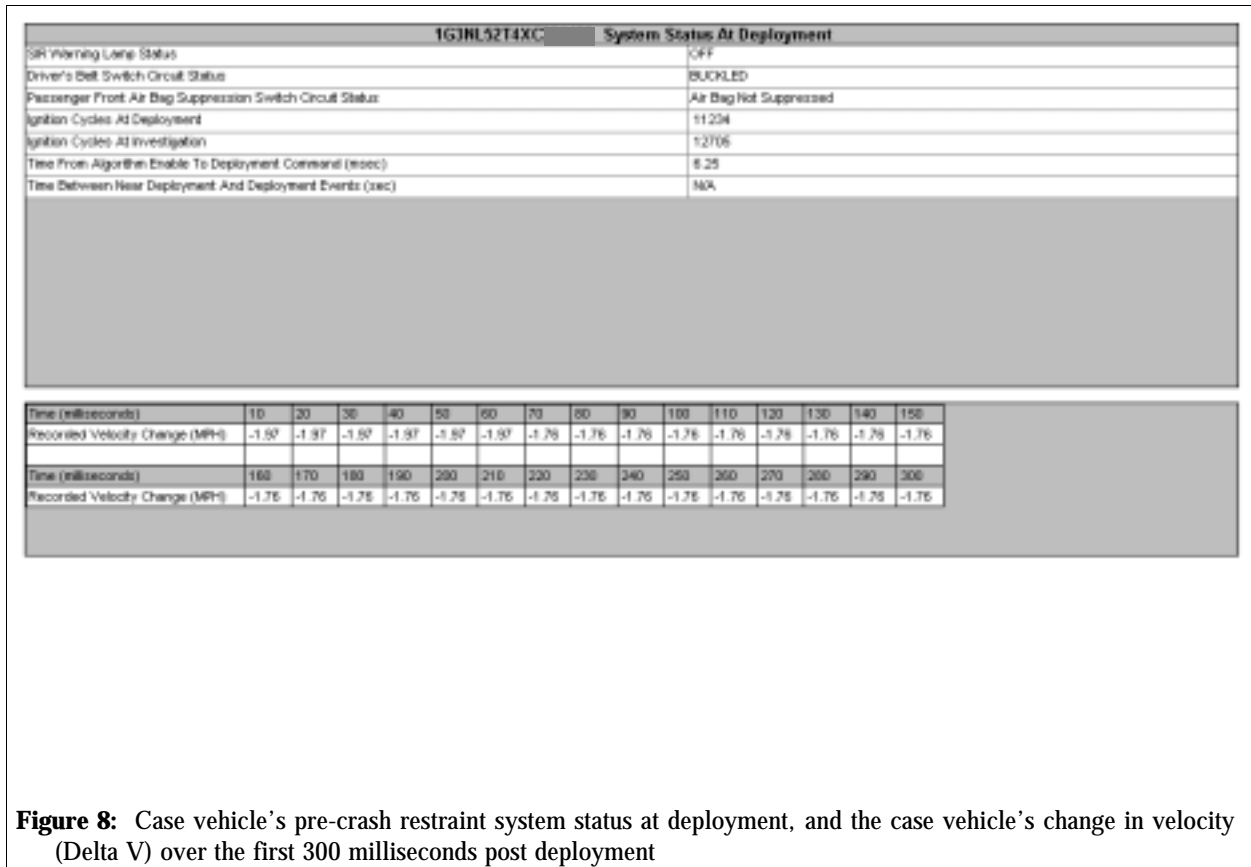
The data downloaded from the case vehicle's **EDR** was provided by the consultant hired by General Motors. The **EDR** showed the vehicle's SIR warning lamp status, driver's seat belt buckle status, ignition cycles at deployment, time from algorithm enable to deployment command (i.e., air bag deployment) and velocity change (i.e., Delta V). Downloaded data of interest indicated the following. The case vehicle's driver seat belt status showed it was buckled, and the Delta V was insignificant; see **EVENT DATA RECORDER DOWNLOAD (Figures 7 and 8)** below. The first 60 milliseconds showed a 3.17 km.p.h. (1.97 m.p.h.) velocity loss, which changed to a 2.83 km.p.h. (1.76 m.p.h.) velocity loss for the remaining 240 milliseconds of recorded measurement. This inferred slight increase [i.e., -0.34 km.p.h. (-0.21 m.p.h.)] in acceleration might have resulted from an involuntary foot depression on the accelerator pedal as a result of being startled by the deployment of the air bag. This contractor believes that the recorded Delta V supports the allegation that the driver's air bag did not deploy as a result of a crash event and, therefore, deployed inadvertently.

Figure 8: Case vehicle's pre-crash restraint system status at deployment, and the case vehicle's change in velocity (Delta V) over the first 300 milliseconds post deployment

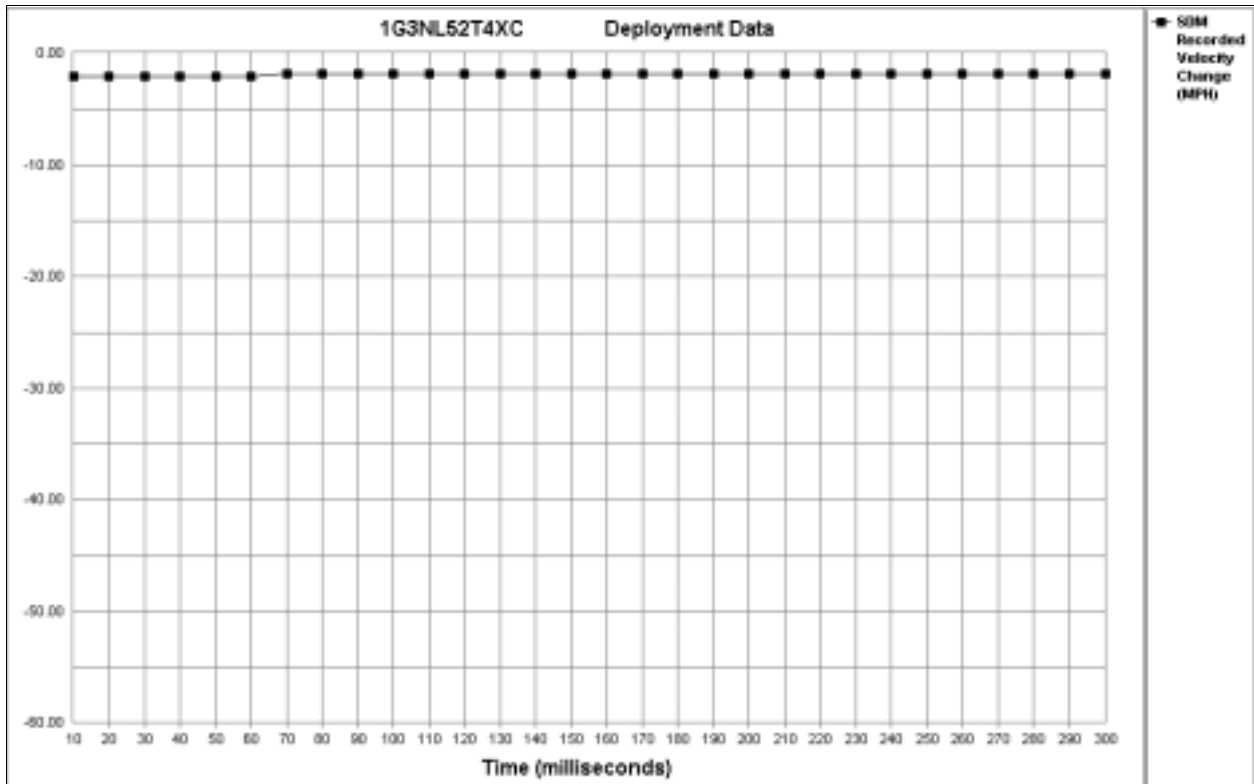
Figure 9: The case vehicle did not sustained any significant velocity change during the first 300 milliseconds after the incident was detected
