**TRANSPORTATION SCIENCES
CRASH DATA RESEARCH CENTER**

**VERIDIAN ON-SITE ADVANCED OCCUPANT
PROTECTION SYSTEM STUDY (AOPSS) AND SIDE IMPACT
OCCUPANT PROTECTION INVESTIGATION**

VERIDIAN CASE NO. CA01-028

**VEHICLES - 2000 FORD TAURUS LX
2001 BMW 325xi**

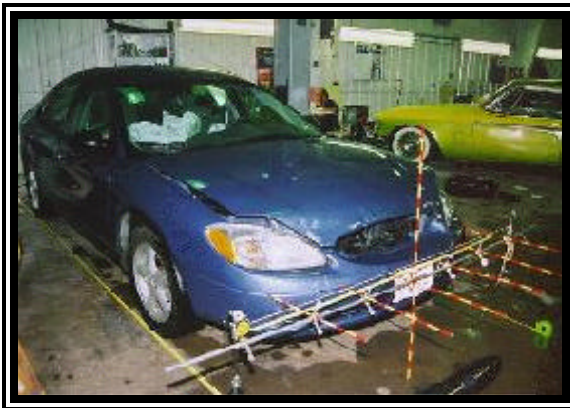
The 2000 Ford Taurus LX sustained minor frontal damage as a result of the impact with the BMW (**Figure 3**). The direct contact damage began at the front right bumper corner and extended 104.0 cm (40.9 in) inboard. The impact deformed the full frontal width resulting in a combined direct and induced damage length (Field L) of 144.0 cm (56.7 in). Six crush measurements were documented at the level of the bumper, however, they were projected to the *reinforcement bar* as the bumper fascia recoiled outward: C1= 1.0 cm (0.4 in), C2= 2.0 cm (0.8 in), C3= 5.0 cm (2.0 in), C4= 9.0 cm (3.5 in), C5= 6.0 cm (2.4 in), C6= 3.0 cm (1.2 in). The Collision Deformation Classification (CDC) for this impact to the Ford was 12-FDEW-1 with a principal direction of force of (+)10 degrees. The hood was displaced slightly up and rearward from engagement against the side surface of the BMW (*headlights and grille remained undamaged*). Brown paint transfers were documented along the direct contact damage. Induced damage was noted to the forward aspect of the left front door seam from a forced opening post-crash. Reduction in the left wheelbase measured 1.5 cm (0.6 in). The windshield and tempered glazings remained undamaged.

Figure 3. Frontal damage to the 2000 Ford Taurus LX.

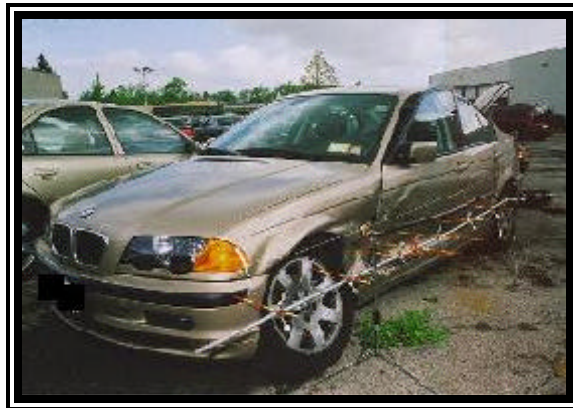
Figure 4. Left side surface damage to the 2001 BMW 325xi.

The 2001 BMW 325xi sustained minor left side damage as a result of the impact with the Ford Taurus (**Figure 4**). The direct contact damage began 3.0 cm (1.2 in) aft of the front left bumper corner and extended 144.0 cm (56.7 in) rearward. The combined direct and induced damage length (Field L) began 3.0 cm (1.2 in) aft of the front left bumper corner and extended 213.0 cm (83.9 in) rearward.

Six crush measurements were documented at the level of the mid-door: C1= 0 cm, C2= 4.0 cm (1.6 in), C3= 11.0 cm (4.3 in), C4= 11.0 cm (4.3 in), C5= 1.0 cm (0.4 in), C6= 0 cm. A *maximum crush value of 12.0 cm (4.7 in) was identified 14.0 cm (5.5 in) aft of the C4 position*. The Collision Deformation Classification (CDC) for this impact to the BMW was 09-LYEW-2 with a principal direction of force of (-)80 degrees. White/blue paint transfers were documented along the direct contact damage with pocketing noted aft of the left front wheel/tire. The pocketing tapered into surface scratching forward to the bumper area, which allowed for use of the body contour crush documentation method. Induced damage to the left front door produced outward buckling to the upper window frame area (*no passenger compartment integrity loss*). Reduction in the right wheelbase measured 2.5 cm (1.0 in) as the left wheelbase was elongated 1.5 cm (0.6 in). The windshield and tempered glazings remained undamaged.

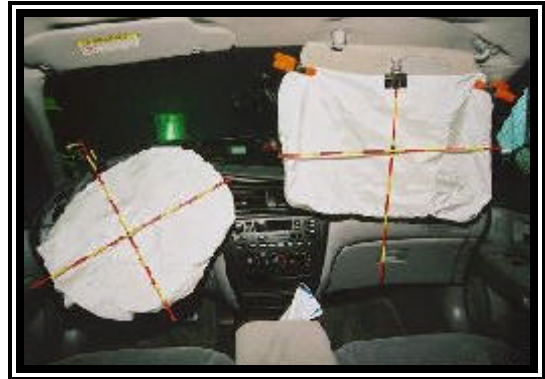
The 2000 Ford Taurus LX was equipped with dual stage frontal air bags for the driver and front right passenger positions. The air bags deployed as a result of the crash (**Figure 5**). The driver air bag was identified by the following part number: P5206000-00D with a bar coded lot number of:

Figure 5. 2000 Ford Taurus LX deployed frontal air bags.

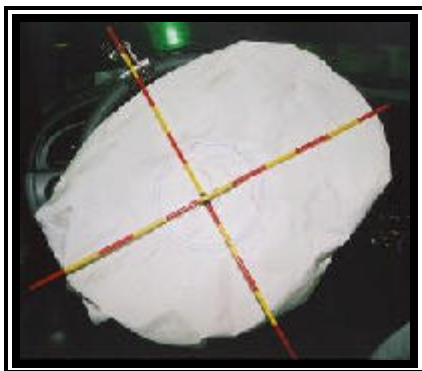
identified on the air bag or exterior surface of the module cover flaps. The diameter of the driver air bag measured 58.2 cm (22.9 in) in its deflated state (**Figure 6**). The bag was tethered by two internal straps and vented by two 3.3 cm (1.3 in) diameter ports located at the 10 o'clock and 2 o'clock sectors on the rear aspect of the air bag. Rearward air bag excursion measured 29.0 cm (11.4 in) from the steering wheel hub.

Figure 6. 2000 Ford Taurus LX deployed driver air bag.

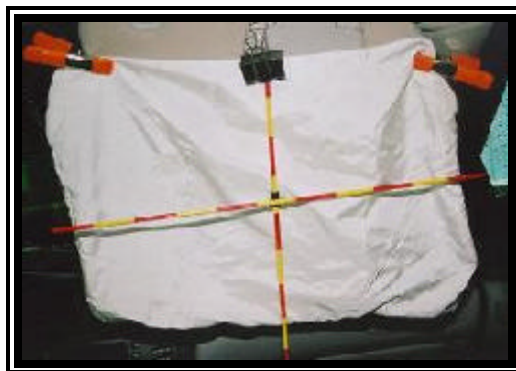
The front right passenger air bag deployed from the right top instrument panel area with a single cover flap design hinged at the forward aspect. The cover flap was rectangular in shape and measured 27.5 cm (10.8 in) in width and 12.5 cm (4.9 in) in height. Although no contact evidence was identified on the exterior surface of the module cover flap, multiple black vinyl transfers were noted across the face of the bag from expansion within the module. The passenger air bag measured 58.6 cm (23.1 in) in width and 45.0 cm (17.7 in) in height in its deflated state (**Figure 7**). The bag was vented by two 5.6 cm (2.2 in) diameter ports located at the 9 o'clock and 3 o'clock sectors on the side aspect of the bag. No internal tether straps were present. Rearward air bag excursion measured 46.0 cm (18.1 in) from the aft portion of the right instrument panel.

Figure 7. 2000 Ford Taurus LX deployed passenger air bag.

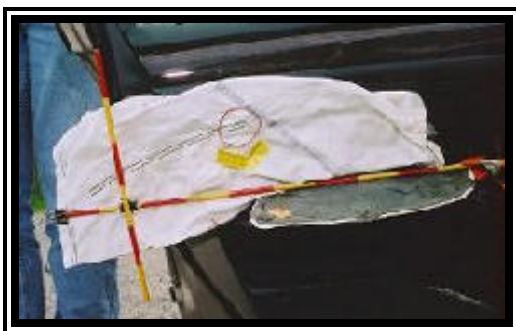
The 2001 BMW 325xi was equipped with door mounted side impact air bags for the front seated positions. The left front side impact air bag deployed as a result of the crash (**Figure 8**). The air bag modules were housed in the door panel above the armrest [32.0 cm (12.6 in) above floor level] with a single cover flap design hinged at the lower aspect. The flap was rectangular in shape and measured 25.0 cm (9.8 in) in width and 10.0 cm (3.9 in) in height. No contact evidence was identified on the exterior surface of the module cover flap, however, a small smudge mark was documented along the centered portion of the air bag face. The air bag was rectangular in shape and measured 49.0 cm (19.3 in) in width and 21.4 cm (8.4 in) in height in its deflated state. The bag was tethered by a horizontal stitch pattern which extended across the face of the membrane into a circular figure. No vent ports were present. The side impact air bag sensors were located in the front door cavities.

Figure 8. 2001 BMW 325xi deployed left front side impact air bag.

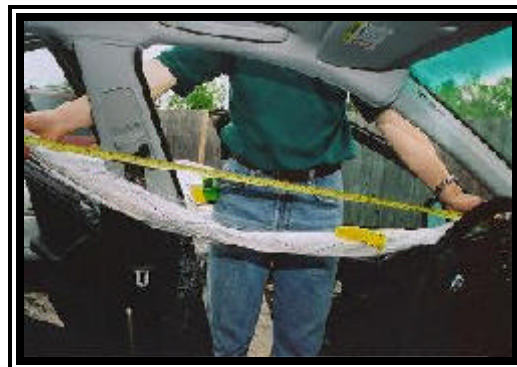
The BMW was also equipped with a head protection air bag for the front seated positions. The left side head protection air bag deployed as a result of the crash (**Figure 9**). The head air bag was housed between the interior roof headliner and structural roof side rail with a horizontal seam measuring 146.0 cm (57.5 in) in length (separation of the headliner versus an actual flap). The air bag measured 7.0 cm (2.8 in) in diameter and 104.0 cm (40.9 in) in length in its deflated state. The air bag was tethered by 22.0 cm (8.7 in) external straps connected to the left A-pillar and left rear roof side rail.

Figure 9. 2001 BMW 325xi deployed head protection air bag.

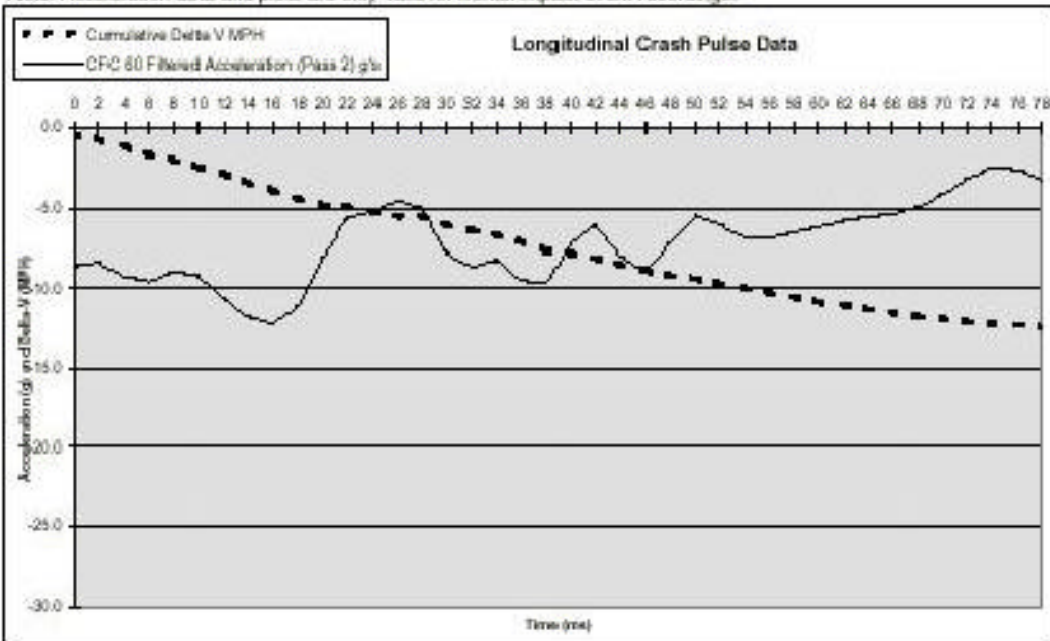
Longitudinal Cumulative Delta-V

Time (ms)	0	10	20	30	40	50	60	70	78
Delta-V (MPH)	-0.4	-2.4	-4.3	-6.1	-7.9	-9.4	-10.9	-12.0	-13.5

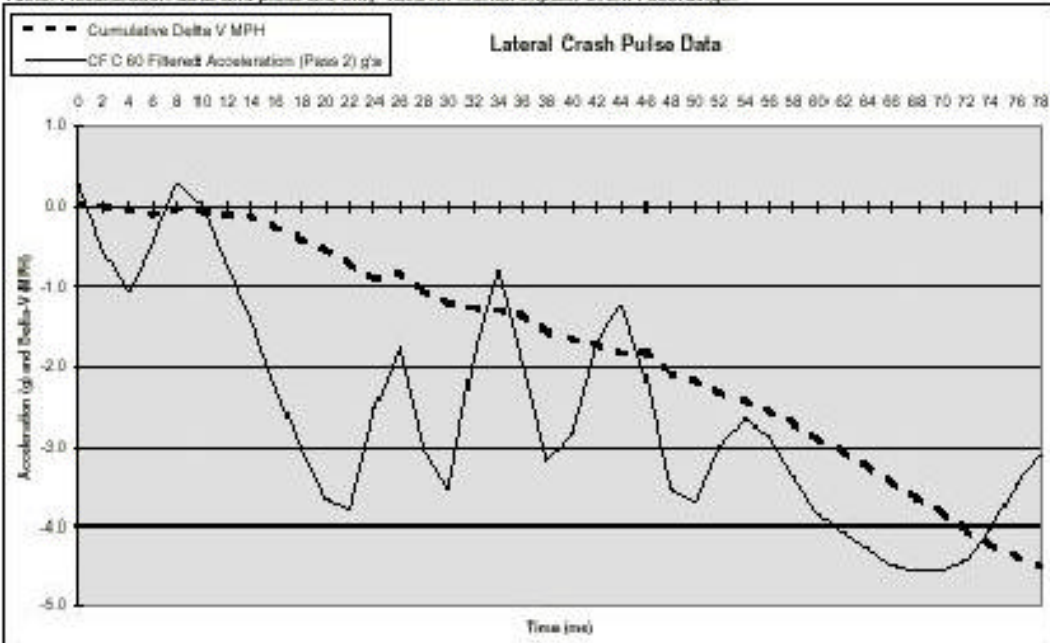
Figure 14. 2000 Ford Taurus LX EDR report.

Lateral Cumulative Delta-V

Time (ms)	0	10	20	30	40	50	60	70	78
Delta-V (MPH)	0.0	-0.1	-0.8	-1.2	-1.6	-2.2	-2.8	-3.4	-4.5
