## ON-SITE CHILD SAFETY SEAT INVESTIGATION

CASE NUMBER - IN01-028

VEHICLE - 2002 VOLKSWAGEN JETTA

CRASH DATE - December 2001

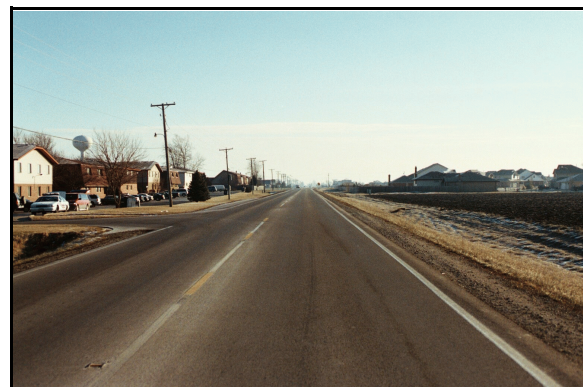
The case vehicle had been traveling east in the eastbound lane of a two-lane undivided local road and was stopped at a three-leg intersection, intending to turn left to travel north. The Chevrolet pickup was also traveling east in the eastbound lane of the same roadway, approaching the same intersection (**Figure 1**). The speed limit for the east-west roadway was 80 km.p.h. [50 m.p.h.], the asphalt surface was dry and free of defects, the weather was clear, it was dark but lighted by overhead street lamps, and there were no traffic controls for east-west traffic. The paved surface was 7.4 meters [24.3 feet] wide on the

**Figure 1:** Eastbound view of the intersection where the case vehicle was stopped, waiting to turn left, as the other vehicle approached from behind (case photo #01)

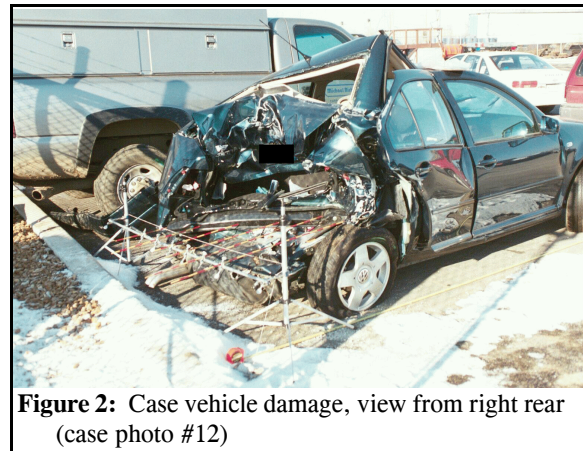
The case vehicle's initial contact with the Chevrolet pickup involved the right two-thirds of the back plane (**Figures 2 and 3**), but as the pickup penetrated the case vehicle's trunk and the case vehicle began rotating counterclockwise, the leftmost portion of the back plane was pulled inward, resulting in direct contact across the entire back plane and induced damage on the left quarter panel. Maximum crush was measured as 109 centimeters [42.9 inches] at C5. The wheelbase on the case vehicle's left side was stretched 7 centimeters [2.8 inches] while the right side was shortened 3 centimeters [1.2 inches]. The case vehicle's back bumper cover was torn off and the

**Figure 2:** Case vehicle damage, view from right rear (case photo #12)

bumper was separated from the mounting brackets, with the right end of the bumper pushed forward through the trunk space and against the back of the second row bench seat. The trunk floor and spare tire well were forced slightly downward, but were otherwise essentially undamaged as the pickup's override penetration pushed the back components forward. The trunk lid was folded double against the base of the back light, the right quarter panel was crushed forward to the right C-pillar, and the C-pillar was pushed forward resulting in the roof buckling upward 23 centimeters [9.1 inches] in the area of the right back door. The right back door was deformed outward and was jammed shut. The left quarter panel was curled and pulled inward. There was induced damage up to the left C-pillar, but the left back door remained closed and operational. The two rear tires were both deflated and restricted by deformed body panels. The back light glazing disintegrated, but there was no other glazing damage.

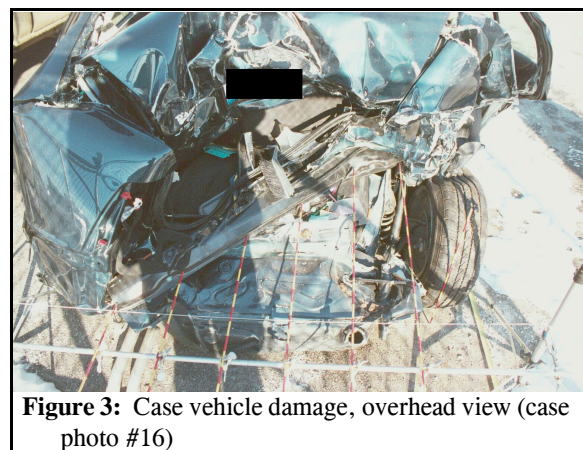
**Figure 3:** Case vehicle damage, overhead view (case photo #16)

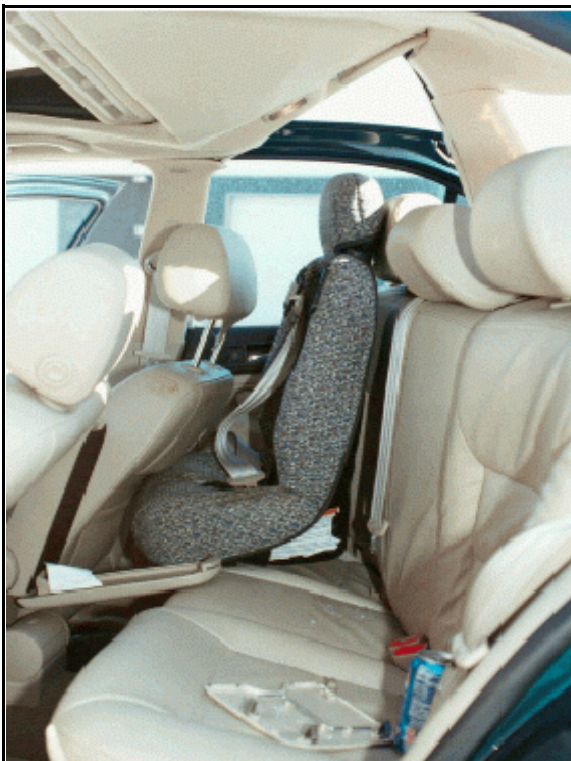
Inspection of the case vehicle's interior revealed major back-to-front intrusion in the second seat row on the right, combined with rearward deformation of the front right seat back (**Figure**

**Figure 4:** Case vehicle's second seat row, showing intrusion in the area where the booster seat was positioned (case photo #26)

4). At the inspection, the front right seat back was tilted at an angle of approximately 40 degrees rearward of vertical. The driver's seat back was also slightly deformed rearward, more on the left side. The left (outboard) edge of the driver's seat back was tilted at an angle of approximately 40 degrees rearward of vertical while the right (inboard) edge was approximately 30 degrees rearward of vertical. The pre-impact adjustments of the seat backs are not known. The front right seat back was flexed rearward by the rear impact crash pulse due to the front right occupant's inertial loading, causing a tear in the upholstery seam along the front outboard edge (**Figure 5**).

The right edge of the second row seat back and the head restraint were displaced forward 34 centimeters [13.4 inches], and the right C-pillar was crushed forward 26 centimeters [10.2 inches]. Note that the foregoing intrusion measurements reflect the residual effects of the impact. The dynamic crush certainly caused intrusion of greater magnitude, probably compressing the second row right occupant against the front right seat back, which was occupied by an adult male. The front right seat back had two areas of blood smear (**Figure 6**). One, in the center of the back surface directly below the head restraint, was probably the result of contact by the second row right occupant during the crash. The other, on the inboard side surface at the upper corner, probably occurred when the second row right occupant was removed from the vehicle.

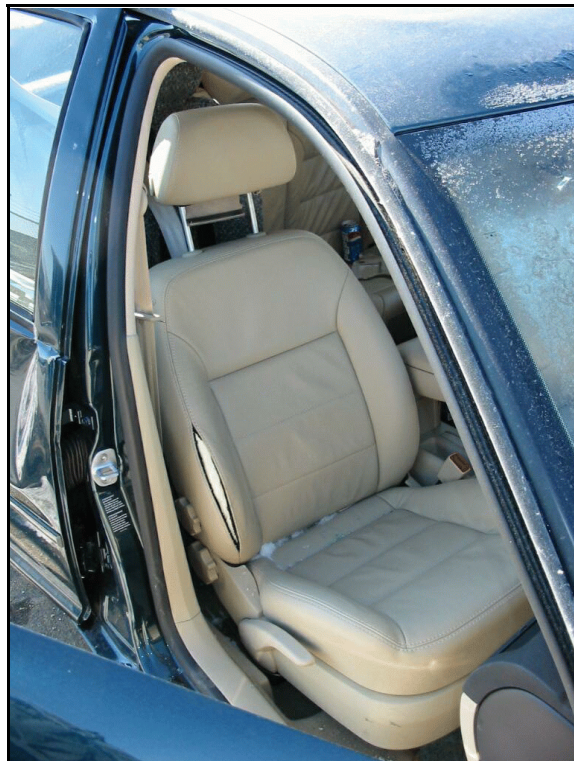
**Figure 5:** Front right passenger's seat, showing torn upholstery seam due to rearward flexing of the seat back (case photo #24)

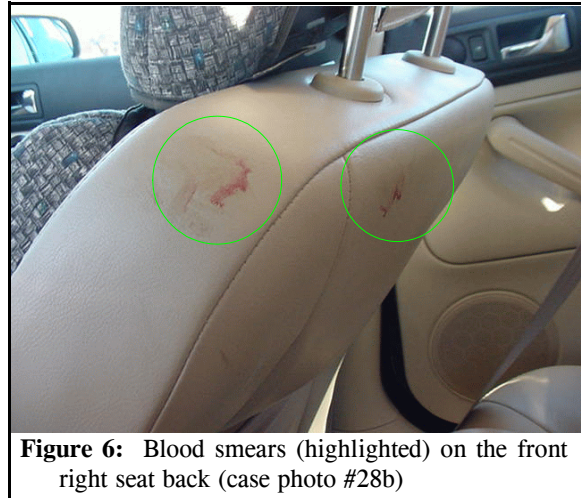
**Figure 6:** Blood smears (highlighted) on the front right seat back (case photo #28b)

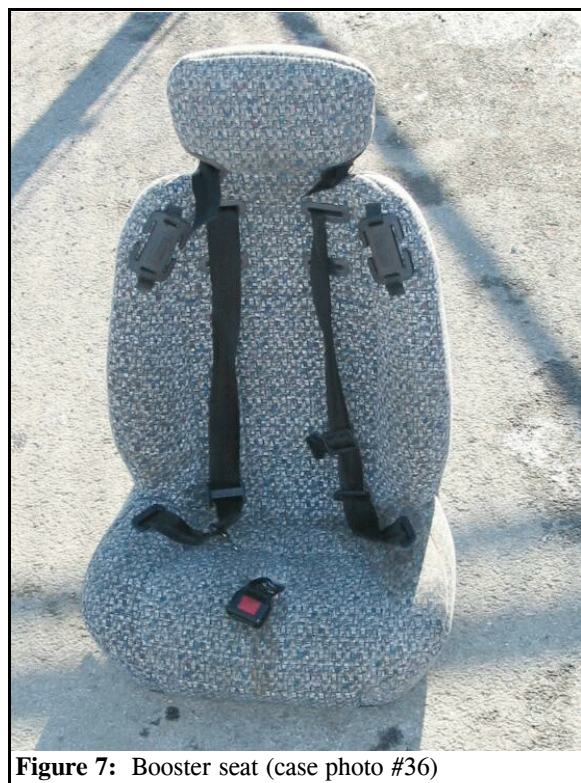
The second row right passenger was seated in a Century Breverra Classic belt-positioning booster seat (Century Products, model #4865RCK, date 10/08/97) (**Figure 7**). The

**Figure 7:** Booster seat (case photo #36)

booster seat was equipped with a five-point integral harness system, but this was not in use (i.e., the five-year-old was sitting on the booster seat's harness webbing). Inspection of the booster seat showed that it had been heavily used but had no obvious defects. The harness webbing was creased against the body of the booster seat, indicating that it had not been used to buckle the child into the booster seat recently. The body of the booster seat was a single piece of molded, thick, vinyl-like plastic, without excessive wear. There was a small dent in the plastic at the front right edge of the booster seat's cushion.

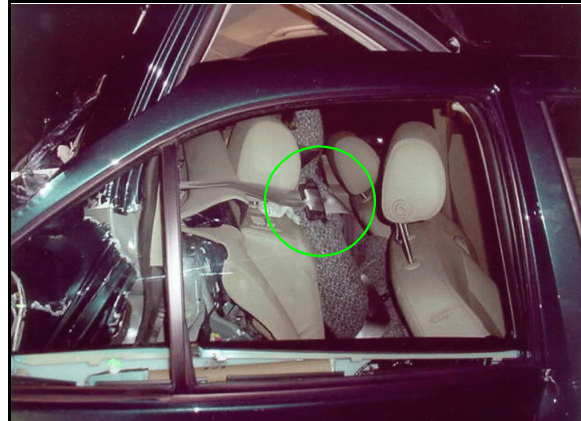
The booster seat was positioned in the second row right position in the case vehicle. This seat position was fitted with the Lower Anchor and Tethers for Children (LATCH) system and a continuous loop, three-point safety belt with a sliding latch plate and a switchable retractor. The four-year-old booster seat did not include the LATCH components, no tether was added and the LATCH system features in this vehicle were not in use. Because the retractor was crushed as a result of the impact, it is not known if the switchable retractor was in ALR or ELR mode. At the time of the vehicle inspection, a substantial length of the safety belt webbing was drawn out off the spool, laying on the seat with the latch unbuckled. The damage to the retractor and/or deformation of the chassis along the belt's path through the C-pillar to the retractor probably prevented the spool from reeling in this slack webbing. The booster seat was equipped with a belt positioning guide clip at the upper right corner, with the shoulder portion of the vehicle's manual safety belt system threaded through the guide at the time of the crash (**Figure 8**). The driver indicated (through her attorney) that the child was restrained by the vehicle's safety belt system, but there was no evidence to support or refute this assertion. The absence of evidence is, however, not conclusive because the rear-impact configuration of this crash did not result in any loading of the safety belt system as is seen in frontal collisions. There is no reason to doubt the driver's assertion and this contractor concludes that the child was restrained by the vehicle's safety belt system.

**Figure 8:** On-scene view of right rear seat position, looking through right rear door window; note vehicle's shoulder belt threaded through booster seat's positioning guide clip (highlighted) (case photo #63)

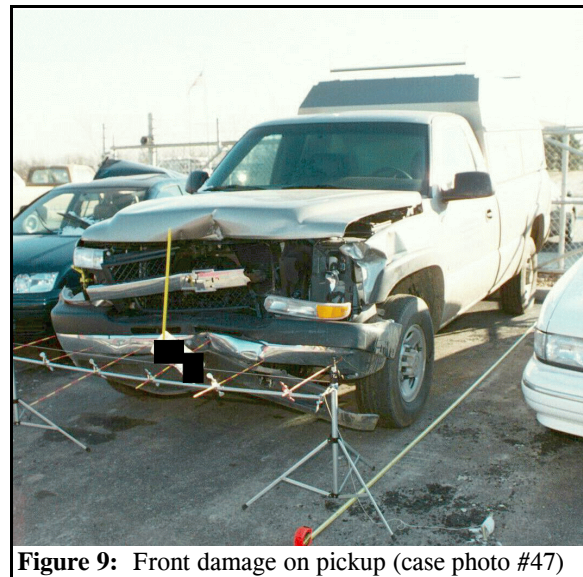
The impact with the case vehicle involved direct contact to the left half of the pickup's front (**Figure 9**). Maximum crush was measured as 19 centimeters [7.5 inches] at C3, near the center of the bumper. The grille and left headlamp assembly were shattered, but the right headlamp was intact. There was direct contact on the leading edge of the hood from the case vehicle's C-pillar, and the radiator support bracket was bent and pushed rearward. The wheelbase was not changed on either side.

**Figure 9:** Front damage on pickup (case photo #47)

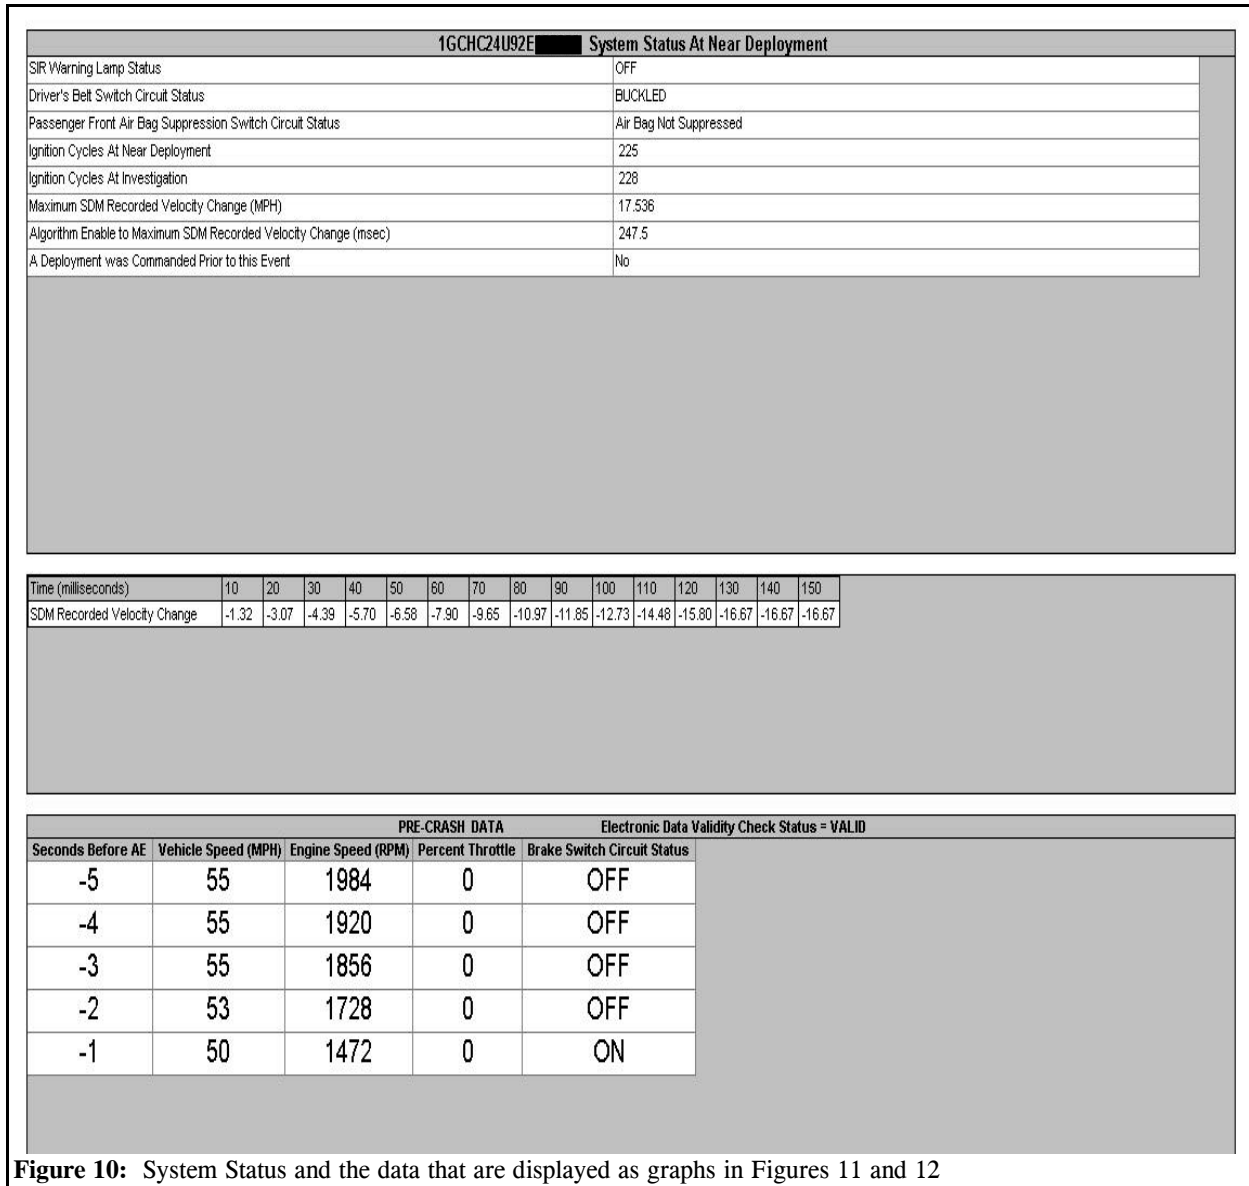
The pickup's EDR recorded a near deployment event that was successfully downloaded (**Figures 10, 11 and 12**). The EDR indicated that the pickup was coasting with zero throttle input at 89 km.p.h. [55 m.p.h.] five seconds prior to the impact and drifted down to 85 km.p.h. [53

Figure 10: System Status and the data that are displayed as graphs in Figures 11 and 12

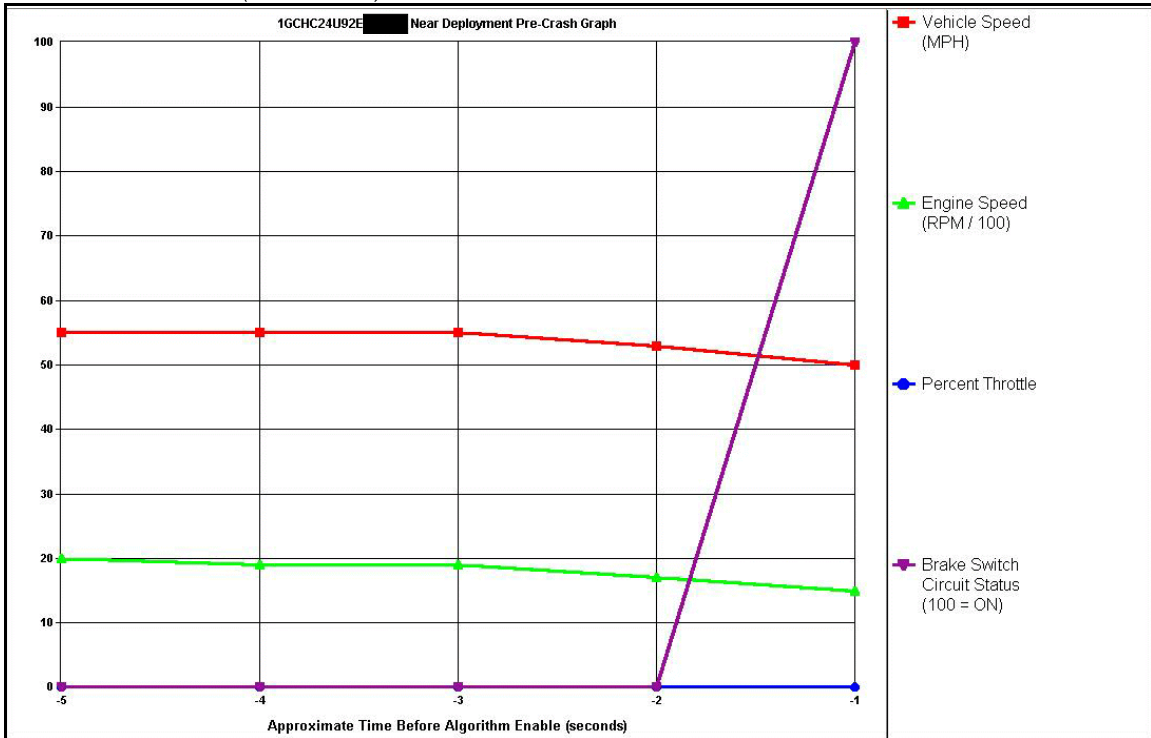
**Figure 11:** The pickup was coasting with zero throttle input at 89 km.p.h. [55 m.p.h.] five seconds prior to the impact and drifted down to 85 km.p.h. [53 m.p.h.] when the driver applied the brakes two seconds prior to the impact

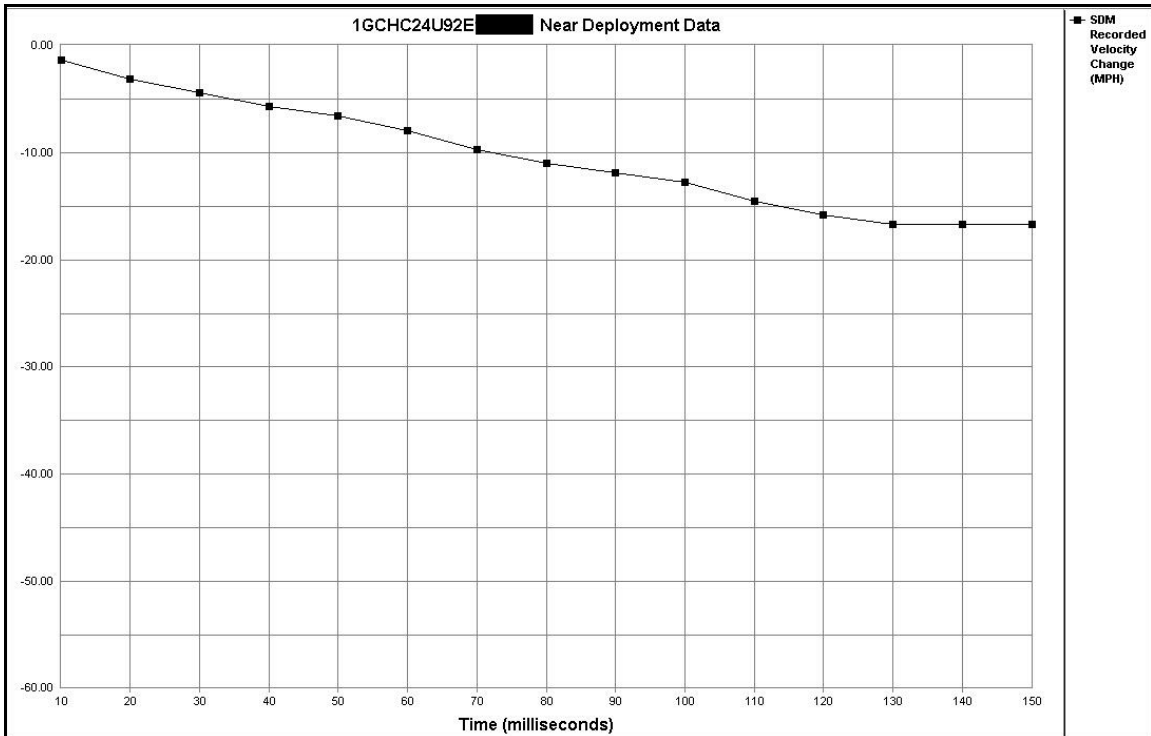
m.p.h.] at -2 seconds. The pickup's driver braked and the pickup was recorded as traveling at 80 km.p.h. [50 m.p.h.] one second prior to the impact. The maximum recorded velocity change was -28 km.p.h. [-17.5 m.p.h.] at 248 milliseconds [0.248 seconds] after the impact. The EDR-recorded Delta V is 3 km.p.h. [1.9 m.p.h.] greater than the WinSMASH reconstruction Delta V.

**Figure 12:** The pickup sustained -27 km.p.h. [-16.7 m.p.h.] Delta V at 150 milliseconds, with maximum Delta V of -28 km.p.h. [-17.5 m.p.h.] at 248 milliseconds (see Figure 10)
