**VERIDIAN ON-SITE ADAPTIVE AND EVENT DATA  
RECORDER (EDR) EQUIPPED VEHICLE INVESTIGATION**

**VERIDIAN CASE NO. CA01-036**

**VEHICLE - 2000 CHEVROLET G2500 EXPRESS VAN**

**CRASH DATE - JUNE, 2001**

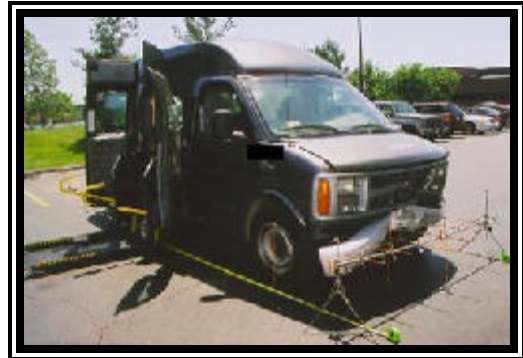
The 2000 Chevrolet G2500 Express van sustained moderate frontal damage as a result of the impact with the 1998 Mazda 626 (**Figure 3**). The direct contact damage began 15.0 cm (5.9 in) inboard of the front left bumper corner and extended to the right 154.0 cm (60.6 in). The impact deformed the entire front end width resulting in a combined direct and induced damage length (Field L) of 173.0 cm (68.1 in). Six crush measurements were documented at the level of the bumper: C1= 21.0 cm (8.3 in), C2= 31.0 cm (12.2 in), C3= 47.0 cm (18.5 in), C4= 24.0 cm (9.4 in), C5= 4.0 cm (1.6 in), C6= 0 cm. The Collision Deformation Classification (CDC) for this impact to the Chevrolet 12-FDEW-4 with a principal direction of force of (-)10 degrees. Dark colored paint transfers were documented along the direct contact damage. An indentation was identified to the center bumper area and attributed to the front right bumper corner on the Mazda. The hood was deformed up and rearward from the impact force. Both fenders were displaced slightly rearward (no restricted/deflated wheels). Reduction in the left side wheelbase measured 1.5 cm (0.6 in). All glazing remained undamaged.

**Figure 3. Frontal damage to the 2000 Chevrolet G2500 Express van.**

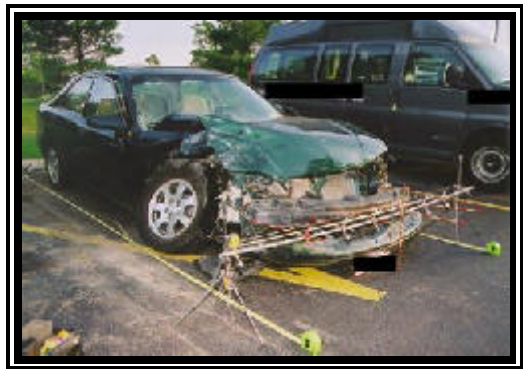
The 1998 Mazda 626 4-door sedan sustained moderate frontal damage as a result of the impact with the 2000 Chevrolet Express van (**Figure 4**). The direct contact damage began at the front right bumper corner and extended 88.0 cm (34.6 in) inboard. The impact deformed the entire front end width resulting in a combined direct and induced damage length (Field L) of 140.0 cm (55.1 in). Six crush measurements were documented at the level of the reinforcement bar (*bumper fascia separation*): C1= 4.5 cm (1.8 in), C2= 1.5 cm (0.6 in), C3= 4.5 cm (1.8 in), C4= 6.50 cm (2.6 in), C5= 8.5 cm (3.3 in), C6= 18.5 cm (7.3 in). A secondary crush profile was obtained 11.0 cm (4.3 in) above the level of the bumper to capture the underride damage resulting in an *averaged profile* of: C1= 5.0 cm (2.0 in), C2= 11.0 cm (4.3 in), C3= 19.0 cm (7.5 in), C4= 20.0 cm (7.9 in), C5= 20.0 cm (7.9 in), C6= 19.0 cm (7.5 in). The CDC for this impact to the Mazda was 01-FZEW-2 with a principal direction of force of (+)20 degrees. The hood was deformed up and rearward from the impact force. The right fender was displaced rearward which restricted the right front wheel/tire (not deflated). Direct contact damage was also documented on the right fender and attributed sustained vehicle contact (wrap contact) during post-impact travel to

**Figure 4. Front right damage to the 1998 Mazda 626.**

final rest. The left front tire was deflated (not restricted) with minor abrasions noted on the wheel. Induced contact damage produced buckling along the right A-pillar and B-pillar. The windshield was fractured in multiple locations from exterior impact forces (only). Reduction in the right side wheelbase measured 4.5 cm (1.8 in) while elongation of the left side wheelbase measured 2.0 cm (0.8 in).

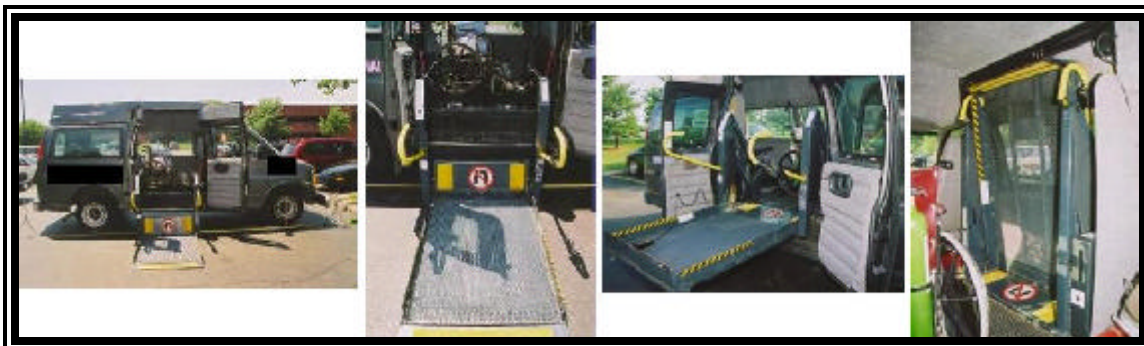
The 2000 Chevrolet G2500 Express van was modified for the transport of wheelchair patients. Placards affixed to the hydraulic arms confirmed that the modifications complied with ADA and national school bus standards, however, police removed the vehicle from service (post-crash) due to inadequate/non-operational restraints for the wheelchair passengers. The adaptive vehicle was equipped with a hydraulic wheelchair lift system (**Figure 5**) with a maximum load rating of 362.9 kg (800.0 lb). The lift system operated from the right rear doors which must be latched in the full open position for the mechanism to operate. The lift system utilized both an automatic and manual release design. To automatically deploy the lift, the operator must first fully open the rear doors, activate the “deploy” switch on the remote unit (stowed on the aft side door) to unfold the platform to the vehicle floor level, and then activate the “down” switch to lower the platform to ground level. The operator must enter the platform centrally facing outward and lock the wheelchair brakes. The operator activates the “up” switch to raise the platform to the vehicle floor level, then release the wheelchair brakes to enter the vehicle. The operator must activate the “stow” switch to fold the platform, which stops automatically when completely folded. A manual lever is provided with operational instructions and located adjacent to the aft lift arm. Warning labels were affixed to key components of the lift system for safe operation and use, as designated handrails and platforms were identified by yellow paint markings. The roof encompassed the full length of the vehicle (header to backlight) and extended 37.0 cm (14.6 in) above the level of the side rail for increased headroom. There was no damage or separation of the fiberglass roof from the vehicle sheet metal.

**Figure 5. Wheelchair lift system in the down and retracted position.**

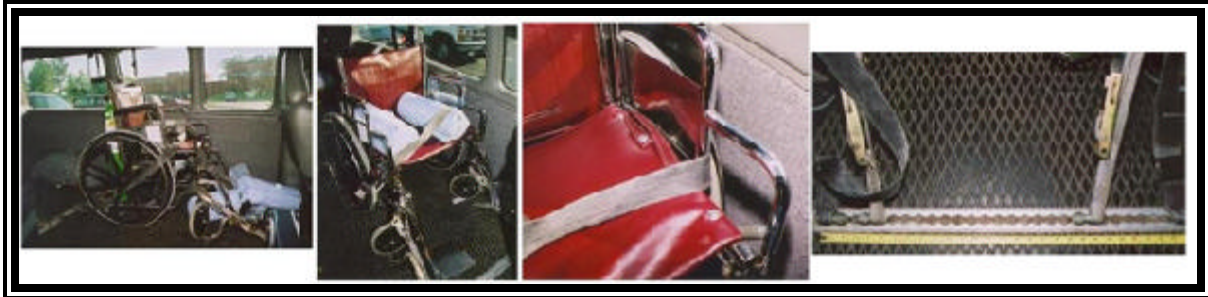
The 79 year old female passenger of the 2000 Chevrolet Express van was seated in a manually operated wheelchair (**Figure 6**) secured in the rear left area by a nylon strap harness system. The wheelchair harness system utilized a floor anchorage system as the nylon straps are looped through the designated frame slots and secured to the floor with adjustable fasteners. Improper placement of the 2-point manual lap belt through the wheelchair frame resulted in impact related deformation to the frame and hip panels. Small pillows were identified in the wheelchair which were placed between the hip and side panel. An oxygen tank was found strapped to the rear of the wheelchair.

**Figure 6. Passenger wheelchair.**

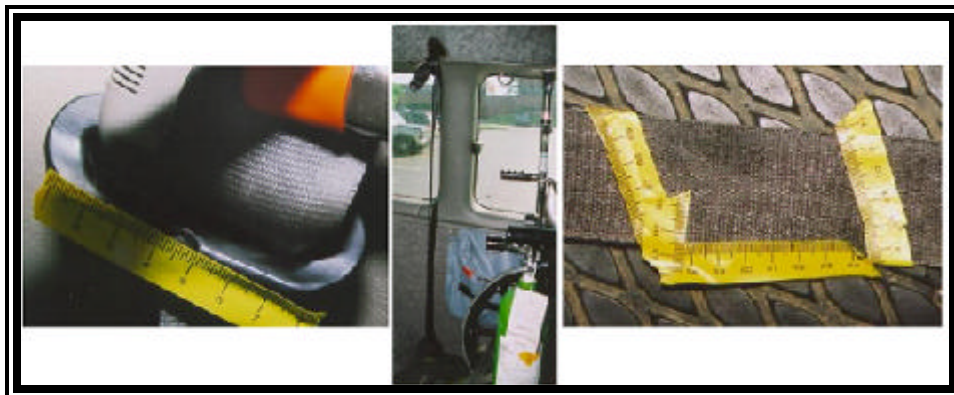
The interior of the Chevrolet Express consisted of a two passenger seating configuration with front box-mounted (van type) bucket seats. The driver 3-point manual lap and shoulder belt system consisted of a continuous loop belt webbing with a sliding latchplate and a dual mode retractor (inertial lock/belt sensitive). Loading evidence consisted of light abrasions to the D-ring and latchplate with an associated transfer to the shoulder belt webbing. The front right seating position was equipped with a 3-point manual lap and shoulder belt system which consisted of a continuous loop belt webbing with a sliding latchplate and a retractor equipped with an inertial and switchable lock mechanism. The Chevrolet was not equipped with pretensioner devices for the front seating positions. The rear (two) wheelchair positions were equipped with 3-point manual lap and shoulder belt systems which consisted of a non-integral/non-continuous loop belt webbing with a fixed latchplate and a dual mode retractor (inertial lock/belt sensitive). Tissue was identified on the lap belt webbing of the rear left restraint as the shoulder portion was found to be tied off and rendered non-operational (**Figure 7**).

**Figure 7. Loading evidence to the driver's D-ring and rear left manual lap belt.**

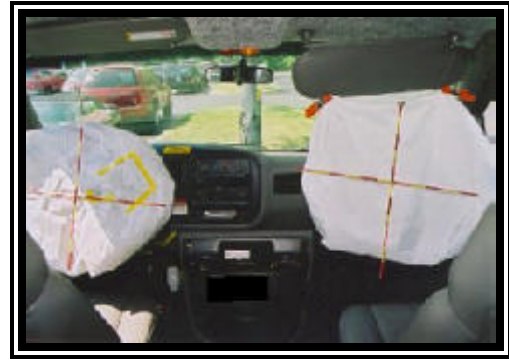
The 2000 Chevrolet G2500 Express van was equipped with redesigned frontal air bags for the driver and front right passenger positions which deployed as a result of the crash (**Figure 8**). The driver air bag was identified by the following part number: \*P16761159008\* with a bar coded lot number of: \*TML1308S1363\*. The air bag was housed in the center of the steering wheel with a vertically oriented flap tear seam (I-configuration). The flaps were symmetrical in shape and measured 6.7 cm (2.6 in) in width and 10.7 cm (4.2 in) in height. No contact evidence was identified on the exterior surface of the module cover flaps. Light smudge marks were documented across the lower portion of the air bag face along with black vinyl transfers to the upper left quadrant from expansion within the module. The diameter of the driver air bag measured 65.0 cm (25.6 in) in its deflated state (**Figure 9**). The bag was tethered by four internal straps and vented by two 2.7 cm (1.1 in) ports located at the 10 o'clock and 2 o'clock sectors on the rear aspect of the air bag. Rearward air bag excursion measured 23.0 cm (9.1 in) from the steering wheel hub.

**Figure 8. 2000 Chevrolet Express deployed redesigned frontal air bag system.**

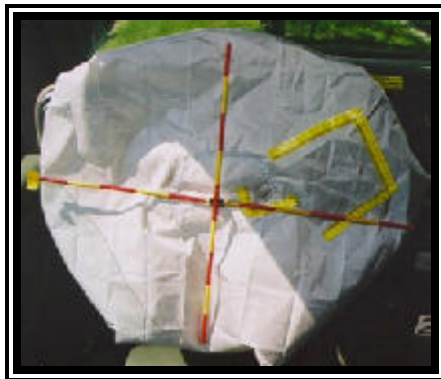
**Figure 9. 2000 Chevrolet Express deployed redesigned driver air bag.**

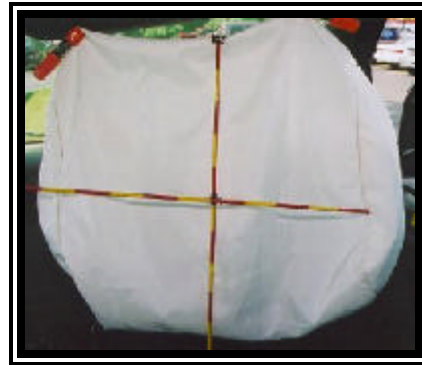
The front right passenger air bag deployed from the right mid-instrument panel area with a horizontally oriented flap tear seam (H-configuration). The flaps were rectangular and symmetrical in shape and measured 32.0 cm (12.6 in) in width and 6.5 cm (2.6 in) in height. No contact evidence was identified on the air bag or exterior surface of the module cover flaps. The passenger air bag measured 63.0 cm (24.8 in) in width and 58.0 cm (22.8 in) in height in its deflated state (**Figure 10**). The bag was vented by two 4.5 cm (1.8 in) diameter ports located at the 10 o'clock and 2 o'clock sectors on the side aspect of the bag. No internal tether straps were present.

**Figure 10. 2000 Chevrolet Express deployed redesigned passenger air bag.**

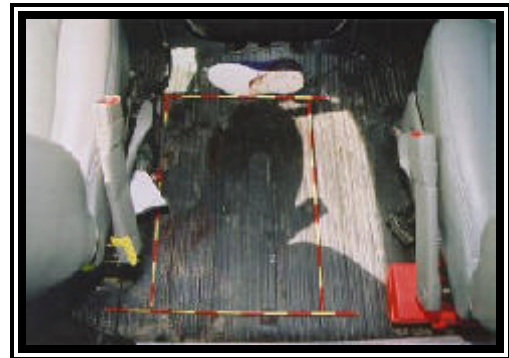
Figure 11. Blood stained shoe and pooling area.

At impact, the rear left passenger initiated a forward trajectory in response to the 12 o'clock impact force and submarined the manual lap restraint resulting in an abrasion to the anterior aspect of the neck and unspecified fatal liver and spleen injuries. She also sustained a laceration of the medial right ankle from contact to the driver's lower seat back frame. This injury mechanism was evidenced by the location of the injury relative to the deformation documented to this component. Following the crash, the Chevrolet driver reportedly found the passenger slumped forward onto the floor (partially out of the wheelchair) with the lap restraint around her neck. Her lower extremities were positioned in the front center floor area in a pool of blood (**Figure 11**). The driver unbuckled the lap belt and laid the passenger onto the rear floor area as rescue personnel arrived on-scene within minutes of the crash to find her semi-responsive. The rear left passenger was subsequently transported by ambulance to a local trauma center and pronounced deceased approximately 52 minutes following the crash. Injury information is limited as the driver and his attorney refused the SCI interview.

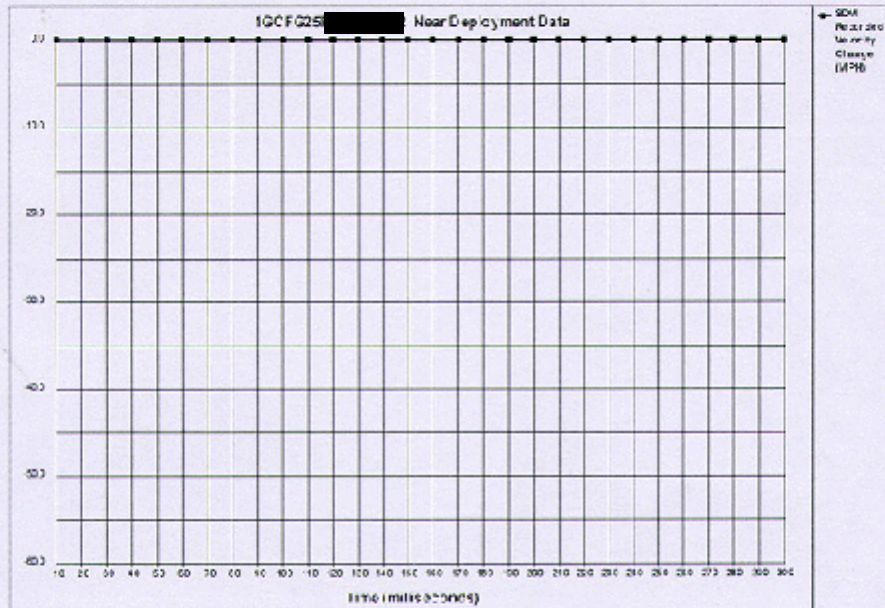
SIR Warning Lamp Status	OFF
Driver's Belt Switch Circuit Status	BUCKLED
Passenger Front Air Bag Suppression Switch Circuit Status	Air Bag Not Suppressed
Ignition Cycles At Near Deployment	2739
Ignition Cycles At Investigation	2621
Algorithm Enable to Maximum EDM Recorded Velocity Change (msec)	0
Maximum EDM Recorded Velocity Change (MPH)	0

Figure 13. 2000 Chevrolet Express van EDR report (unrelated near deployment event).

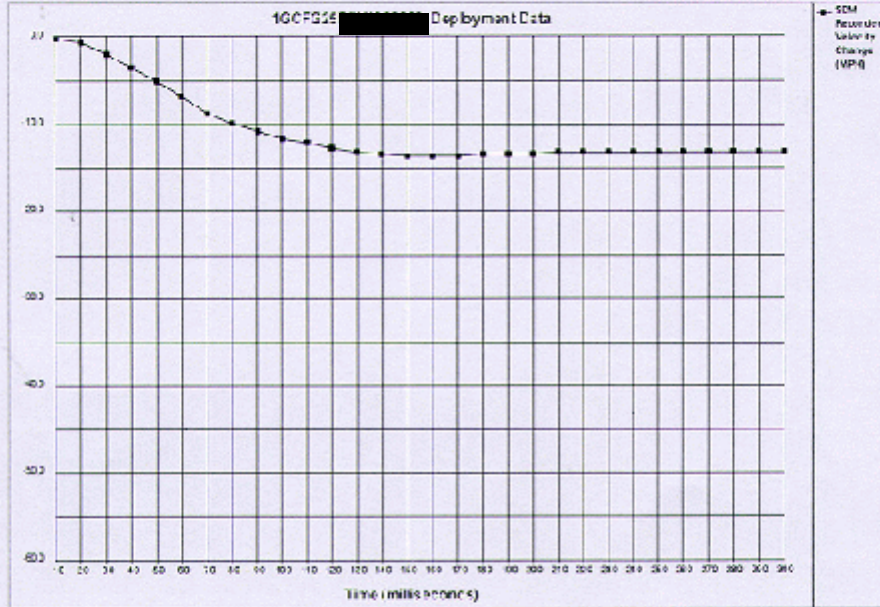
SIR Warning Lamp Status	OFF
Driver's Belt Switch Circuit Status	BUCKLED
Passenger Front Air Bag Suppression Switch Circuit Status	Air Bag Not Suppressed
Ignition Cycles At Deployment	2504
Ignition Cycles At Investigation	2521
Time From Algorithm Enable To Deployment Command (msec)	21.26
Time Between Near Deployment And Deployment Events (sec)	N/A

Figure 14. 2000 Chevrolet Express van EDR report (deployment event).
