**VERIDIAN ON-SITE SIDE IMPACT OCCUPANT PROTECTION
INVESTIGATION**

VERIDIAN CASE NO. CA01-041

VEHICLE - 2001 VOLKSWAGEN JETTA

CRASH DATE - FEBRUARY, 2001

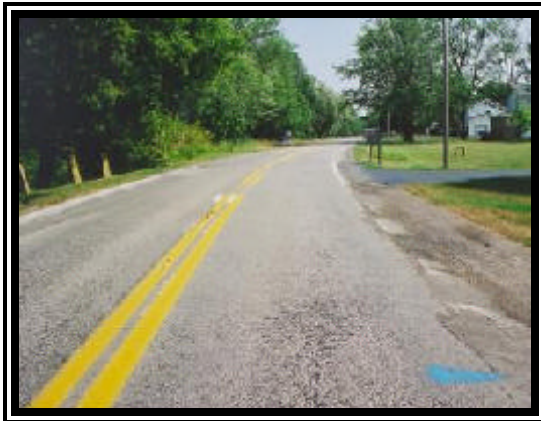
The 16 year old male driver of the 1987 Toyota Celica 2-door coupe was operating the vehicle eastbound (**Figure 1**) and negotiating a right curve at a (police reported) unknown speed when he allowed the vehicle to cross the centerline into the path of the westbound 2001 Volkswagen Jetta. The police reported no tire marks at the scene indicative of driver avoidance maneuvers.

Figure 1. Eastbound approach for the 1987 Toyota Celica 2-door coupe.

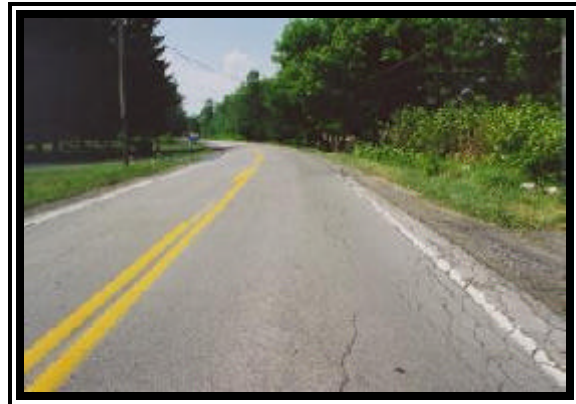
The 43 year old male driver of the 2001 Volkswagen Jetta was operating the vehicle westbound (**Figure 2**) on approach to a left curve at a (driver reported) speed of 72 km/h (45 mph) when he observed the 1987 Toyota Celica cross his path of travel. Upon recognition of the impending harmful event, the Volkswagen driver steered right and slowed (braked) the vehicle to a speed of 8 km/h (5 mph) as he partially departed the north (right) pavement edge prior to the collision.

Figure 2. Westbound approach for the 2001 Volkswagen Jetta 4-door sedan.

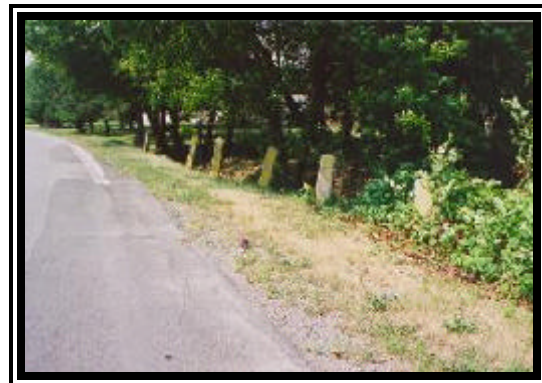
At this point, the Volkswagen Jetta rotated 210 degrees counterclockwise and traveled approximately 11.9 meters (39.0 feet) in a northwesterly direction as the left rear side surface struck a concrete post (**Figure 3**) resulting in minor damage. Although the impact was classified as out-of-scope (*yielding object*), the WinSMASH reconstruction program computed a barrier equivalent velocity change of 5.3 km/h (3.3 mph) with a latitudinal component of 5.2 k/h (3.2 mph). The impact deployed the Volkswagen's

Figure 3. 2001 Volkswagen Jetta northwest post-impact trajectory to secondary impact with a roadside concrete post.

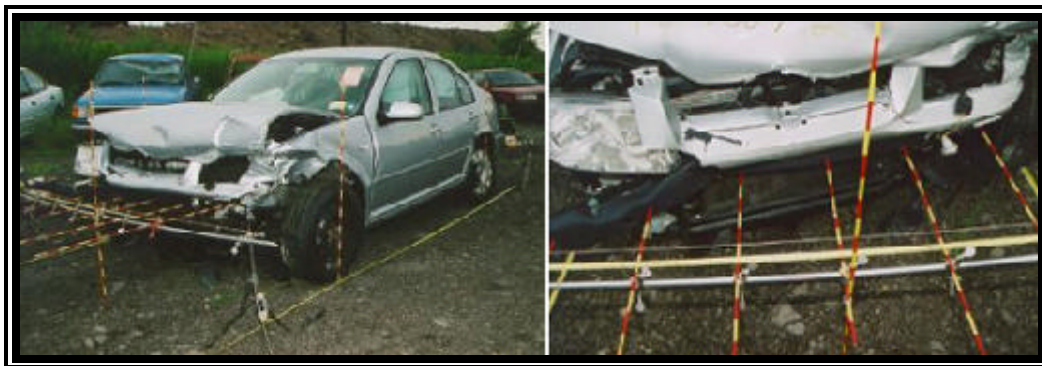
The 2001 Volkswagen Jetta sustained moderate frontal damage as a result of the impact with the 1987 Toyota Celica (**Figure 4**). The direct contact damage began at the front left bumper corner and extended 94.0 cm (37.0 in) inboard. The impact deformed the entire front end width resulting in a combined direct and induced damage length (Field L) of 119.0 cm (46.9 in). Six crush measurements were documented at the level of the reinforcement bar (*bumper fascia separation*): C1= 27.5 cm (10.8 in), C2= 22.5 cm (8.9 in), C3= 21.5 cm (8.5 in), C4= 18.5 cm (7.3 in), C5= 2.5 cm (1.0 in), C6= 0 cm. The Collision Deformation Classification (CDC) assigned for this initial impact to the Volkswagen was 11-FYEW-2 with a principal direction of force of (-)20 degrees. An indentation was

Figure 4. Front left damage to the 2001 Volkswagen Jetta.

documented along the reinforcement bar and attributed to the front left bumper corner of the opposing Toyota. The hood was deformed slightly up and rearward from the impact force. The left fender was deformed rearward which produced a partial restriction of the left front door opening. Induced contact damage produced minor roof buckling at the left B-pillar area. The windshield was fractured at the left lower A-pillar from exterior impact forces (only). All tempered glazing remained undamaged. Reduction in the left side wheelbase measured 4.0 cm (1.6 in).

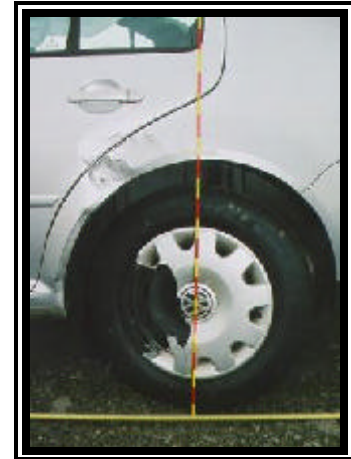
Direct contact damage was also identified to the left rear side surface and attributed to the concrete post impact (**Figure 5**). The direct contact damage began 108.0 cm (42.5 in) forward of the rear left bumper corner and extended forward 35.0 cm (13.8 in). The combined direct and induced damage length (Field L) began 96.0 cm (37.8 in) forward of the rear left bumper corner and extended forward 52.0 cm (20.5 in). Six crush measurements were documented at the level of the mid door: C1= 0, C2= 2.0 cm (0.8 in), C3= 4.0 cm (1.6 in), C4= 7.0 cm (2.8 in), C5= 3.0 cm (1.2 in), C6= 0 cm. The CDC assigned for this secondary impact was 09-LPEN-2 with a principal direction of force of (-)100 degrees. The hubcap was fractured as the left rear wheel was bent inward from the impact force. Unknown superficial contact damage (*red paint transfers - no crush*) was also identified on the rear left bumper corner and attributed to tow yard/salvage damage post-crash.

Figure 5. Left rear side surface damage to the 2001 Volkswagen Jetta.

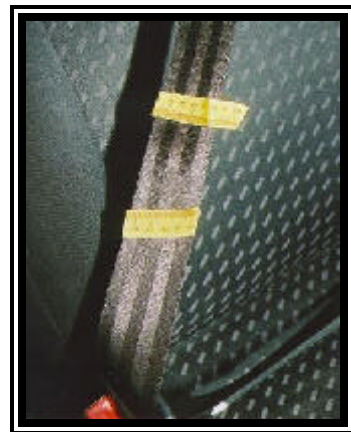
The interior of the Volkswagen Jetta consisted of a five passenger seating configuration with front bucket and a rear split bench seat (with folding backs). The driver 3-point manual lap and shoulder belt system consisted of a continuous loop belt webbing with a sliding latchplate and a dual mode retractor (inertial lock/belt sensitive). Dimpling was noted to the shoulder portion of the driver restraint and attributed to latchplate loading (**Figure 6**). The front right (and rear) seating position was equipped with a 3-point manual lap and shoulder belt system which consisted of a continuous loop belt webbing with a sliding latchplate and a retractor equipped with an inertial and switchable lock mechanism. The front restraint systems also included retractor pretensioners mounted in the lower B-pillars. The activated driver retractor pretensioner reduced the amount of slack in both the lap and shoulder belt webbing.

Figure 6. Loading evidence to the 2001 Volkswagen Jetta driver restraint.

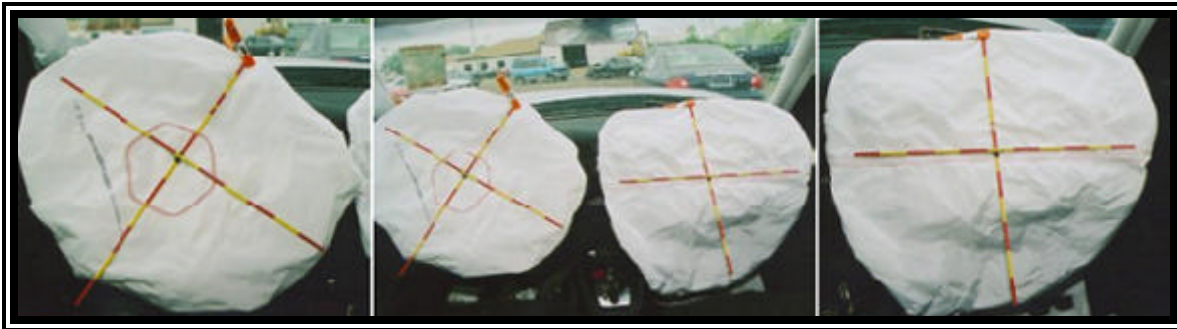
The 2001 Volkswagen Jetta was equipped with redesigned frontal air bags for the driver and front right passenger positions which deployed as a result of the crash (**Figure 7**). The driver air bag was housed in the center of the steering wheel with a horizontally oriented flap tear seam (H-configuration). The flaps were symmetrical in shape and measured 16.7 cm (6.6 in) in width and 6.1 cm (2.4 in) in height. No contact evidence was identified on the air bag or exterior surface of the module cover flaps. The diameter of the driver air bag measured 61.0 cm (24.0 in) in its deflated state. The bag was tethered by one internal strap and vented by one 5.0 cm (2.0 in) diameter port located at the 12 o'clock sector on the rear aspect of the air bag. Air bag excursion measured 29.0 cm (11.4 in) from the steering wheel hub.

Figure 7. 2001 Volkswagen Jetta deployed redesigned frontal air bags.

The front right passenger air bag deployed from the right mid-instrument panel area with a single cover module cover flap design hinged at the top aspect. The flap was rectangular in shape and measured 31.9 cm (12.6 in) in width and 17.6 cm (6.9 in) in height. No contact evidence was identified on the exterior surface of the cover flap, however, multiple black vinyl transfers were noted across the top portion of the bag face from expansion within the module. The passenger air bag measured 77.5 cm (30.5 in) in width and 70.0 cm (27.6 in) in height in its deflated state. The bag was tethered by one internal strap and vented by two 6.5 cm (2.6 in) diameter ports located at the 10 o'clock and 2 o'clock sectors on the side aspect of the air bag. Air bag excursion measured 54.0 cm (21.3 in) from the aft portion of the right instrument panel.

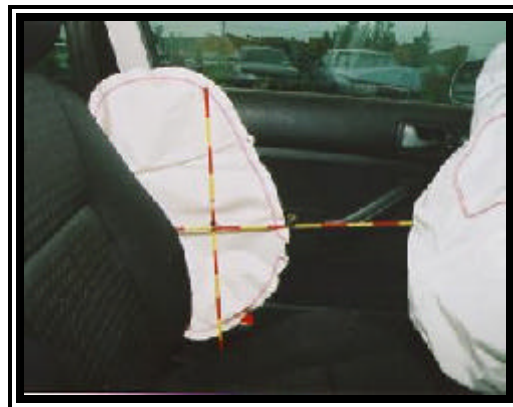
The Volkswagen was equipped with seat-mounted side impact air bags for the front seated positions. The driver side impact air bag deployed as a result of the impact with the concrete post (**Figure 8**). The air bag modules were housed in the outboard side aspect of the front seat backs [16.5 cm (6.5 in) above the level of the seat cushion] with a single cover flap design. No contact evidence was identified on the air bag or exterior surface of the module cover flap. The air bag was oval shaped and measured 29.5 cm (11.6 in) in width and 58.0 cm (22.8 in) in height in its deflated state. No internal tether straps or vent ports were present.

Figure 8. 2001 Volkswagen Jetta deployed driver side impact air bag.

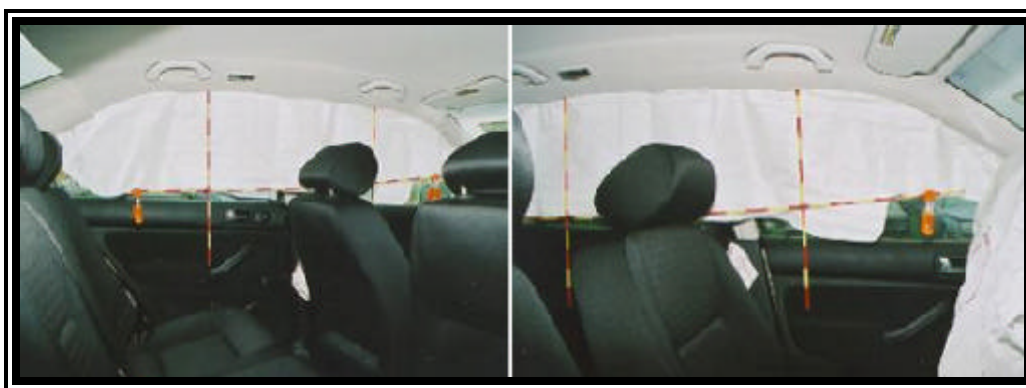
The Volkswagen was also equipped with side impact curtains for the outboard seating positions. The left side impact curtain deployed as a result of the impact with the concrete post (**Figure 9**). No contact evidence was identified to the side impact curtain. The side curtain air bag was housed between the interior roof headliner and structural roof side rail with a horizontal seam measuring 195.0 cm (76.8 in) in length (separation of the headliner versus an actual flap). Inflation was achieved by the use of a cold gas (stored) inflator located in the C-pillar. The air bag measured 180.0 cm (70.9 in) in width and 33.0 cm (13.0 in) in height in its deflated state. The air bag utilized a stitched tether design as no vent ports were present.

Figure 9. 2001 Volkswagen Jetta deployed left side impact curtain.

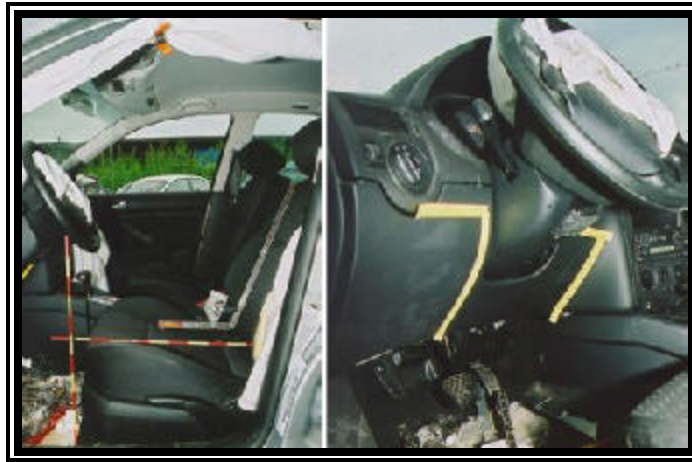
At impact with the 1987 Toyota Celica, the driver initiated a forward and slightly lateral trajectory in response to the 11 o'clock impact force and loaded the knee bolster, manual restraint, and deployed redesigned driver air bag. Loading of the knee bolster was evidenced by the scuff marks documented on each side of the steering column (**Figure 10**), however, no injury was reported as a result. Loading of the manual restraint resulted in a cervical strain which was a result of the sudden forward head movement as the body loaded the belt system (flexion). At this point, the driver initiated a lateral trajectory in response to the secondary 9 o'clock impact force and loaded the deployed side impact air bag and curtain. Contact to the deployed side impact curtain resulted in an abrasion to the posterior aspect of the left wrist, as evidenced by the aspect of the injury relative to the driver's stated placement of the left hand at the 10 o'clock position on the steering wheel rim during pre-crash avoidance maneuvers. Following the crash, he exited the vehicle under his own power through the left front door and was transported by ambulance to the emergency room of a local hospital for treatment and released within three hours. The deployed redesigned frontal, side impact air bag and curtain provided additional protection against further contact to frontal and left side components, and this, potential serious injury.

Figure 10. Interior view of the 2001 Volkswagen Jetta driver space.
