**ON-SITE SIDE IMPACT OCCUPANT PROTECTION SYSTEM CRASH
INVESTIGATION
SCI TECHNICAL SUMMARY REPORT**

VERIDIAN CASE NO. CA01-048

VEHICLE - 1999 BMW 328i

CRASH DATE - OCTOBER 2001

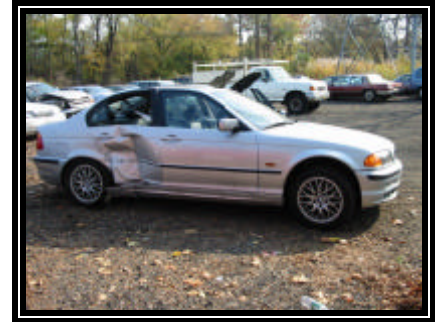
Figure 1. Damaged 1999 BMW 328i

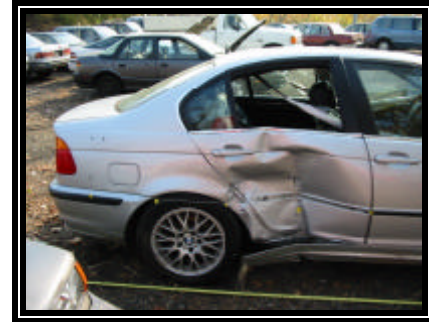
The 1999 BMW 328i sustained moderate right side damage as a result of the luminaire impact (**Figure 4**). The direct damage began 33.0 cm (13.0") aft of the leading edge of the right rear door and extended 48.3 cm (19.0") rearward. The height of the direct damage measured 80.0 cm (31.5") from the right sill to the top aspect of the door panel. The combined direct and induced damage began at the leading edge of the right rear door and extended rearward 194.9 cm (76.8") to the right rear bumper corner. The outline of the luminaire's frangible base was evident on the lower right aspect of the right rear door panel (**Figure 5**). The maximum crush was located 39.1 cm (15.4") aft of the leading edge of the right rear door at C2, and measured 19.1 cm (7.5") along the mid-level trim area. The maximum crush along the right sill was located 34.3 cm (13.5") aft of the leading edge of the right rear door and measured 22.9 cm (9.0"). The right rear door panel was crushed laterally from the side impact. The mid-door trim (rub strip) was separated from the door and the sill trim was separated at the leading edge of the right rear door. The right rear door was abraded and deformed in the shape of the frangible base, and exhibited a 7.6 cm (3.0") vertical laceration in the door panel located 1.3 cm (0.5") aft of C2 and 2.5 cm (1.0") above the mid-door trim line. The leading edge of the right rear quarter panel was abraded from direct contact. Grass and dirt were deposited on the partially separated sill trim and were present in the right rear fender. The entire right rear door was displaced slightly due to the lateral crush and induced buckling and was jammed shut. The right front door sustained minor displacement from induced damage, but remained operational. The right rear wheel was displaced slightly CCW from direct contact to the forward aspect of the wheel. The Collision Deformation Classification for the impact to the luminaire was 03-RPEW-2. Six crush measurements were documented at the mid-door level and were as follows: C1 = 0.0 cm, C2 = 18.4 cm (7.3"), C3 = 9.5 cm (3.8"), C4 = 5.7 cm (2.3"), C5 = 3.2 cm (1.3"), C6 = 2.5 cm (1.0").

Figure 4. View of direct and induced right side damage from the luminaire impact

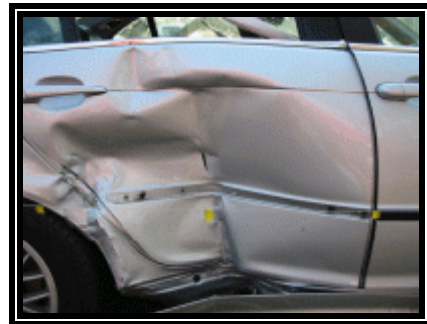
Figure 5. Direct damage showing outline of the luminaire's frangible base

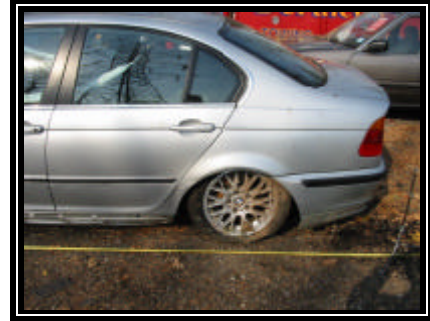
The BMW 328i sustained left rear wheel damage as a result of the secondary curb impact (**Figure 6**). The edge of the left rear wheel was heavily abraded from the lateral contact with the curb. The wheel and tire were coated with dirt and grass. Although the left rear suspension was damaged and the left rear aspect of the BMW was riding low on the left rear wheel, the wheel was not restricted. The rear aspect of the vehicle was shifted to the left slightly from the lateral force of the impact. The left rear quarter panel overlapped the outboard edge of the left rear wheel 9.5 cm (3.8"). An exemplar vehicle exhibited a 2.5 cm (1.0") overlap of the quarter panel. The sill trim was separated from the vehicle and the left rear door panel exhibited longitudinal abrasions on the mid-door area that measured 3.8 cm (1.5") in height. The CDC for the secondary impact was 09-LBWN-2.

Figure 6. View of left side damage

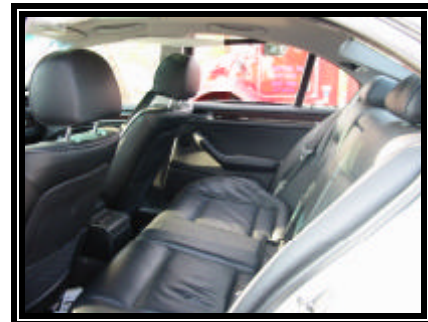
Interior damage to the BMW 328i was minor and was attributed to passenger compartment intrusion (**Figure 7**). The glazing in the rear right door was disintegrated from impact forces. The remaining glazing and windshield laminate was not damaged. The speaker cover on the forward aspect of the lower right front door was partially separated, although it could not be confirmed as resulting from occupant contact. The rear bench seat cushion was separated from the seat brackets at the time of the vehicle inspection. The right rear door had intruded into the rear right occupant space as a result of the side impact with the luminaire. The maximum lateral intrusion in to the rear right occupant space measured 7.6 cm (3.0") at the sill.

Figure 7. View of rear seat area showing the right rear door intrusion

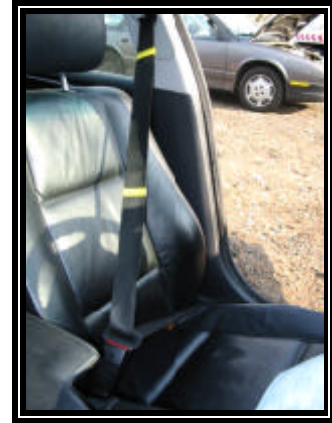
The front seat positions in the 1999 BMW 328i were equipped with manual 3-point lap and shoulder belts with sliding latch plates and inertial lock/belt sensitive retractors. The front right lap and shoulder belt was also equipped with a switchable/automatic locking retractor (ALR). Both front seat manual restraints were also configured with buckle pretensioners which did not deploy as a result of the crash. The non-deployed pretensioner piston measurement was 6.4 cm (2.5") to the forward edge of each canister. At the time of the vehicle inspection, the front seat height adjustments were adjusted to positions where the driver's buckle height measured 10.2 cm (4.0") above the driver's seat cushion, and the front right buckle height measured 7.6 cm (3.0") above the front right seat cushion. The front seat manual restraints were configured with integrated adjustable D-rings. Both D-rings were found in the full-up position and the total vertical travel measured 7.6 cm (3.0"). The driver's and front right passenger's latch plates exhibited routine wear marks consistent with frequent usage. The driver's sliding latch plate also exhibited subtle abrasions on the rear aspect that were consistent with occupant loading against the manual belt webbing. The driver's shoulder belt webbing showed stretching that began approximately 12.7 cm (5.0") above the latch plate and continued upward along the shoulder belt (**Figure 8**). The front right shoulder belt also exhibited stretching that began at the latch plate and continued upward along the shoulder belt.

Figure 8. View of driver's lap and shoulder belt

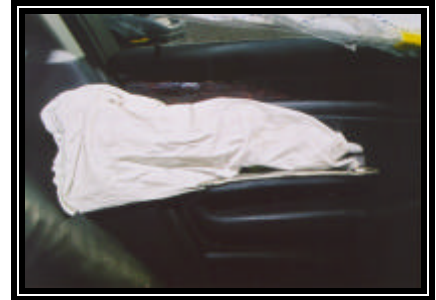
The driver's side air bag deployed from a left front door-mounted module that was located above the driver's arm rest (**Figure 9**). The module was configured with a single cover flap that was rectangular in shape and followed the contour of the interior door panel (**Figure 10**). The cover flap measured 25.4 cm (10.0") in length and 12.1 cm (4.8") in height. The driver's side air bag measured 40.6 cm (16.0") in length, 17.8 cm (7.0") in height at the rear aspect, and 14.0 cm (5.5") in height at the forward aspect. The air bag was not tethered internally, and was not vented by external ports. The surface of the driver's side air bag exhibited dirt and discoloration, most likely as a result of post-crash handling. Longitudinal striation marks were present on the rear aspect of the inboard surface as a result of expansion against the cover flap. There was no occupant contact evidence on the surface of the driver's side air bag or module cover flap.

Figure 9. Driver's door-mounted side air bag

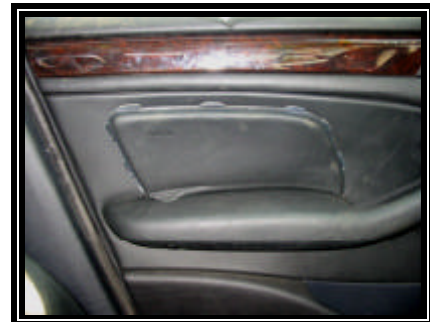
Figure 10. Driver's door-mounted side air bag cover flap

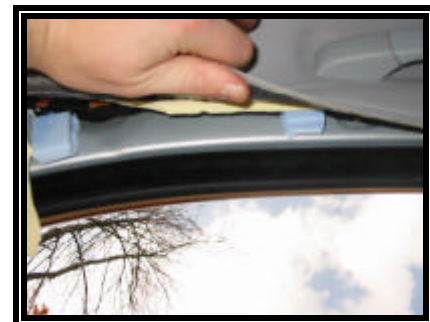
The HPS deployed from the left and right roof rails and A-pillar areas. The separation at the roof rail measured 106.7 cm (42.0") in length. The separation along the A-pillar measured 54.6 cm (21.5") in length. Five clips that measured 5.1 cm (2.0") in height and 2.5 cm (1.0") in width were used to secure the non-deployed HPS in the A-pillar and roof rail (**Figure 11**). Two clips were located in the upper A-pillars and were spaced 15.2 cm (6.0") apart. Two clips were located at the forward edge of the front door frames and were spaced 15.2 cm (6.0") apart. The remaining clip was located aft of the B-pillars and measured a distance of 40.6 cm (16.0") aft of the fourth clip.

Figure 11. Clips in roof side rail used to secure the HPS

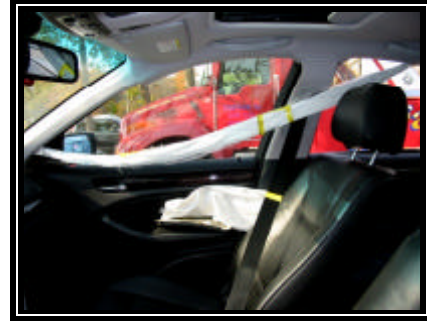
The HPS were positioned diagonally across the driver's and right front passenger's positions at the time of deployment, and extended rearward from the lower A-pillars at an upward angle to the roof rails 37.5 cm (14.8") aft of the B-pillars (**Figure 12**). The nylon tubes were reinforced with Kevlar and were covered with a nylon mesh webbing. A clear plastic membrane cover was present around each HPS which had partially torn due to the deployment. A warning label was affixed to the clear plastic cover regarding the replacement of the deployed HPS. The diameter of the tubes measured 12.7 cm (5.0") and the lengths measured 101.6 cm (40.0"). The tubes were tethered by two reinforced external straps that measured 19.7 cm (7.8") in length and 2.5 cm (1.0") in width. The forward straps (**Figure 13**) were anchored to the interior aspect of each A-pillar and the rear straps were anchored to the roof rail 37.5 cm (14.8") aft of each B-pillar (**Figure 14**). A smaller 3.2 cm (1.3") diameter inflator tube was attached to the forward aspect of each HPS and was connected to the inflator that was located in the A-pillar.

There was no occupant contact evidence on the driver's side HPS. The exterior mesh surface of the driver's HPS exhibited dirt and discoloration, most likely as a result of post-crash handling. The front right passenger's HPS exhibited a faint transfer that was located on the inboard aspect of the tube 78.8 cm (31.0") aft of the A-pillar. This occupant contact measured 7.6 cm (3.0) in length and 2.5 cm (1.0") in width, and was a result of the front-right passenger's head striking the deployed right side HPS.

Figure 12. Deployed front right passenger's HPS

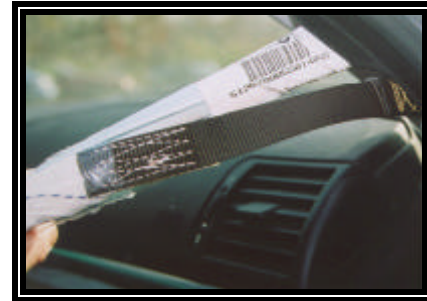
Figure 13. Forward tether strap and inflator tube for the right front HPS

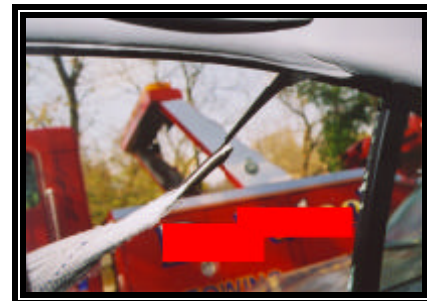
Figure 14. Rear tether strap for the right front HPS
