**VERIDIAN ON-SITE REAR SEAT ADULT PASSENGER
SEAT BELT FATALITY INVESTIGATION**

VERIDIAN CASE NO. CA01-055

VEHICLE - 2000 CHRYSLER CONCORDE LXI

CRASH DATE - DECEMBER, 2001

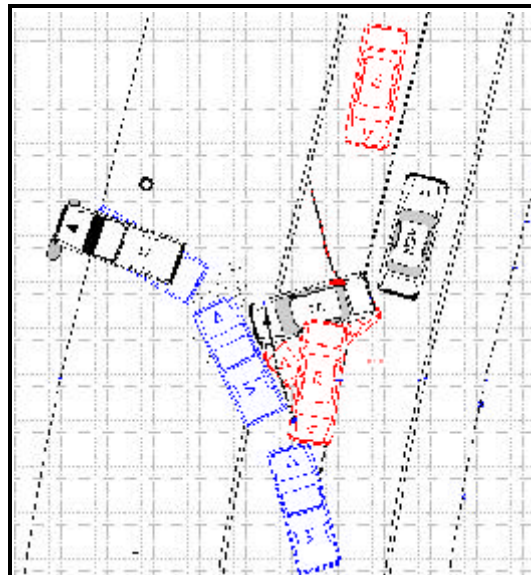
produced an underride/override configuration as the bumper and hood structures underrode the Toyota pickup truck. This configuration allowed the bumper on the Chrysler to engage the undercarriage of the Toyota pickup, which resulted in deployment of the redesigned frontal air bag systems in each vehicle. The trajectory algorithm of the WinSMASH reconstruction program computed impact speeds of 20.8 km/h (12.9 mph) for the subject vehicle and 67.4 km/h (41.9 mph) for the striking Toyota pickup truck. The damage algorithm computed velocity changes of 41.1 km/h (25.5 mph) for the subject vehicle and 36.8 km/h (22.9 mph) for the striking Toyota pickup truck. Respective longitudinal components were -38.7 km/h (-24.0 mph) and -36.2 km/h (-22.5 mph).

Figure 3. Collision dynamics.

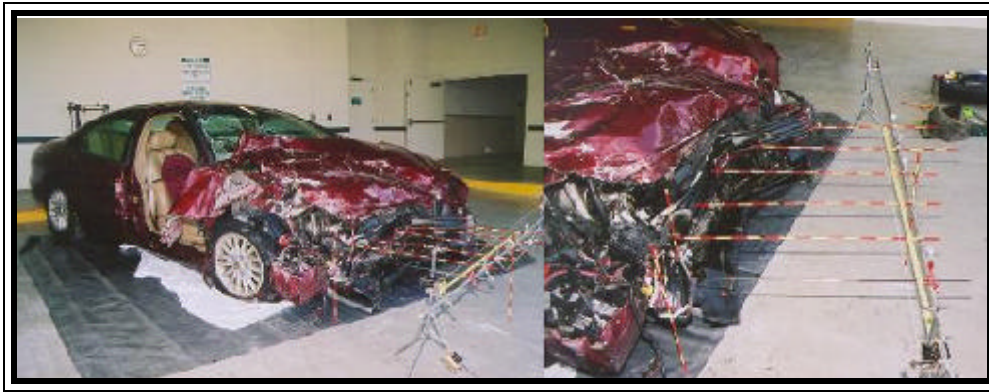
The 2000 Chrysler Concorde Lxi sustained moderately severe frontal damage as a result of the impact with the Toyota Tundra pickup truck (**Figure 4**). The direct contact damage began at the front right bumper corner and extended 99.0 cm (39.0 in) inboard. The impact deformed the entire front end width, resulting in a combined direct and induced damage length (Field L) of 100.0 cm (39.4 in). Six crush measurements were documented at the level of the reinforcement bar (*bumper fascia separation*): C1= 7.0 cm (2.8 in), C2= 41.0 cm (16.1 in), C3= 60.0 cm (23.6 in), C4= 62.0 cm (24.4 in), C5= 60.0 cm (23.6 in), C6= 48.0 cm (18.9 in). A secondary crush profile was obtained 13.0 cm (5.1 in) above the level of the bumper to capture the underride damage, which resulted in an *averaged profile* of: C1= 7.0 cm (2.8 in), C2= 41.0 cm (16.1 in), C3= 60.0 cm (23.6 in), C4= 62.0 cm (24.4 in), C5= 77.0 cm (30.3 in), C6= 63.0 cm (24.8 in). The Collision Deformation Classification (CDC) for this impact to the Chrysler was 11-FZEW-4 with a principal direction of force of (-)20 degrees. White and gray paint transfers were documented along the direct contact damage. A maximum crush value of 94.0 cm (37.0 in) was identified at the (above bumper/mid-radiator) C5 location, as direct contact damage to the hood from the vehicle underride/override extended rearward towards the base of the windshield. Metal scarring and paint transfers were noted across the hood surface and attributed to the front right area of the Toyota pickup truck. In addition, this damage pattern to the hood resulted in minor penetration of the rear edge through the right lower windshield area. The windshield was also fractured in multiple locations (along the base) from exterior impact forces, and the right mid-windshield area from the (interior) passenger air bag flap. Induced contact damage produced roof buckling along the right side support pillars. The right fender was displaced rearward which restricted the right front wheel/tire. Right side wheelbase reduction measured 28.5 cm (11.2 in) while elongation in the left side wheelbase measured 6.5 cm (2.6 in). The right front door was removed by rescue personnel during post-crash occupant extrication activities, with pry marks surrounding the damaged areas.

Figure 4. Frontal damage to the 2000 Chrysler Concorde Lxi.

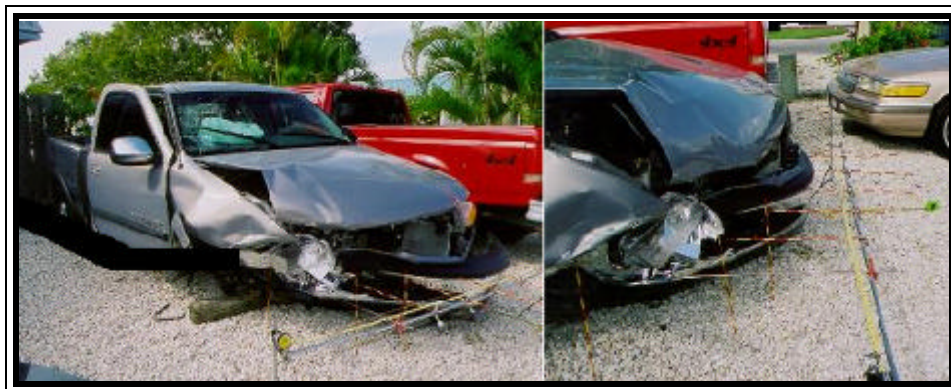
The 2000 Toyota Tundra SR5 4x2 pickup truck sustained moderately severe damage as a result of the impact with the Chrysler Concorde (**Figure 5**). The direct contact damage began at the front right bumper corner and extended 70.0 cm (27.6 in) inboard. The impact deformed the entire front end width, resulting in a combined direct and induced damage length (Field L) of 143.0 cm (56.3 in). Six crush measurements were documented at the level of the bumper: C1= 1.0 cm (0.4 in), C2= 1.0 cm (0.4 in), C3= 8.0 cm (3.1 in), C4= 25.0 cm (9.8 in), C5= 41.0 cm (16.1 in), C6= 83.0 cm (32.7 in). The CDC for this impact to the Toyota was 12-FZEW-4 with a principal direction of force of (+)10 degrees. Red paint transfers were documented along the direct contact damage. The hood was deformed up and rearward from the impact force. The right fender was displaced rearward with impact separation damage noted to the right front wheel/tire and axle area. The windshield was fractured along the right lower windshield from exterior impact forces, and the right mid-windshield area from the (interior) passenger air bag deployment. Induced contact damage produced roof buckling along the right B-pillar and C-pillar. Bed to cab contact was noted on both sides. Right side wheelbase reduction measured 34.0 cm (13.4 in) as elongation in the left side wheelbase measured 7.5 cm (3.0 in).

Figure 5. Front right damage to the 2000 Toyota Tundra SR5 pickup truck.

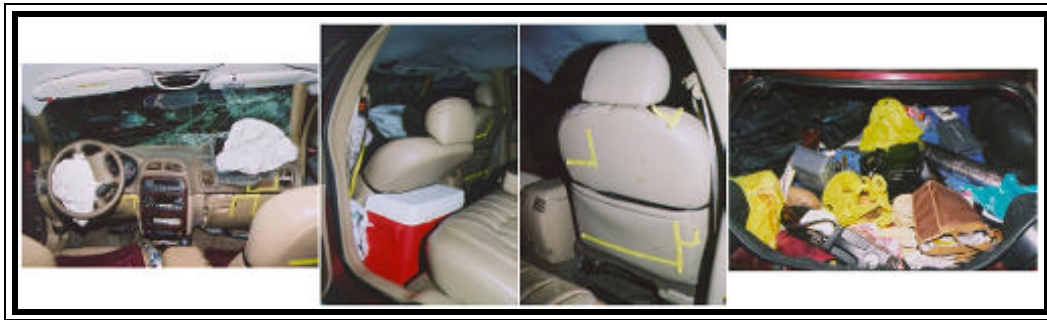
Interior damage to the Chrysler Concorde was severe and was attributed to occupant contacts, component intrusions, and trunk cargo shift (**Figure 6**). Scuff marks and indentations were documented on the left knee bolster and glove compartment door. The glove compartment door opened during the crash (latch mechanism damaged/inoperative), and was noted to be resting on the seat cushion. A circular indentation was also identified to the right mid-instrument panel area. No steering rim deformation or column compression was identified. The driver seat back was deformed to a rearward mid-range position with a large ice cooler (full of beverages) lodged behind the seat frame. Contact damage to the front right seat back consisted of small indentations and abrasions to the aft aspect. A narrow/deep abrasion was also documented to the right of the (front right) head restraint and attributed to a rear seated occupant bracing posture. Blood pooling and socket tools (*trunk cargo*) were noted in the seat bight and on the floor area.

Figure 6. Interior damage to the 2000 Chrysler Concorde.

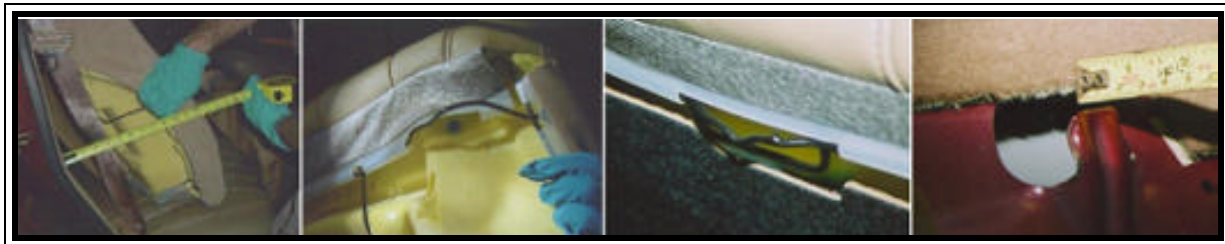
Excessive cargo shift in the trunk area deformed the fixed rear right and center seat backs with an associated anchorage failure at the upper frame retainer clips (**Figure 7**). The fixed seat back design utilizes a 6.4 mm (1/4 in) thin gauge metal wire to provide frame support, and act as a barrier between the two vehicle compartments. The seat back is then affixed to the vehicle frame through the use of three “U” channel retaining clips located at the upper left, center, and right seating positions. Although deformed sections of the wire seat back frame were removed by the medical examiner’s office for further analysis, forward displacement of the retaining clips were identified during the SCI vehicle inspection as a source of the seat back failure, and spacings (*gaps*) which measured 2.6 cm (1.0 in), and 3.0 cm (1.2 in), respectively. Cargo stowed in the trunk consisted of books, tools, clothing bags, coconuts and home video equipment. The items were removed from the trunk area and weighed for a total of 29.9 kg (66.0 lb), as the heaviest items (*books and tools*) were then singled out for a total weight of 11.3 kg (25.0 lb). The multitude of socket tools found in the rear right seat bight suggested the heaviest concentration of loading forces in this occupant space. Longitudinal component intrusions into the passenger compartment included 14.0 cm (5.5 in) of right toepan, 7.0 cm (2.8 in) of right instrument panel, 10.0 cm (3.9 in) of external hood, and 12.0 cm (4.7 in) of rear seat back intrusion.

Figure 7. Rear seat back damage and associated anchorage failure in the 2000 Chrysler Concorde.

At this point, the cargo stowed in the trunk area shifted forward and impacted the fixed rear seat back. The retainer clips failed which allowed excessive loading forces against the restrained occupant. This "vise" mechanism combined with the abnormal folding characteristic of the lap portion of the restraint into a "W" pattern acted as a razor blade (*sharp edge under tension*) along the abdominal belt path. Folding of the restraint webbing reduced the width which lacerated into the soft tissue resulting in extensive abdominal soft tissue and underlying internal laceration/avulsive type trauma. This very large, deep, and "gaping" laceration extended from the lateral aspect of the right side, slightly downward and oblique (well below the umbilicus) toward the midline to the pubic symphysis. The laceration extended to, but did not involve, the spinal column or other internal organs. Underlying abdominal avulsive and trauma was sustained to the bowel (colon/ileum), which eviscerated (protruded) through the wide laceration. Following the crash, the rear right passenger came to rest slumped to the right against the door panel, evidenced by the extensive blood pooling noted in the passenger space. She was removed from the vehicle through the right rear door by rescue personnel, and subsequently pronounced deceased at the scene.

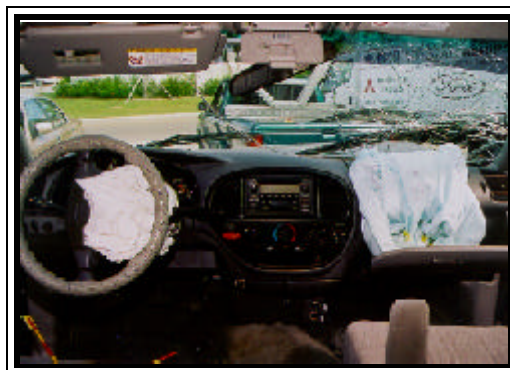
Interior damage to the Toyota Tundra pickup truck was minimal and was attributed to occupant contacts, component intrusions, and bed cargo shift (**Figure 8**). Friction marks were documented on the outboard aspect of the driver seat cushion, and attributed to interaction with the lap portion of the 3-point manual restraint. No steering rim deformation or column compression was identified. The glove compartment door opened during the crash (latch mechanism damaged/inoperative) and was noted to be displaced slightly to the right. A small indentation and scratch mark were documented on the aft aspect of the front right head restraint. Light scuff marks and cloth abrasions were documented on the aft aspect of the front right seat back. The left portion of the backlight glazing was disintegrated, and attributed to cargo shift stowed in the bed area. Component intrusions into the front right passenger space involved 15.0 cm (5.9 in) of longitudinal toepan, and 8.0 cm (3.1 in) of vertical floorpan intrusion.

Figure 8. Interior view of the 2000 Toyota Tundra SR5.

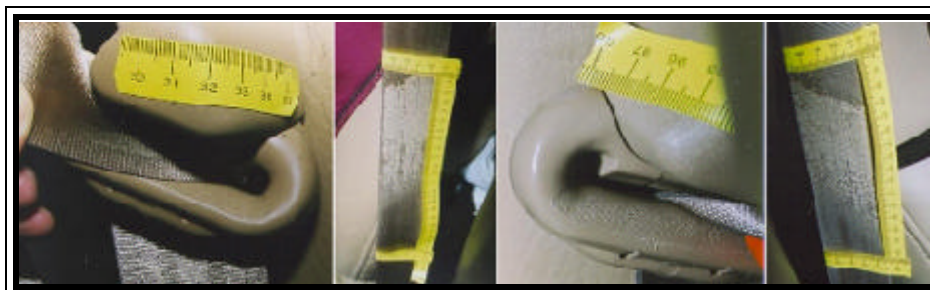
The interior of the Chrysler Concorde consisted of a five passenger seating configuration with front bucket and rear bench seats. The outboard seating positions were equipped with 3-point manual lap and shoulder belt systems, which consisted of a continuous loop belt webbing with a sliding latchplate and a dual mode retractor (inertial lock/belt sensitive). The rear center seating position was equipped with a 2-point manual lap belt with a locking latchplate. Extensive loading evidence was documented on the front restraint systems. Evidence included deep abrasions to the D-ring and latchplate webbing sleeve, with associated transfers embedded into the webbing (**Figure 9**).

Figure 9. Loading evidence to the front left and right 3-point restraint systems (D-ring/shoulder webbing).

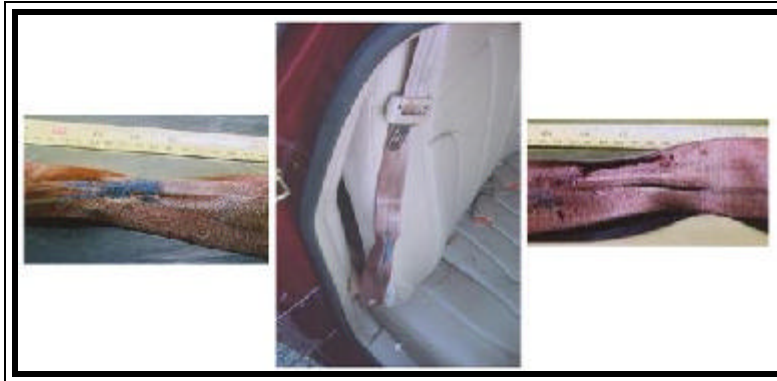
Extensive loading evidence was also documented on the webbing of the rear right restraint (**Figure 10**). Although a 0.9 meter (3.0 feet) section was removed by the medical examiner's office post-crash for further analysis, the webbing exhibited distinct curling characteristics with inner folds resembling a "W" pattern. This folding mechanism may have produced razor blade like injuries, as the width of the webbing was reduced which allowed laceration into the soft abdominal tissue of the rear right passenger. Blue fabric transfers were embedded deep into the lap portion (forward side), with skin tissue and blood transfers embedded into the aft side. Abrasions were identified on the D-ring and latchplate.

Figure 10. Loading evidence and fabric transfers to the rear right 3-point manual restraint.

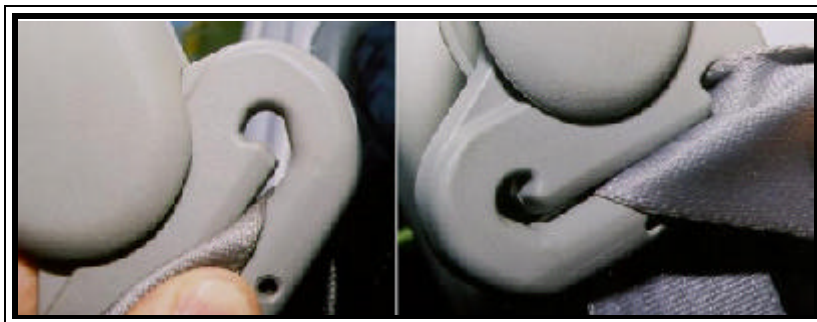
The interior of the Toyota Tundra pickup truck consisted of a five passenger seating configuration with front bucket and rear (split) bench seats. The outboard seating positions were equipped with 3-point manual lap and shoulder belt systems which consisted of a continuous loop belt webbing with a sliding latchplate and a dual mode retractor (inertial lock/belt sensitive). The rear center seating position was equipped with a 2-point manual lap belt with a semi-locking latchplate. Loading evidence documented on the front restraint systems consisted of abrasions to the D-ring (**Figure 11**) and latchplate. “Dimpling” of the shoulder belt webbing was also noted. Loading evidence documented on the rear right restraint included distinct markings on the shoulder webbing, and attributed to the child safety seat locking clip. Black fabric and light plastic transfers were also embedded into the shoulder webbing of the rear right restraint, and attributed to the child safety seat (plastic shell and cloth liner) in use at the time of the crash.

Figure 11. Loading evidence on the driver and front right passenger restraint D-rings (respectively).

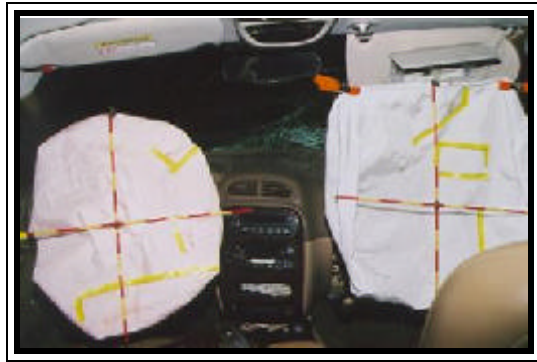
The 2000 Chrysler Concorde Lxi was equipped with redesigned frontal air bags for the driver and front right passenger positions which deployed as a result of the crash (**Figure 12**). The driver air bag was identified by the part number: *P120545-82H* with a bar coded lot number of: *TMK3448G1396* and housed in the center of the steering wheel with a horizontally oriented flap tear seam (H-configuration). The upper flap was trapezoidal in shape and measured 11.3 cm (4.4 in) in width along the top portion, 13.4 cm (5.3 in) in width along the flap tear seam, and 9.0 cm (3.5 in) in height. The

lower flap was rectangular in shape and measured 13.4 cm (5.3 in) in width and 5.4 cm (2.1 in) in height. No contact evidence was identified on the exterior surface of the module cover flaps. Although the surface of the air bag seemed lightly abraded from occupant interaction, blood spattering across the face of the membrane masked any obvious contact evidence. The diameter of the driver air bag measured 51.4 cm (20.2 in) in its deflated state. No vent ports or internal tether straps were present. Air bag excursion measured 21.0 cm (8.3 in) from the steering wheel hub.

Figure 12. 2000 Chrysler Concorde deployed redesigned frontal air bags.

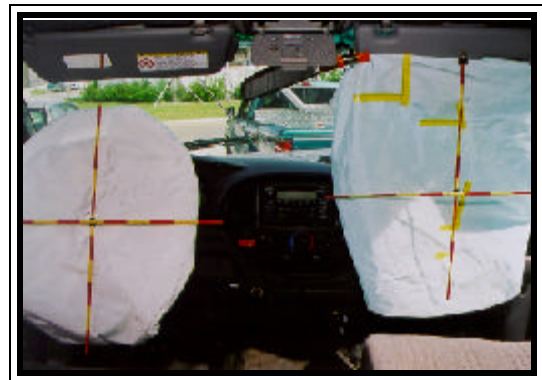
The 2000 Toyota Tundra pickup truck was equipped with redesigned frontal air bags for the driver and front right passenger positions which deployed as a result of the crash (**Figure 13**). The driver air bag was housed in the center of the steering wheel with a horizontally oriented flap tear seam (H-configuration). The flaps were nearly symmetrical in shape, as the upper flap measured 16.2 cm (6.4 in) in width and 4.7 cm (1.9 in) in height; while the lower flap measured 16.2 cm (6.4 in) in width and 7.6 cm (3.0 in) in height. No contact evidence was identified on the exterior surface of the module cover flaps, however, light abrading was documented across the face of the air bag membrane. The diameter of the driver air bag measured 58.2 cm (22.9 in) in its deflated state. The bag was tethered by four internal straps, and vented by two 2.0 cm (0.8 in) diameter ports located at the 10 o'clock and 2 o'clock sectors on the rear aspect of the air bag. Air bag excursion measured 38.5 cm (15.2 in) from the steering wheel hub.

Figure 13. 2000 Toyota Tundra SR5 deployed redesigned frontal air bags.

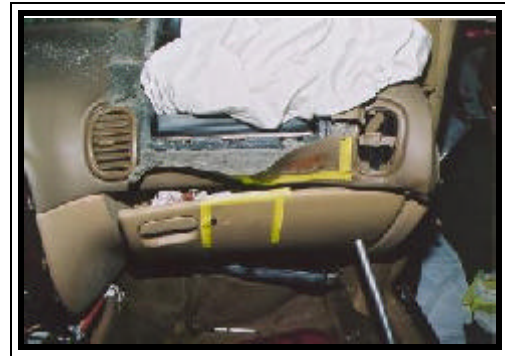
At impact, she initiated a forward and slightly lateral trajectory in response to the 11 o'clock impact force and loaded the manual restraint, right instrument panel, toe pan, and deployed redesigned front right passenger air bag. Loading of the manual restraint resulted in contusions to the right chest. Bracing against the instrument panel resulted in fractures of the right 4th metacarpal neck (hand) and distal radius fracture. This injury mechanism was evidenced by the scuff marks and distinct indentation identified just above the glove compartment door (**Figure 15**). Her knees struck the glove compartment door, which resulted in bilateral soft tissue injury to the lower extremities as evidenced by the deformation documented

Figure 15. Contact evidence to the right mid-instrument panel and glove compartment door.

to this component. She also sustained fractures of the right 2nd and 3rd metatarsal shaft (foot) from loading to the *intruded* toe pan, evidenced by the location of the injury in conjunction with the passenger's stated placement of the feet on the toe pan during pre-crash brace posturing. Contact to the deployed redesigned passenger air bag compressed the eyeglasses into the nose, resulting in a small contusion on the bridge of the nose and a rupture of the mucosal vessels ("nosebleed"). This injury mechanism was evidenced by the makeup and fabric transfers documented on the right aspect of the air bag face. The front right passenger stated during the SCI interview that her glasses were "broke in half" at the bridge due to air bag interaction. Although not entrapped by intruded components, she also stated the (open) glove compartment door partially restricted movement of her right lower extremity during extrication procedures post-crash. Following the crash, the passenger was removed from the vehicle by rescue personnel due to perceived serious injury, and transported by ambulance to a nearby hospital. After initial evaluation by emergency room personnel, she was transferred to a nearby trauma center for specialized treatment of her extremity fractures. On hospitalization day eight, she was transferred back to the initial hospital facility for the remainder of her 28 day admit. The redesigned passenger air bag provided additional protection against further contact to frontal components, and potential serious injury.

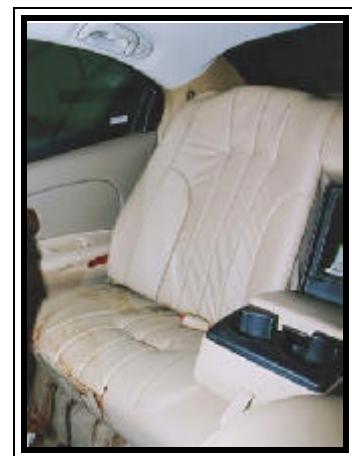
Figure 16. Interior view of the rear right seating area.

At impact, the rear right passenger initiated a forward and slightly lateral trajectory in response to the 11 o'clock impact force, and loaded the manual restraint and rear aspect of the front right seat back. The passenger initially sustained a cervical spine fracture (at C1), which was a result of the sudden forward movement of the head as the body loaded the belt system. Loading of the manual restraint resulted in distinct patterned abrasions to the anterior neck and left torso, with contusions extending to the left breast and left lateral torso. The unique pattern of these soft tissue injuries was indicative of improper shoulder harness placement high across the chest. Her right arm/hand struck the front right seat back which resulted in a contusion to the posterior aspect of the wrist, an underlying avulsion of the flexor muscle, and an open fracture of the distal ulna. These extremity injuries were evidenced by the abrasions and scuff marks identified to the right of the front right head restraint, and further confirmed the passenger's pre-impact bracing posture. Her right knee struck the front right seat back, as both feet/ankles slid under and loaded the seat cushion frame, resulting in multiple contusions as evidenced by the scuff marks and indentations documented along the mid-to-lower aspects of this component.

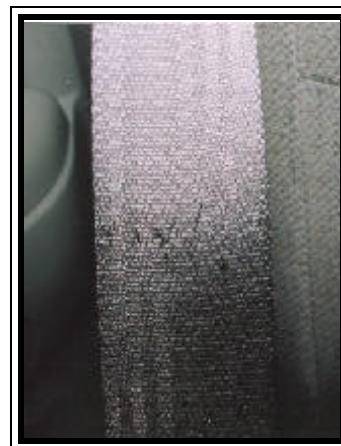
The 3 year old male rear right passenger of the 2000 Toyota Tundra pickup truck was upright and restrained within the forward facing child safety seat, which was loosely secured by the vehicle’s available 3-point manual lap and shoulder belt system. Belt usage was confirmed by the loading evidence identified on the shoulder webbing of the rear right restraint (**Figure 17**). At impact, the child passenger initiated a forward trajectory in response to the 12 o’clock impact force as the child safety seat’s improper installation allowed the seat to flip forward. The child struck the rear aspect of the front right seat back and head restraint, which resulted in multiple soft tissue injury to the face and an avulsion of a front upper tooth. These injury mechanisms were evidenced by the abrasions and indentations identified on these components. He also sustained a *through and through* upper lip laceration which was an indirect result of the tooth trauma (“*bit lip*”). Following the crash, the child passenger was removed from the vehicle by the driver through the left front door, and subsequently transported by ambulance to a local trauma center for treatment and released.

Figure 17. Loading evidence on the rear right shoulder harness.
