**ON-SITE CHILD SAFETY SEAT CRASH INVESTIGATION
SCI TECHNICAL SUMMARY REPORT**

VERIDIAN CASE NO. CA01-056

SUBJECT VEHICLE - 2002 FORD TAURUS

CRASH DATE - DECEMBER 2001

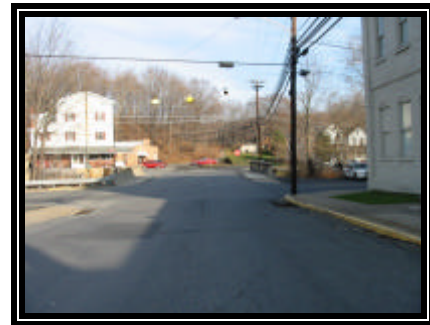
The 30-year-old female driver was operating the 2002 Ford Taurus eastbound on the two-lane local roadway, on approach to the four-leg intersection (**Figure 2**). The driver estimated her speed to be approximately 40 km/h (25 mph). The driver of the log truck was operating the vehicle northbound on the state roadway (**Figure 3**). The driver of the truck reportedly slowed as the truck approached the intersection, but did not come to a complete stop. The truck rolled into the intersection at a low speed. The driver of the Taurus observed the truck entering the intersection and applied the brakes in full lockup and steered left in an attempt to avoid the collision. The Taurus was not equipped with anti-lock brakes (ABS) and tire marks that measured approximately 6 m (20') in length were documented at the scene. It did not appear that the driver of the truck attempted any avoidance maneuvers.

Figure 2. Eastbound approach for the Ford Taurus

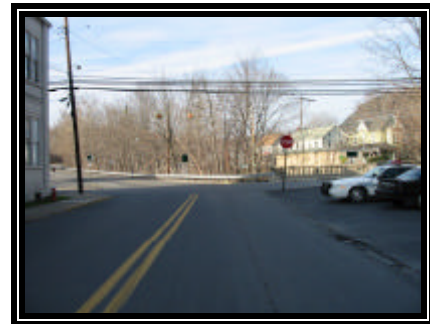
Figure 3. Northbound approach for the truck

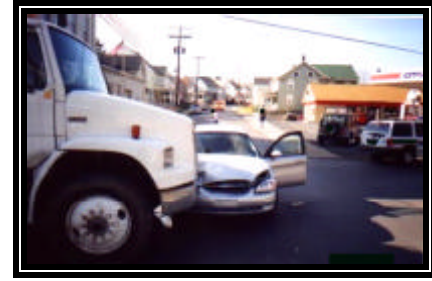
The front right area of the Taurus impacted the left front aspect of the log truck in an “L” configuration. Impact resulted in minor damage to both vehicles. The resultant impact forces were in the 1 o’clock sector for the Taurus and in the 9 o’clock sector for the log truck. The barrier equivalent damage algorithm of the WinSMASH program computed a total delta-V of 10.0 km/h (6.2 mph) for the Taurus which was below the threshold to deploy the frontal air bag system or fire the seat belt pretensioners. The longitudinal and latitudinal components were -9.4 km/h (-5.8 mph) and -3.4 km/h (-2.1 mph), respectively. The Taurus was deflected slightly to the left and the vehicles remained engaged as they came to final rest in the intersection (Figure 4).

Figure 4. On-scene photograph

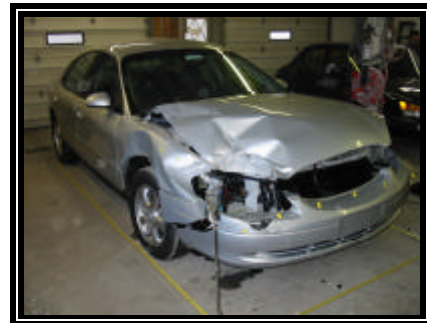
The 2002 Ford Taurus sustained minor damage as a result of the impact with the log truck (**Figure 6**) and was under partial repair at the time of the SCI inspection. The maximum residual crush along the bumper beam was located at the front right corner and measured 5.1 cm (3.0"). The maximum residual crush at the upper radiator support measured 6.4 cm (2.5") and was located on the right corner of the radiator support. The direct contact damage began 43.8 cm (17.3") right of center on the bumper fascia, and extended 29.2 cm (11.5") to the front right corner. The combined direct and induced damage involved the entire frontal width of the Taurus. The bumper fascia was fractured on the right front corner and on the left front aspect. The right front fender was crushed and displaced rearward. The hood was buckled and crushed on the front right aspect, and the head lamp assemblies were removed by the body shop. Longitudinal abrasions were present on the front right corner of the bumper fascia, front right aspect of the hood, and on the right front fender. The right front alloy wheel was also abraded from contact with the truck. The vertical radiator core supports were fractured on both sides from the impact (**Figure 7**), and the upper radiator support was separated from the vehicle. The Collision Deformation Classification (CDC) for the impact with the truck was 01-FREE-5. Six crush measurements were taken along the bumper beam and were as follows: C1 = 0.0 cm, C2 = 0.3 cm (0.1"), C3 = 0.5 cm (0.2") , C4 = 1.0 cm (0.4"), C5 = 2.5 cm (1.0"), C6 = 5.1 cm (3.0").

Figure 6. Damage to 2002 Ford Taurus

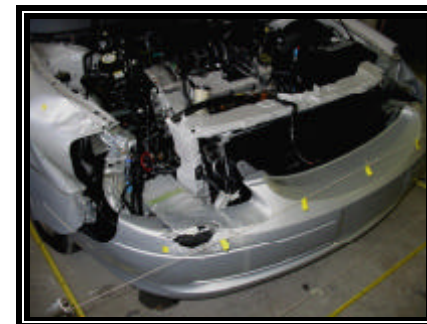
Figure 7. Damaged radiator supports

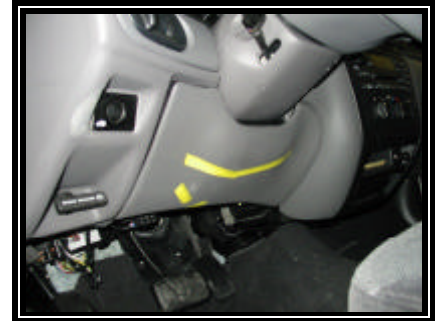
The 2002 Ford Taurus sustained minor interior damage as a result of occupant contact. The rigid plastic knee bolster was slightly displaced and scuffed from contact with the driver's knees (**Figure 8**). The bottom right aspect of the windshield was fractured from the rearward displacement of the right hood hinge assembly. There was no additional interior damage.

Figure 8. View of displaced and scuffed knee bolster

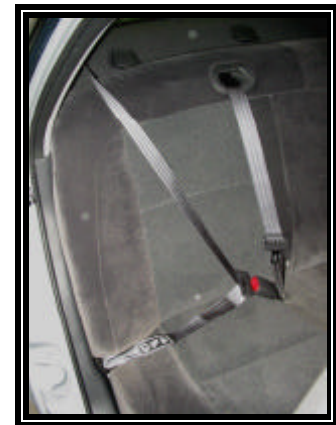
Figure 9. View of creases in the rear right belt webbing

The rear seat positions were equipped with manual 3-point continuous loop lap and shoulder belts with sliding latch plates and inertial lock/belt sensitive retractors. Each rear seat restraint was configured with a switchable/ALR. The rear right manual restraint exhibited four creases in the lap belt portion of the webbing spaced 10.2 cm (4.0") apart and located 19.1 cm (7.5") above the lower anchor (**Figure 9**). These creases did not correlate to any points on the child safety seat, and appear to have been unrelated to this crash.

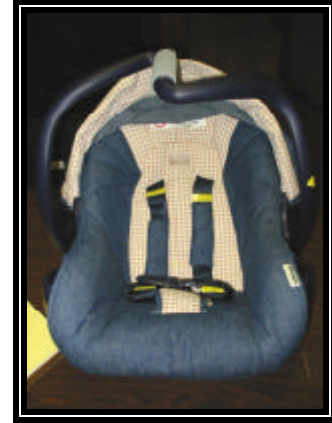
Figure 10. Evenflo rear facing CSS

There were minor abrasions on the carrying handle and minor abrasions on the plastic shell at the belt path. Scuff marks were also present on the bottom outboard aspects. The harness straps exhibited creases that began 10.2 cm (4.0") and 13.3 cm (5.3") above the bottom aspects on the left and right harness straps, respectively. The creases marks extended upward 26.6 cm (10.5") on the harness system.

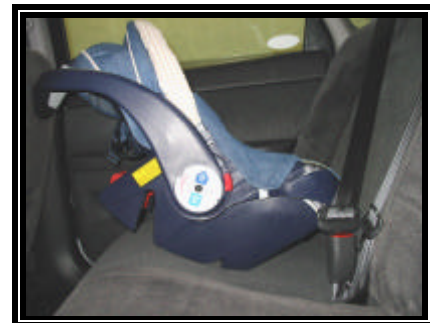
The CSS was installed without the base in the rear right position of the Ford Taurus (**Figure 11**). The owner's manual for the rented Taurus was in the glove box, however, it was not consulted by the driver regarding the CSS installation. The driver stated that she installed the seat on the morning of the crash, and noticed that it appeared to be rocking as she backed the vehicle out of the driveway. She stopped the Taurus and evaluated the installation of the CSS. She determined that the manual 3-point lap and shoulder belt was not routed properly through the belt path on the CSS,

Figure 11. Left side view of installed CSS

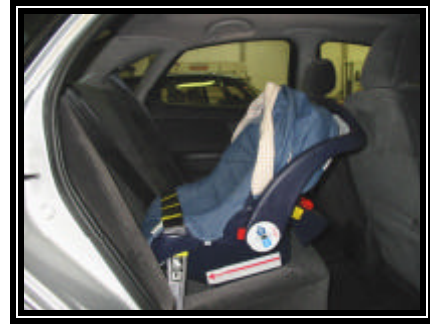
and corrected the installation based on the labeling present on the CSS. The driver stated that she engaged the automatic locking retractor (ALR) by extending the seat belt webbing all the way out and pulled the webbing tight to secure the CSS. She described the attachment of the CSS to the vehicle as tight. She checked the recline angle and determined that the level indicator on the CSS was in the green area. It should be noted that this CSS was not equipped with a level indicator. The lower left aspect of the CSS exhibited a sticker with a horizontal arrow that pointed to the rear of the vehicle that read: "Place child restraint on vehicle seat so that Position Right line is parallel to the ground." There were no additional objects used to ensure a 45 degree recline angle (**Figure 12**).

Figure 12. Right side view of installed CSS showing sticker with horizontal arrow

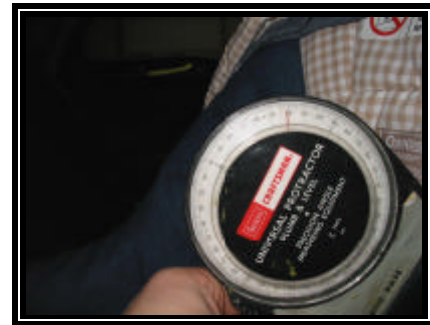
The SCI Investigator obtained the CSS during the vehicle inspection and performed repeated installations in the Ford Taurus based on the known crash information at the time. Repeated installation attempts were unsuccessful in obtaining the NHTSA recommended 45 degree recline angle without the use of styrofoam pool noodles or a firmly rolled towel. Without additional objects placed under the CSS, the lowest recline angle obtained by the SCI Investigator was 60 degrees from horizontal (**Figure 13**).

Figure 13. View of inclinometer showing recline angle

trajectories. The CSS loaded the manual restraint and the infant loaded the rear aspect of the CSS. The infant rebounded forward (toward the rear of the vehicle) and loaded the integrated harness system. Due to the CSS's probable recline angle of 60 degrees, his head flexed forward of his body while seated in the rear-facing CSS. As a result of the young age of the infant and lack of developed neck muscles, he may not have been able to lift his head from the forward position. The position of his head may have occluded his airway which resulted in respiratory arrest.
