**REMOTE ADVANCED 208-COMPLIANT VEHICLE INVESTIGATION  
SCI TECHNICAL SUMMARY REPORT**

**NASS/SCI COMBO CASE NO. 02-12-150E**

**VEHICLE – 2003 CHEVROLET SUBURBAN**

**CRASH DATE – NOVEMBER 2002**

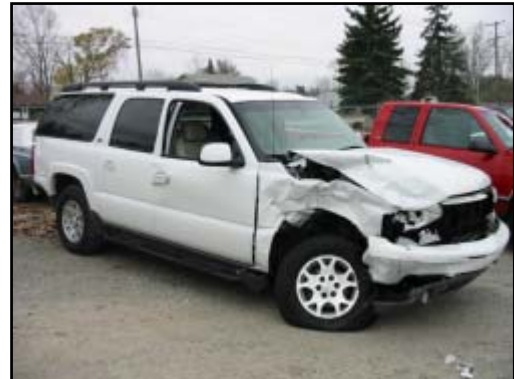
**Figure 1. Damaged 2003 Chevrolet Suburban**

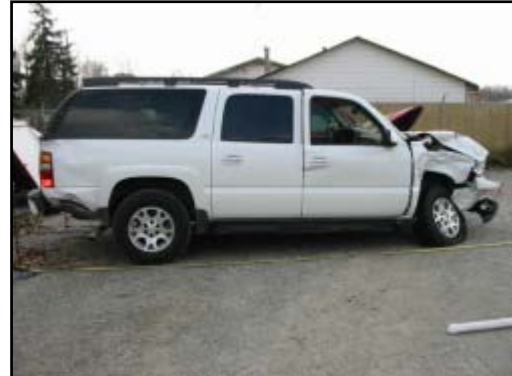
The 2003 Chevrolet Suburban sustained moderate damage to the right front aspect as a result of the impact with the Chevrolet pickup truck (**Figure 5**). The direct contact damage began 45 cm (18”) forward of the right front axle and extended 98 cm (39”) rearward along the right front fender. The combined direct and induced damage began 45 cm (18”) forward of the right front axle and extended 222 cm (87”) rearward along the right side plane. The right front fender was abraded and crushed laterally from direct contact. The rear edge of the fender was pulled forward as a result of the lateral displacement of the front aspect of the fender. The hood was displaced laterally and buckled rearward. The right front corner of the bumper was crushed laterally and longitudinally and the right aspect of the front bumper fascia was fractured and partially separated. The entire front bumper fascia was displaced laterally. The right headlamp assembly was fractured and the grille and front trim were separated. The right front tire was punctured on the top aspect of the sidewall as a result of engagement with the front bumper corner. The Collision Deformation Classification (CDC) for the initial impact with the Chevrolet pickup truck was 02-RFEW-3. Six crush measurements, illustrated in **Figure 6**, were documented at the mid-door level and were as follows: C1 = 0 cm, C2 = 0 cm, C3 = 0 cm, C4 = 6 cm (2”), C5 = 38 cm (15”), C6 = 28 cm (11”).

**Figure 5. Right side view of damaged Suburban**

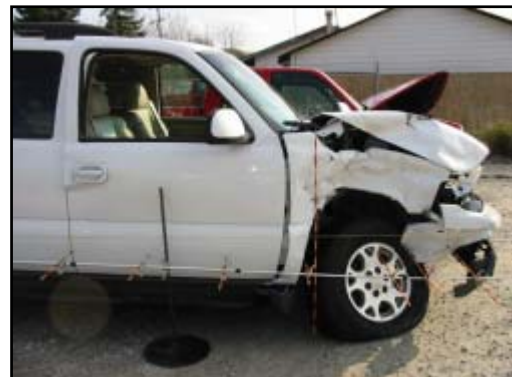
**Figure 6. View of right front crush measurements**

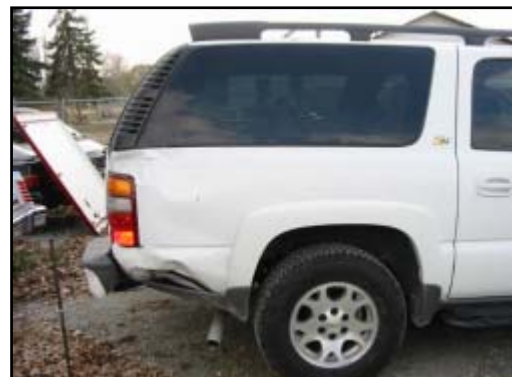
The Chevrolet Suburban sustained minor damage as a result of the secondary sideslap impact with the Chevrolet pickup truck (**Figure 7**). The direct damage began 18 cm (7”) aft of the right rear axle and extended rearward 108 cm (43”). The right rear wheel sustained direct contact abrasions. The lower rear aspect of the right rear quarter panel adjacent to the bumper corner was abraded and crushed laterally aft of the wheel

**Figure 7. Close-up of right rear sideslap damage**

opening. Direct contact deformation extended vertically to the belt line. The bottom aspect of the right rear taillight was fractured. The CDC for the sideslap event was 03-RBAW-2. Six crush measurements were documented at the lower door level and were as follows: C1 = 4 cm (2"), C2 = 12 cm (5"), C3 = 19 cm (7"), C4 = 8 cm (3"), C5 = 0 cm, C6 = 0 cm.

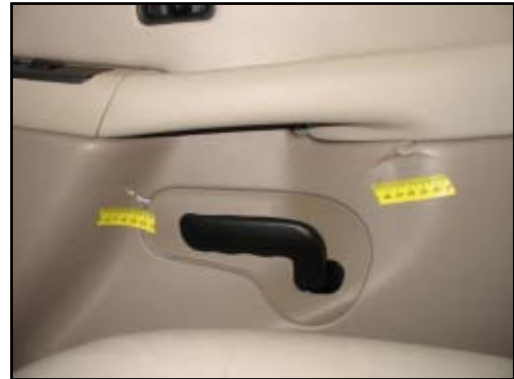
The interior damage to the 2003 Chevrolet Suburban was minor and attributed to occupant contact. The right front window glazing was disintegrated. It could not be determined if the front right window glazing fractured as a result of impact forces or occupant contact. The loading to the interior aspect of the right front door resulted in fractures to the interior door panel (**Figure 8**). The fractures were located fore and aft of the door release handle below the forward aspect of the arm rest. A rubber transfer from possible contact with the front right passenger's shoe was present on the rear aspect of the interior door surface near the belt line. A 3 cm (1") scuff was present on the right roof side rail.

**Figure 8. View of occupant contact to the interior right front door**

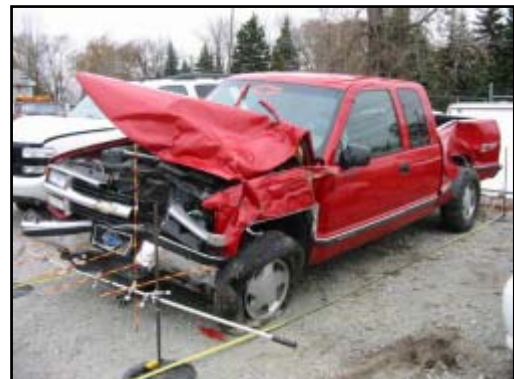
The 1997 Chevrolet 1500 series pickup truck sustained moderate frontal damage as a result of the impact with the Chevrolet Suburban. The direct damage began at the front left bumper corner and extended 140 cm (55") laterally across the frontal plane (**Figure 9**). The combined direct and induced damage measured 166 cm (65") across the entire frontal plane. The bumper was crushed rearward on the left side and displaced forward on the right corner. The grille was fractured and the left headlamp was separated. The left front fender was crushed rearward and buckled. The aft aspect of the left front fender overlapped the leading edge of the left front door. The hood was buckled rearward and displaced rearward, which resulted in a fracture of the windshield on the lower left aspect. The frontal crush displaced the left front wheel rearward, which resulted in a reduction of the left wheelbase by 3 cm (1"). A large cut was present on the tread of the left front tire from the impact. The tire was deflated and deboned as a result of the crash. Six crush measurements were documented along the front bumper of the pickup truck and were as follows: C1 = 35 cm (14"), C2 = 30 cm (12"), C3 = 43 cm (17"), C4 = 34 cm (13"), C5 = 4 cm (2"), C6 = 0 cm. The CDC for the frontal impact with the Suburban was 11-FDEW-2.

**Figure 9. View of frontal damage to the Chevrolet pickup truck**

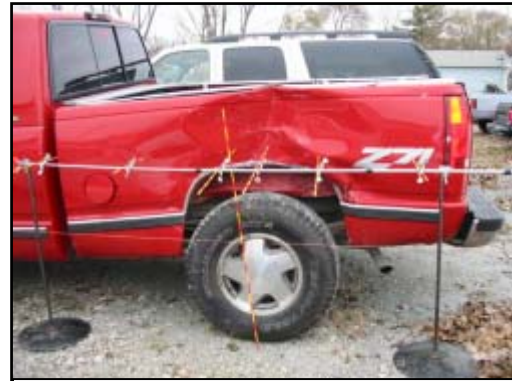
The Chevrolet pickup truck sustained minor left side damage as a result of the secondary sideslap event (**Figure 10**). The direct damage on the left aspect of the pickup box began 70 cm (28") forward of the rear axle and extended rearward 118 cm (46"). The combined direct and induced damage began at the rear bumper corner and extended forward 218 cm (86"). Direct contact abrasions were present above the left rear wheel from contact with the Suburban. Six crush measurements were documented along the left side plane at the mid-door level and were as follows: C1 = 0 cm, C2 = 0 cm, C3 = 15 cm (6"), C4 = 22 cm (9"), C5 = 6 cm (2"), C6 = 2 cm (1"). The CDC for the sideslap impact was 09-LBEW-2.

**Figure 10. Left rear damage from the sideslap event**

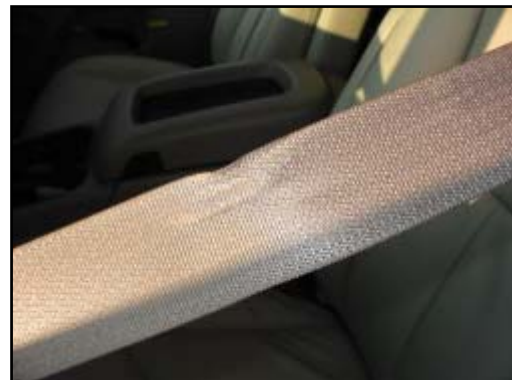
The 2003 Chevrolet Suburban was equipped with integrated continuous loop manual 3-point lap and shoulder belts with sliding latch plates for both front seat positions. The driver's safety belt was configured with an Emergency Locking Retractor (ELR) and the front right safety belt was configured with a switchable ELR/Automatic Locking Retractor (ALR). The driver's safety belt webbing was deformed as a result of loading against the latch plate (**Figure 11**). The plastic trim cover on the top left aspect of the driver's seat back was separated as a result of the driver loading the manual restraint.

**Figure 11. View of deformed driver's safety belt webbing**

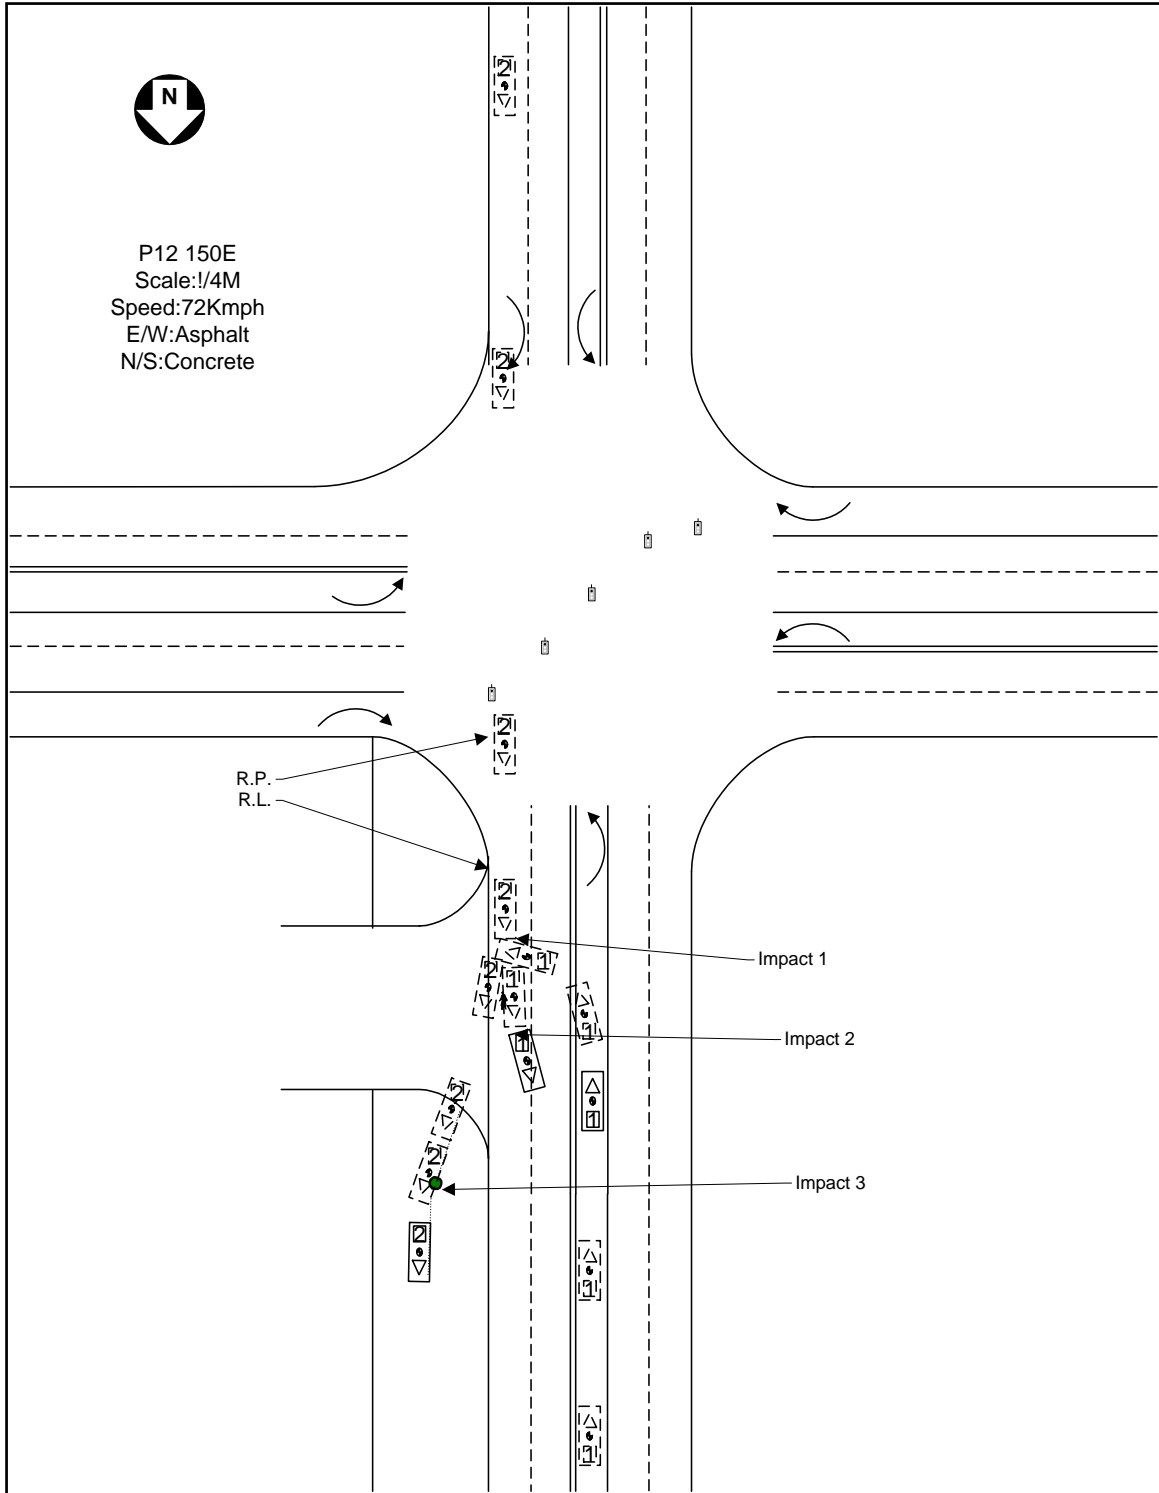
Figure 13: Nass scene schematic

rapid CCW direction, which caused the right rear aspect of the Suburban to sideslap the left rear aspect of the pickup truck. The WinSMASH-computed delta-V for the sideslap impact was 6 km/h (4 mph) for the Suburban and 7 km/h (4 mph) for the pickup truck. The Suburban continued to rotate CCW and came to rest facing north in the center of the northbound lanes. Although the Suburban was equipped with the OnStar system, it was not reported if the driver subscribed to the service, or if the system activated as a result of the crash. The pickup truck was redirected slightly CW and departed the right roadside in a tracking mode. The vehicle ramped the curb, impacted a small tree on the roadside, and came to rest facing north on the roadside.

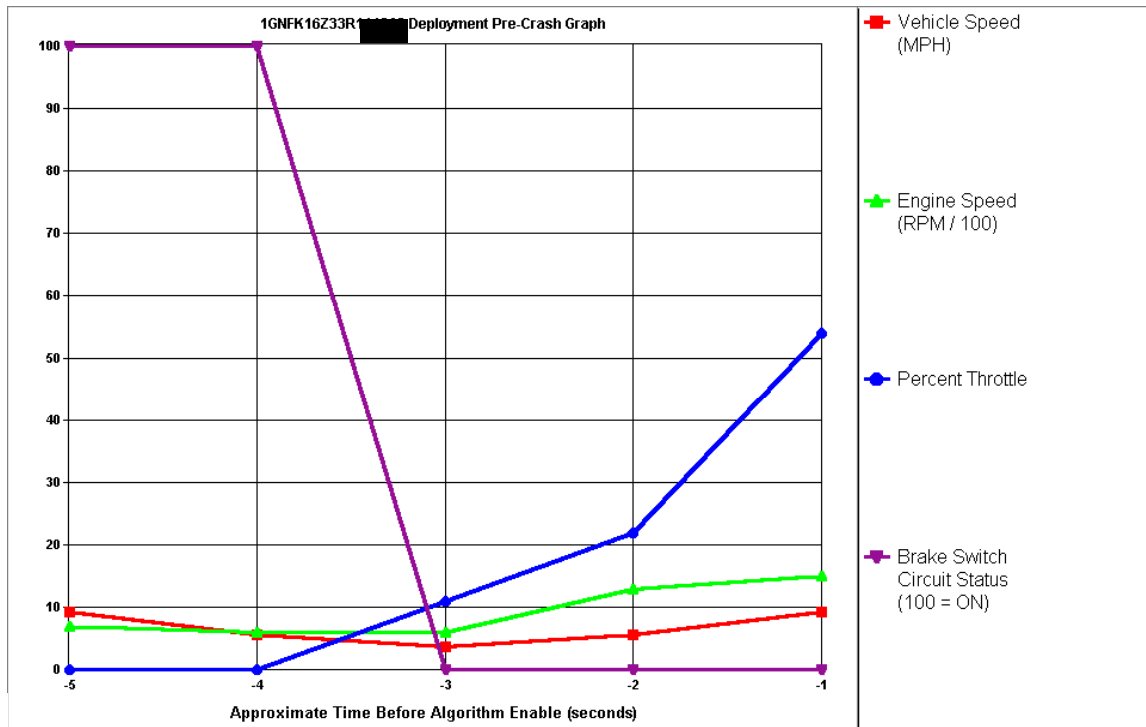
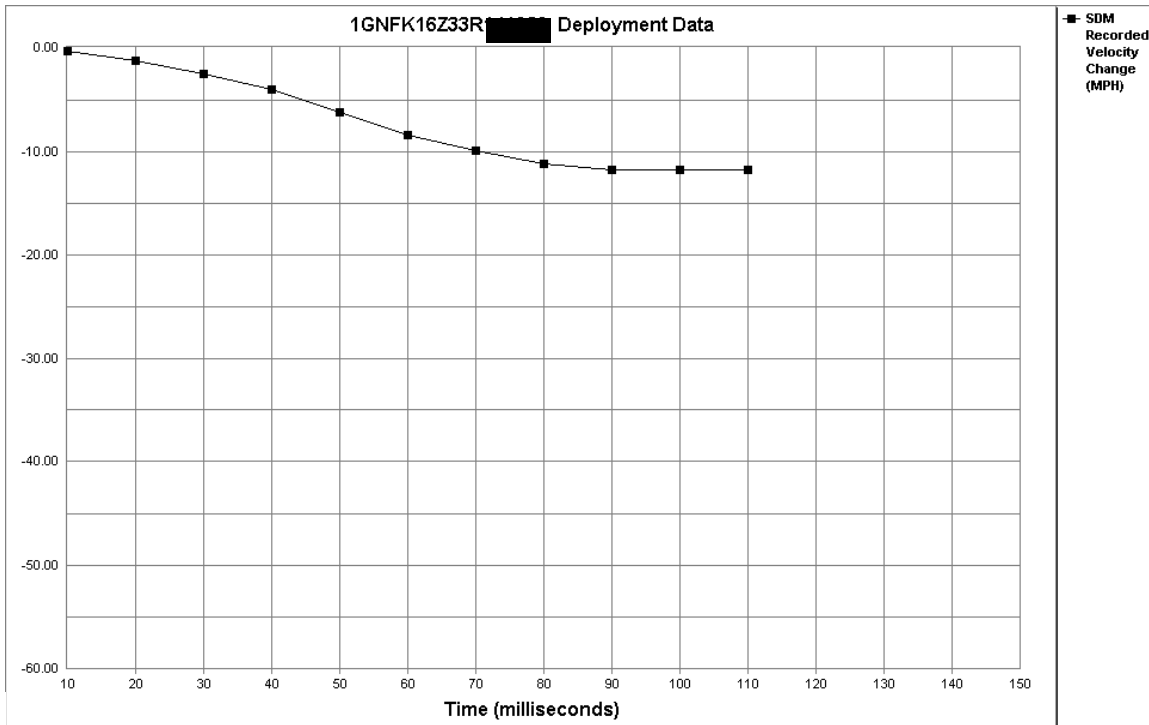
Although the vehicle inspection confirmed that there was no air bag deployment in the 2003 Chevrolet Suburban, the EDR in the Suburban recorded a Deployment event and a Non-Deployment event for this crash. According to the Suburban’s EDR output, a deployment was commanded for the first stage of the frontal air bags at 17.5 milliseconds after Algorithm Enable (AE). In addition, the five seconds of pre-crash data is identical for both the Deployment event and the Non-Deployment Event, which suggested that the time duration between the events was minimal.
