TRANSPORTATION RESEARCH CENTER

NASS/SCI COMBINATION CASE REPORT

CASE NUMBER - NASS-2002-48-070C
LOCATION - Alabama
VEHICLE - 2001 MERCEDES BENZ ML 320
CRASH DATE - MAY 2002

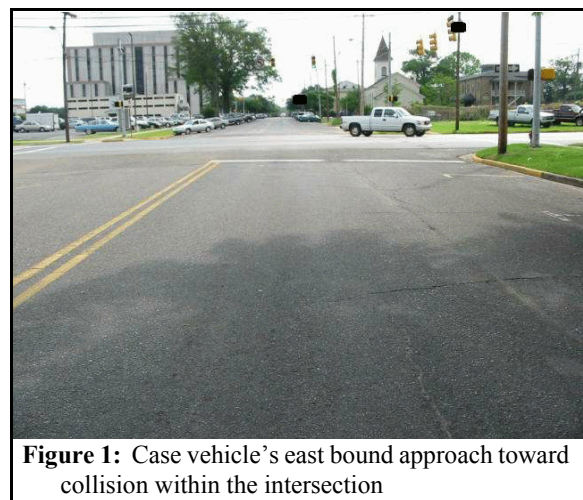
The case vehicle was traveling east in the eastbound lane of a two-lane roadway, approaching a four-leg intersection and intending to continue east. The other vehicle was traveling west in the westbound lane of the same roadway and intended to turn left to travel north on the intersecting roadway. For both the east and west legs of the intersection, the paved surface was wide enough to permit unrestricted angle parking along the north side and parallel parking along the south side of the roadway. The roadway was of asphalt construction with no apparent defects, the weather was clear and it was dark but lighted. The speed limit for both vehicles was 40 km.p.h. [25 m.p.h.]. The opposing lanes were separated by a double yellow line and the intersection was controlled by overhead automatic signals. The two vehicles entered the intersection at the same time, with the other vehicle attempting to turn left as the case vehicle was traveling straight through (**Figure 1**).

Figure 1: Case vehicle's east bound approach toward collision within the intersection

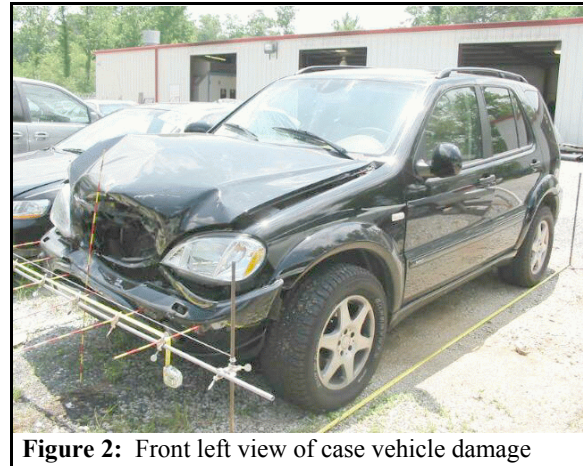
The case vehicle sustained direct contact damage across the entire front plane (**Figures 2 and 3**), a measured distance of 159 centimeters [62.6 inches]. Maximum crush was 16 centimeters [6.3 inches] at the front right corner of the hood. The bumper was moved rearward and slightly distorted but otherwise not seriously damaged. The grille (which was part of the hood on this vehicle) was crushed rearward at the center. The leading edge of the hood was crushed and the entire hood was buckled and displaced rearward, more so on the right. There was induced damaged on both fenders. The headlight and turn signal assemblies were intact but were slightly displaced due to the damage on adjacent body components. The wheelbase was shortened one centimeter [0.4 inches] on the left and lengthened one centimeter [0.4 inches] on the right. There was no damage to the wheels or tires and there was no glazing damage. The CDC was determined to be **11-FDEW-1 (340)** for the case vehicle's single impact. The WinSMASH reconstruction program was used, based on the measured crush profile of both vehicles. The case vehicle's Total, Longitudinal and Lateral Delta-Vs are, respectively: 24.0 km.p.h. [14.9 m.p.h.], -22.6 km.p.h. [-14.0 m.p.h.] and +8.2 km.p.h. [+5.1 m.p.h.]. This was a crash of low to moderate severity for the case vehicle.

Figure 2: Front left view of case vehicle damage

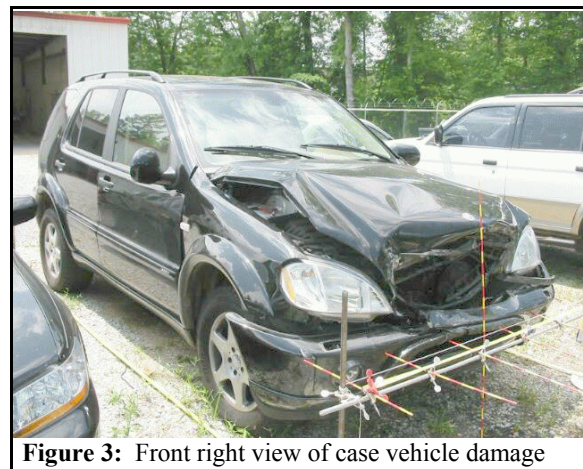
Figure 3: Front right view of case vehicle damage

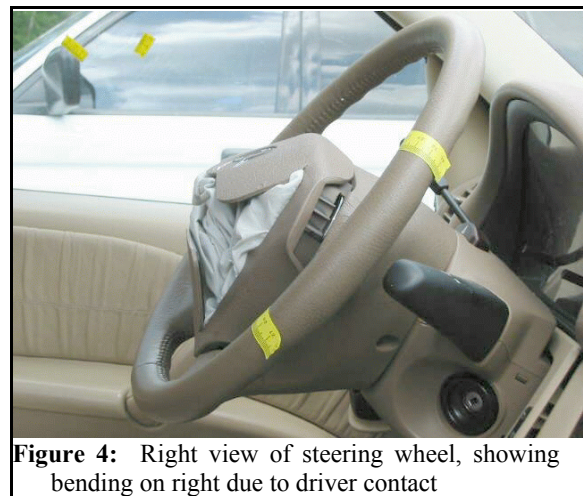
Inspection of the case vehicle's interior revealed no intrusions and several points of contact. The right half of the steering wheel rim was bent forward 2 centimeters [0.8 inches], which the NASS investigator determined was due to contact by the driver's chest (**Figure 4**). The knee bolster was cracked due to contact by the driver's right knee and the center of the instrument panel showed a cloth transfer due to contact by the driver's right arm. The driver's door window showed a smudge of skin oil due to contact by the driver's head and the interior rear view mirror was displaced, possibly as a result of contact by the driver's right hand. In addition, there was blood on the driver's and the front right passenger's sunvisors and on the roof-mounted map light console.

Figure 4: Right view of steering wheel, showing bending on right due to driver contact

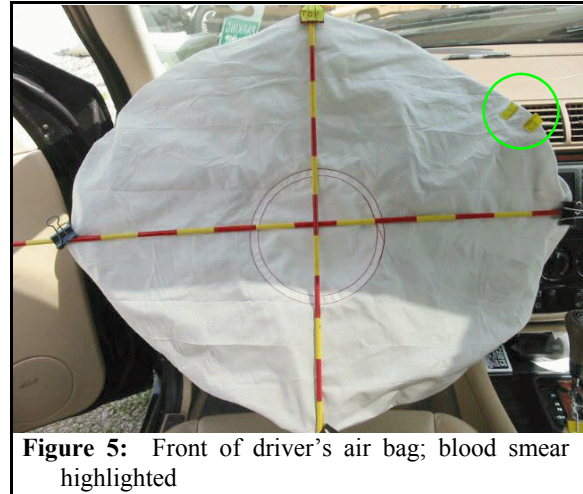
The driver's front air bag was located in the steering wheel hub, with two cover flaps in the H configuration. The upper flap measured 20 centimeters horizontally and 9 centimeters vertically, and the lower flap measured 19 centimeters horizontally and 7 centimeters vertically. The flaps opened at the tear points and there was no damage to the flap or the adjacent structures. The driver's air bag was reported as being elliptical, measuring 66 centimeters horizontally and 56 centimeters vertically. There were three tether straps and two vent ports, each approximately 3 centimeters in diameter, at the 11 and 1 o'clock positions. There were two areas of blood smear on the air bag fabric, on the front near the edge at approximately the 2:30 o'clock position (**Figure 5**), and on the back near the top (**Figure 6**).

Figure 5: Front of driver's air bag; blood smear highlighted

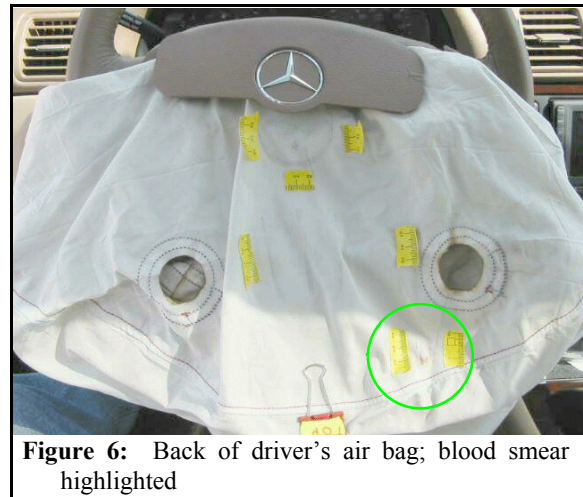
Figure 6: Back of driver's air bag; blood smear highlighted

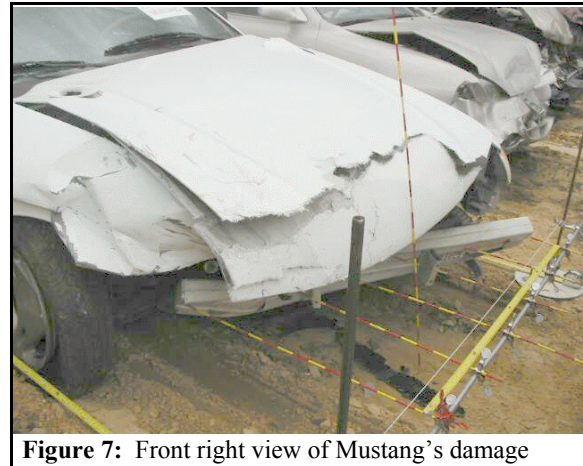
The Mustang sustained direct contact damage across the entire front, with maximum crush 66 centimeters [30.0 inches] at the front right corner. The grille, bumper fascia and both headlamp assemblies were broken away, exposing the steel bumper (**Figure 7**). The right fender was crushed inward and rearward and the right turn signal assembly was destroyed. The left fender sustained only minor induced damage and the left turn signal assembly was intact. The engine hood was made

of fiberglass and the leading edge was shattered and bent downward. The wheelbase was stretched 3 centimeters [1.2 inches] on the left and shortened 18 centimeters [7.1 inches] on the right. The windshield was cracked and there was no other glazing damage. The CDC was determined to be **01-FDEW-3 (20)**. The WinSMASH reconstruction program was used, based on the measured crush profile of both vehicles. The Mustang's Total, Longitudinal and Lateral Delta-Vs are, respectively: 36.0 km.p.h. [22.4 m.p.h.], -33.8 km.p.h. [-21.0 m.p.h.] and -12.3 km.p.h. [-7.6 m.p.h.]. This was a crash of moderate severity for the Mustang.

Figure 7: Front right view of Mustang's damage
