ON-SITE ADVANCED OCCUPANT PROTECTION SYSTEM INVESTIGATION

CASE NUMBER - IN-02-001
LOCATION - TEXAS
VEHICLE - 2000 CADILLAC DEVILLE TOURING SEDAN
CRASH DATE - December 2001

1. <i>Report No.</i> IN-02-001		2. <i>Government Accession No.</i>		3. <i>Recipient's Catalog No.</i>	
4. <i>Title and Subtitle</i> On-Site Advanced Occupant Protection System Investigation Vehicle - 2000 Cadillac DeVille Touring Sedan Location - Texas			5. <i>Report Date:</i> November 26, 2003

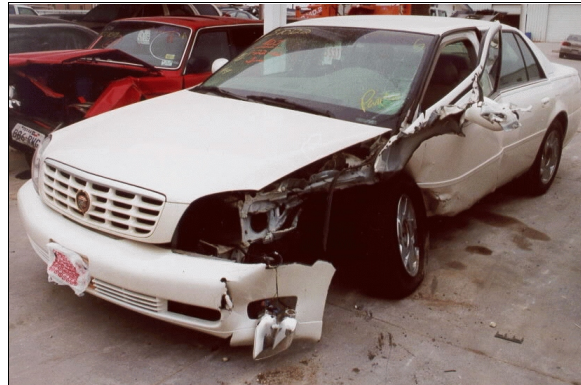
Figure 2: Case vehicle's front left damage viewed from left of front; Note: direct damage continues down left side and involves left outside rearview mirror and left front wheel was displaced rearward (case photo #08)

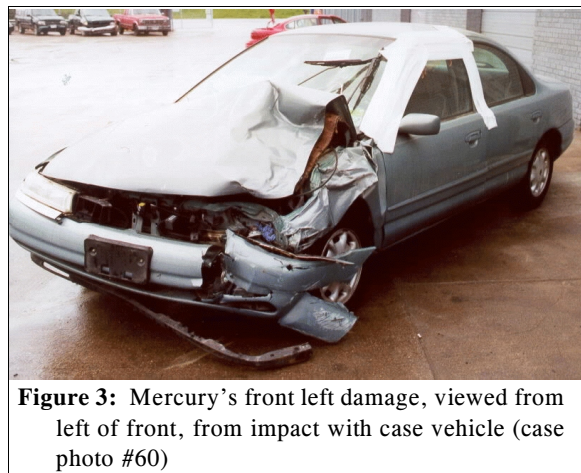
Figure 3: Mercury's front left damage, viewed from left of front, from impact with case vehicle (case photo #60)

The Mercury's contact with the case vehicle involved the front left one-third of the front bumper (Figure 3 above). Direct damage began 37 centimeters (14.6 inches) leftward from the center of the front bumper and extended, a measured distance of 42 centimeters (16.5 inches), along the front bumper to the front left bumper corner (Figure 18). Maximum crush was measured as 73 centimeters (28.7 inches) at C₁; however, residual crush was 65 centimeters (25.6 inches) at C₁ (Figure 19). The wheelbase on the Mercury's left side was shortened 20 centimeters (7.9 inches), while the right side was extended 6 centimeters (2.4 inches). The Mercury's front left splash guard, front bumper, bumper fascia, grille, front left corner of the hood, left headlight and turn signal assemblies, and left fender were directly damaged and crushed rearward. The Mercury's left front tire was displaced rearward and physically restricted by the lower left "A"-pillar.

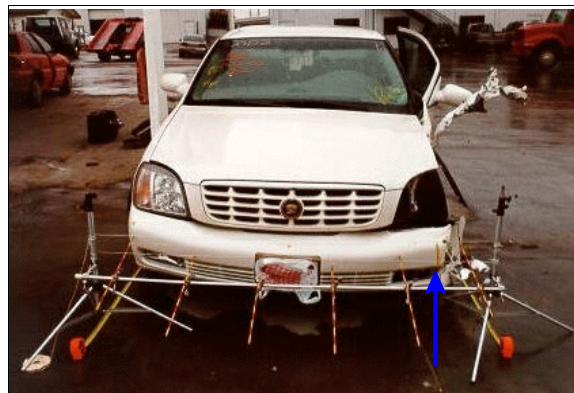
The case vehicle's contact with the Mercury involved the extreme front left corner of the bumper (**Figure 4**). Direct damage began 76.5 centimeters (30.1 inches) left of the front bumper's center and extended, a measured distance of 8 centimeters (3.1 inches), leftward to the bumper corner. The direct contact to the case vehicle extended down its left side past the base of the windshield. The wheelbase on the case vehicle's left side was shortened 42 centimeters (16.5 inches), while the right side was shortened 3 centimeters (1.2 inches). The case vehicle's front left bumper, bumper fascia, left headlight and turn signal assemblies, left fender, and left front tire and wheel assembly were directly damaged and crushed rearward. The left front wheel separated from the front axle, the tie rod, and the steering arm, and the suspension system was damaged, as well (**Figure 5**). The case vehicle's left front tire was physically restricted and driven into the lower left "A"-pillar. The forward portion of the left rocker panel and the lower front left corner of the left front door sustained induced damage. Remote buckling was found at the left front door's upper window frame and, also, at the lower right corner of the door's rear seam where it meets the left "B"-pillar.

Figure 4: Elevated view of case vehicle's frontal damage with contour gauge present at bumper level; Note: yellow tape (arrow) marks width of direct damage on bumper (case photo #06)

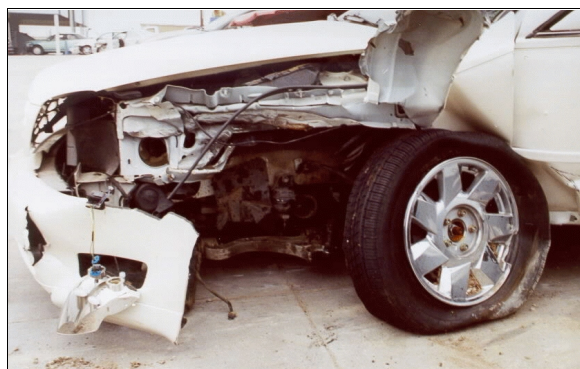
Figure 5: Case vehicle's front left damage viewed from left; Note: left front tire and wheel assembly were crushed rearward and separated from front axle, tire rod, steering arm, and suspension (case photo #11)

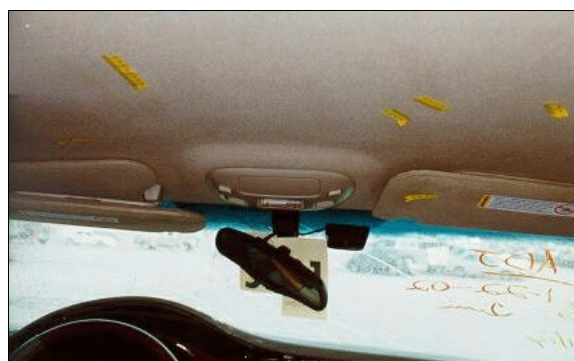
Figure 6: Case vehicle's roof and windshield header areas showing hair deposits on roof over both front passenger positions, hair deposit on front right sun visor, and a scrape over driver's position (case photo #28)

Inspection of the case vehicle's interior revealed hair deposits on the roof over both the driver and front right passenger seating positions. Furthermore, there was a scrape on the roof area above the driver's seat and there was hair on the left corner of the front right passenger's sun visor (**Figure 6** above); however, in this contractor's opinion, there is no evidence that the front right passenger moved forward and upward enough to contact the right sun visor. Furthermore, the roof deposits could have been spurious or they could have occurred as the front occupants were rebounding backward during the vehicle's post-impact trajectory, but there are no injuries, for either front seat occupant, associated with these deposits. The back left passenger contacted the left rear door glazing and the door panel, both above and below the armrest. Furthermore, the back left passenger imprinted lipstick on the back of the driver's seat (**Figure 7**) and deposited blood on her own seat cushion, back rest, and the webbing of her safety belt. The back right passenger contacted the right rear door panel above the armrest and fractured the back panel of the front right passenger's seat back (**Figure 8**). There was extensive intrusion into the driver's seating area. The steering assembly was driven upwards while the floor pan, hood latch lever, side panel forward of the left "A"-pillar, and door side panel intruded laterally (**Figure 9**). The steering column was completely separated from its shear capsules and could be moved up and down.

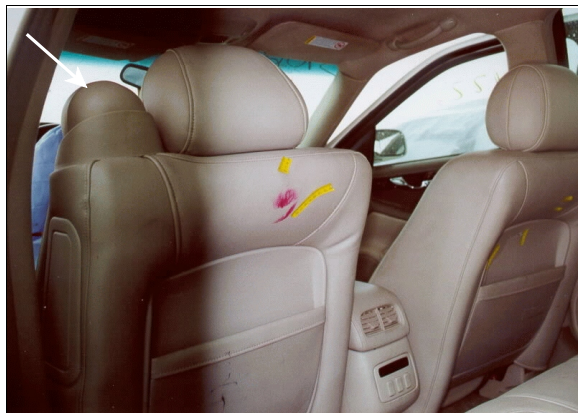
Figure 7: Lipstick imprint on back surface of case vehicle's driver seat back from contact by back left passenger; Note: driver's seat integrated restraint system (case photo #49)

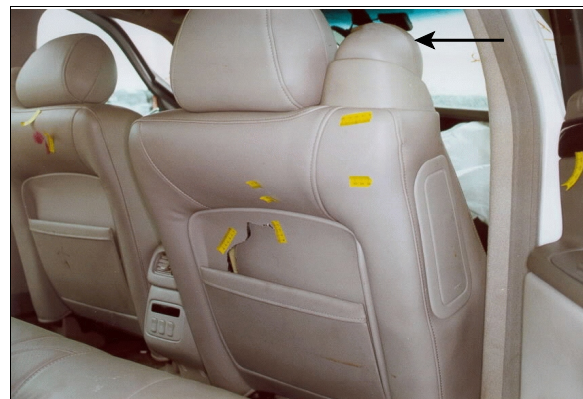
Figure 8: Fracture and contact evidence on back surface of case vehicle's front right passenger seat back from contact by back right passenger; Note: front right passenger's seat integrated restraint system (case photo #51)

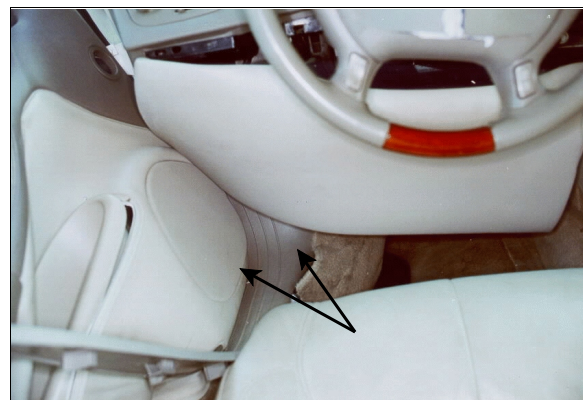
Figure 9: Overhead view of case vehicle's driver seating area showing lateral intrusion into area (case photo #33)

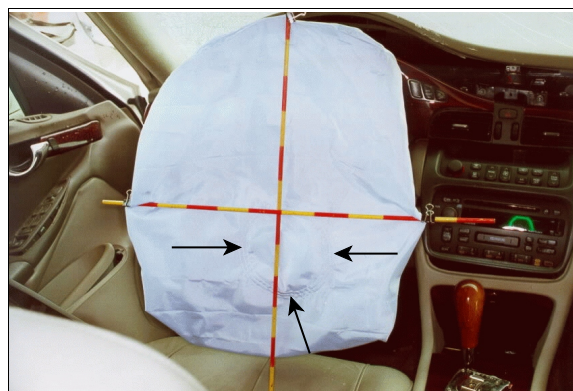
The case vehicle was equipped with a Supplemental Restraint System (SRS) that contained single-stage, redesigned frontal air bags at the driver and front right passenger positions. In addition, the vehicle was equipped with front and back, seat back-mounted, side impact air bags. Both frontal air bags deployed as a result of the frontal impact with the Mercury. None of the case vehicle's four seat back-mounted side air bags deployed as a result of the case vehicle's frontal impact with the Mercury. The case vehicle's driver air bag was located in the steering wheel hub. An inspection of the air bag module's cover flaps and the air bag's fabric revealed that the cover flaps opened at the designated tear points, and there was no evidence of damage during the deployment to the air bag or the cover flaps. The module cover consisted of symmetrical "I"-configuration cover flaps made of thick vinyl with overall dimensions of 8 centimeters (3.1 inches) at the left and right horizontal seams and 12 centimeters (4.7 inches) vertically. The driver's air bag was designed with four tethers, each 8 centimeters (3.1 inches) wide, and attached to the center circular stitching. The driver's air bag had two vent ports, approximately 3 centimeters (1.2 inches) in diameter, located at the 11 and 1 o'clock positions. The deployed driver's air bag was elliptical with a height of approximately 64 centimeters (25.2 inches) and a width of approximately 46 centimeters (18.1 inches). An inspection of the driver's air bag revealed that there was no contact evidence readily apparent on the air bag's fabric (**Figure 10**).

Figure 10: Case vehicle's deployed driver air bag showing no obvious occupant contact evidence; Note: below center location of circular stitched area (case photo #37)

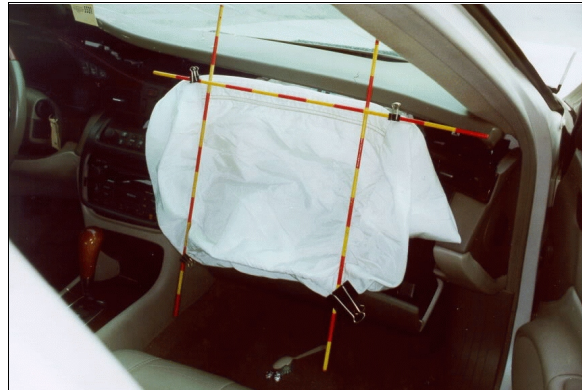
The front right passenger's air bag was located in the middle of the instrument panel. There was no module cover flap. Rather, as the deploying air bag expands, it forces the top, padded portion of the instrument panel upward, by an approximate 5 centimeters (2.0 inches), creating an opening between the horizontal top and the vertical front of the instrument panel. The air bag deployed through this opening. The automobile manufacturer refers to this design as an **ACTIVE INSTRUMENT PANEL**. An inspection of the front right instrument panel and air bag's fabric revealed that the instrument panel opened at the designated points of attachment, and there was no evidence of damage during the deployment to the air bag or the instrument panel. The front right passenger's air bag was designed without any tethers, but it did have two vent ports, approximately 6 centimeters (2.4 inches) in diameter, located at the 3 and 9 o'clock positions. The deployed front right air bag was rectangular with a height of approximately 42 centimeters (16.5 inches) and a width of approximately 35 centimeters (13.8 inches). An inspection of the front right passenger's air bag revealed that there was no contact evidence readily apparent on the air bag's fabric (**Figure 11**).

Figure 11: Case vehicle's deployed front right passenger air bag showing no obvious evidence of occupant contact (case photo #38)

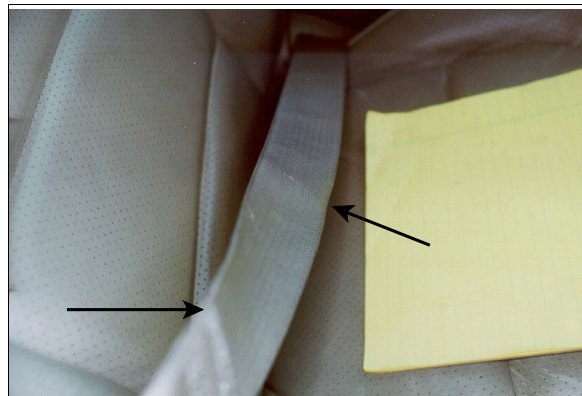
Figure 12: Close-up of seat belt webbing for case vehicle's driver showing evidence of loading (case photo #39)

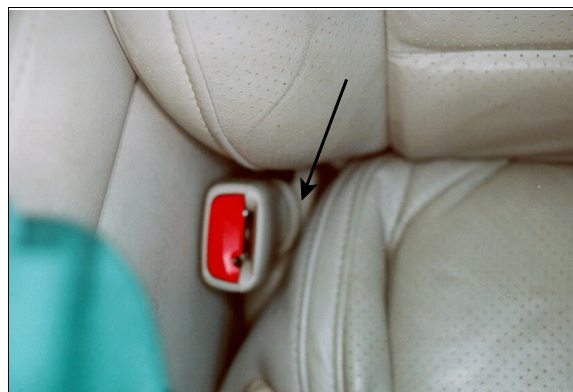
driver’s seat being moved slightly toward the center console, the seat belt pretensioner’s piston stroke could not be measured (**Figure 13**).

Figure 13: Close-up of buckle from case vehicle’s driver seat belt system showing actuated seat belt pretensioner; Note: driver’s seat jammed against center console as a result of lateral intrusion into driver’ seating area (case photo #40)

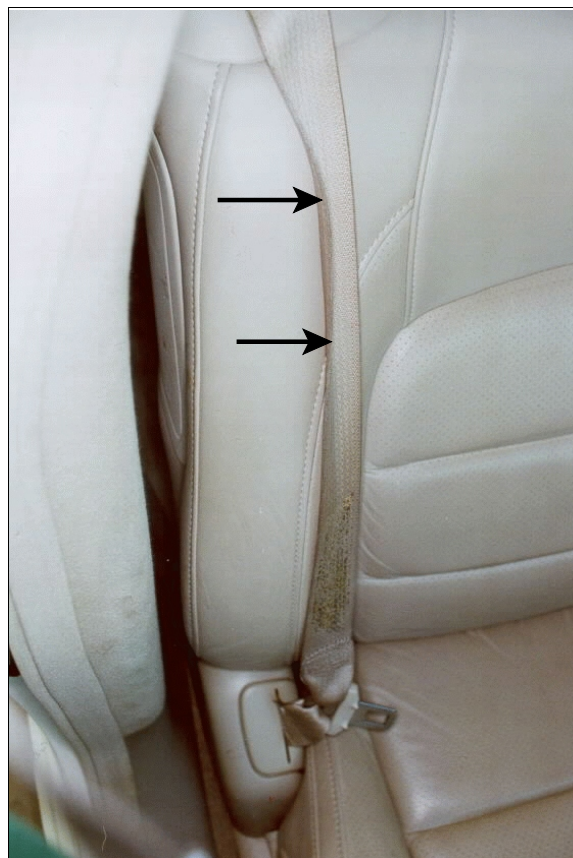
Figure 14: Close-up of case vehicle's front right passenger seat belt system showing evidence of loading on belt's webbing (case photo #55)

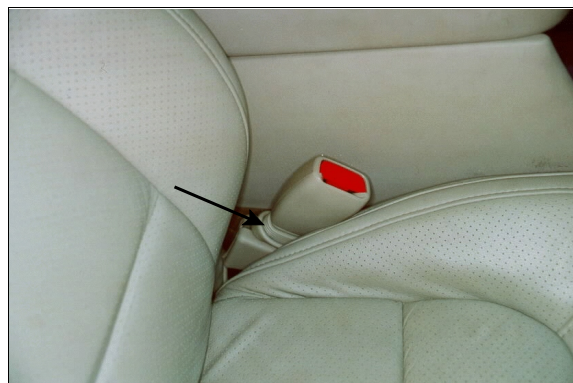
The case vehicle's front right passenger was restrained by her available, active, three-point, lap-and-shoulder, safety belt system; the belt system was also equipped with a pretensioner. Furthermore, according to the driver's interview, there was evidence of belt pattern bruising to the front right passenger's body, and the inspection of the front right passenger's seat belt webbing showed evidence of loading (**Figure 14**). The front right seat belt system was also seat integrated and, thus, there was no "D"-ring (**Figure 8** above). The latch plate showed evidence of recent usage, but no loading damage was noted. The piston stroke for this seat position's seat belt pretensioner (**Figure 15** below) was measured at 3.5 centimeters (1.4 inches).

Figure 15: Close-up of buckle for case vehicle’s front right passenger seat belt system showing actuated pretensioner (case photo #42)

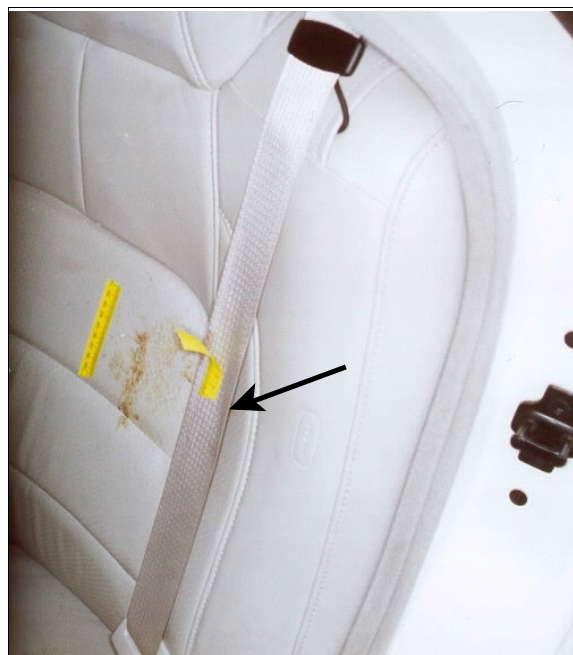
Figure 16: Close-up of case vehicle's back left seat belt system showing loading evidence on belt webbing (i.e., yellow tape) and blood evidence on seat back's cushion (case photo #47)

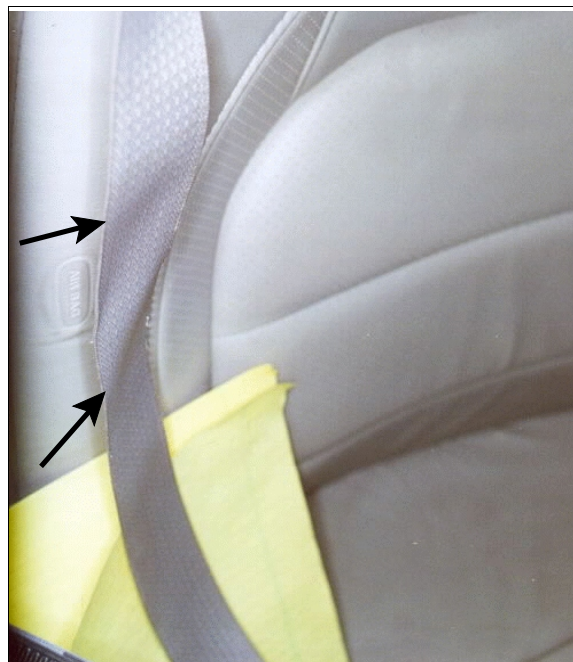
Figure 17: Close-up of seat belt webbing for case vehicle's back right passenger showing evidence of loading on webbing (case photo #52)

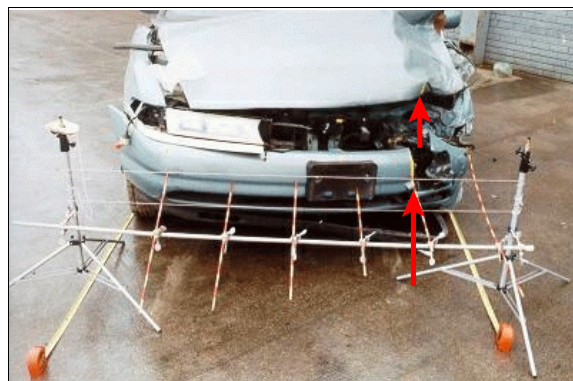
Figure 18: Elevated view of Mercury's frontal damage with contour gauge present at bumper level; Note: yellow tape (arrows) shows width of direct damage on bumper and hood (case photo #57)

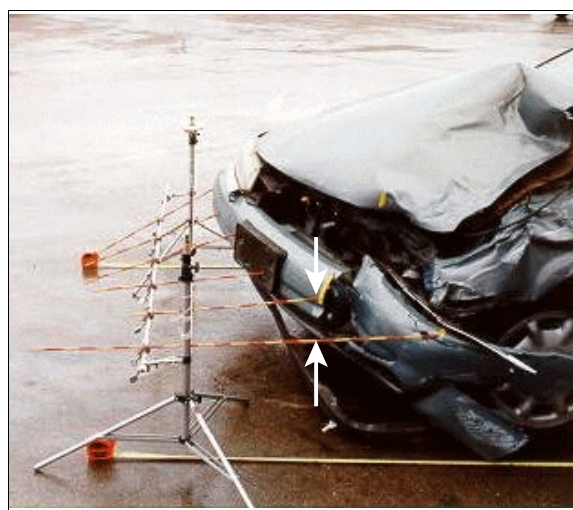
Figure 19: Reference line view of Mercury's frontal damage viewed from left with contour gauge present at bumper level; Note: arrows show width of direct damage on bumper (case photo #62)

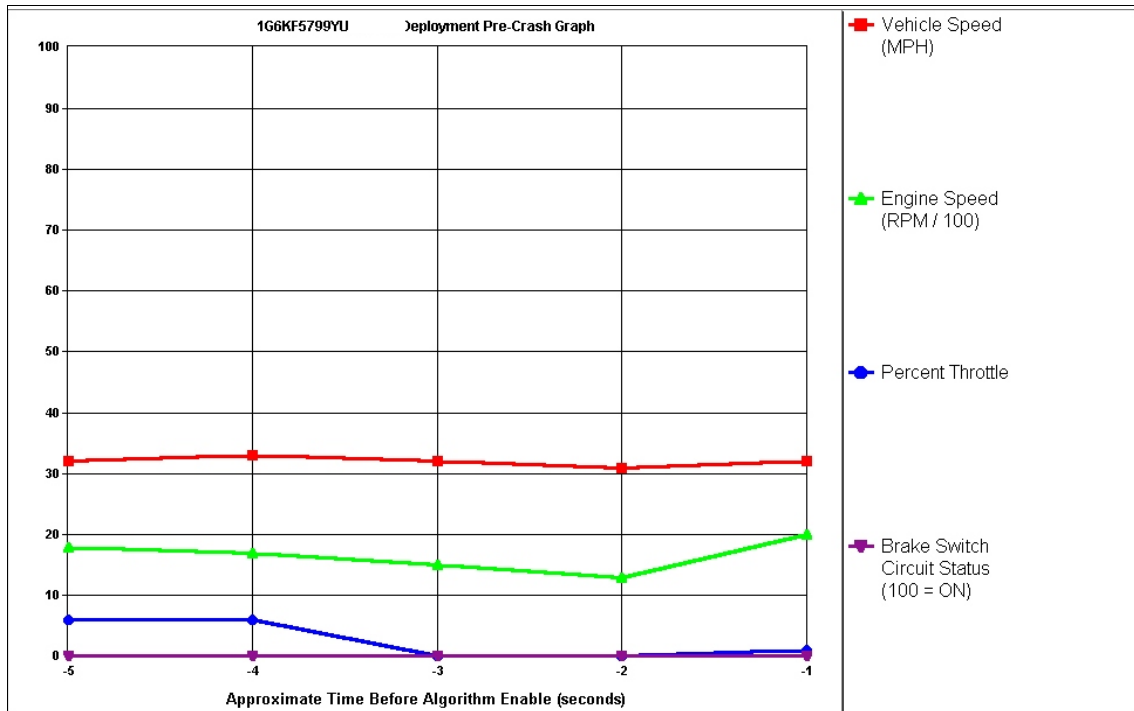
Figure 21: Case vehicle’s pre-crash speed and brake switch circuit status showing that the vehicle had been traveling at approximately 50 km.p.h. (31 m.p.h.) and that the brake switch had not been activated.

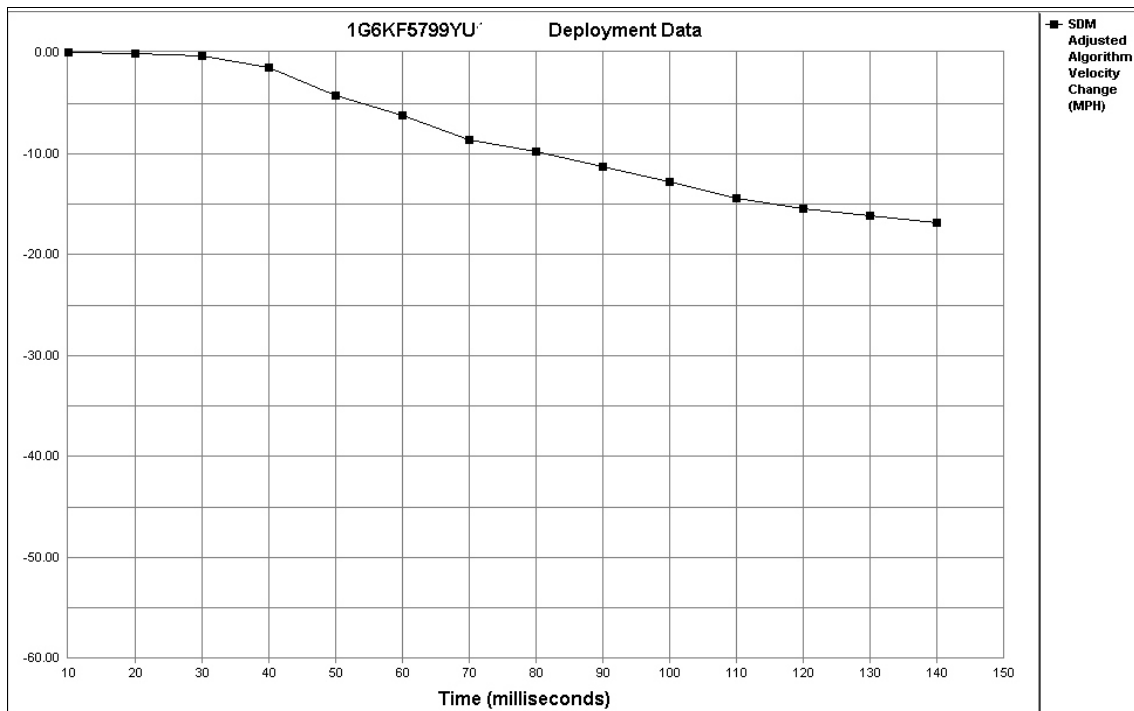
Figure 22: The case vehicle sustained a velocity change of approximately 27.0 km.p.h. (16.8 m.p.h.) during the first 140 milliseconds after the crash was detected
