**ON-SITE FRONTAL AIR BAG NON-DEPLOYMENT/  
DRIVER FATALITY INVESTIGATION**

**VERIDIAN CASE NO. CA02-001**

**VEHICLE: 2001 KIA RIO**

**CRASH DATE: DECEMBER 2001**

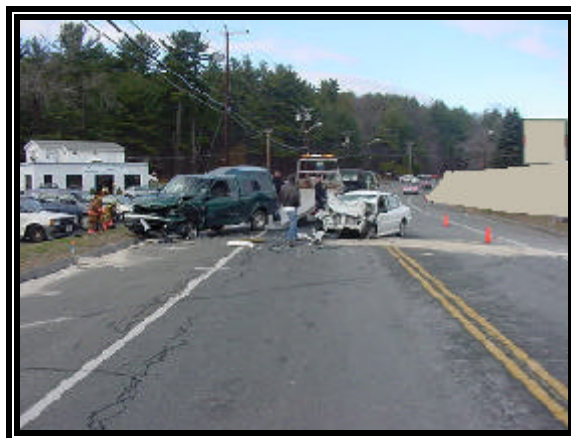
This two-vehicle crash occurred during the afternoon hours in December, 2001. At the time of the crash, it was daylight and the weather was not a factor. The asphalt road surface was dry. The crash occurred in the southbound lane of a two-lane north/south road in a commercial area of the city. Small businesses bordered both sides of the roadway. The crash occurred on a straight section of the road, relative to the Kia's northbound travel direction. The southbound Ford had just exited a left curve as it approached the point of impact. **Figure 1** is an on-scene police photo looking northward, depicting the vehicles at final rest. The posted speed limit was 64 km/h (40 mph).

**Figure 1:** Final rest position of the vehicles looking northward.

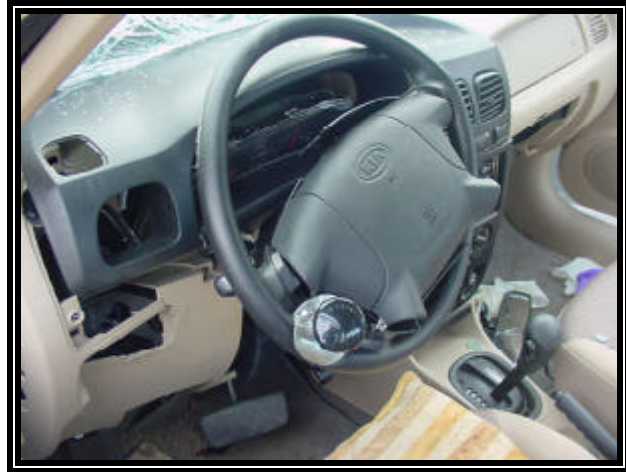
**Figure 2:** View of the spinner knob and deformed steering wheel rim.

The driver's chest and abdomen contacted and deformed the steering wheel rim. The entire circumference of the rim was deformed forward around the center hub and air bag module (approximately 5cm (2 in)). There no was displacement of the steering column shear capsules. The contact to the steering wheel

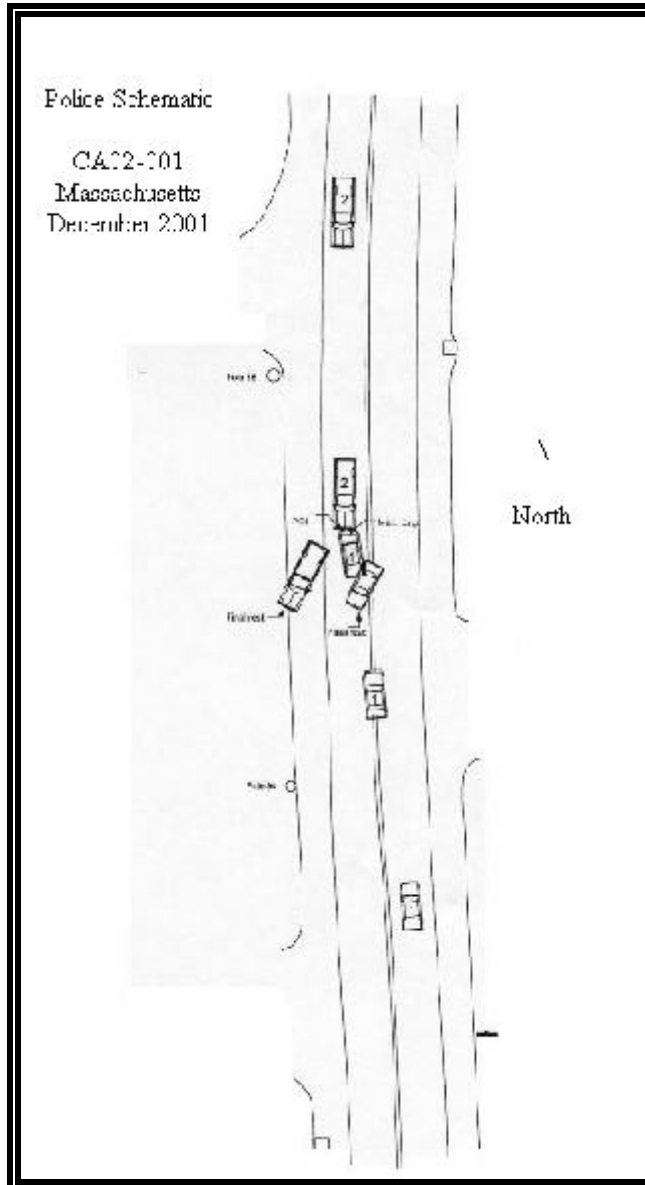
Figure 3: Police Crash Schematic

The full frontal area of the Kia impacted the front of the Ford in a head-on impact configuration resulting in severe frontal crush to the Kia. The force of the impact reversed the Kia's northward momentum and caused the vehicle to rotate counterclockwise approximately 150 degrees, as it slid southward to rest. The Kia came to rest facing southwest straddling the centerline of the road 3.3 m (10.8 ft) south of impact. The delta V of the Kia Rio calculated by the Damage algorithm of the WINSMASH model was 59.0 km/h (36.7 mph). The Kia's seat belt pretensioners fired as a result of the impact, however, the air bag system did not deploy.

The impact deflected the southbound Ford approximately 30 degrees to the west. The Ford came to rest facing southwest along the west shoulder of the road 7.5 m (24.5 ft) south of the impact. The force of the impact caused the deployment of the frontal air bag system in the Ford. The Collision Deformation Classifications (CDC's) were 12-FDEW-3 and 12-FYEW-3 for the Kia and Ford, respectively.

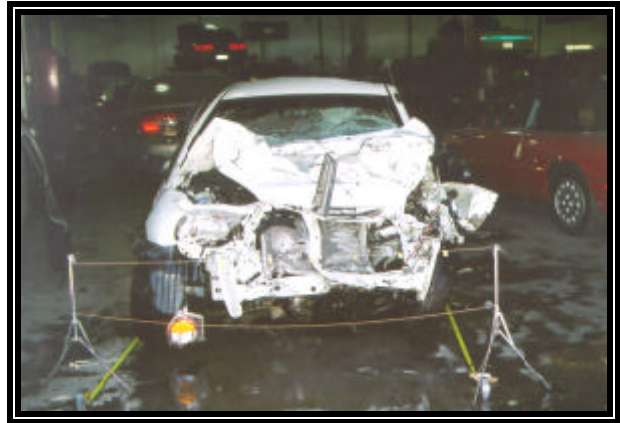
**Figures 4 through 6** are the front, left side and right front views of the Kia, respectively. The vehicle sustained severe frontal damage that extended across the entire 123 cm (48 in) undeformed frontal end width. The impact had displaced the bumper fascia, foam backer and bumper reinforcement bar from the vehicle. The displacement of these components exposed the upper and lower radiator supports and the vehicle's forward sub-frame. The longitudinal extent of crush along the upper radiator support was greater in magnitude than the crush along the lower support indicative of an underride. Crush profiles along both elevations were documented. The average residual crush profile across the frontal plane of the Kia was as follows: C1=58 cm (23 in), C2=63 cm (25 in), C3=58 cm (23 in), C4=58 cm (23 in), C5=51 cm (20 in), C6=30 cm (12 in). The delta V of the Kia Rio calculated by the Damage algorithm of the WINSMASH model was 59.0 km/h (36.7 mph). The longitudinal and lateral delta V components were -58.1 km/h (-36.1 mph) and -10.2 km/h (-6.4 mph), respectively. The PDOF was within the 12 o'clock sector estimated at 10 to 15 degrees. The magnitude of crush was biased to the left side of the vehicle. The left wheelbase was foreshortened 12.7 cm (5.0 in). The right wheelbase was unchanged. The left front corner of the was roof buckled.

**Figure 4:** Front view of the Kia.

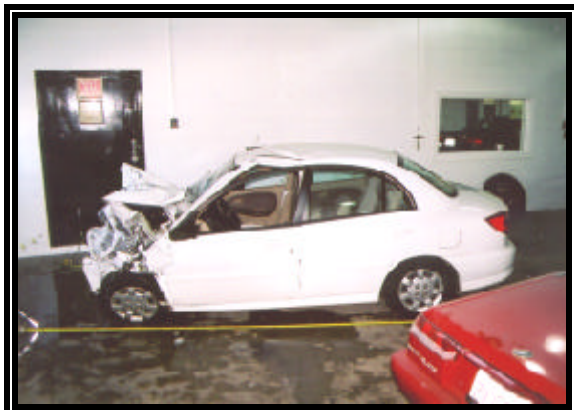
**Figure 5:** Left side view of the Kia.

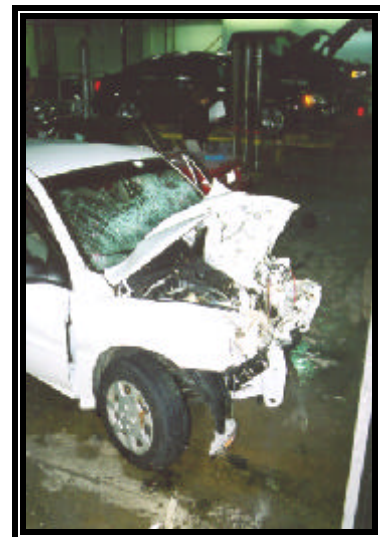
**Figure 6:** Right front view of the Kia.

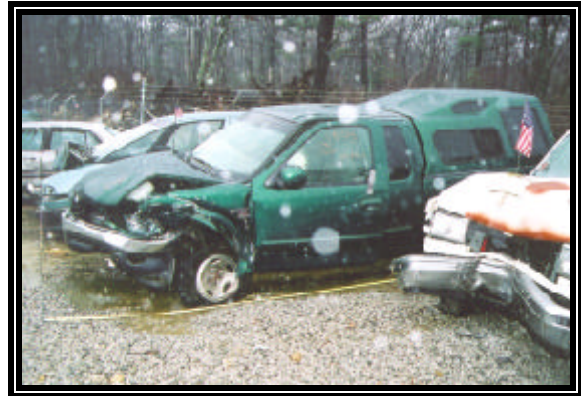
**Figures 7 and 8** are the front and left side views of the Ford, respectively. The front of the Ford sustained 106.0 cm (41.7 in) of direct contact damage that began 26.1 cm (10.3 in) right of center and extended to the left front bumper corner. The residual crush profile measured along the front bumper was as follows: C1=71 cm (28 in), C2=53 cm (21 in), C3=36 cm (14 in), C4=28 cm (11 in), C5=19 cm (7.5 in), C6=10 cm (4 in). The left wheelbase was foreshortened 31.2 cm (12.3 in). The driver's door was jammed shut by the force of the impact and forced open by the emergency responders. Contact between the forward aspect of the rear bed and back of the cab was noted. The delta V of the Ford calculated by the Damage algorithm of the WINSMASH model was 34.0 km/h (21.1 mph). The longitudinal and lateral delta V components were -33.5 km/h (-20.8 mph) and 5.9 km/h (3.7 mph), respectively.

**Figure 7:** Left side view of the Ford.

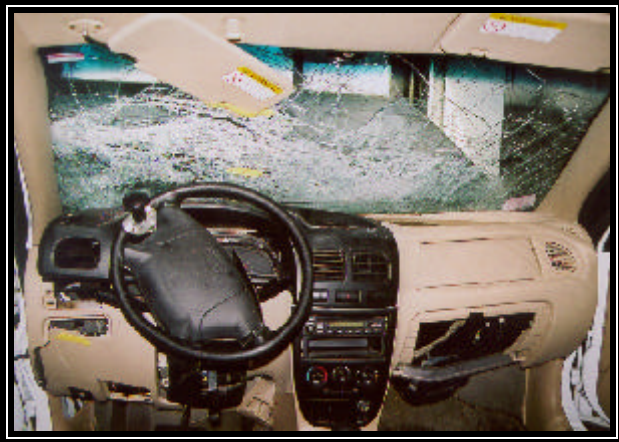
**Figure 9** is an overall view of the Kia's forward interior. The vehicle's interior sustained moderate damage and intrusion consistent with the exterior forces of the crash. Four specific points of occupant contact were noted. The driver's head contacted the windshield directly forward of the steering assembly and her chest contacted and deformed the lower half of the steering wheel rim. The left knee contacted the left outboard aspect of the bolster panel and her right knee contacted the steering column assembly immediately right of the adjustment lever. (This contact is hidden by the lower steering wheel rim in Figure 9).

The driver's foot well intrusion was an estimated 15 to 20 cm (6 to 8 in). The lower aspect of the steering column intruded rearward into the driver's space causing the column to rotate to a more vertical orientation. There was no displacement of the steering column's shear capsules. The center instrument panel intrusion was approximately 6.4 cm (2.5 in). The glove box was displaced from its mounted position and was found in the back seat. The intrusion of the metal support bracket behind the glove box measured approximately 8.3 cm (3.3 in).

Figure 9: View of the front interior.

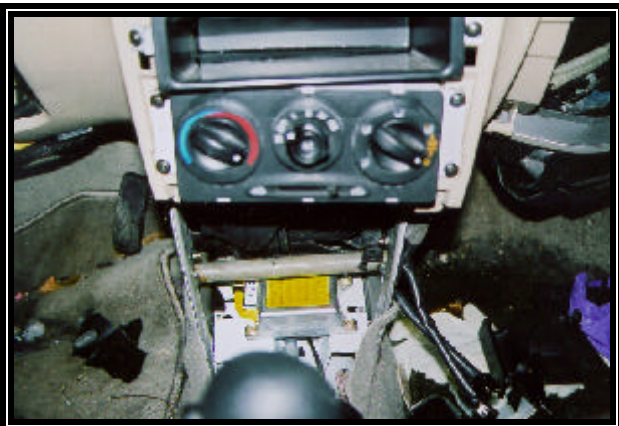
The design of the air bag system consisted of the driver air bag module and clock spring, the front right passenger air bag module, an instrument cluster indicator lamp, associated wiring, and an Air Bag Diagnostic Unit (ADU). The ADU consisted of a processor, memory, auxiliary power supply, and the crash and safing sensors. The ADU was located under the center electronic stack and is depicted in **Figure 10**. The processor performed a diagnostic test of the system upon each key-cycle and also initiated the deployment upon crash recognition. The seat belt pretensioners were incorporated in the SRS design and were also deployed by the ADU. Reportedly, the Kia had been taken back to the dealer three times for routine service. This routine service was not related to the air bag system. No fault codes were ever reported during those service requests.

Figure 10: View of the Air Bag Diagnostic Unit.

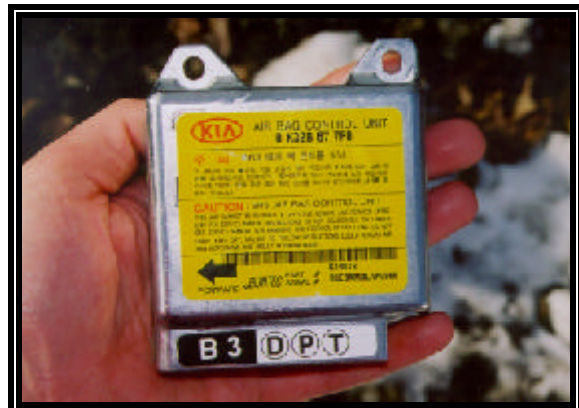
The ADU was attached to the vehicle by three 5 mm fasteners and was properly mounted. The nuts were found to be properly torqued upon removal. A ground wire was properly attached to the forward right fastener and was corrosion free. The wiring harness appeared to be positively attached upon disassembly. **Figure 11** is a close-up view of the subject ADU. It was not damaged in the impact.

**Figure 11:** Close-up view of the subject ADU.

The subject ADU was installed in the exemplar vehicle. Upon ignition, the air bag warning lamp illuminated, as the ADU went through its standard diagnostic procedure, and then went off after approximately 6 seconds. The "off" status of the warning lamp indicated the SRS was functioning properly. The scan tool was used to access the ADU for any stored diagnostic trouble codes. There were no diagnostic trouble codes stored within the subject ADU. This indicated to the Kia Technician that the ADU was operating properly at the time of the inspection and should have been operating properly at the time of the crash. The root cause for the non-deployment of the frontal air bag system in the subject 2001 Kia Rio could not be determined.

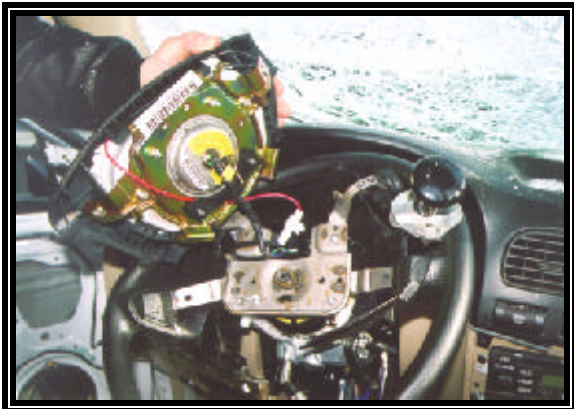
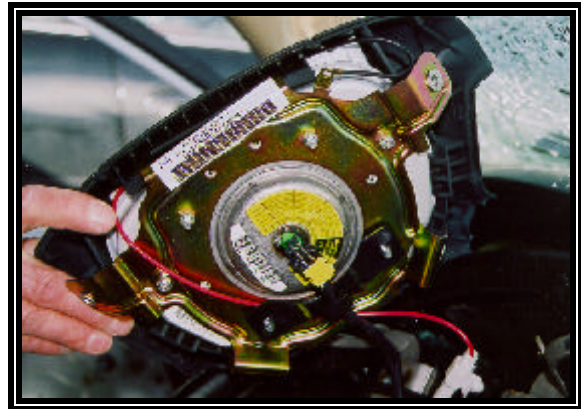
During this second inspection, the driver air bag was removed from the subject Kia and inspected. **Figures 12-15** are a series of photographs depicting the driver air bag module and its mounting location in the center hub of the steering wheel rim. The driver air bag was identified by the following nomenclature:

**Figure 12:** Driver air bag disassembly.

**Figure 13:** Drive air bag module.

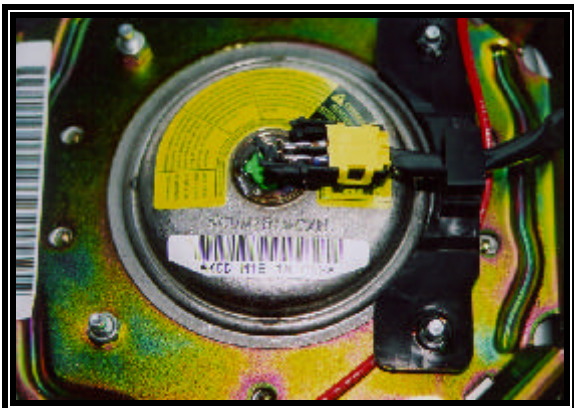
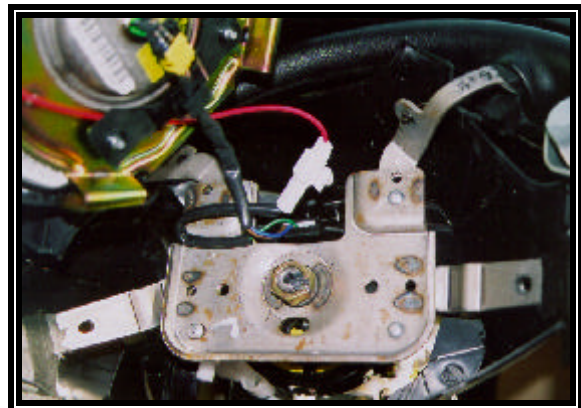
The driver air bag module appeared to be undamaged. All the electrical appeared to be intact and were corrosion free. It was noted that the electrical connector attached to the inflator had contacted the hardware that attached the steering wheel rim to the steering column. Refer to **Figures 14 and 15**. Although the connector's molded insulator jacket was damaged by this contact, the electrical connection itself appeared to be intact. This contact between the inflator and steering column would have occurred in the later stages of the crash sequence and should not have affected the performance of the air bag system. It was probable the deployment sequence should have been initiated before this contact occurred.

**Figure 14:** Close-up of inflator and electrical connection.

**Figure 15:** Close-up view of the end of the steering column.
