ON-SITE SIDE IMPACT INFLATABLE OCCUPANT PROTECTION INVESTIGATION

CASE NUMBER - IN-02-002
LOCATION - ILLINOIS
VEHICLE - 2001 CHEVROLET IMPALA LS
CRASH DATE - July 2002

1. <i>Report No.</i> IN-02-002		2. <i>Government Accession No.</i>		3. <i>Recipient's Catalog No.</i>	
4. <i>Title and Subtitle</i> On-Site Side Impact Inflatable Occupant Protection Investigation Vehicle - 2001 Chevrolet Impala LS Location - Illinois			5. <i>Report Date:</i> April 26, 2005

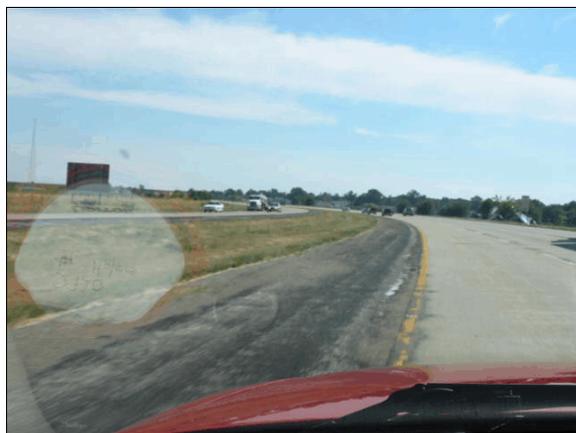
Figure 1: Case vehicle's southerly travel path in inside lane of southern roadway's left-hand curve (case photo #03)

Pre-Crash: The case vehicle was in a left-hand curve (**Figure 1** above), traveling south-southwestward in the inside lane of the southbound roadway. The case vehicle's driver intended to continue in his southerly direction of travel. The 1st and 2nd other vehicles were negotiating a right-hand curve (**Figure 2** above), traveling north-northwestward in the inside lane of the northbound roadway and intended to continue their northerly travel paths. The case vehicle's driver lost control of his vehicle, and it began to rotate counterclockwise. The case vehicle departed the southbound roadway (**Figure 3**) onto the east shoulder and traveled approximately 81 meters (266 feet) longitudinally along and transversely across the grassy median (**Figure 4**). The case vehicle entered the inside lane of the northbound roadway (**Figure 5**) while continuing to rotate counterclockwise. The avoidance maneuvers, if any, taken by the case vehicle's driver are unknown. The driver of the 2001 Honda steered right toward the center through lane, attempting to avoid the crash. The crash occurred near the lane line that separates the center and inside through lanes of the northbound roadway.

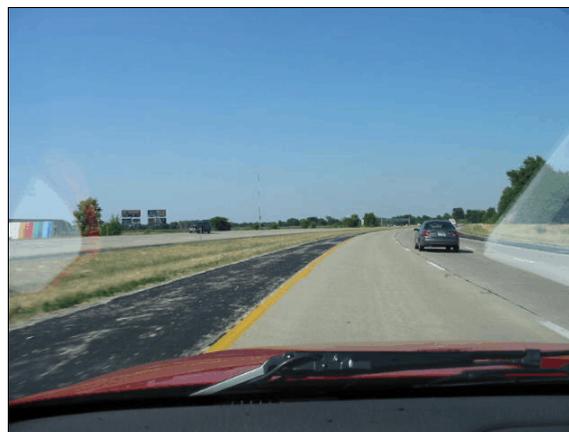
Figure 2: 2001 Honda's northerly travel path in inside lane of northern roadway's right-hand curve; Note: 1996 Honda following 2001 Honda in center lane of roadway (case photo #11)

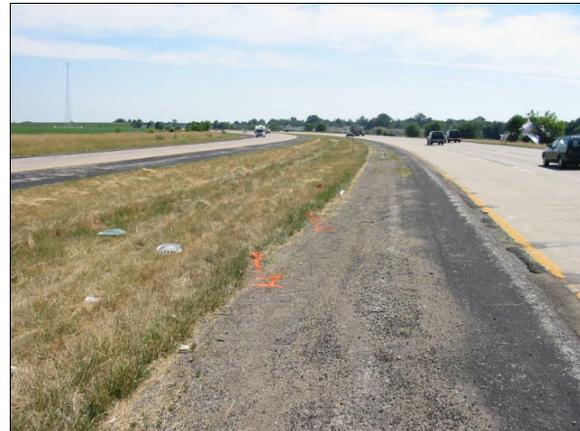
Figure 3: Case vehicle's southerly departure into median from southbound roadway of interstate trafficway (case photo #04)

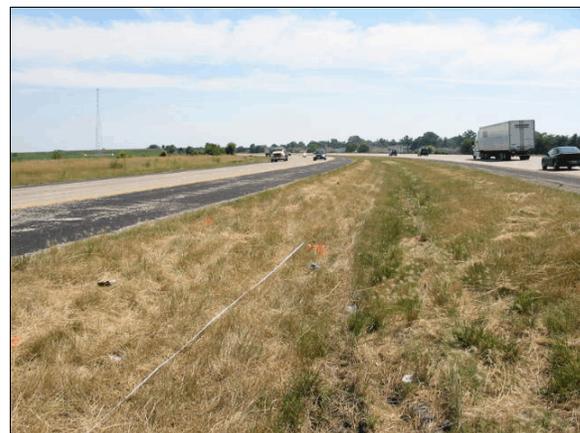
Figure 4: Case vehicle's oblique travel path from southern roadway through median toward northern roadway; Note: vehicle rotating counterclockwise while traversing median (case photo #06)

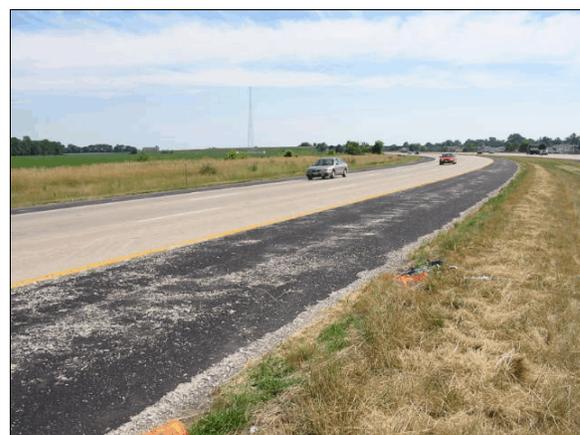
Figure 5: Case vehicle's oblique travel path across median and onto northern roadway; Note: case vehicle traveling backwards upon entry onto northern roadway (case photo #07)

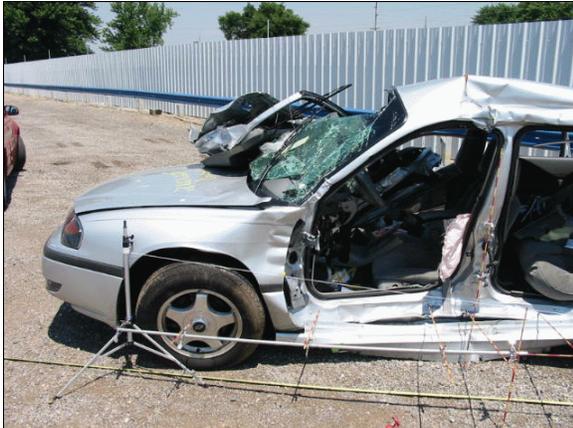
Crash: The left side doors (**Figures 6** and **7** below) of the case vehicle were impacted by the front (**Figure 8** below) of the 2001 Honda,

Figure 6: Damage to case vehicle's left side and specifically driver's area from impact (1st event) with 2001 Accord; Note: doors removed for occupant extrication (case photo #17)

Exterior Damage: The case vehicle's contact with the 2001 Honda involved the left center of the vehicle (**Figures 6 and 7** above). Direct damage began 42 centimeters (16.5 inches) behind of the left front axle and extended 196 centimeters (77.2 inches) rearward, ending at the forward portion of the left rear wheel well (**Figures 12 and 13**). Residual maximum crush was measured as 51 centimeters (20.1 inches). The measurement was taken along the sill level and 35 centimeters (13.8 inches) forward of C₃. The case vehicle's contact with the 1996 Honda involved the right front and center areas of the vehicle (**Figures 10 and 11** above). Direct damage began 45 centimeters (17.7 inches) forward of the right rear axle and extend 138 centimeters (54.3 inches) forward along the right side (**Figure 14**). Maximum crush for this right side impact was measured as 34 centimeters (13.4 inches) at C₄.

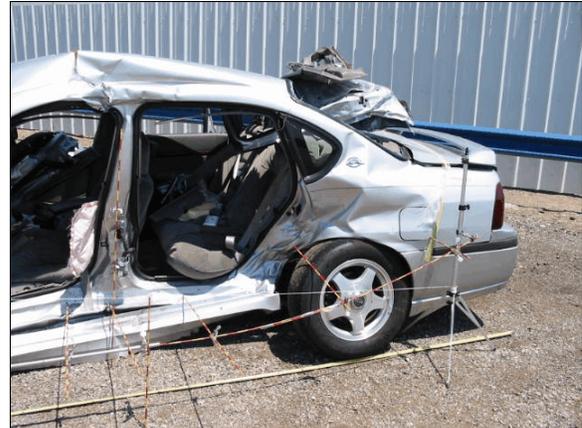
Figure 7: Damage to case vehicle's left side and specifically back left area from impact (1st event) with 2001 Accord; Note: doors removed for occupant extrication (case photo #18)

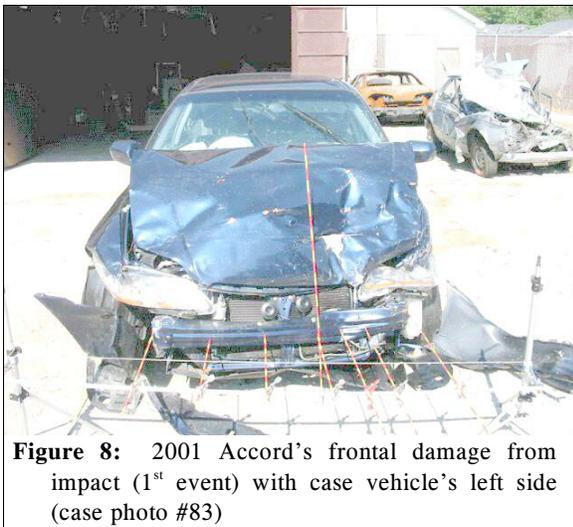
Figure 8: 2001 Accord's frontal damage from impact (1st event) with case vehicle's left side (case photo #83)

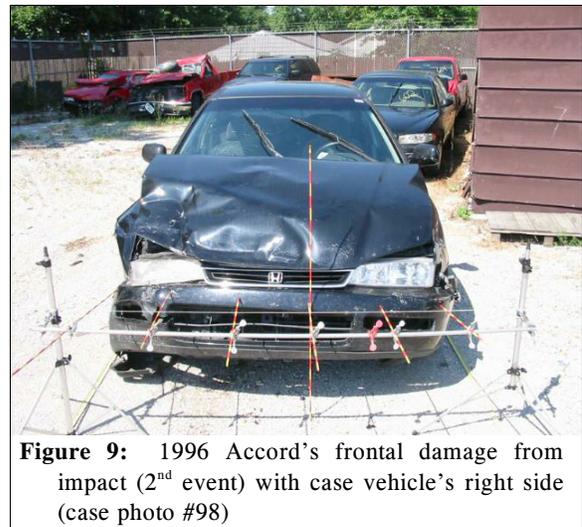
Figure 9: 1996 Accord's frontal damage from impact (2nd event) with case vehicle's right side (case photo #98)

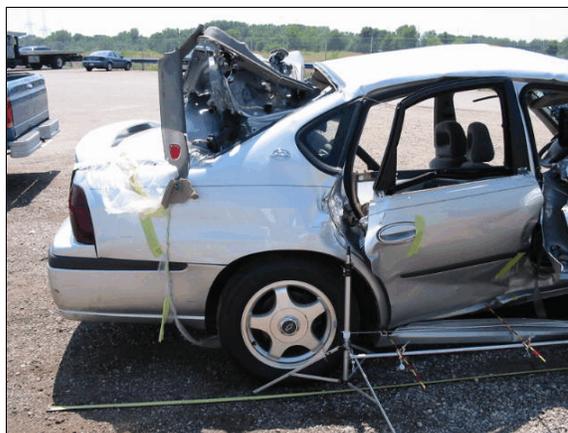
Figure 10: Damage to case vehicle's right side, rear half, from impact (2nd event) with 1996 Accord; Note: distortion to right rear door and intrusion at sill level near "B"-pillar (case photo #28)

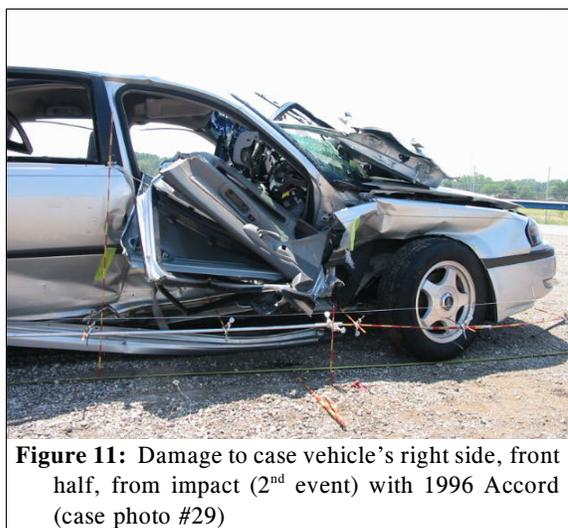
Figure 11: Damage to case vehicle's right side, front half, from impact (2nd event) with 1996 Accord (case photo #29)

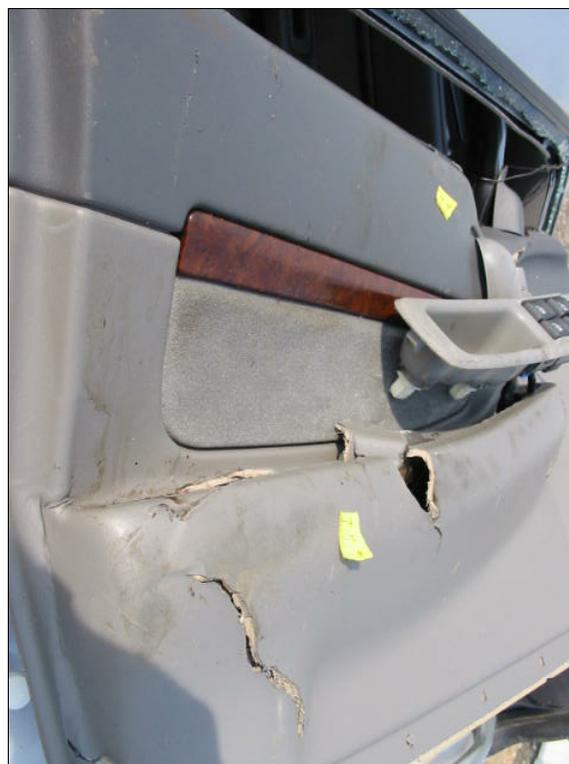
Interior Damage: Inspection of the case vehicle’s interior revealed cracks and scuffs to the driver’s (Figure 15), left rear (Figure 16 below), and right front interior door surfaces (Figure 17 below). Furthermore, the center console was cracked possibly by contact from the front right passenger but more likely by the compression that the case vehicle sustained as a result of the intrusion produced by both its left and right side impacts. There was possible contact evidence on the left “B”-pillar and evidence of contact on the left roof side rail, just forward of the left “B”-pillar (Figures 18 and 19 below). In addition, the driver’s seat back was scuffed from contact by one of the back passengers (Figure 19). There were multiple lateral and vertical intrusions to the case vehicle’s interior. Vertical intrusions occurred to the steering wheel assembly and steering wheel rim; left, center, and right instrument panels and windshield’s glazing; and the front left windshield’s header; see **ADDITIONAL INTERIOR PHOTOGRAPHS** below (i.e., specifically Figure 28 through Figure 30). The vertical intrusion resulted from the lateral compression (i.e.,

Figure 15: Interior surface of case vehicle’s left front door showing driver’s contacts and damage from intrusion (case photo #81)

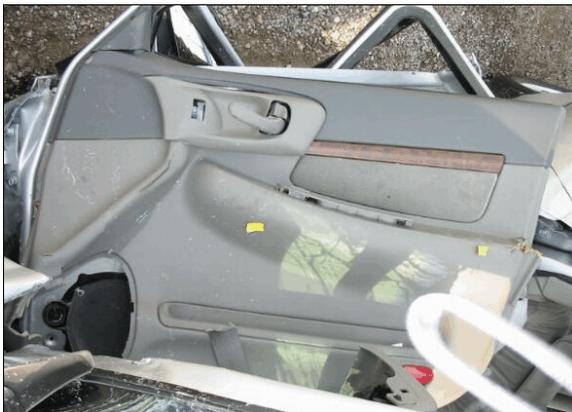
Figure 17: Interior surface of case vehicle’s right front door showing suspected areas of occupant contact (case photo #51)

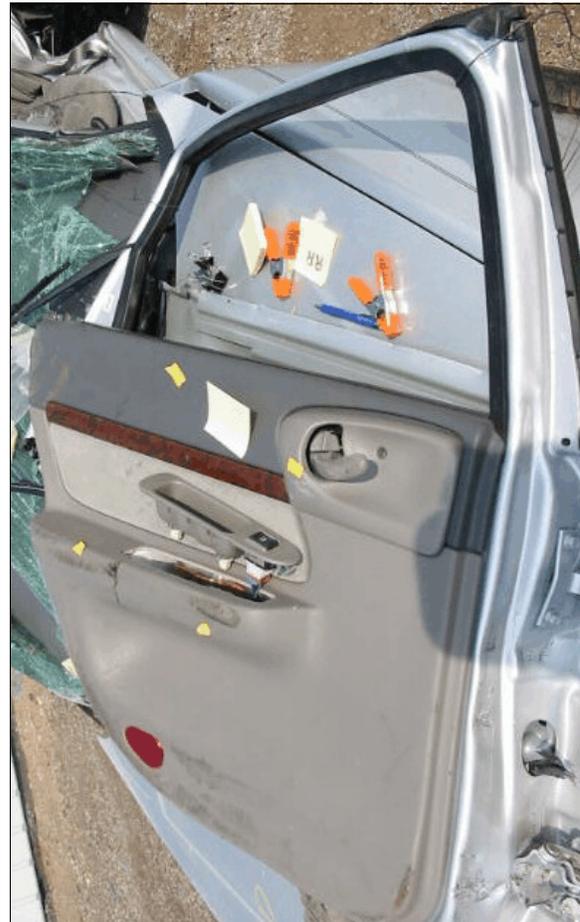
Figure 16: Interior surface of case vehicle’s left rear door showing intrusion damage and evidence of possible occupant contacts (case photo #78)

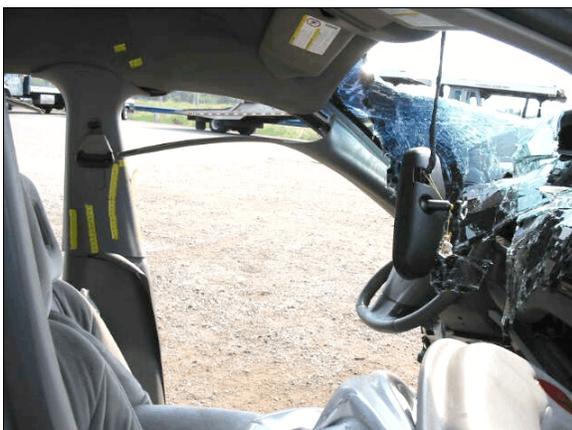
Figure 18: Case vehicle’s front seating area showing suspected occupant contacts to left roof side rail and left “B”-pillar areas (case photo #54)

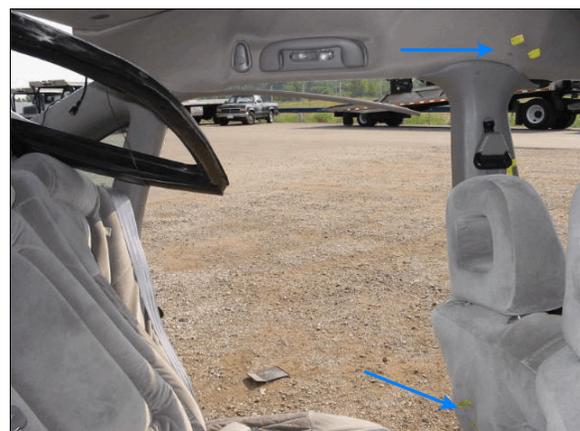
Figure 19: Case vehicle’s back seating area showing contact evidence on left roof side rail near left “B”-pillar and back left of driver’s seat back; Note: removed left side doors (case photo #77)

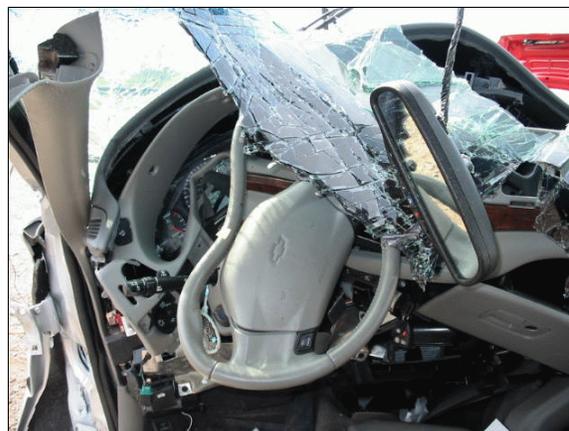
Figure 20: Case vehicle's steering wheel rim and left instrument panel deformed by lateral intrusion into driver's door (case photo #47)

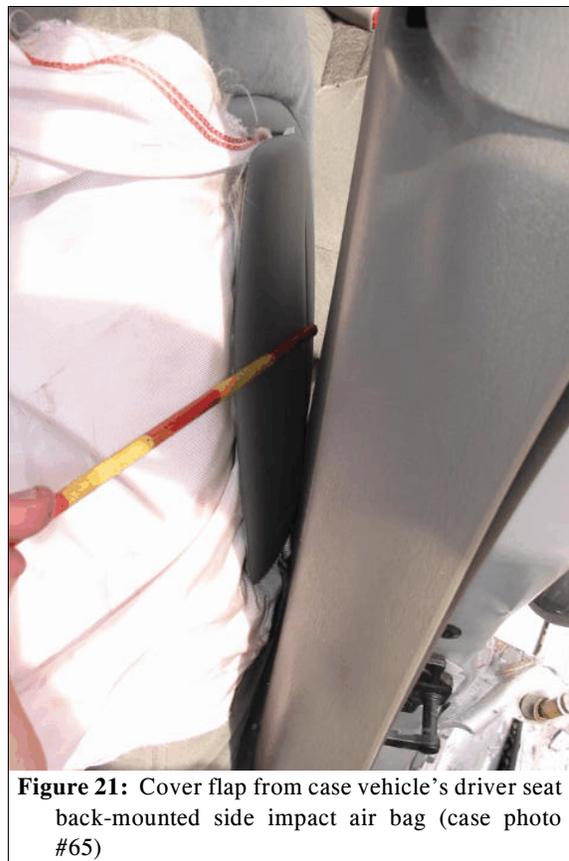
The case vehicle's driver seat back-mounted side impact air bag was located on the outboard side, near the top of the front seat back. An inspection of the air bag module's cover flap and air bag revealed that the cover flap opened at the designated tear points, and there was no evidence of damage during the deployment to the air bag or cover flap (**Figure 21**). This side air bag was

Figure 21: Cover flap from case vehicle's driver seat back-mounted side impact air bag (case photo #65)

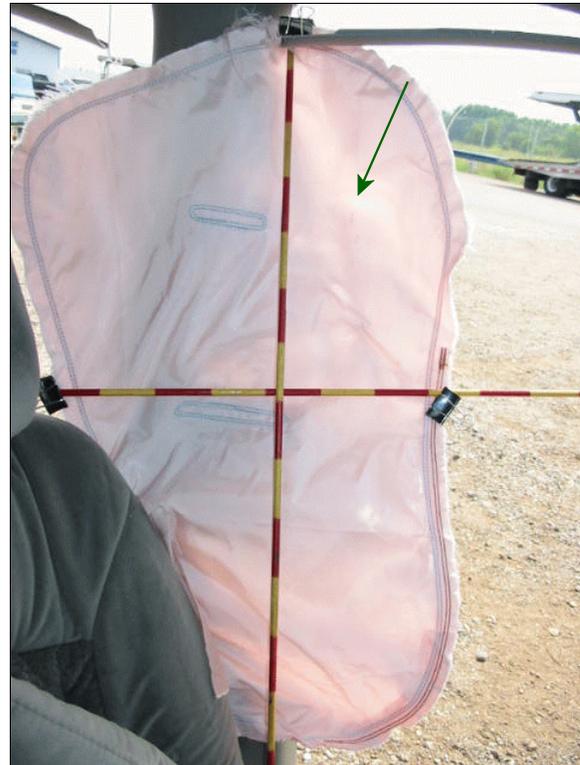
designed with two tethers, stitched internally, connecting the inboard and outboard sides of the air bag. One tether was located midway between the center and top of the air bag and the other was near the center of the air bag. The top tether was approximately 7 centimeters (2.8 inches) in width, and the bottom tether was approximately 10 centimeters (3.9 inches) in width. There were no vent ports. The deployed side air bag was essentially rectangular with a height of 68 centimeters (26.8 inches) and width of 37 centimeters (14.6 inches). An inspection of the driver's side air bag fabric revealed only a very small amount of blood/body fluid (**Figure 22**).

Figure 22: Inboard view of case vehicle's driver seat back-mounted side air bag showing internal tether stitching and faint occupant contact (arrow) on air bag's fabric (case photo #60)

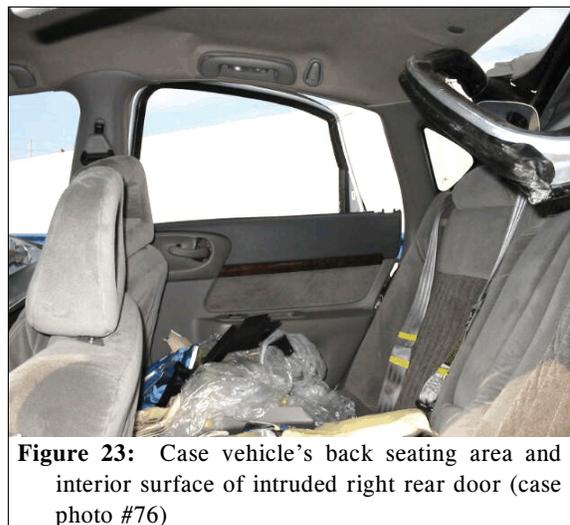
Figure 23: Case vehicle’s back seating area and interior surface of intruded right rear door (case photo #76)

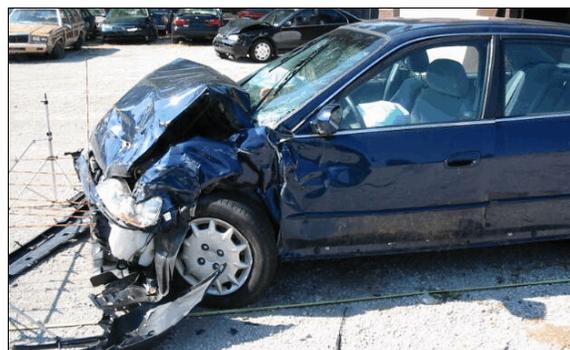
The 2001 Honda Accord LX was a front wheel drive, five-passenger, four-door sedan (VIN: 1FAFP13P9WW-----) equipped with a 2.3L, I-4 engine and a four-speed automatic transmission. Braking was achieved by a power-assisted, front disc and rear drum system. The case vehicle's wheelbase was 272 centimeters (106.9 inches), and the odometer reading is unknown because this vehicle's interior was not inspected. The 2001 Honda was equipped with advanced occupant protection system features including redesigned, dual-stage, driver and front right passenger air bags and front seat back-mounted side impact air bags. This vehicle's front air bags deployed as a result this vehicle's frontal impact (**Figure 24**).

Figure 24: 2001 Accord's frontal damage viewed from left; Note: severity of crush and deployed frontal air bags (case photo #88)

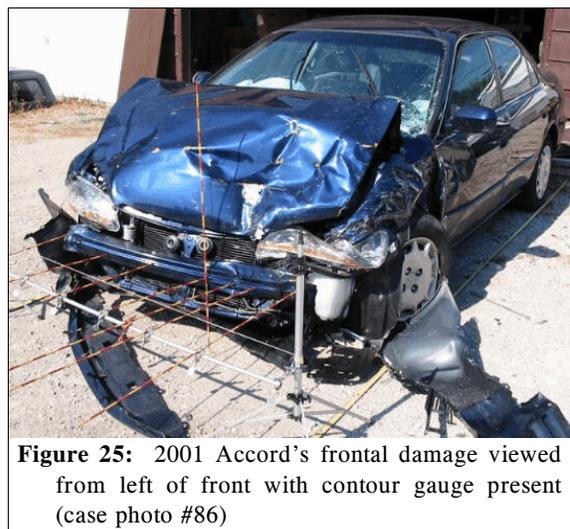
Exterior Damage: Based on vehicle inspection (**Figure 25**), the CDC for the 2001 Accord was determined to be: **12-FDEW-2 (350 degrees-1st event)**. The crush profile for the 2001 Accord is shown in the table below; maximum crush was 48 centimeters (18.9 inches) and was located 10 centimeters (3.9 inches) to the left of C₂. The WinSMASH reconstruction program, damage only algorithm, was used on the 2001 Accord's highest severity impact. The Total, Longitudinal, and Lateral Delta Vs are, respectively: 49.0 km.p.h. (30.4 m.p.h.), -48.3 km.p.h. (-30.0 m.p.h.), and +8.5 km.p.h. (+5.3 m.p.h.). The 2001 Accord was towed due to damage.

Figure 25: 2001 Accord's frontal damage viewed from left of front with contour gauge present (case photo #86)

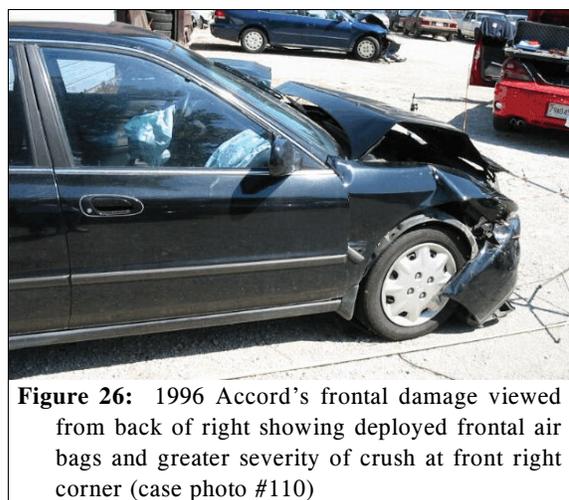
The 1996 Honda Accord LX was a front wheel drive, five-passenger, four-door sedan (VIN: 1HGCG56421A-----) equipped with a 2.2L, I-4 engine and a four-speed automatic transmission. Braking was achieved by a power-assisted, front disc and rear drum system. The case vehicle’s wheelbase was 272 centimeters (106.9 inches), and the odometer reading is unknown because this vehicle’s interior was not inspected. This 1996 Honda was equipped with driver and front right passenger air bags which deployed as a result this vehicle’s frontal impact (Figure 26).

Figure 26: 1996 Accord’s frontal damage viewed from back of right showing deployed frontal air bags and greater severity of crush at front right corner (case photo #110)

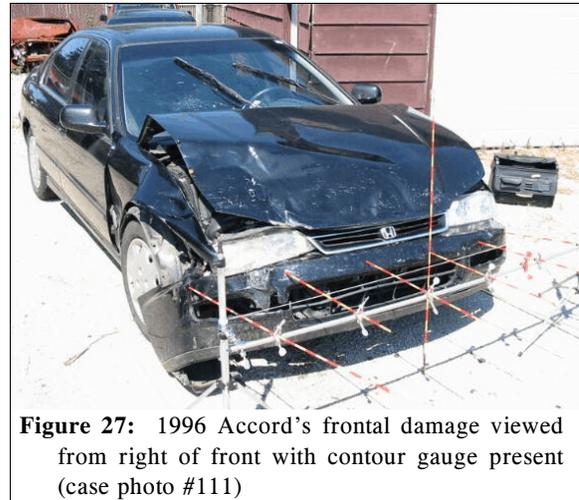
Exterior Damage: Based on vehicle inspection (Figure 27), the CDC for the 1996 Accord was determined to be **11-FDEW-02** (340 degrees–2nd event). The crush profile for the 1996 Accord is shown in the table below; maximum crush 32 cm (12.5 in) at C₆. The WinSMASH reconstruction program, damage only algorithm, was used on the 1996 Accord's highest severity impact. The Total, Longitudinal, and Lateral Delta Vs are, respectively: 31.0 km.p.h. (19.3 m.p.h.), -29.1 km.p.h. (-18.1 m.p.h.), and +10.6 km.p.h. +6.6 m.p.h.). The 1996 Accord was towed from the scene due to damage.

Figure 27: 1996 Accord's frontal damage viewed from right of front with contour gauge present (case photo #111)

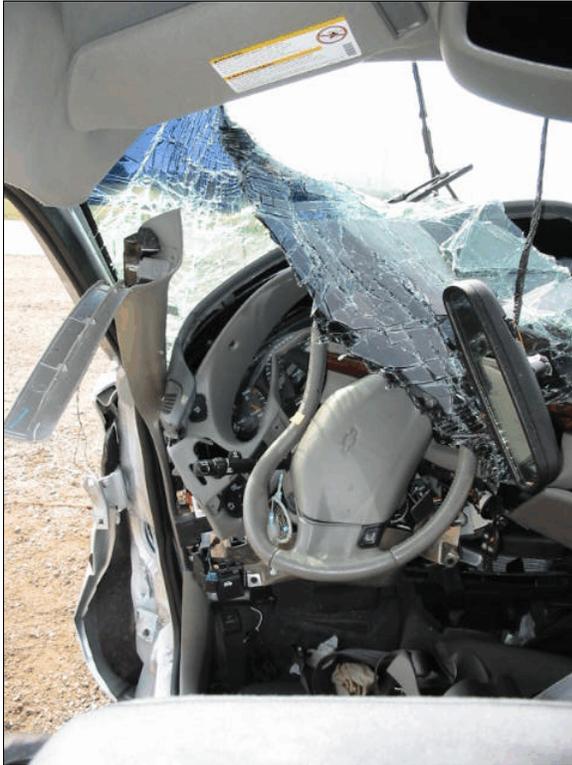
Figure 28: Case vehicle's driver seating area showing holed windshield, deformed steering wheel rim, and lateral and vertical intrusion to left instrument panel; Note: driver's door was removed during extrication (case photo #48)

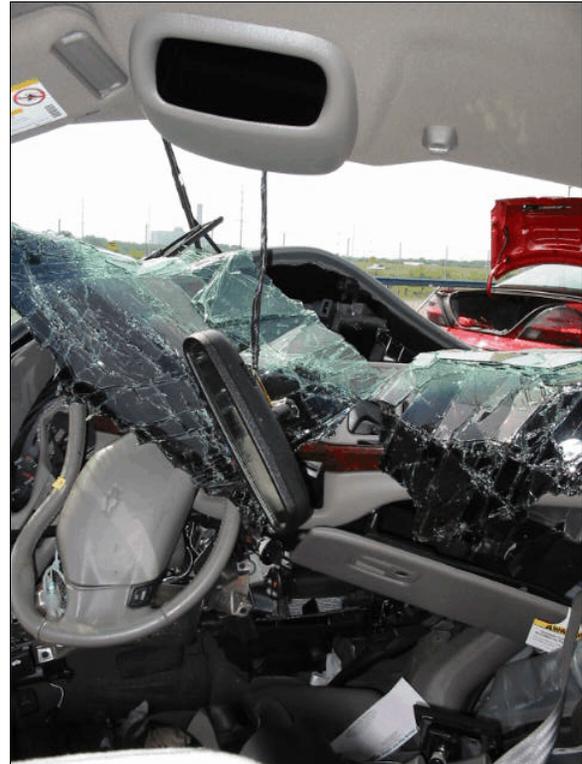
Figure 29: Case vehicle's center instrument panel area showing extensive vertical intrusion and upward roof buckling resulting from combination of left and right side impacts (case photo #49)

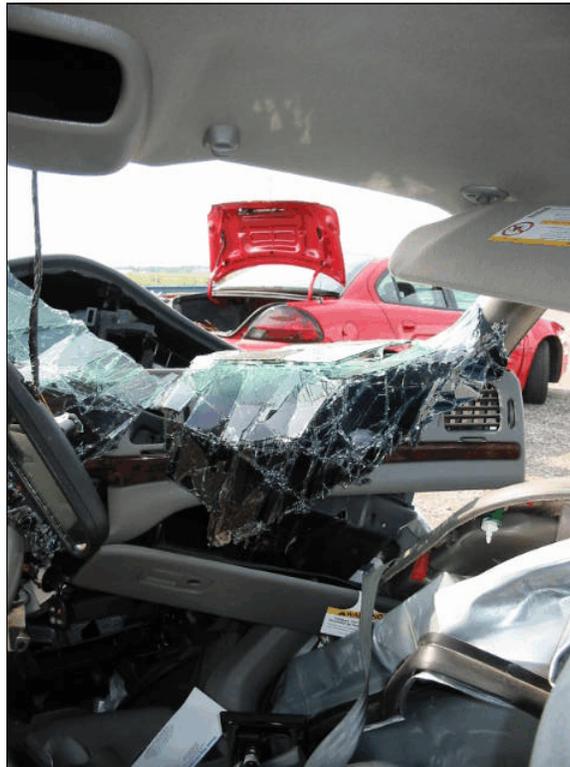
Figure 30: Case vehicle's front right passenger seating area showing lateral and vertical intrusion to right instrument panel (case photo #50)

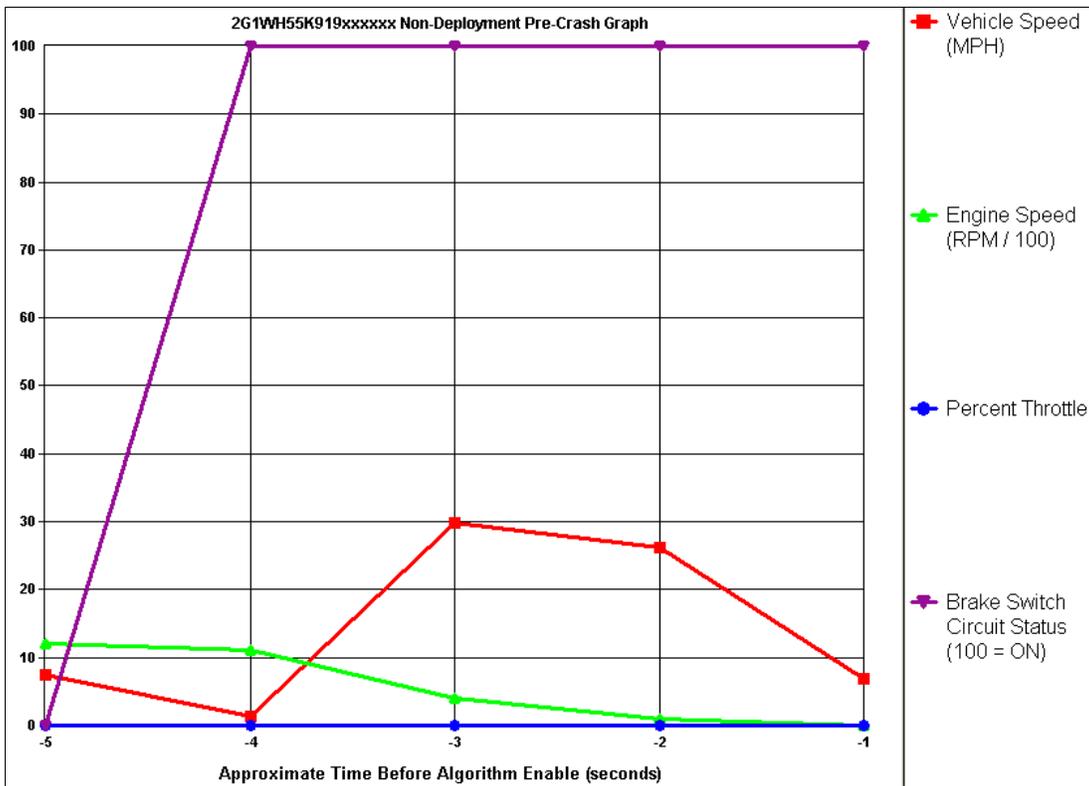
Figure 32: Case vehicle’s pre-crash speed and brake switch circuit status showing that the vehicle was most likely in a yaw [i.e., recorded speed was approximately 11 km.p.h. (7 m.p.h.)] with the driver’s foot off the accelerator when the brake was activated approximately 5 seconds prior to algorithm enable

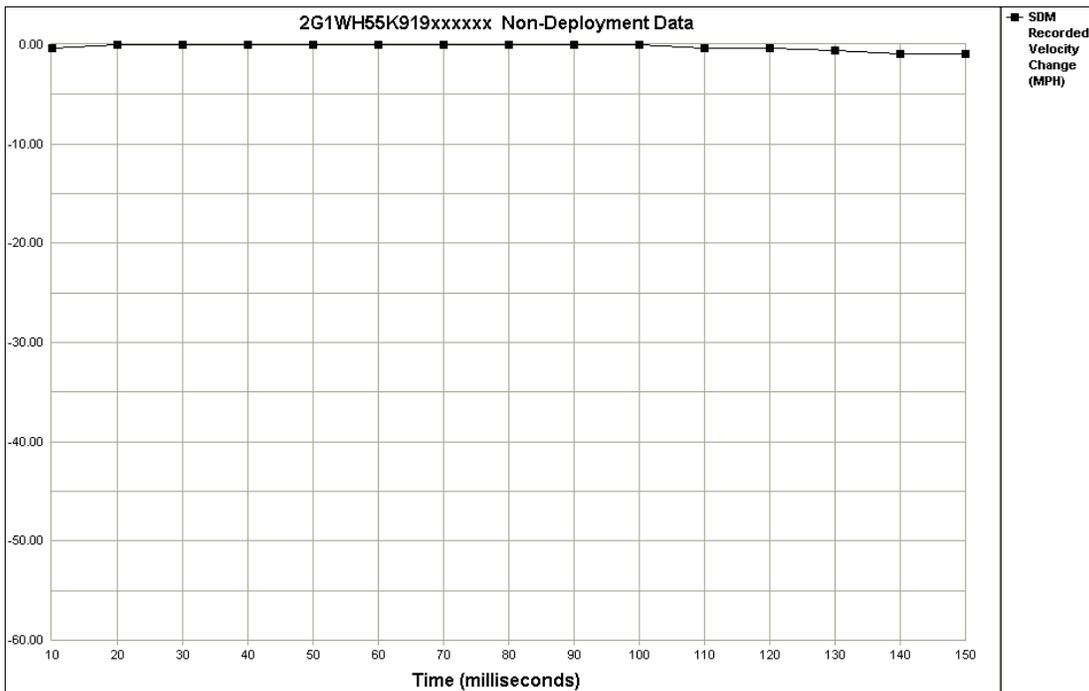
Figure 33: The case vehicle sustained a velocity change of approximately 1.5 km.p.h. (0.9 m.p.h.) during the first 150 milliseconds after the algorithm was enabled; maximum velocity change was recorded as 2.3 km.p.h. (1.4 m.p.h.) at 175 milliseconds
