On-site Child Seat Investigation / Vehicle to Vehicle
Dynamic Science, Inc. / Case Number: DS02002
1996 Honda Accord LX four-door
California
July, 2001

Dynamic Science, Inc.
Accident Investigation
Case Number: DS02002

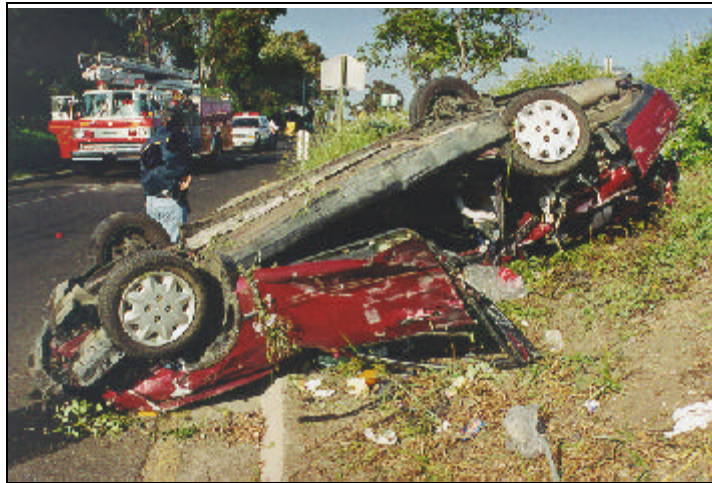
Figure 5. Final rest, case vehicle.

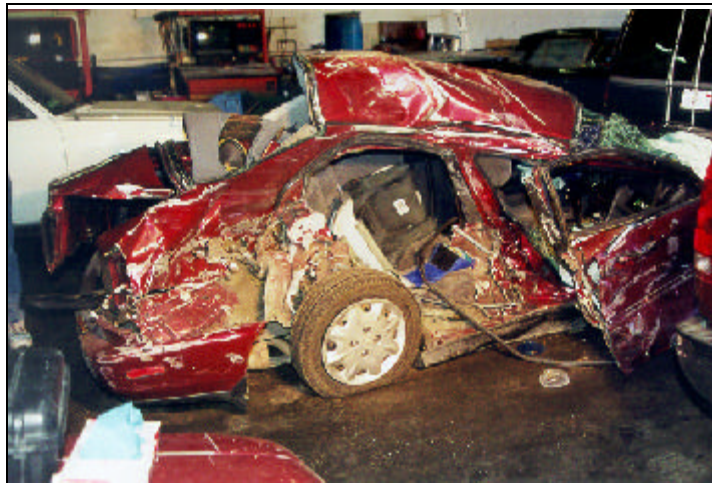
Figure 6. Right side, case vehicle.

Description:	1996 Honda Accord LX four-door	
VIN:	1HGCD5631TAXXXXXX	
Odometer:	211,866 km (131,651 miles)	
Engine:	Unknown	
Reported Defects:	None	
Cargo:	Carriage, child seats	
Damage Description:	Major right side lateral crush. Intrusion through right side plane. Vehicle declared a total loss.	
CDC:	Impact 1: Unknown Impact 2: 03RZAW4 Impact 3: 03RFEW2 Impact 4: 00TDDO3	
Delta V:	Total	Unknown
	Longitudinal	Unknown
	Latitudinal	Unknown
	Energy	Unknown

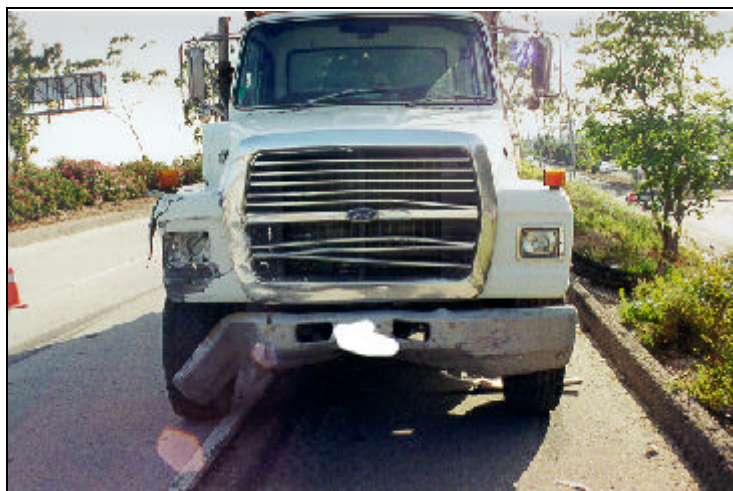
Figure 4. Front, other vehicle.

Description:	1993 Ford L8000 dump truck, 26,000-33,000 lbs GVWR	
VIN:	1FDXR82E1PVAxxxxxx	
Odometer:	Unknown	
Engine:	8.3 L, I6 diesel	
Reported Defects:	Brake on left front out of adjustment.	
Cargo:	None. Dump body empty.	
Damage Description:	Minor contact damage to front bumper and grille.	
TDC:	Impact 2: 12FZEW1 Impact 3: 03RFEW1	
Delta V:	Total	Unknown
	Longitudinal	Unknown
	Latitudinal	Unknown
	Energy	Unknown

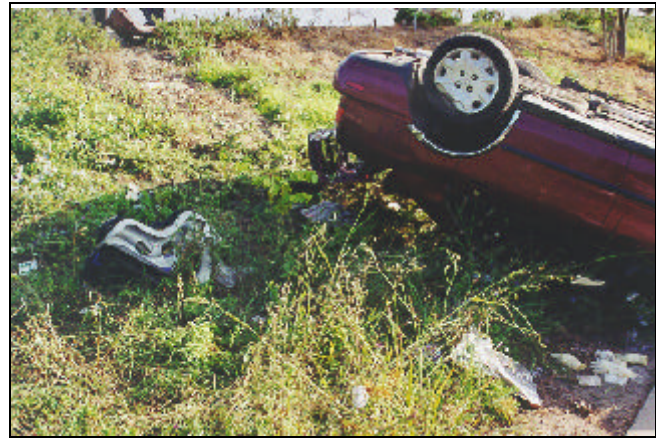
Figure 7. Reported final rest position of right rear child seat.

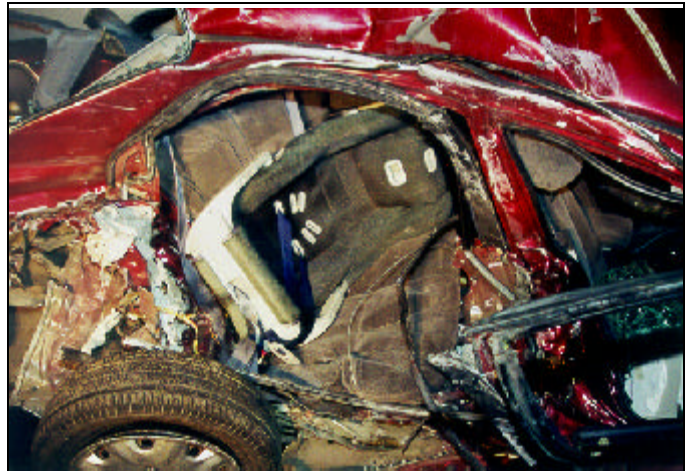
Figure 8. Final position of left rear child seat.

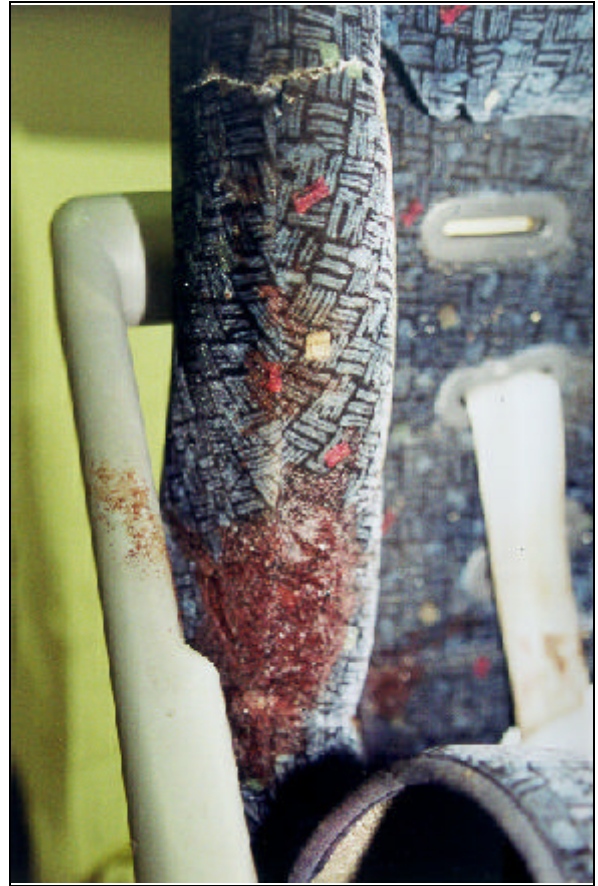
Figure 12. Right side of Century child seat showing shell fracture.

Both child seats had been placed in the vehicle and were attached to the vehicle using the available lap and shoulder belts. At impact, both child seats would have initially moved to the right. This movement was almost immediately negated by the massive intrusion through the right side. The right child seat (Century) was essentially driven into the side of the left child seat (Evenflo)—particularly the base of the seat. This internal impact caused fractures to the facing side of the child seat shells. It appears that some portion of the left child seat struck the vehicle buckle release on the seat belt securing the right child seat. The buckle came open as the vehicles separated and restitution began. As the case vehicle rolled, the right side child seat was ejected from the vehicle.

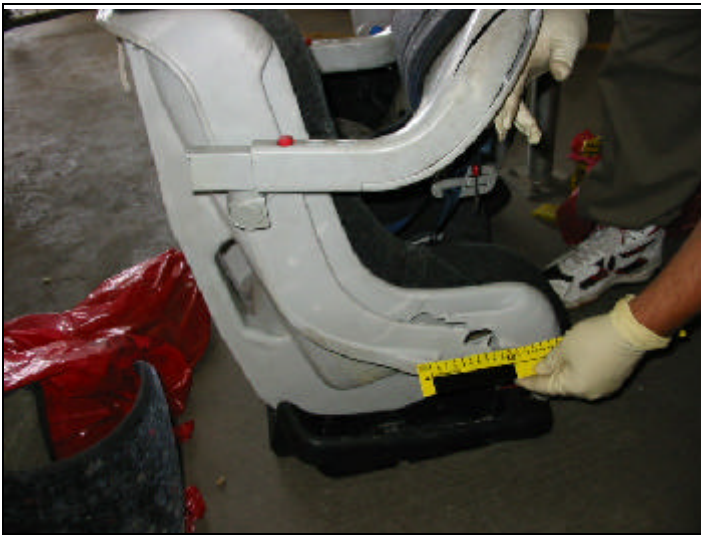
The left rear child seat remained in the vehicle. It was found lying on its right side with the seatbelt still latched and locked in ALR mode. Once the seatbelt is locked, the available length of the belt would remain fixed. As the right side of the vehicle (and the right side child seat), moved into the base of this child seat it was being compressed. The base is essentially a hollow object. As pressure was brought to bear, the base of this seat was compressed—allowing some rotational movement. The seat was pushed laterally—forcing the bottom to the left and the top to the right. Eventually, the seat was forced over onto its right side.

Figure 15. Right side, left rear child seat (Evenflo).

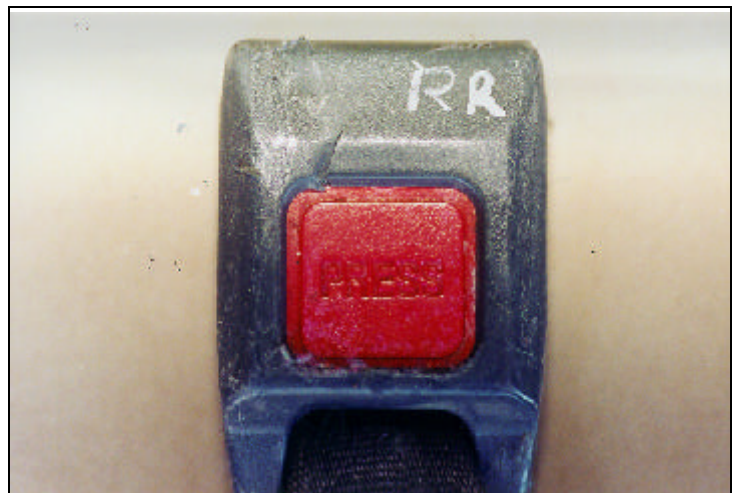
Figure 17. Indication that right rear seat belt latch button had been contacted by external object.

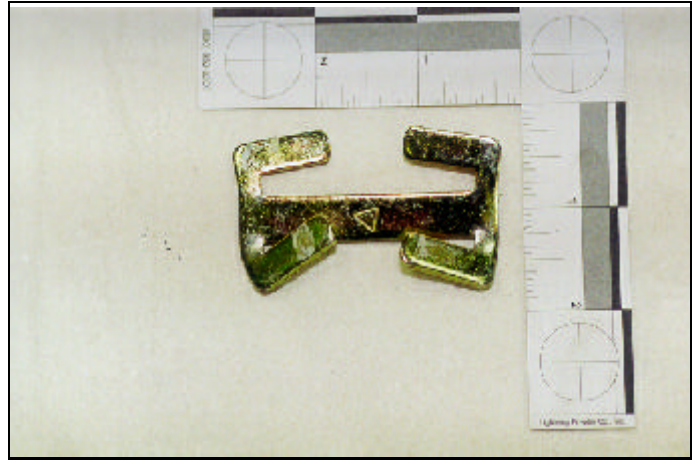
Both the right rear lap and shoulder belt and child safety seat locking clip were damaged during the crash. The damage to the seat belt was due to both lateral loading as the truck penetrated the passenger compartment and a tearing action from sharp metal surrounding the door. The seat belt was not severed. The damage to the clip was due to loading against the child seat shell as the seat was forced sideways. It is not known why the locking clip was being used since the seat belt at this seat position is equipped with a switchable retractor.

Figure 18. Deformed locking clip for right side child seat.

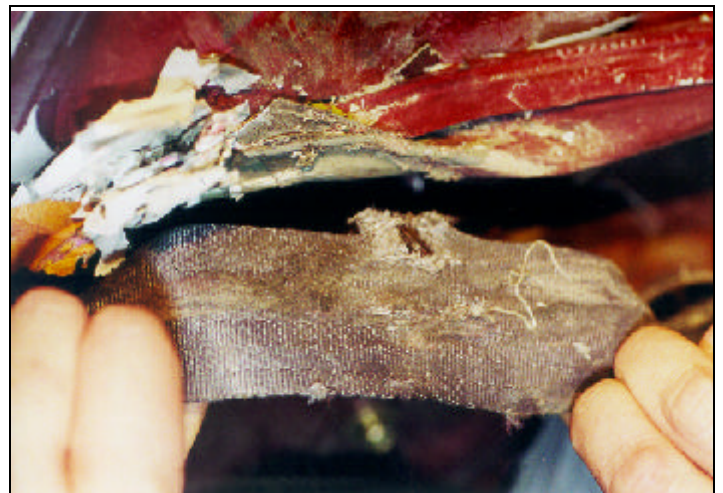
Figure 20. Tearing damage from torn metal.

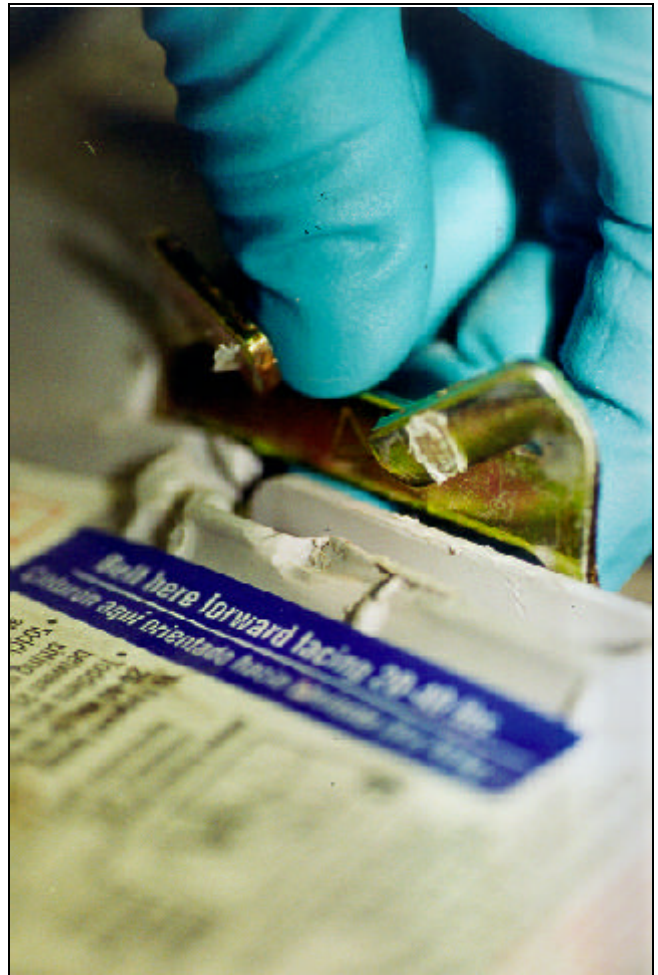
Figure 21. Locking clip damage.
