# INDIANA UNIVERSITY

### **ON-SITE ADVANCED OCCUPANT PROTECTION SYSTEM INVESTIGATION**

CASE NUMBER - IN-02-005  
LOCATION - TEXAS  
VEHICLE - 2003 TOYOTA COROLLA LE  
CRASH DATE - July, 2002

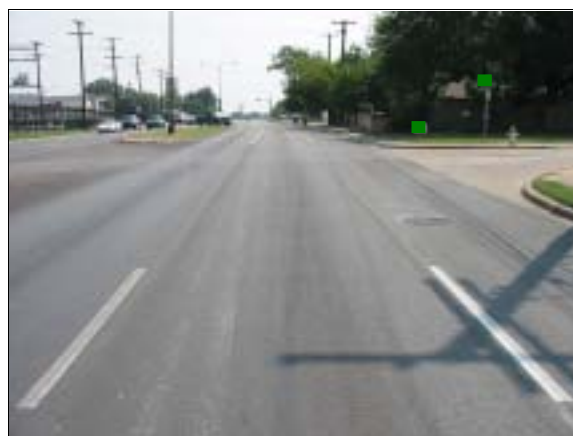
**Figure 1:** Case vehicle eastward travel path in center through lane of eastbound roadway approaching impact area at roadway's junction with Tee intersection (case photo #02)

The eastbound roadway of the case vehicle's city trafficway was straight and essentially level (i.e., there was a very slight incline, positive to the east) at the area of impact (**Figure 1** above). The pavement was bituminous but "traveled," and the width of all three eastbound lanes was 3.1 meters (10.2 feet). The eastbound roadway was bordered by barrier curbs with the curb on the north associated with a raised, unprotected, grassy median. The grassy median was approximately 4.6 meters (15.1 feet) wide, separating the east and westbound roadways. Pavement markings consisted of single, dash white lane lines that separated the three eastbound through lanes. In addition, no edge lines were present on either the north or south sides of the roadway. There was a narrow concrete shoulder/rain gutter just prior to the south curb. The coefficient of friction was estimated to be 0.65. There were no visible traffic controls in the immediate area of the crash. The posted speed limit was 56 km.p.h. (35 m.p.h.).

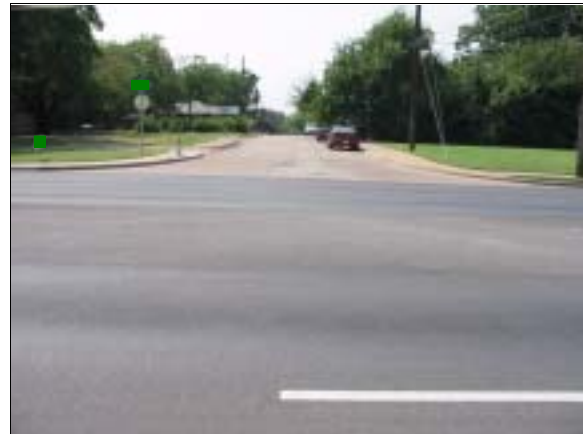
**Figure 2:** Southward view of south leg of "Tee" intersection from which Ford pickup traveled northward, across eastbound roadway, during pickup's attempted left-hand turn (case photo #11)

The other vehicle's city roadway was straight and level (i.e., there was a very slight incline, positive to the north as a result of the crown of the eastbound roadway) at the area of impact (**Figure 2**). The pavement on the south leg of the intersection was concrete but "traveled" and became bituminous where it intersected the roadway of the case vehicle. The width of the roadway measured 8 meters (26.2 feet). The roadway was bordered by barrier curbs on both the east and west sides. There were no pavement markings, and no edge lines were present. The estimated coefficient of friction was 0.65. Traffic controls consisted of a regulatory **STOP** sign (Manual on Uniform Traffic Control Devices, R1-1) located on the southeast corner of the "Tee" intersection. The statutory speed limit was 48 km.p.h. (30 m.p.h.). No regulatory speed limit sign was posted near the crash site.

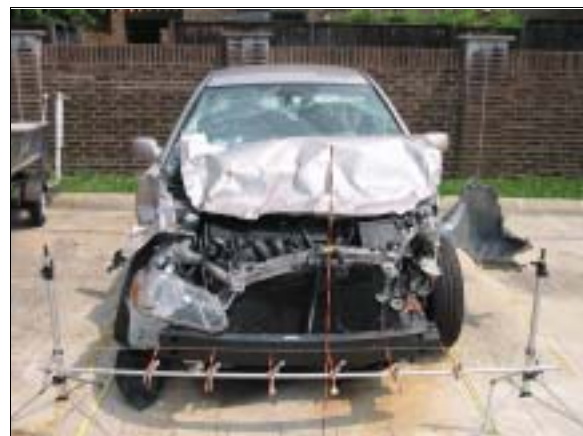
**Figure 3:** Case vehicle's frontal damage with contour gauge set at bumper level; Note: case vehicle underrode left side of Ford pickup (case photo #18)

The front (**Figure 3** above) of the case vehicle collided with and underrode the left side of the Ford (**Figure 4**), causing the case vehicle's driver and front right passenger supplemental restraints (air bags) to deploy. The exact final rest locations of both vehicles are unknown, but the case vehicle most likely continued forward a short distance while rotating slightly counterclockwise before coming to rest in the inside through lane, heading east-northeastward. The Ford rotated counterclockwise and rolled onto its right side. The Ford came to rest in the median cut between the eastbound and westbound roadways on its right side heading northwestward. The driver of the Ford fled the scene before police arrived.

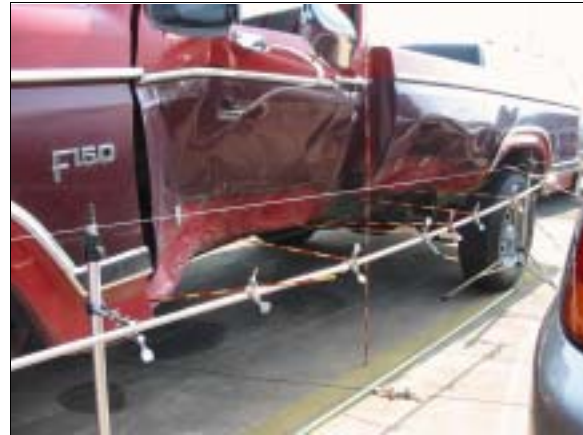
**Figure 4:** Ford pickup's left side damage—with contour gauge at sill level, resulting from impact with case vehicle; Note: case vehicle's front underrode left side of pickup (case photo #72)

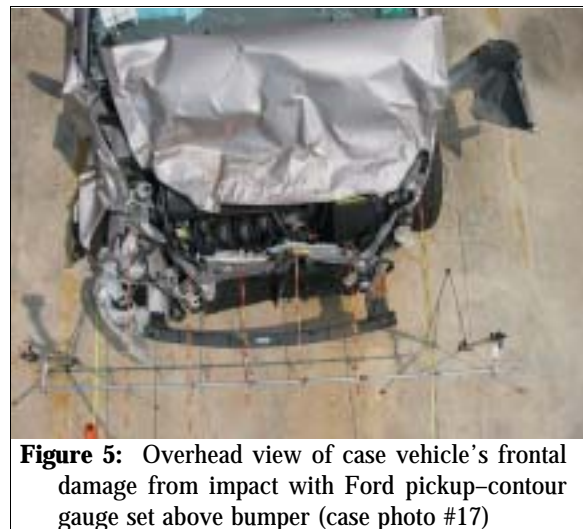
**Figure 5:** Overhead view of case vehicle's frontal damage from impact with Ford pickup—contour gauge set above bumper (case photo #17)

The case vehicle's contact with the Ford involved its entire front surface. The bumper fascia was not available, so crush measurements were taken on the actual metal bumper and there is damage across the entire front (**Figure 5** above). Furthermore, the case vehicle underrode the Ford necessitating a second set of C-measurements above the front bumper. These measurements were averaged where applicable, producing a residual maximum averaged crush of 17 centimeters (6.7 inches) at C<sub>1</sub>. The case vehicle's front bumper, bumper fascia, grille, hood, radiator, right and left headlight and turn signal assemblies, and the right and left fenders were directly damaged and crushed rearward (**Figure 3** above). The greater portion of the crush occurred above the bumper, including the hood (**Figure 5** above). The case vehicle's wheelbase was unaltered from the crash, and none of the tires were damaged, deflated, or physically restricted. The case vehicle's windshield was cracked from the impact as well. No obvious induced damage or remote buckling was noted to the remainder of the case vehicle's exterior.

Based on vehicle inspection, the CDC for the case vehicle was determined to be: **01-FDEW-3 (20 degrees)**. The WinSMASH reconstruction program, damage only algorithm, was used on the case vehicle's impact. The Total, Longitudinal, and Lateral Delta V's are, respectively: 29.0 km.p.h.(18. 0 m.p.h.), -27.3 km.p.h. (-17.0 m.p.h.), and -9.9 km.p.h. (-6.2 m.p.h.). The case vehicle was towed from the scene due to damage.

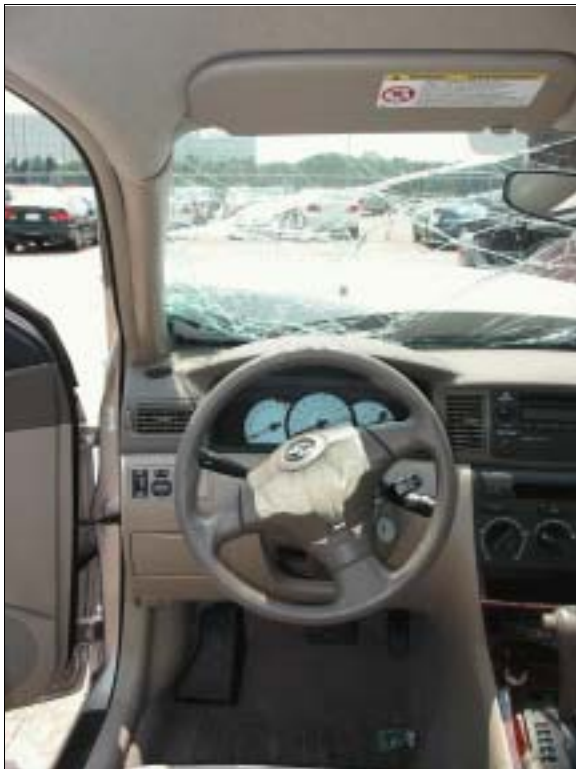
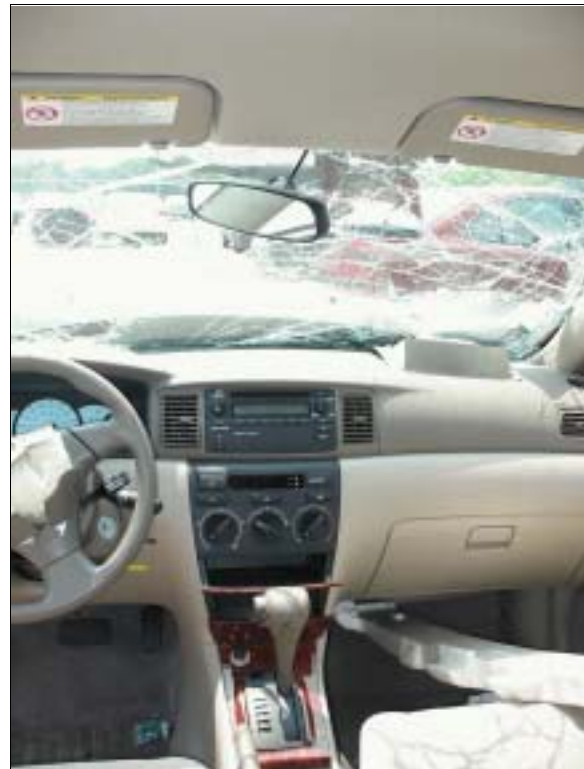
**Figure 6:** Case vehicle's driver seating and greenhouse areas showing steering wheel-mounted deployed air bag module and no obvious contact evidence to left "A"-pillar, sun visor/windshield header, and/or roof (case photo #44)

**Figure 7:** Case vehicle's front instrument panel, center console, sun visors, roof, and windshield's header and glazing; Note: only obvious contact occurred to driver's knee bolster (yellow tape), right of steering column (case photo #45)

Inspection of the case vehicle's interior revealed no major contacts to the vehicle (**Figures 6 and 7** above) though a small possible right knee scuff was found on the right portion of the knee bolster (**Figure 8**). In addition, there was no evidence of intrusion to the case vehicle's interior and no deformation to the steering wheel rim (**Figure 9**).

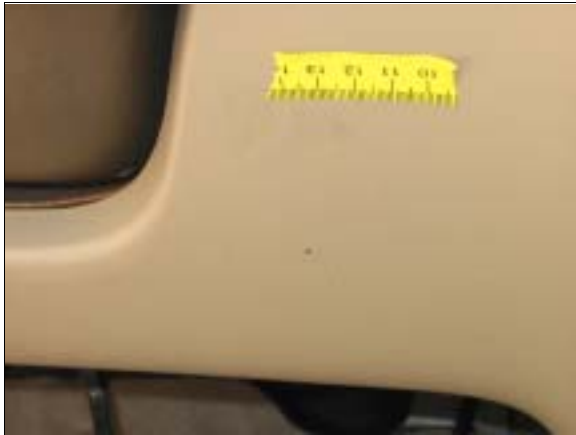
**Figure 8:** Close-up of scuff mark on case vehicle's driver knee bolster, right of steering column (case photo #48)

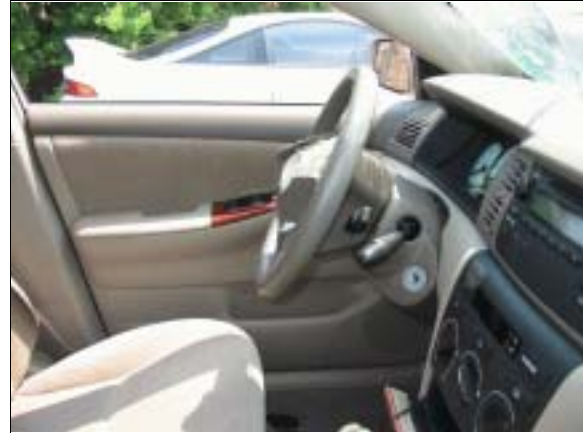
**Figure 9:** Case vehicle's driver seating area viewed from right showing no deformation to steering wheel or other obvious occupant contact evidence (case photo #51)

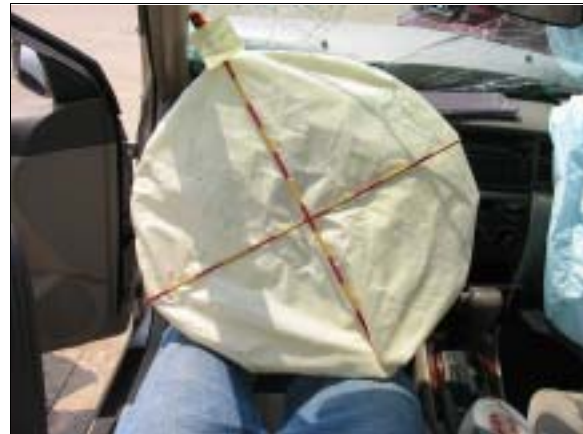
contact to the air bag's fabric in the form of scuffing, but this is more likely due to the rapid deployment out of the module (**Figure 10**).

**Figure 10:** Case vehicle's deployed driver air bag showing no apparent evidence of occupant contact (case photo #52)

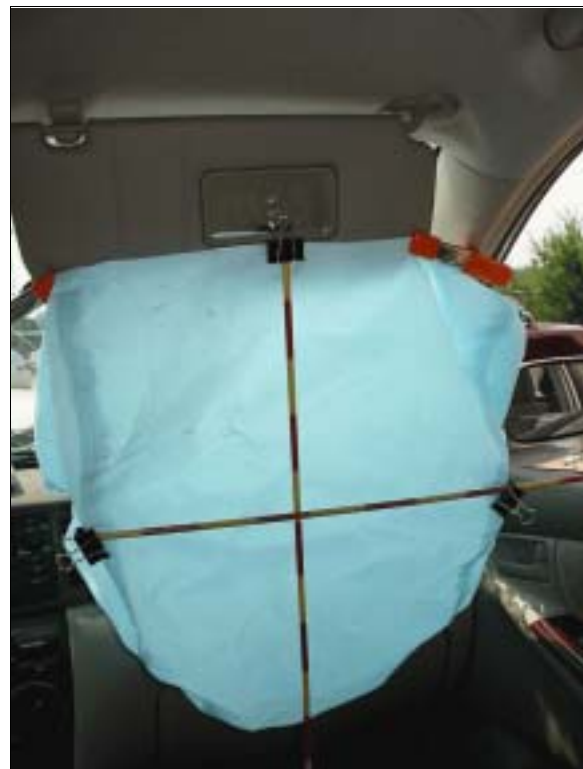
The front right passenger's air bag was located in the top of the instrument panel. There were two, symmetrical, "H"-configuration, modular cover flaps. The cover flaps were made of thick vinyl with overall dimensions of 20.5 centimeters (8.1 inches) at the horizontal seam and 6 centimeters (2.4 inches) vertically for both the upper and lower flaps. The profile of the case vehicle's instrument panel resulted in a 15 centimeter (5.9 inch) setback of the leading edge of the cover flap relative to the protruding right instrument panel. An inspection of the front right air bag module's cover flaps and air bag revealed that the cover flaps opened at the designated tear points and there was no evidence of damage during the deployment to the air bag or the cover flaps. The front right passenger's air bag was designed without tethers. The front right air bag had two vent ports, approximately 5.5 centimeters (2.2 inches) in diameter, located at the 9:30 and 2:30 o'clock positions. The deployed front right air bag was rectangular with a height of approximately 57 centimeters (22.4 inches) and a width of approximately 40 centimeters (15.7 inches). An inspection of the front right passenger's air bag fabric revealed that there was some discoloration on the front left portion of the air bag, but this was again due to flap scuffing incurred during deployment (**Figure 11**).

**Figure 11:** Case vehicle's deployed front right passenger air bag showing no occupant contact evidence (case photo #59)

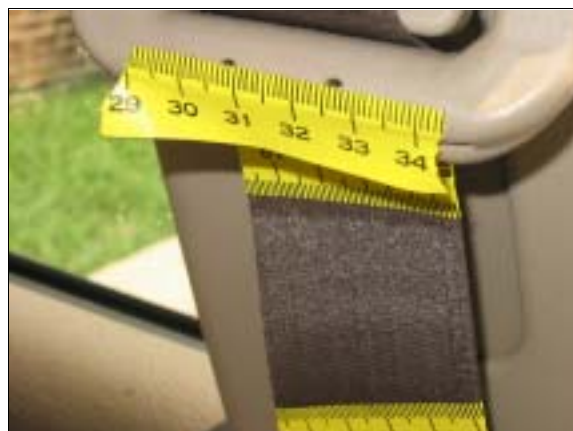
The case vehicle's driver was restrained by his available, active, three-point, lap-and-shoulder, safety belt system; the belt system was equipped with a retractor-mounted pretensioner with force limiters, housed within the "B"-pillar. Although there were no interviewee reported belt pattern bruises and/or abrasions to the driver's body, the inspection of the driver's seat belt webbing, "D"-ring, and latch plate showed a significant friction burn/scuff to the belt webbing and "D"-ring (**Figure 12**), indicating a clear sign of loading.

**Figure 12:** Close-up view of scuffing/friction burn on seat belt of case vehicle's driver (case photo #36)

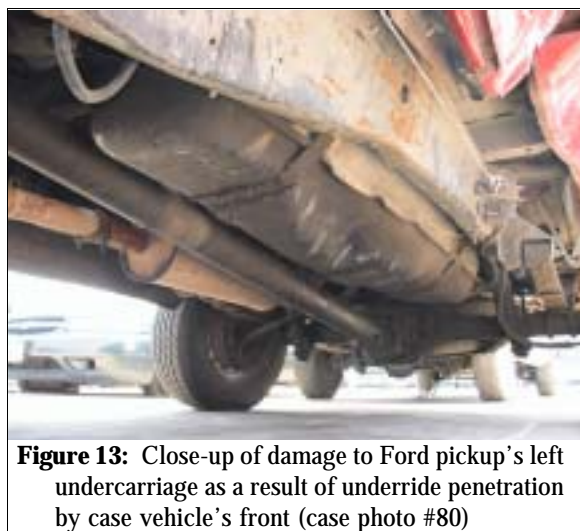
The Ford's contact with the case vehicle (1<sup>st</sup> event) involved the left side between its wheels. Direct damage began 78 centimeters (30.7 inches) rearward of the left front axle and extended 204 centimeters (80.3 inches), along the left side toward the left rear axle. Maximum crush was measured as 44 centimeters (17.3 inches) and was located 19 centimeters (7.5 inches) rearward of C<sub>4</sub>. The wheelbase on the Ford's left side was shortened 5 centimeters (2.0 inches) while the right side was unaltered from the crash. The pickup's left front door and the left side of the truck bed were directly damaged and crushed inward. Because the case vehicle underrode the pickup, there was direct contact to the left frame rail and gas tank areas (**Figure 13**). None of the Ford's tires were damaged, deflated, or physically restricted. The pickup's truck bed sustained induced damage as it was shifted rightward as a result of the left side impact. As a result of the rollover impact (2<sup>nd</sup> event), the entire right side of the Ford, rearward of the right front axle, was directly damaged (**Figure 14**).

**Figure 13:** Close-up of damage to Ford pickup's left undercarriage as a result of underride penetration by case vehicle's front (case photo #80)

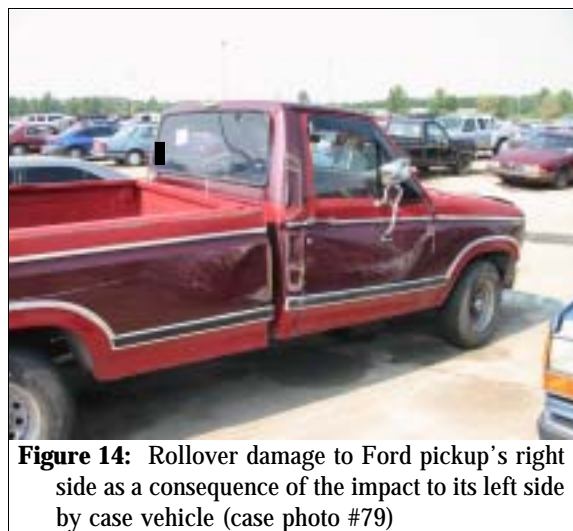
**Figure 14:** Rollover damage to Ford pickup's right side as a consequence of the impact to its left side by case vehicle (case photo #79)

Based on the vehicle inspection, the CDCs for the Ford were determined to be: **10-LZEW-3 (290 degrees)** for the impact with the case vehicle (1<sup>st</sup> event), and **00-RDAO-2** for the rollover impact (2<sup>nd</sup> event). The WinSMASH reconstruction program, damage only algorithm, was used on the Ford's highest severity impact (1<sup>st</sup> event). The Total, Longitudinal, and Lateral Delta Vs are, respectively: 21.0 km.p.h. (13.0 m.p.h.), -7.2 km.p.h. (-4.5 m.p.h.), and + 19.7 km.p.h. (+ 12.2 m.p.h.). The Ford was towed due to damage after being abandoned at the crash scene.
