**VERIDIAN ON-SITE REDESIGNED AIR BAG DEPLOYMENT  
INVESTIGATION**

**VERIDIDAN CASE NO: CA02-010**

**VEHICLE: 1998 TOYOTA RAV4**

**CRASH DATE: DECEMBER 2001**

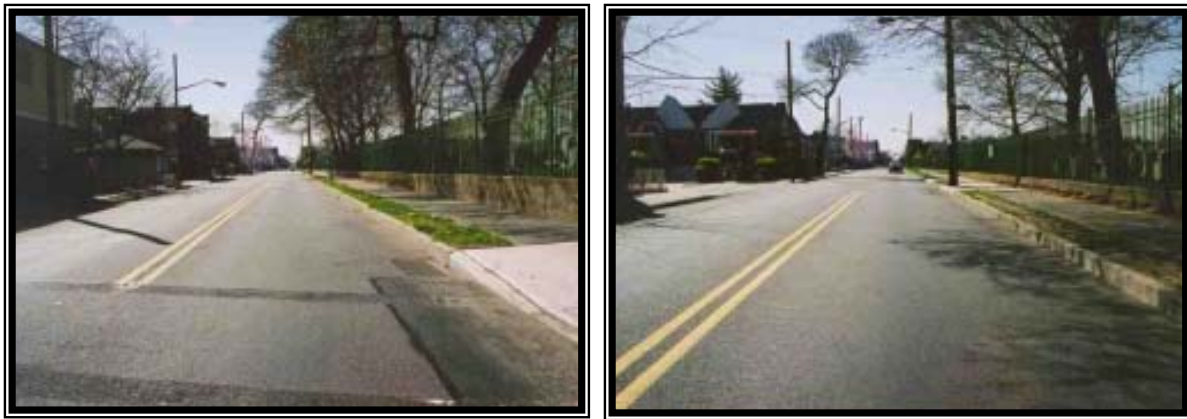
The 26 year old male driver of the 1998 Toyota Rav-4 sport utility vehicle was en-route to a holiday party and operating the vehicle westbound (**Figure 1**) at a (SCI estimated) speed of 72 km/h (45 mph) when he apparently fell asleep and allowed the vehicle to depart the right (north) pavement edge in a forward tracking mode. This pre-impact event was evidenced by the straight-line trajectory and absence of tire marks at the scene indicative of driver avoidance maneuvers (*no pre-crash braking*).

**Figure 1. Westbound approach for the 1998 Toyota RAV4.**

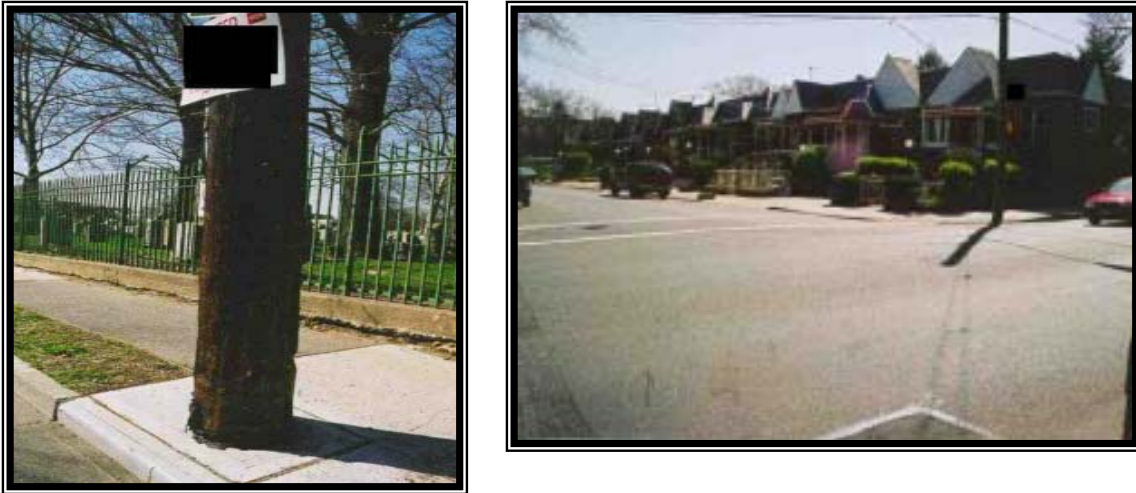
As the Toyota departed the right (north) pavement edge of the two lane urban roadway, the right front tire entered the mountable sidewalk access (left front tire still on the road) as the front right area impacted the 50.0 cm (19.7 in) diameter light support pole (**Figure 2**) resulting in severe damage. The impact-induced deceleration was sufficient to deploy the Toyota's redesigned frontal air bag system. Impact speeds and velocity changes were calculated utilizing the WinSMASH reconstruction program. The trajectory algorithm of the WinSMASH reconstruction program computed as impact speed of 72.3 km/h (44.9 mph) as the damage algorithm computed an overall velocity change of 51.2 km/h (31.8 mph) with a matching negative longitudinal component. At this point, the Toyota rotated 146 degrees clockwise and traveled 6.4 meters (21.0 feet) to final rest in the westbound lane facing northeast. This post-impact trajectory was evidenced by pavement gouge marks documented at the crash site.

**Figure 2. Northwest view of struck pole and southwest view of post-impact trajectory to final rest.**

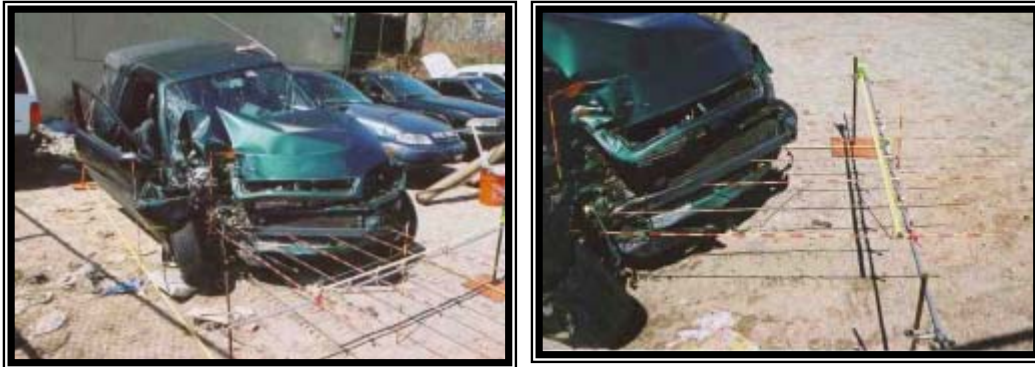
The 1998 Toyota Rav-4 sport utility vehicle sustained severe frontal damage as a result of the impact with the wooden light support pole (**Figure 3**). The direct contact damage began at the front right bumper corner and extended 38.0 cm (15.0 in) inboard. The impact deformed the entire front end width resulting in an combined direct and induced damage length (Field L) of 94.0 cm (37.0 in). Six crush measurements were documented at the level of the reinforcement bar (*bumper fascia separation*): C1=0 cm, C2=0 cm, C3=21.0 cm (8.3 in), C4=39.0 cm (15.4 in),

C5=66.0 cm (26.0 in), C6=66.0 cm (26.0 in). The Collision Deformation Classification (CDC) for this impact to the Toyota was 12-FREE-4 with a principal direction of force of 0 degrees. Wooden pole transfers were identified along the direct indentation. The right reinforcement bar corner was deformed rearward to the brake rotor as the left corner was displaced outward. The right fender was deformed rearward which restricted/deflated the right front wheel/tire and jammed the right door (tempered glazing disintegrated). Induced contact damage also produced roof buckling along the right side support pillars and outward displacement of the right door/window frame resulting in 34.5 cm (13.6 in) of passenger compartment integrity loss.

**Figure 3. Front right damage to the 1998 Toyota RAV4.**

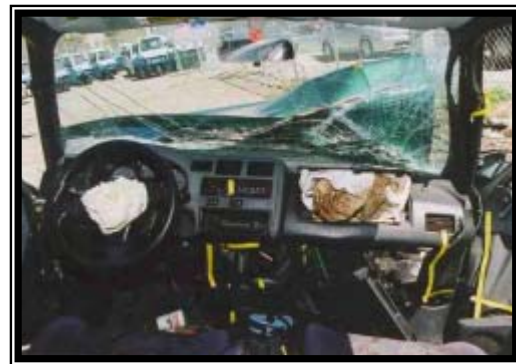
Interior damage to the Toyota was severe and was attributed to occupant contacts and component intrusions (**Figure 4**). Deep indentations and scuff marks were identified on the left knee bolster and glove compartment door. The floor-mounted transmission selector lever and console were deformed to the right, with a heavy accumulation of scuff marks noted on both side aspects. The left aspect of the front right seat back was displaced rearward approximately 5.0 cm (2.0 in). The heavy concentration of contact evidence noted to the right of each occupant space was indicative of both occupants leaning to the right pre-crash. Multiple indentations and scuff marks were documented on the instrument panel and forward portion of the right door panel, which clearly outlined extremity and pelvic regions. Tissue and hair strands were identified on the right A-pillar with a distinct head imprint and scratch marks surrounding the contact site (**Figure 5**).

**Figure 4. Interior view of the 1998 Toyota RAV4.**

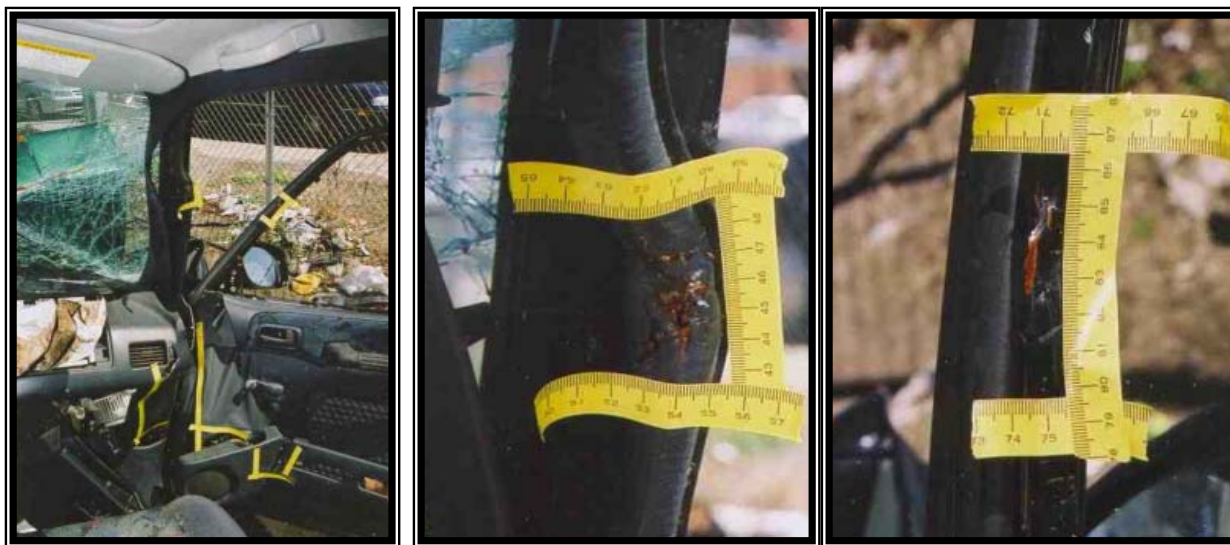
Passenger head loading of the right A-pillar extended onto the right upper window frame with outward displacement of the sheet metal noted. Spots of hand lotion were noted along the lower right instrument panel and right door panel (*plastic bottle found fractured on the right sill area*). No rim deformation or column compression was identified. Longitudinal component intrusions into the front right passenger space included 10.0 cm (3.9 in) of instrument panel, 17.0 cm (6.7 in) of toepan, and 5.0 cm (2.0 in) of hood/windshield intrusion. Longitudinal component intrusions into the front center space included 6.0 cm (2.4 in) of instrument panel, and 7.0 cm (2.8 in) of hood/windshield intrusion.

**Figure 5. Occupant contact evidence to the front right passenger space.**

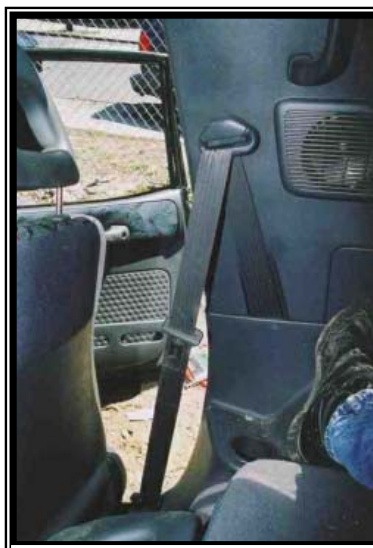
**Figure 7. Front right restraint system restricted in the stowed position.**

loading evidence identified on the D-ring, latchplate, or webbing of the front right restraint to suggest belt usage by the passenger. Furthermore, the front right restraint was found restricted in the stowed position by retractor pretensioner deployment (**Figure 7**).

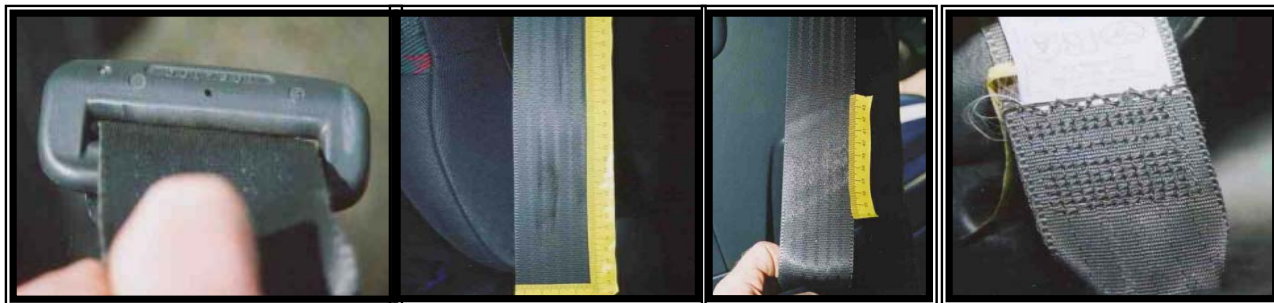
**Figure 6. Loading evidence to the driver restraint system.**

The 26 year old male driver of the 1998 Toyota Rav-4 was restrained by the available 3-point manual lap and shoulder belt system, and presumed to be leaning to the right, against the center armrest (*asleep*) with the seat track adjusted to the full rearward position. Belt usage was determined by the extensive loading evidence identified on the latchplate, D-ring, and webbing of the front left restraint.

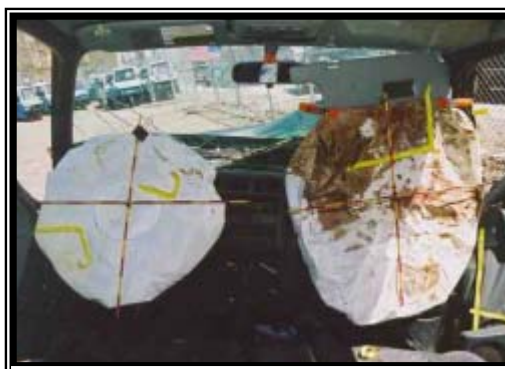
The 1998 Toyota Rav-4 was equipped with redesigned frontal air bags for the driver and front right passenger positions which deployed as a result of the crash (**Figure 8**). The driver air bag was identified by the part number: 9860214V0523 and housed in the center of the steering wheel with a horizontally oriented flap tear seam (H-configuration). The flaps were rectangular in shape as the upper flap measured 15.0 cm (5.9 in) in width and 6.0cm (2.4 in) in height as the lower flap measured 15.0 cm (5.9 in) in width and 4.5 cm (1.8 in) in height. A vertical split was noted on the lower flap. No contact evidence was identified on the exterior surface of the module cover flaps. Although the surface of the air bag seemed lightly abraded and discolored from driver interaction, light blood spattering across the upper face of the membrane masked any possible contact evidence. The diameter of the driver air bag measured 59.0 cm (23.2 in) in its deflated state (**Figure 9**). The bag was tethered by two internal straps and vented by two 2.5 cm (1.0 in) ports located at the 11 o'clock and 1 o'clock positions on the rear aspect. Air bag excursion measured 28.0 cm (11.0 in) from the steering wheel hub.

**Figure 8. 1998 Toyota RAV4 deployed redesigned frontal air bag system.**

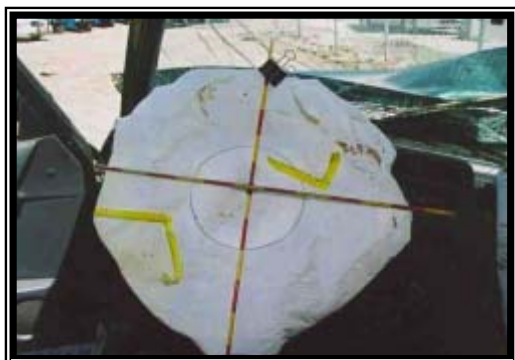
**Figure 9. 1998 Toyota RAV4 deployed redesigned driver air bag.**

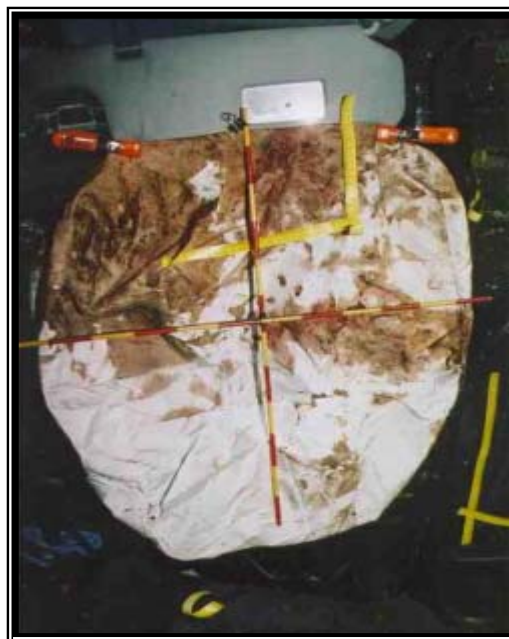
The front right passenger air bag deployed from the right mid-instrument panel area with a single cover module cover flap design hinged at the top aspect. The flap was rectangular in shape and measured 34.0 cm (13.4 in) in width and 22.0 cm (8.7 in) in height. No contact evidence was identified on the exterior surface of the cover flap. Most of the membrane was soaked with blood as extensive spattering was noted along the top portion and left side surface. Tissue transfers were identified at the left lower quadrant and right mid-portion of the air bag face. Dark colored fabric transfers were documented on the upper right quadrant and side surface of the air bag. Spots of hand lotion were noted across the center portion. The passenger air bag measured 74.0 cm (29.1 in) in width and 66.0 cm (26.0 in) in height in its deflated state (**Figure 10**). The bag was tethered by two internal straps and vented by two 4.0 cm (1.6 in) diameter

**Figure 10. 1998 Toyota RAV4 deployed redesigned passenger air bag.**

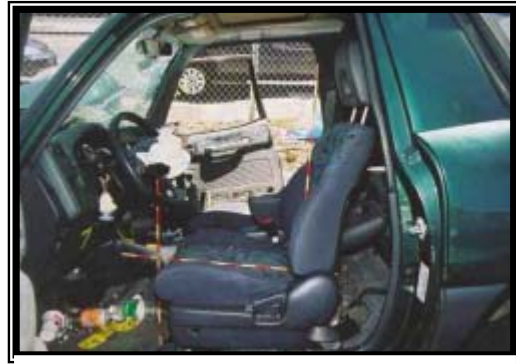
At impact, the driver initiated a forward trajectory in response to the 12 o'clock impact force and loaded the manual restraint, knee bolster, and deployed redesigned driver air bag (**Figure 11**). Contact to the deployed driver air bag was confirmed by the discoloration and abrasion pattern identified across the face of the air bag. Loading of the knee bolster was evidenced by the deformation documented to this component; however, injury information is unknown. His right lower extremity subsequently struck the center console and floor-mounted transmission selector lever, as evidenced by the displacement (forward and to the right) documented to these components. The occupant kinematics and relative concentration of contacts to the right of the driver space clearly defined that he was leaning to the right pre-crash. In addition, tissue transfers documented along the left lower quadrant of the *front right passenger air bag* were indicative of driver right upper extremity interaction. Contact to the deployed redesigned passenger air bag was further evidenced by the contrasting transfer patterns across the face of the membrane. The exit status of the driver was unknown, however, he was reported by police as transported to a local hospital for treatment of unspecified minor injuries and released. The redesigned driver air bag provided additional protection against further contact to the steering wheel hub/rim, and potential serious injury.

**Figure 11. Driver seating area.**

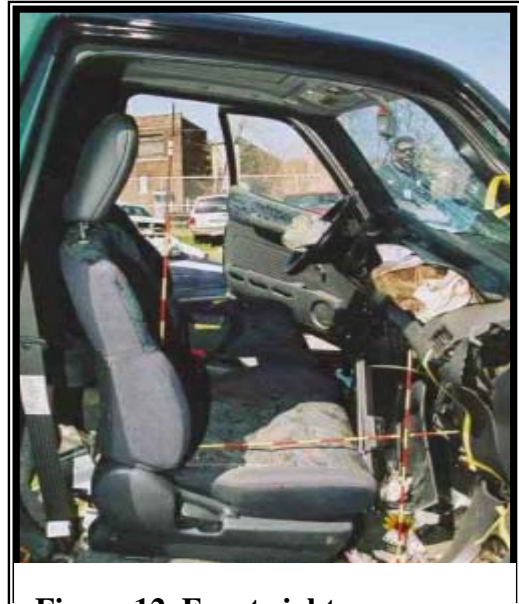
At impact, the front right passenger initiated a forward trajectory in response to the 12 o'clock impact force (**Figure 12**) as her lower extremities loaded the glove compartment door and knee bolster. The distinct indentations clearly outlined lower leg and pelvic regions with subsequent (continued) occupant loading into the forward aspect of the right door panel. Loading of these components resulted in bilateral thigh contusions and a (indirect contact) fracture of the right femur. Her left upper extremity struck the adjacent right instrument panel resulting in a posterior contusion and an unspecified radius/ulna fracture. Her right upper extremity contacted the forward portion of the right door panel resulting in additional posterior soft tissue injury. These injury mechanisms were evidenced by the narrow indentations and scuff marks documented on these components. The occupant kinematics and relative concentration of contacts to the right of the passenger space clearly defined an out-of-position pre-impact posture. The contact pattern identified on the outboard and right side aspect of the membrane indicated only minimal occupant interaction with the deployed redesigned front right passenger air bag. Fabric transfers documented along the upper right quadrant and side aspects of the membrane were attributed to probable left torso/upper arm interaction. At this point, she struck the right A-pillar which resulted in extensive multiple head trauma, evidenced by the indentations, hair strands, and tissue surrounding the contact site. Soft tissue injury involved a 12.7 cm (5.0 in) laceration that extended from the left frontal scalp diagonally across the forehead to the right eyebrow, and a 1.3 cm (0.5 in) right eyelid laceration. The globe of the right eye was also diffusely hemorrhagic and avulsed posteriorly into the skull. Multiple skull fractures were sustained to the (basilar) anterior/middle cranial fossa along with comminuted and depressed fractures of the frontal bone (vault). Underlying brain trauma included acute cerebral contusions, a cerebral avulsion across multiple regions, a diffuse axonal injury, with subdural and subarachnoid hemorrhages.

**Figure 12. Front right passenger space.**
