**VERIDIAN ON-SITE ADVANCED OCCUPANT PROTECTION
SYSTEM (AOPS) INVESTIGATION**

VERIDIAN CASE NO. CA02-011

VEHICLE - 2000 FORD TAURUS SE

CRASH DATE - FEBRUARY, 2002

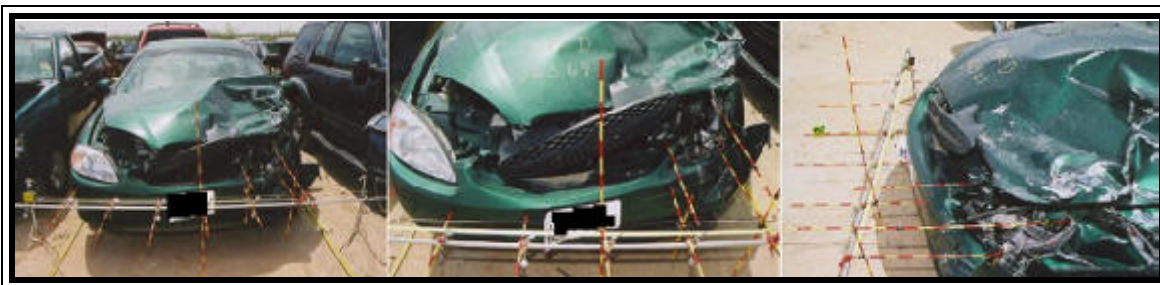
The 2000 Ford Taurus SE sustained moderate frontal damage as a result of the impact with the 1990 Ford F-150 pickup truck (**Figure 3**). The direct contact damage began at the front left bumper corner and extended 27.0 cm (10.6 in) inboard. The impact deformed the entire front end width resulting in a combined direct and induced damage length (Field L) of 133.0 cm (52.4 in). Six crush measurements were documented at the level of the reinforcement bar (*bumper fascia separation*): C1= 28.0 cm (11.0 in), C2= 12.5 cm (4.9 in), C3= 7.5 cm (3.0 in), C4= 2.5 cm (1.0 in), C5= 0 cm, C6= 0 cm. The Collision Deformation Classification (CDC) assigned for this impact to the Ford was 12-FLEE-4 with a principal direction of force of (-)10 degrees. The hood was deformed slightly up and rearward from the impact force. Direct contact damage was also identified on the left front side surface and attributed to spin-out contact following initial engagement. This direct damage began at the front left bumper corner and extended rearward 91.0 cm (35.8 in). The left fender was deformed rearward which partially restricted the right front wheel/tire (not deflated). No wheelbase reduction was identified. The windshield was fractured at the left lower A-pillar from exterior impact forces only. All tempered glazing remained undamaged.

Figure 3. Front left damage to the 2000 Ford Taurus SE.

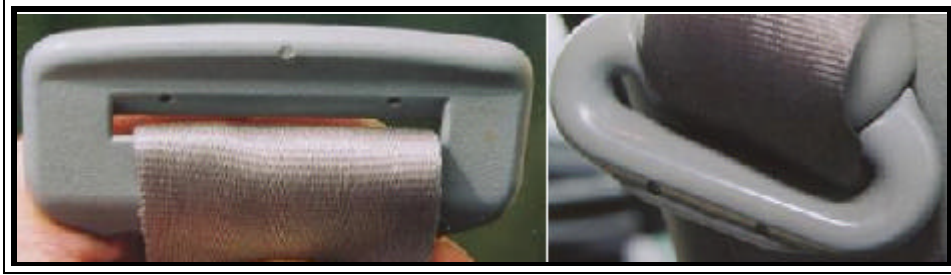
The interior of the Ford Taurus consisted of a five passenger seating configuration with front bucket and rear bench seats. The driver 3-point manual lap and shoulder belt system consisted of a continuous loop belt webbing with a sliding latchplate and a dual mode retractor (inertial lock/belt sensitive). Dimpling was documented on the shoulder portion of the driver restraint along with abrading to the latchplate webbing sleeve, which was attributed to latchplate loading (**Figure 4**). The front right (and rear) seating position was equipped with a 3-point manual lap and shoulder belt system which consisted of a continuous loop belt webbing with a sliding latchplate and a retractor equipped with an inertial and switchable lock mechanism.

Figure 4. Loading evidence to the driver restraint.

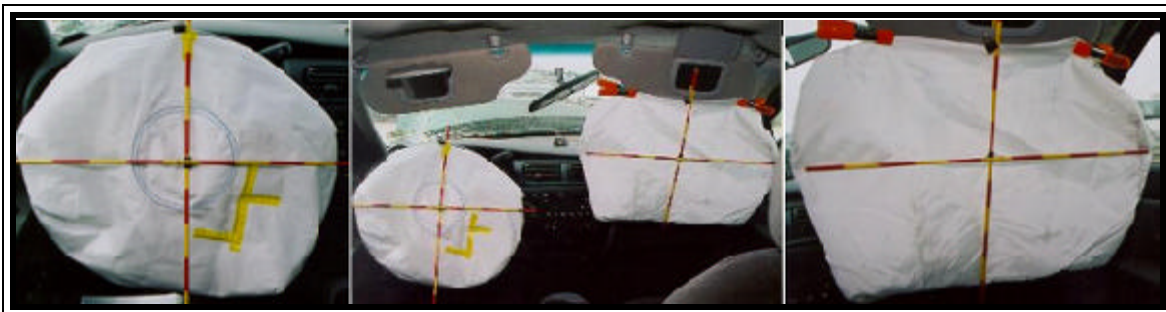
The 2000 Ford Taurus SE was equipped with dual stage frontal air bags for the driver and front right passenger positions which deployed as a result of the crash (**Figure 5**). The driver air bag was identified by the Ford part number: P5206000-00D. The air bag was housed in the center of the steering wheel with a horizontally oriented flap tear seam (H-configuration). The flaps were nearly symmetrical in shape as the upper flap measured 16.5 cm (6.5 in) in width and 7.5 cm (3.0 in) in height while the lower flap measured 16.5 cm (6.5 in) in width and 5.5 cm (2.2 in) in height. No contact evidence was identified on the exterior surface of the module cover flaps, however, elongated black vinyl transfers were identified at the right lower quadrant of the air bag face from expansion within the module. The diameter of the driver air bag measured 54.5 cm (21.5 in) in its deflated state. The bag was tethered by two internal straps and vented by two 3.2 cm (1.3 in) ports located at the 11 o'clock and 1 o'clock sectors on the rear aspect of the air bag. Rearward air bag excursion measured 27.5 cm (10.8 in) from the steering wheel hub. The vehicle was also equipped with a driver's seat track positioning sensor. The driver was not seated within a 10.2 cm (4.0 in) zone of full forward, therefore, the frontal air bag system's second stage deployed. It should be noted that the driver's seat track was found at the full rearward position (*no vehicle power*) at the time of the SCI inspection. The lack of driver height and weight prevents determination of the exact seat track position.

The front right passenger air bag deployed from the right top instrument panel area with a single cover flap design hinged at the forward aspect. The passenger air bag was identified by the Ford part number: P5202880-00A with a bar coded lot number of: *TS0202N0403*. The flap was rectangular in shape and measured 27.6 cm (10.9 in) in width and 14.5 cm (5.7 in) in height. No contact evidence was

Figure 5. 2000 Ford Taurus SE deployed redesigned frontal air bags.

identified on the exterior surface of the module cover flap, however, multiple black vinyl transfers were noted across the lower portion of the bag face from expansion within the module. The passenger air bag measured 58.8 cm (23.1 in) in width and 53.0 cm (20.9 in) in height in its deflated state. The bag was vented by two 5.4 cm (2.1 in) diameter ports located at the 10 o'clock and 2 o'clock sectors on the side aspect of the bag. No internal tether straps were present. Rearward bag excursion measured 51.0 cm (20.1 in) from the aft portion of the right instrument panel.

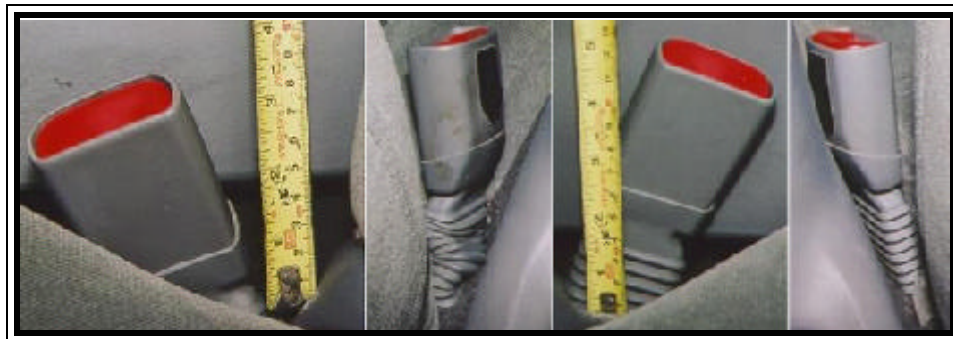
The front restraint systems also included buckle pretensioners mounted longitudinally alongside the seat cushions (**Figure 6**). The activation of the driver side pretensioner resulted in 57.0 millimeters (2.2 in) of piston movement. The piston pulls a cable which lowers the height of the buckle assembly, reducing slack in both the lap and shoulder belt webbing. The front right seating position was not occupied, therefore, the buckle pretensioner did not fire.

Figure 6. 2000 Ford Taurus SE deployed driver and non-deployed front right buckle pretensioners.

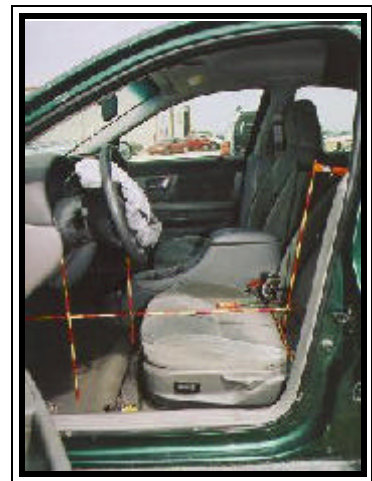
The 17 year old female driver of the 2000 Ford Taurus SE was restrained by the available 3-point manual lap and shoulder belt system, and seated in an upright posture with the seat track adjusted to an approximated mid-to-rear position (**Figure 7**). Contrary to the vehicle’s EDR summary, belt usage was evidenced by the loading marks documented on the webbing and D-ring of the driver restraint.

Figure 7. Interior view of the driver space.

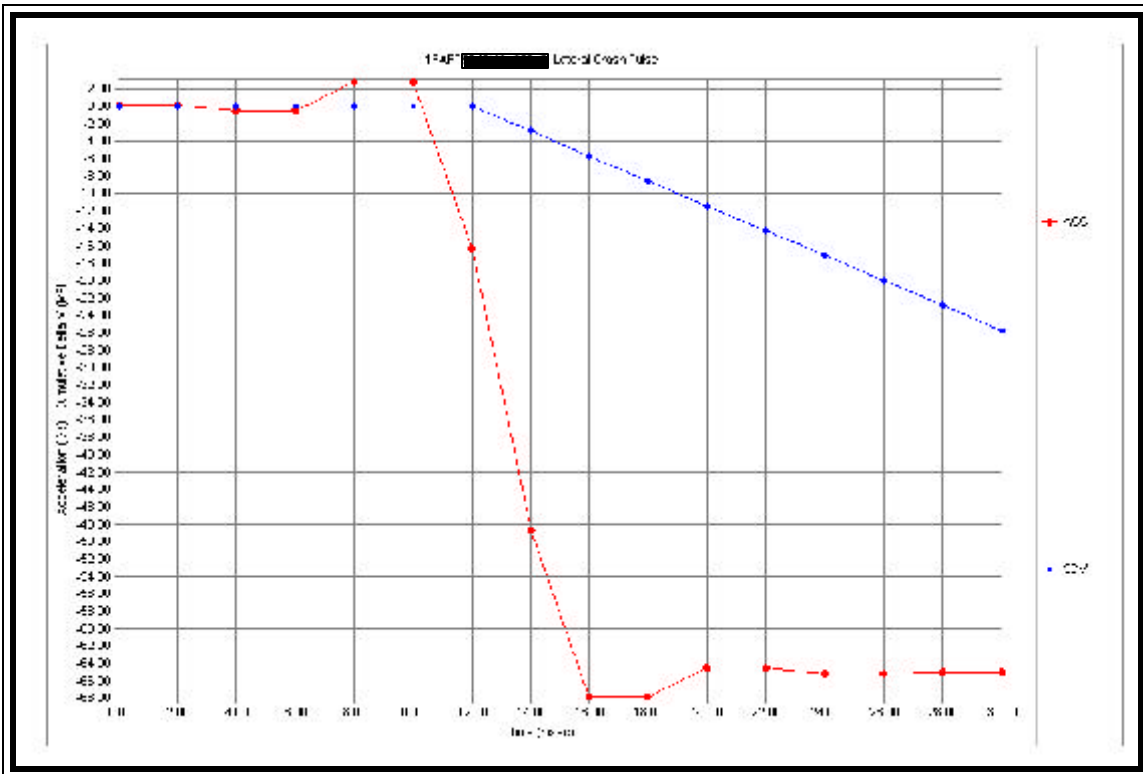
The 2000 Ford Taurus SE Restraints Control Module (RCM) was located under the center instrument panel area as the event data was retrieved via the J1962 connector found to the left of the steering column. The Event Data Recorder (EDR) records deployment events for the AOPS. In this crash, the EDR recorded a *non-deployment* with a longitudinal (element) velocity change of -51.8 km/h (-32.2 mph) at the 30 millisecond interval. The system status at deployment reflected the driver's belt switch circuit status as "unbuckled".

Figure 11. 2000 Ford Taurus SE EDR report.

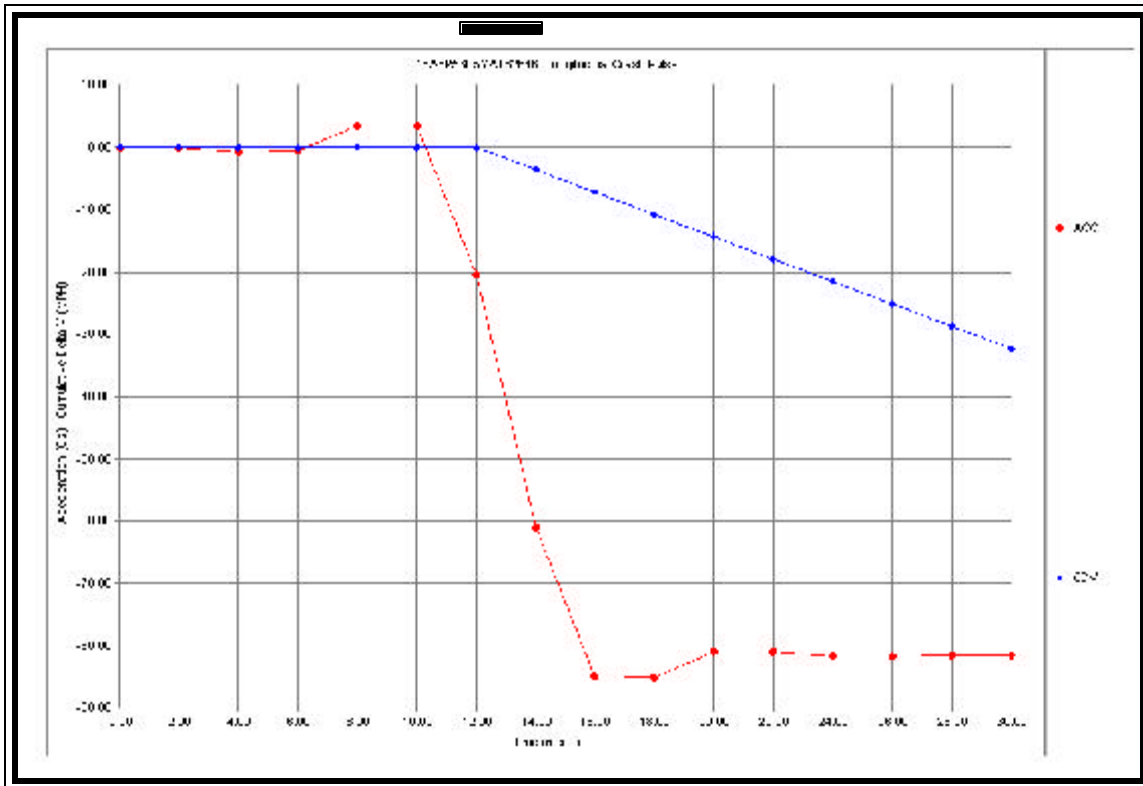
Figure 12. 2000 Ford Taurus SE EDR report.
